**From:** Andrew Van Winkle <avw@braidx.com>  
**Date:** Wednesday, October 8, 2025 at 19:15  
**To:** Veronica Hernandez <vhernandez@rollingwoodtx.gov>  
**Cc:** Michelle Van Winkle <mvw@braidx.com>  
**Subject:** Re: Van Winkle, Water Bill. FW: Clarification on Appeals Process

1. Attached are the materials I printed and handed to the Utility Commission Members at the meeting tonight.
  - Original Adjustment Request which was submitted February 6, 2025.
  - Photo showing the location of the leak relative to the water meter and the trench dug by RW's Utility Contractor to connect the new water line to our meter.
  - Water Bill dated January 31, 2025
  - My calculations dollar amounts related to our adjustment request.

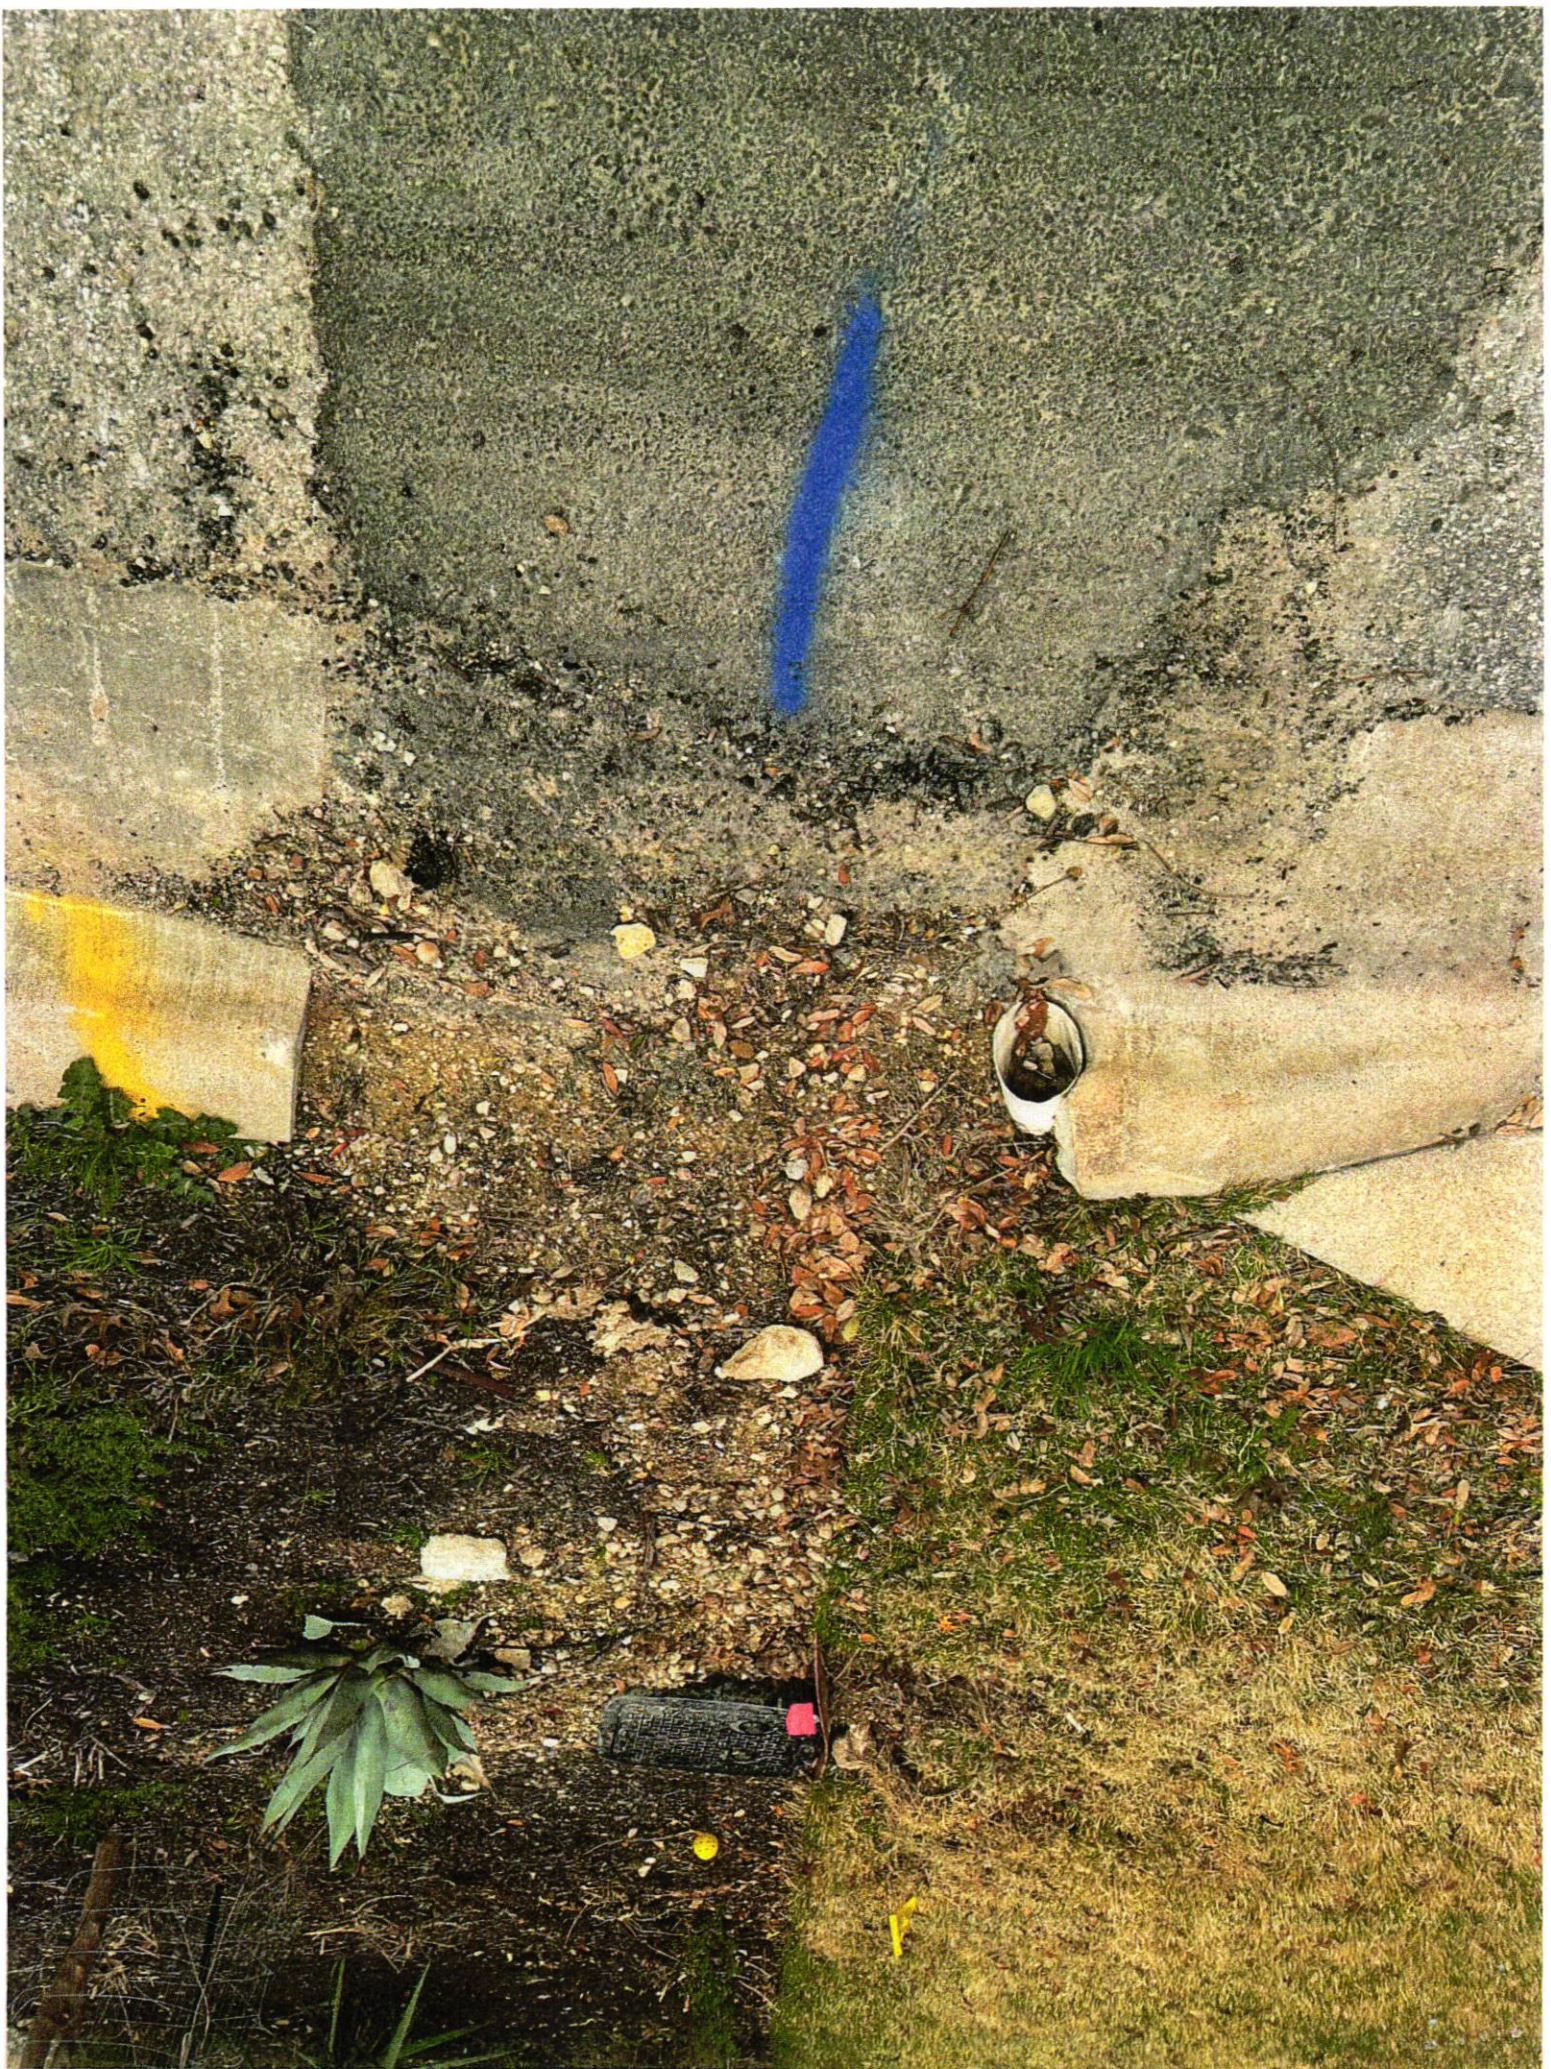
The Utility Commission's information packet regarding our appeal includes a picture which clearly shows a smooth groove ground deep into the outer wall of our water line and shows a fracture through the full wall of the pipe that is connected to and perpendicular that smooth groove.

- Clearly, this groove was made by a circular cutting/grinding tool, and not by something like a sign, shovel, pick axe or other landscaping tool striking our water line.
- A groove ground deeply into the outer wall of a PVC pipe substantially weakens that pipe – making it highly susceptible to developing a fracture anytime thereafter. This is further corroborated by the fact that the volume of leak increased over time. Therefore, if the water utility contractors ground the groove into our pipe anytime (days or many weeks) before the leak began then it is reasonable to assign responsibility for the ensuing fracture connected to that groove to the utility contractor.
