## PROJECT OVERVIEW

As part of their planning efforts, the Roscoe Village Board has requested that a multi-year street study and maintenance plan be completed for all streets currently maintained by and under the jurisdictional authority of the Village of Roscoe. The following report and supporting documents present the basis of the study and the resulting proposed five-year street maintenance program for said streets. The supporting documents include maps which depict the current condition of the Village Roadway network, set forth priorities for proposed maintenance to said streets, and identify the areas within the Village limits currently not served by public water and sewer utilities and the impact this has on the proposed street maintenance program. These documents are also supported by data summarized in tabular format, including projected costs for various maintenance solutions, pavement condition rating summaries for road segments, street functional classification, and existing utilities. It is anticipated that this study and maintenance recommendations will function as a vital planning component to assist with the Village's upcoming five-year Capital Improvement Program i

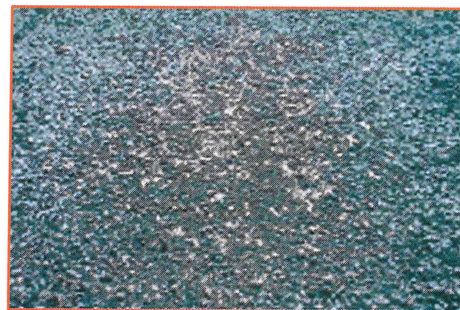
#### **Raveling/Loss of Cover Aggregate**

A smooth asphalt surface becomes rough if the surface materials, such as asphalt binder and fine aggregate, are removed over time. This phenomenon, referred to as raveling, typically results from poor mix design, poor production practices, or poor construction practices. A pavement surface which has experienced raveling will show varying degrees of coarse aggregate at the surface. The severity of raveling is dependent on the amount of binder and fine aggregate lost.

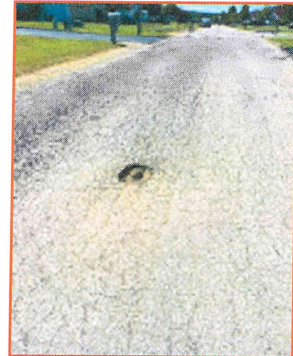
### Potholes

Potholes are one of the most easily distinguishable forms of pavement failure. Potholes typically occur in areas susceptible to freeze thaw cycles as the cycle typically pushes out roadway materials leaving a hole in place. Potholes are a highly problematic pavement distress because of the significant damage they can cause to vehicles and the damage they will cause to the structure of the roadway.

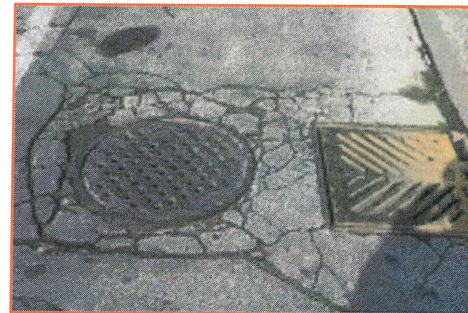
### Manholes & Catch Basins

Manholes are covered openings that allow for persons to enter a cavity. A catch basin is a drainage structure that is designed to remove excess storm water from a roadway. These two structures create a surface defect when constructed in a roadway as the pavement surface will be cut and joints are created. The pavement joints around the structure are more susceptible to cracking and breaking.

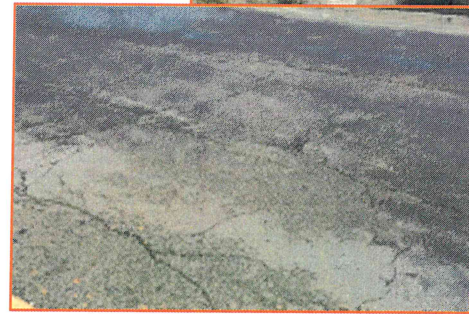
### **Map Cracking**

Map cracking is the cracking pattern in which large, rectangular sections of a bituminous pavement have cracked. This cracking pattern occurs because of the shrinkage and expansion of bituminous pavement due to daily temperature cycles. The asphalt binder is unable to expand and contract with temperature cycles because of poor asphalt binder from the mix or old age.

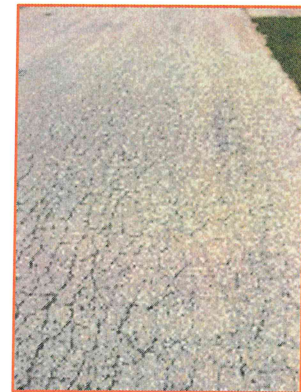
### **Alligator Cracking**

Alligator cracking is a more severe form of cracking for bituminous pavements as the pavement has developed an interconnected system of cracks. This interconnected system resembles the pattern of an alligator skin. The cracking pattern almost always shows the longer cracks in the system being longitudinal. The shorter cracks which connect the longer cracks together and create the interconnected system are typically transverse. Small sections of the pavement may become detached from the overall pavement surface in more extensive alligator cracking. Alligator cracking usually signifies that the underlying base material has failed.

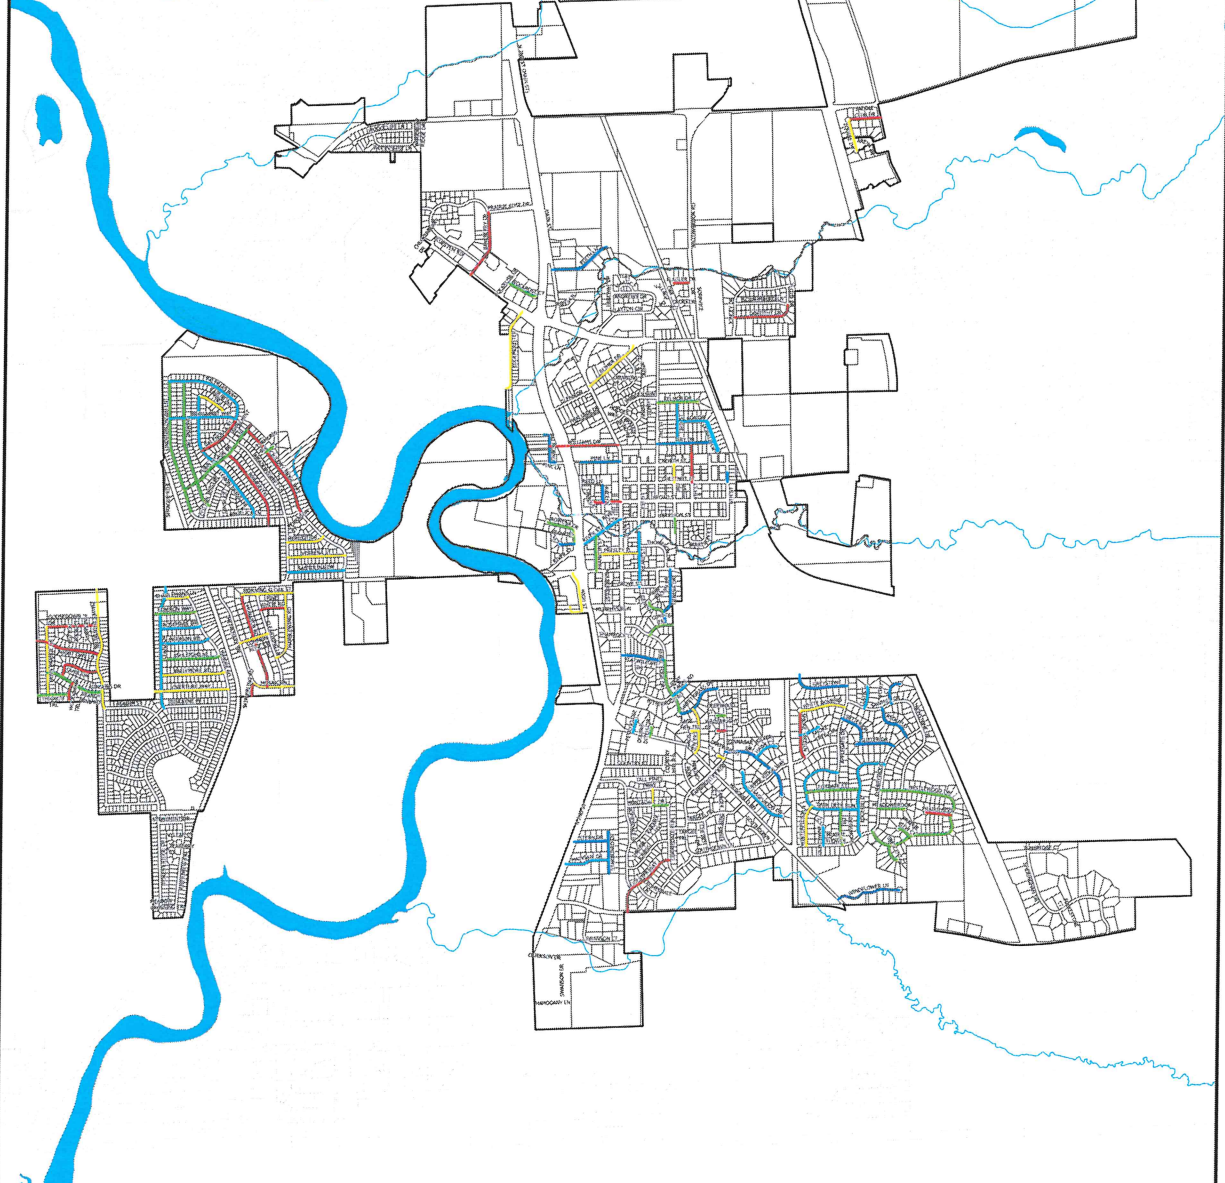
### Street Maintenance Schedule

- Year 1
- Year 2
- Year 3
- Year 4
- Year 5

Based on a road maintenance budget of \$1,500,000 per year
