#### **STAFF REPORT**

<b>MEETING DATE:</b>	April 27, 2023
AGENDA ITEM TITLE:	138 North F Street- Major Certificate of Approval
AGENDA SECTION:	Public Hearing

**REQUEST:** The request is to receive approval for exterior alterations to the façade of the building at 138 North F Street. The building is also known as "Curran Finch/Confectioner".

## 138 North F Street Remodel

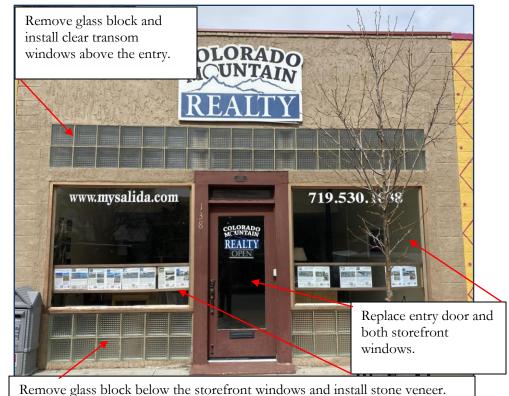
- 4. The applicant is requesting approval for the following alterations to the façade: Remove the upper rows of glass block and replace with clear transom windows, cover the existing stucco with a new smooth stucco finish, replace the front door, replace the store front windows and remove the lower rows of glass block and replace with stone veneer.

The applicant is proposing to remove the upper rows of glass block and replace with clear transom windows, cover the existing stucco with a new smooth stucco finish, replace the front door, replace the store front windows facing F Street and remove the lower rows of glass block and replace with stone veneer.

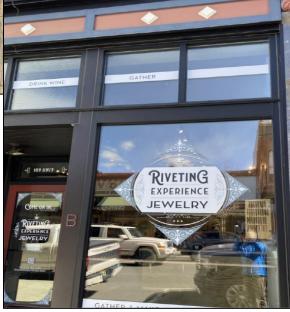
The new transom and storefront windows will be similar to the building at 109 North F Street and the stone veneer and front entry door will be similar to the building located at 139 W. First Street as shown in the application materials.

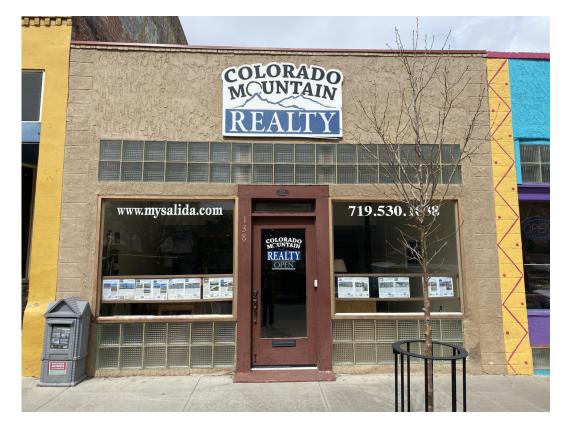
**Existing Storefront / 138 North F Street**

This application is for HPC approval for a storefront renovation at 138 North F Street in Salida. The existing structure is a non-contributing one story building with single pane windows, older front door, stucco and glass block accents. We plan to replace front door and windows facing F Street, replace lower rows of glass block with stone veneer similar to attached photos, the upper rows of glass block with transom windows and cover existing stucco with a new coat with smooth finish.

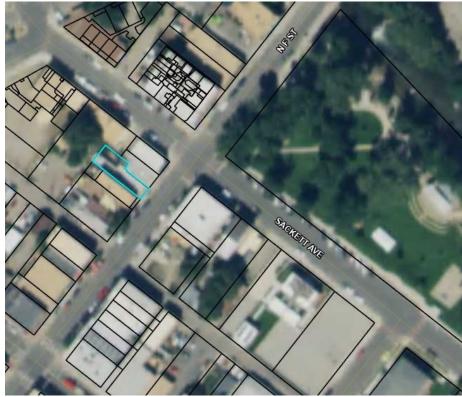
Located in between J Squared and Senor Murphy's **Candy store on North F Street**

# Replace single pane aluminum windows and door

### Replace lower rows of glass blocks with stone veneer

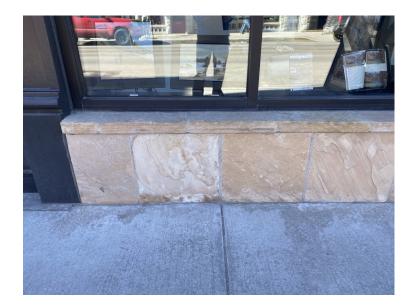
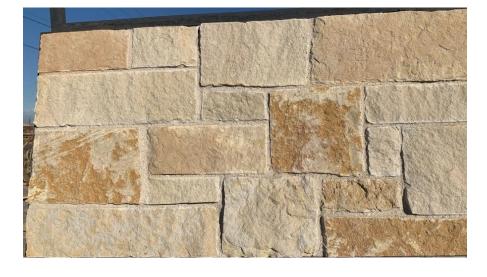
Stone

Stone-natural sandstone similar to attached photos.

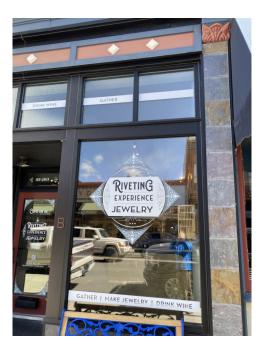
Window + transom

1" IGU. CLR Low E Annealed. 1/4" over 1/4". 1 x 80" x 32".

1" IGU CLR Low E Annealed. 1/4" over 1/4". 1 x 38" x 32".

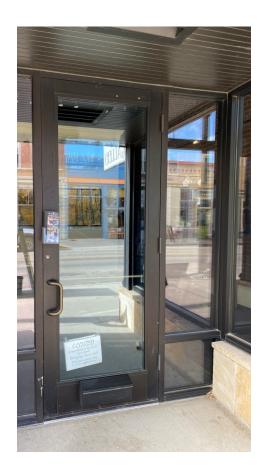
Front Door

Commercial Storefront: Wide Stile full glass door that will swing in, Measuring 3'x7'. Bronze Anodized Aluminum w/Emtek Lever Trim. The glass will be clear LowE insulated units tempered as required by code.
