COLORADO CULTURAL RESOURCE SURVEY

Architectural Inventory Form

1. **Resource Number:** 5CF406.81
2. **Temporary Resource Number:** 72
3. **County:** Chaffee
4. **City:** Salida
5. **Historic Building Name:** Argys Brothers Garage
6. **Current Building Name:** Planit Systems, Inc.
7. **Building Address:** 223 E. 1st St.
8. **Owner Name and Address:** Lindstrom, Kenneth E. & Cathie B., 223 E. 1st St., Salida, CO 81201

48. Report Title: Downtown Salida Historic Buildings Survey, 2001-02

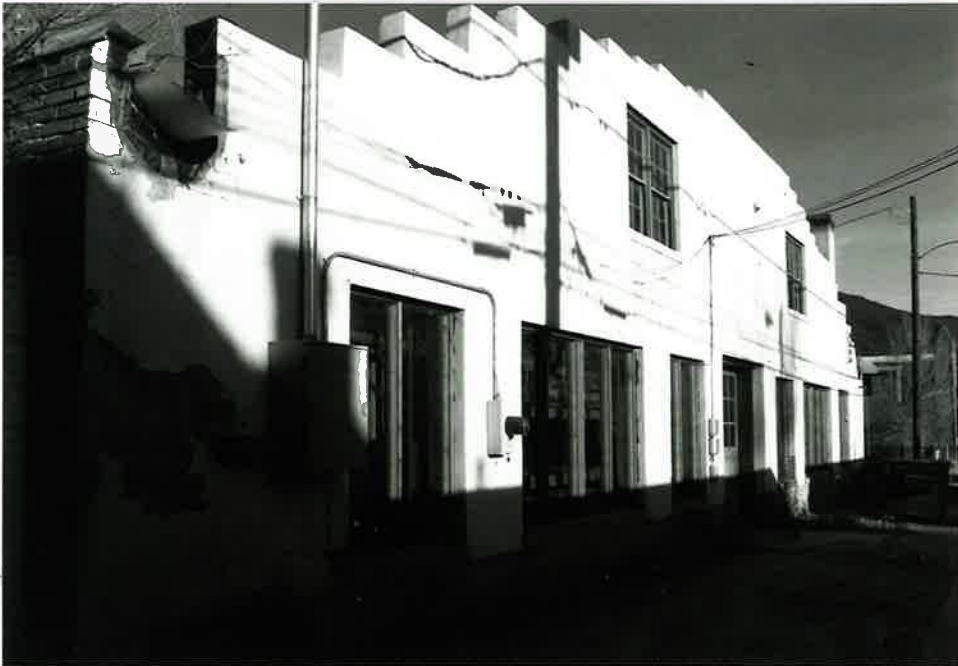
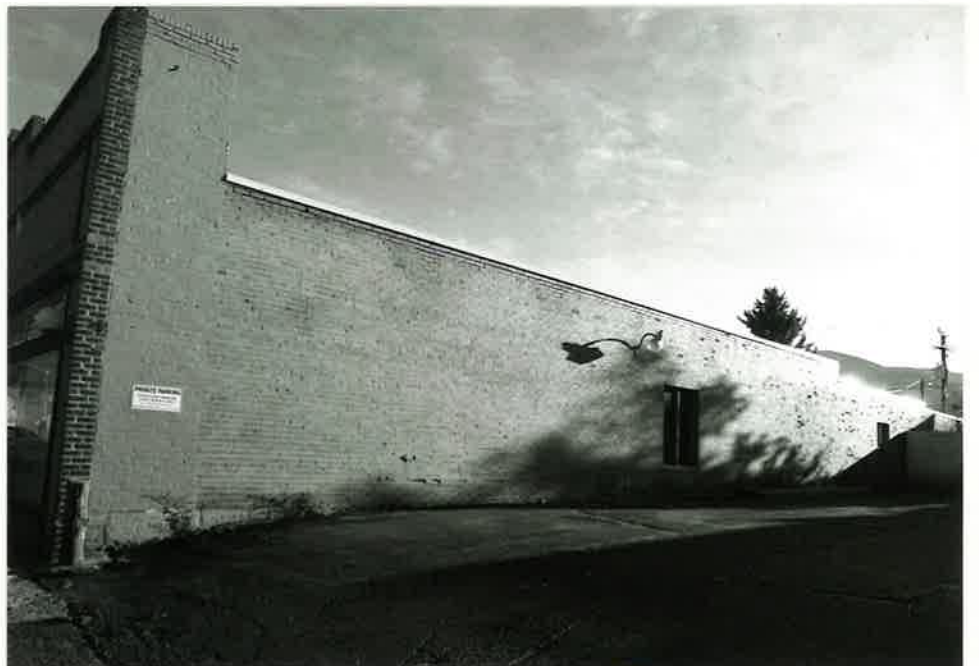
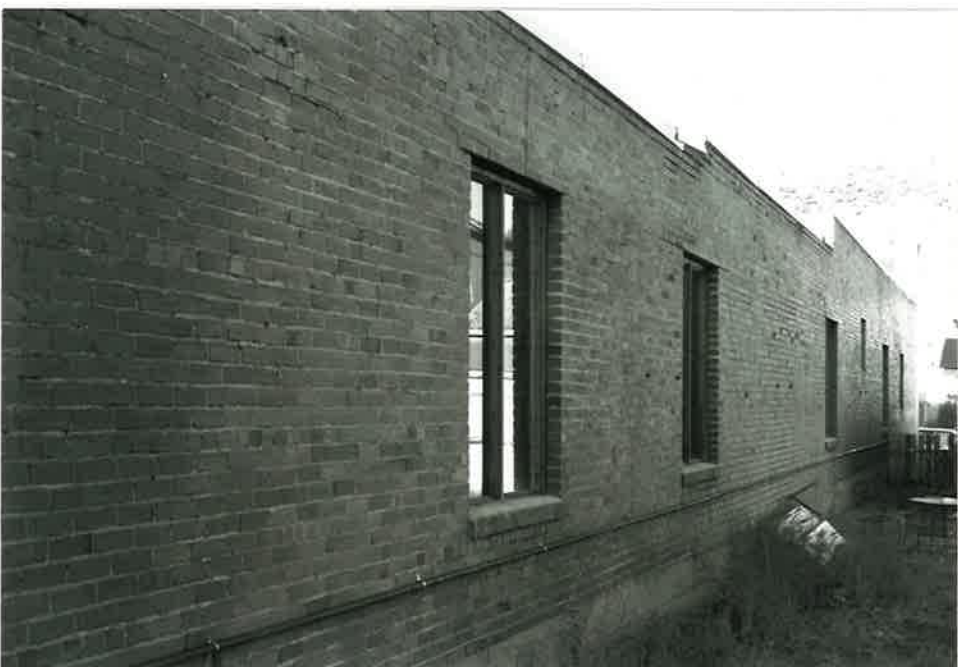
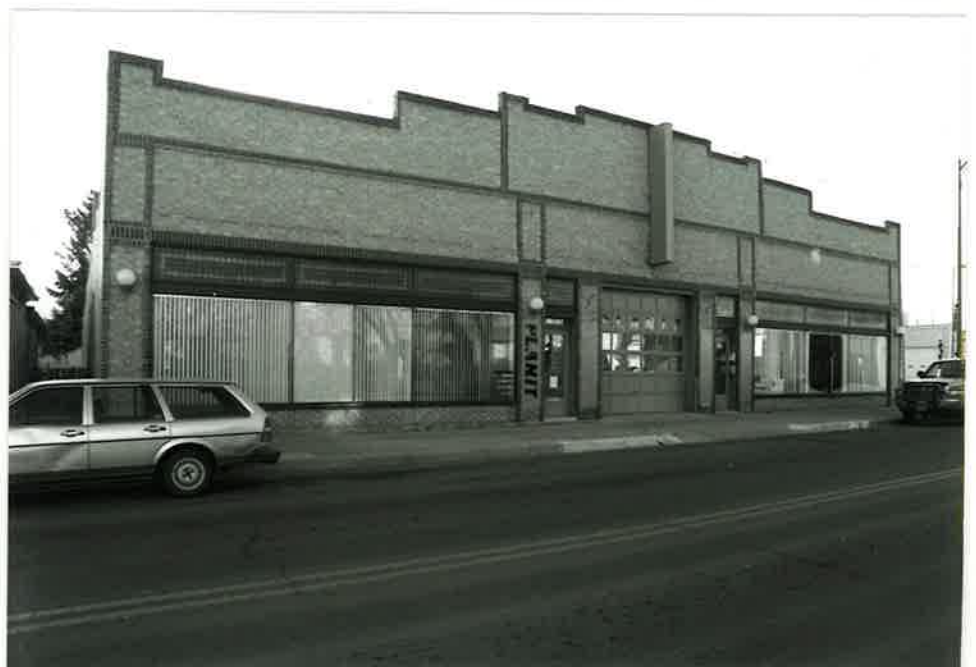
47. Photographic Reference(s): 10: 7A, 9A, 19A, 22A.

One-story rectangular brick automobile service garage with arched roof. Stepped parapet on façade outlined with contrasting brick. Projecting sign attached to wall at center of parapet. Below parapet the brick wall is divided into panels by contrasting brick, with soldier course of brick forming lintel. Façade has tan wire-drawn brick with contrasting brick on piers. Concrete foundation. Piers and brickwork divide the façade into three bays. Center bay has a large paneled and glazed garage door flanked by brick piers and pedestrian doors with large rectangular lights, transoms, and clerestory windows on each side. Each pier has globe-shaped light attached. Bays flanking

central bay have large plate glass display windows surmounted by clerestory windows composed of multiple small lights. Brick below display windows. Tall red brick chimney on east near center of wall. East and west walls of building are red brick and the rear wall is stuccoed.

This building maintains substantial integrity. The façade of the building remains unchanged. The rear wall (south) has been stuccoed and windows have been added. Some windows have been replaced on the sides.
