COLORADO CULTURAL RESOURCE SURVEY

Architectural Inventory Form

1. **Resource Number:** 5CF406.58
2. **Temporary Resource Number:** 40
3. **County:** Chaffee
4. **City:** Salida
5. **Historic Building Name:** Indian Grill, Salida Café
6. **Current Building Name:** Pizzaphilia
7. **Building Address:** 135 N. F St.
8. **Owner Name and Address:** Simonson, Peter, 143 N. F Street, Salida, CO 81201

48. Report Title: Downtown Salida Historic Buildings Survey, 2001-02**49. Date(s):** September 2002**50. Recorder(s):** R.L. Simmons/T.H. Simmons**51. Organization:** Front Range Research Associates, Inc.**52. Address:** 3635 W. 46th Ave.**53. Phone Number(s):** (303) 477-7597

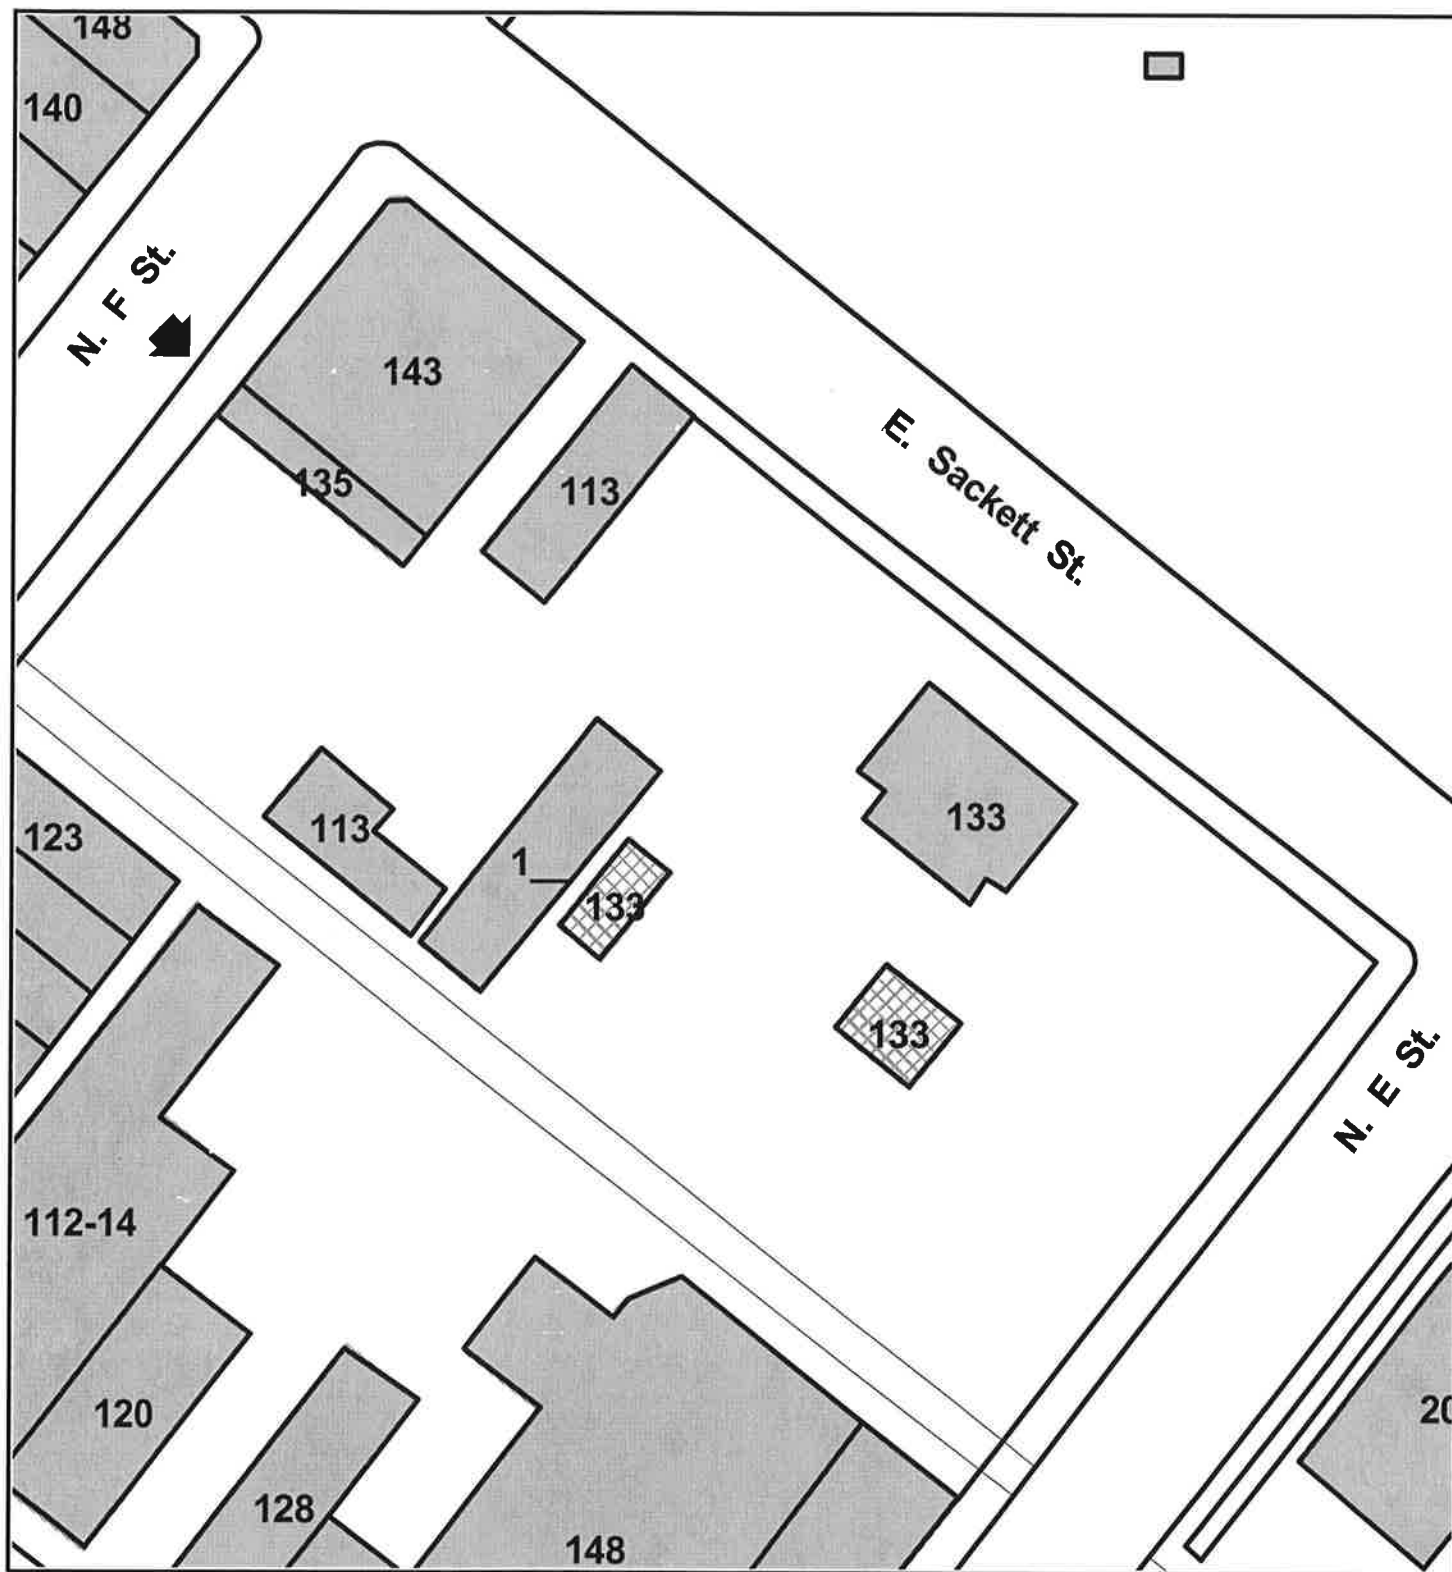
135 N. F Street, 5CF406.58

One-story rectangular brick commercial building with flat roof stepped down toward rear. Cornice composed of bands of multiple courses of brick with piers at each corner projecting above the roof. Brick walls of wire-drawn variegated brick in orange and yellow shades; rowlock course of brick above storefront. Dark brown panel and hanging sign above storefront. Metal lintel across storefront. Clerestory windows and plate glass display windows with brick under windows. Off-center, inset entrance, with wood door with large rectangular light and transom. South wall stuccoed, where an adjacent building was removed.
