# Oljato Trading Post Re-roofing Project

(9-28-20)

## Project Summary

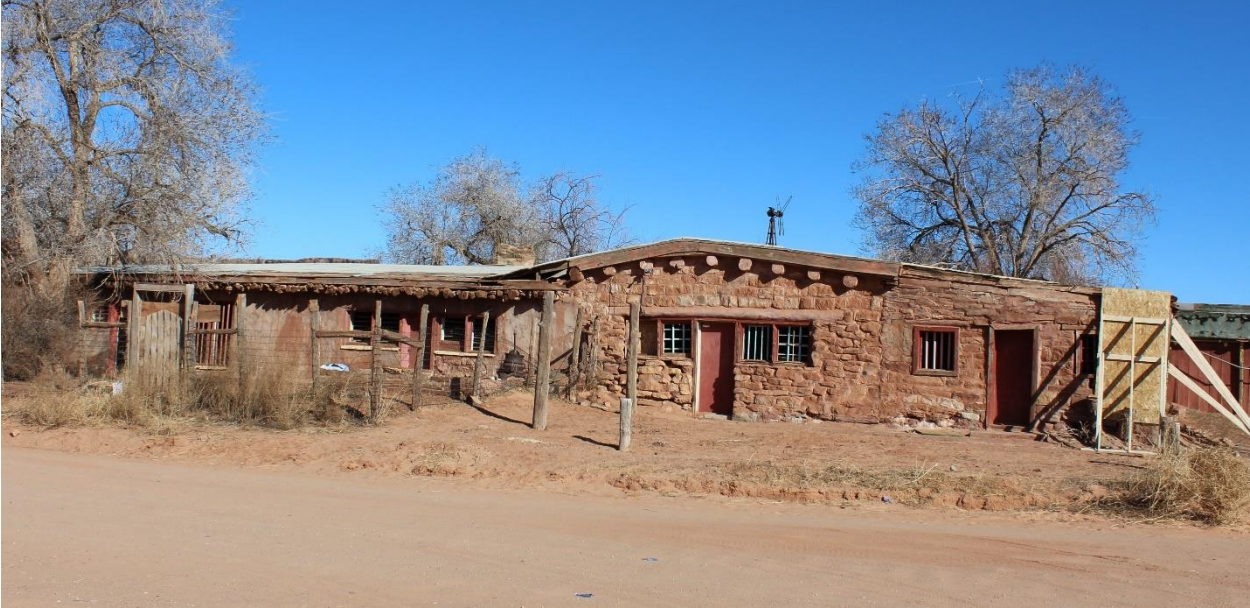
Oljato Trading Post after March 2020 stabilization and clean-up

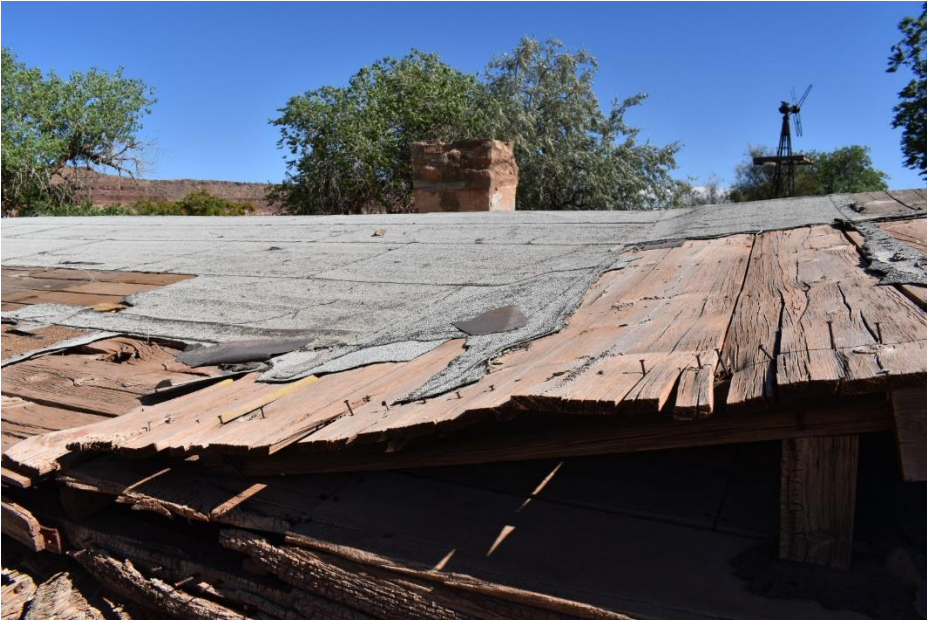
Roof condition-1

This one hundred year old was constructed in 1921 with additions in the 1930s and early '40s. The original structure has a rectangular trading hall with a shallow gable roof. It consists of a center "bull-pen" area for customers surrounded on three sides by an elevated floor for the clerks. Living quarters and storage areas are included in the additions. The walls are primarily double-wythe stacked native sandstone with adobe sections as well. The roof consists of rough-hewn logs over which is a later 1940s(?) roof structure consisting of a 2x4 grid overlaid with sheathing and roofing material. Most of the roofing material and some of the sheathing is missing, and what remains is in very poor condition (see photos).

This project will repair/replace the roof on the long-vacant 1921 Oljato Trading Post. The roof is in a very advanced state of deterioration, allowing water in at various locations, eroding the adobe and stone walls and compromising the structure.

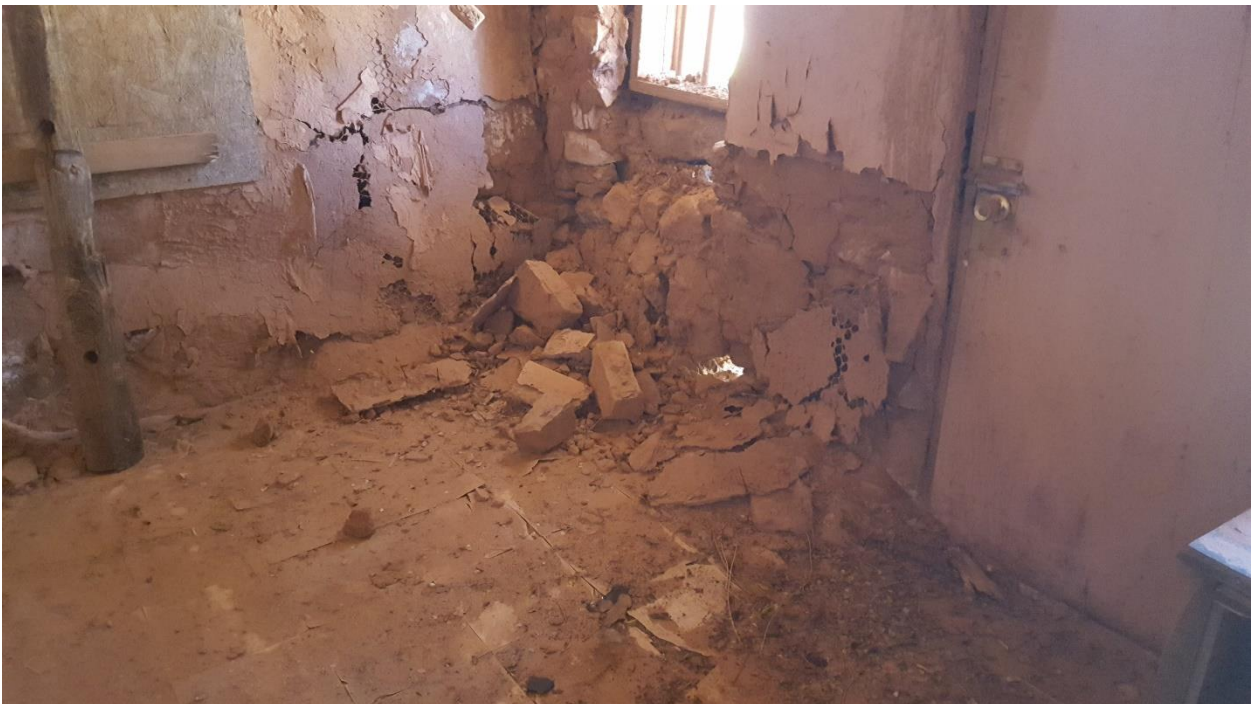
where the resulting damage is going to be irreversible. The fragile materials--stacked stone and adobe--are especially prone to water damage, as evidenced by some significant cracks in the walls and the large quantity of "melted" adobe and plaster that have sloughed off due to water penetration over the years. A three-day clean-up effort in March 2020 stabilized some of the most fragile areas and removed the accumulated debris caused by water erosion. That clean-up effort followed the recommendations made in a structural report prepared by the Utah SHPO's historical architect in the summer of 2019. That assessment deemed the building to still be structurally viable, but unless the roof could be repaired soon there would be significant structural failures.

Interior damage due to water infiltration and tree-root impacts.

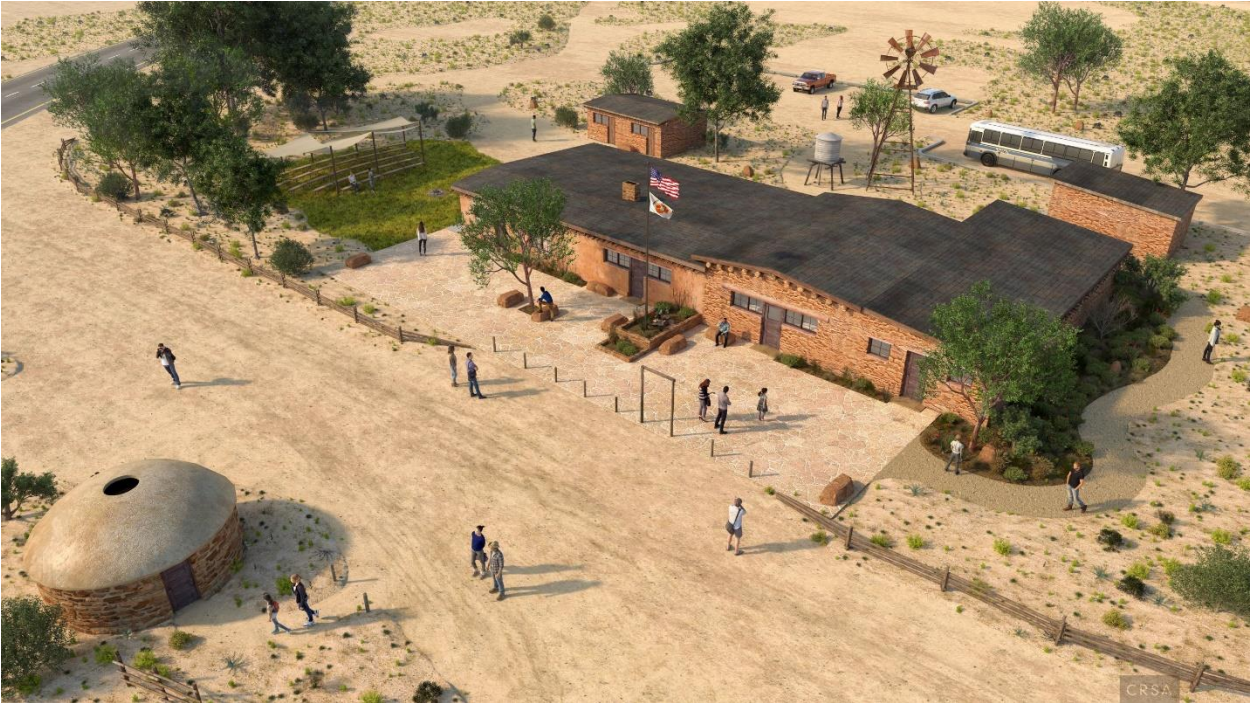
Architect’s rendering of the Oljato Trading Post’s future as a tourist destination and community center. The hogan at the lower left is one of the other historic structures on the property that will be preserved as part of the overall project.
