THE SECRETARY  
OF THE INTERIOR'S  
**STANDARDS FOR  
THE TREATMENT  
OF HISTORIC  
PROPERTIES**

WITH  
**GUIDELINES FOR  
PRESERVING,  
REHABILITATING,  
RESTORING &  
RECONSTRUCTING  
HISTORIC  
BUILDINGS**

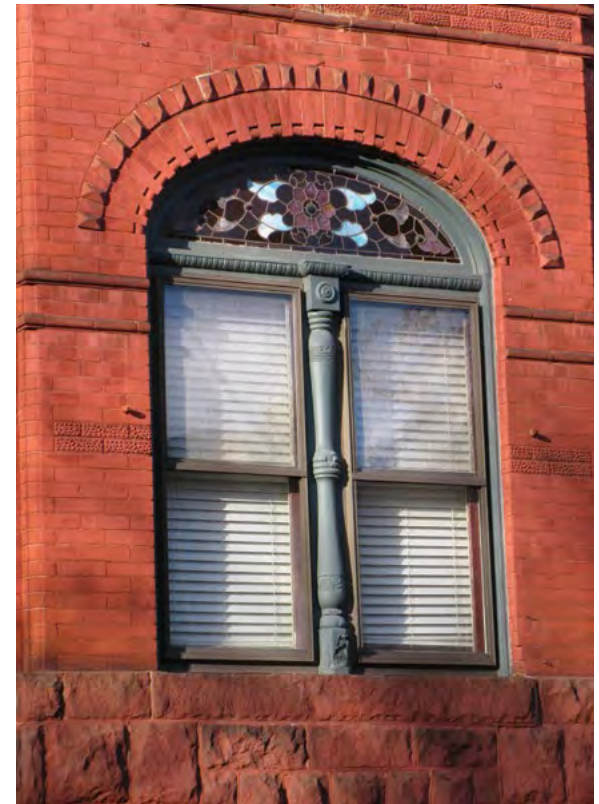
## Entrances and Porches

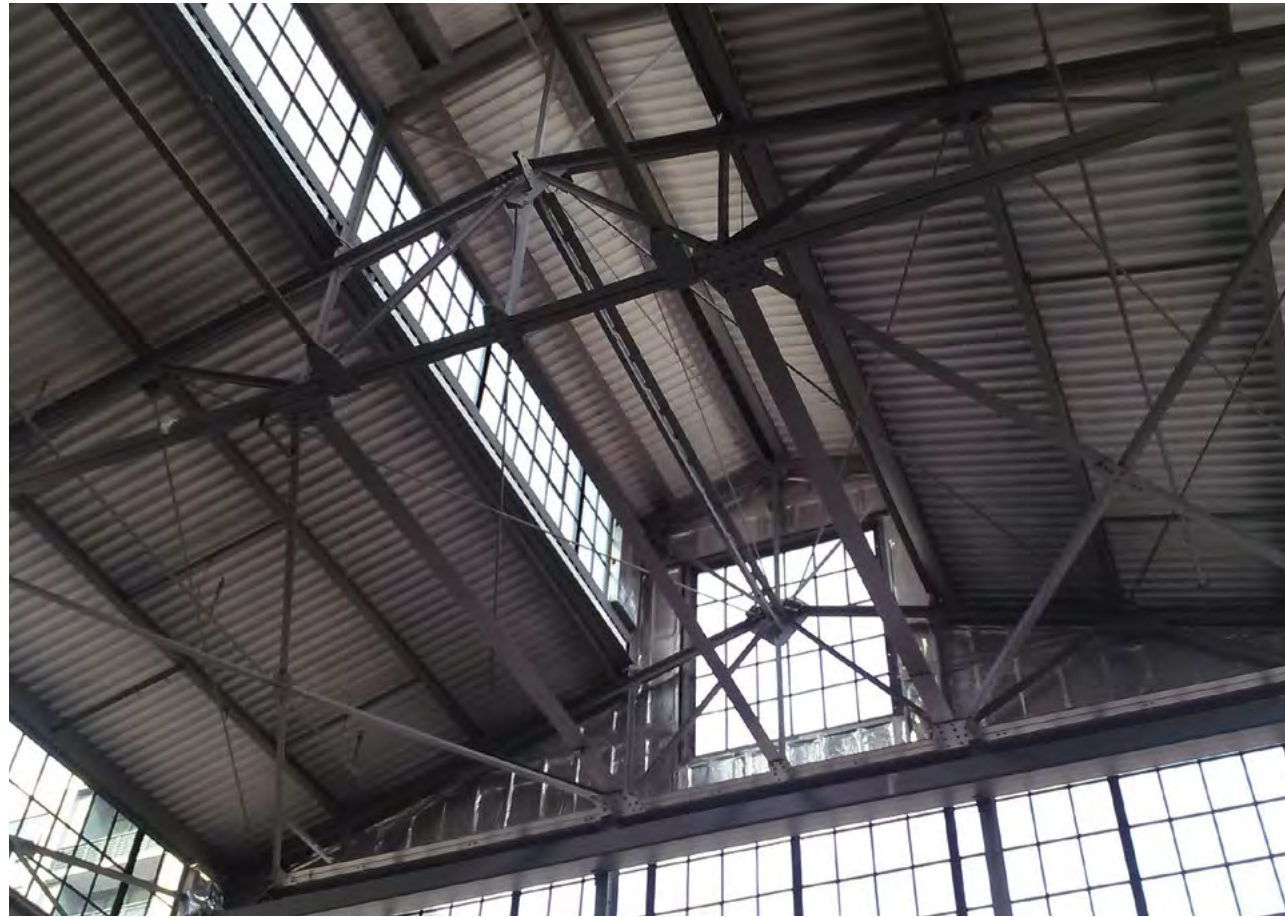
beams, vigas, and outriggers, or masonry foundation walls), they are likely to be important in defining the building's overall historic character. A concealed structural system, although not character defining, may still be significant as an example of historic building technology.

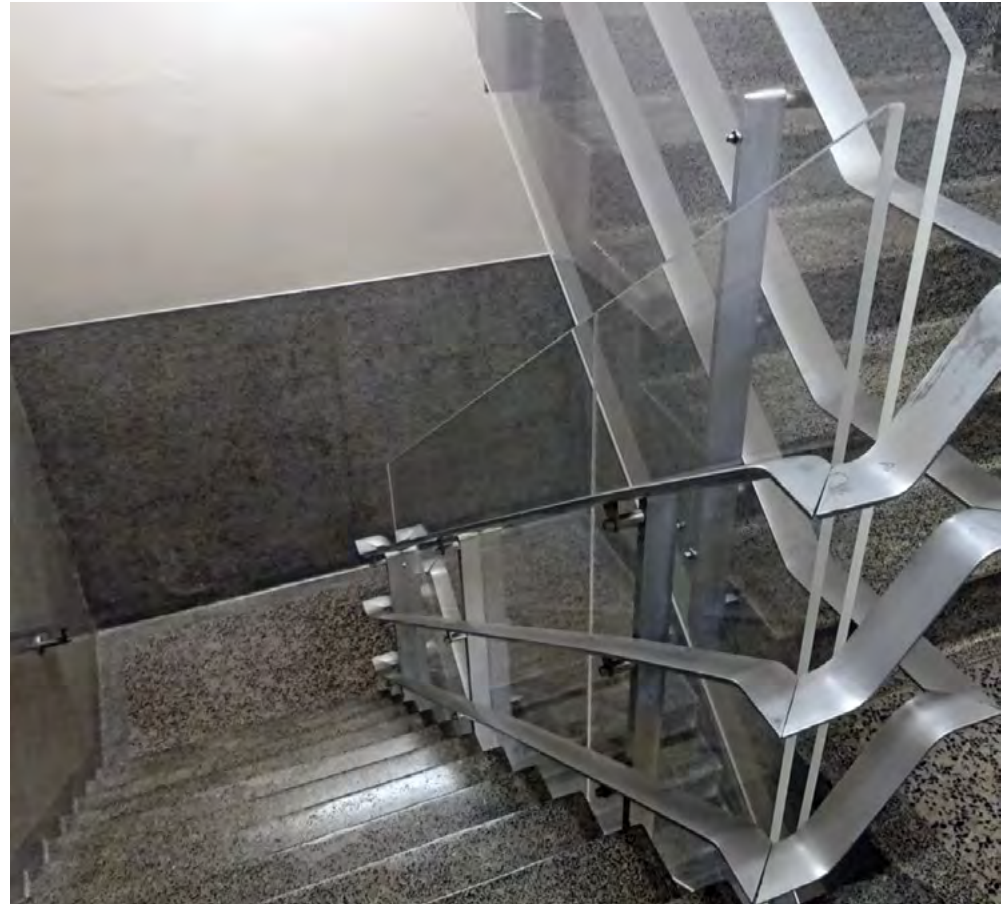
When undertaking work on historic buildings, it is also necessary to consider the impact that meeting life-safety codes (public health, occupational health, life safety, electrical, seismic, structural, and building codes) will have on both exterior and interior spaces, features, and finishes. Historic building materials that are hazardous, such as lead paint and asbestos, will require abatement or encapsulation. Some newer life-safety codes are more flexible and allow greater leniency for historic buildings when making them code compliant. It is also possible that there may be an alternative approach to meeting codes that will be less damaging to the historic building. Coordinating with code officials early in project planning will help ensure that code requirements can be met in a historic building without negatively impacting its character.

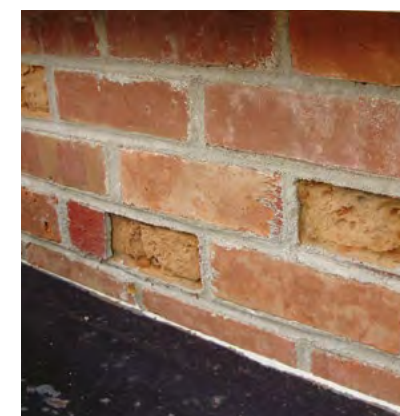
[2] **Not Recommended:** The use of inappropriate Portland cement mortar to repoint these soft 19th-century bricks has caused some of them to spall. *Photo: Courtesy Nebraska State Historic Preservation Office.*

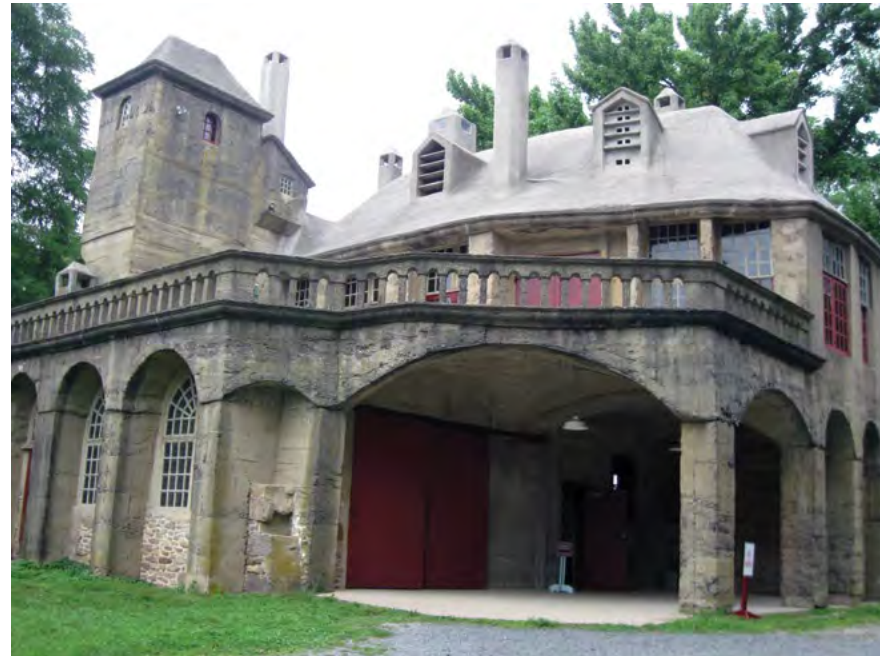
[9] Distinctively-shaped roofs are important in defining the historic character of these early 20<sup>th</sup>-century structures: (a) an asphalt shingle roof on a house; (b) and a concrete roof on Fonthill, Doylestown, PA (1908-1912), designed and built by Henry Chapman Mercer.

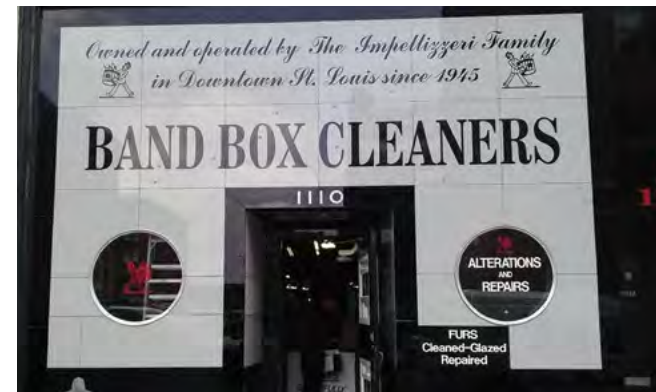
[14] The signage is an original and integral part of this historic Carrara glass storefront.

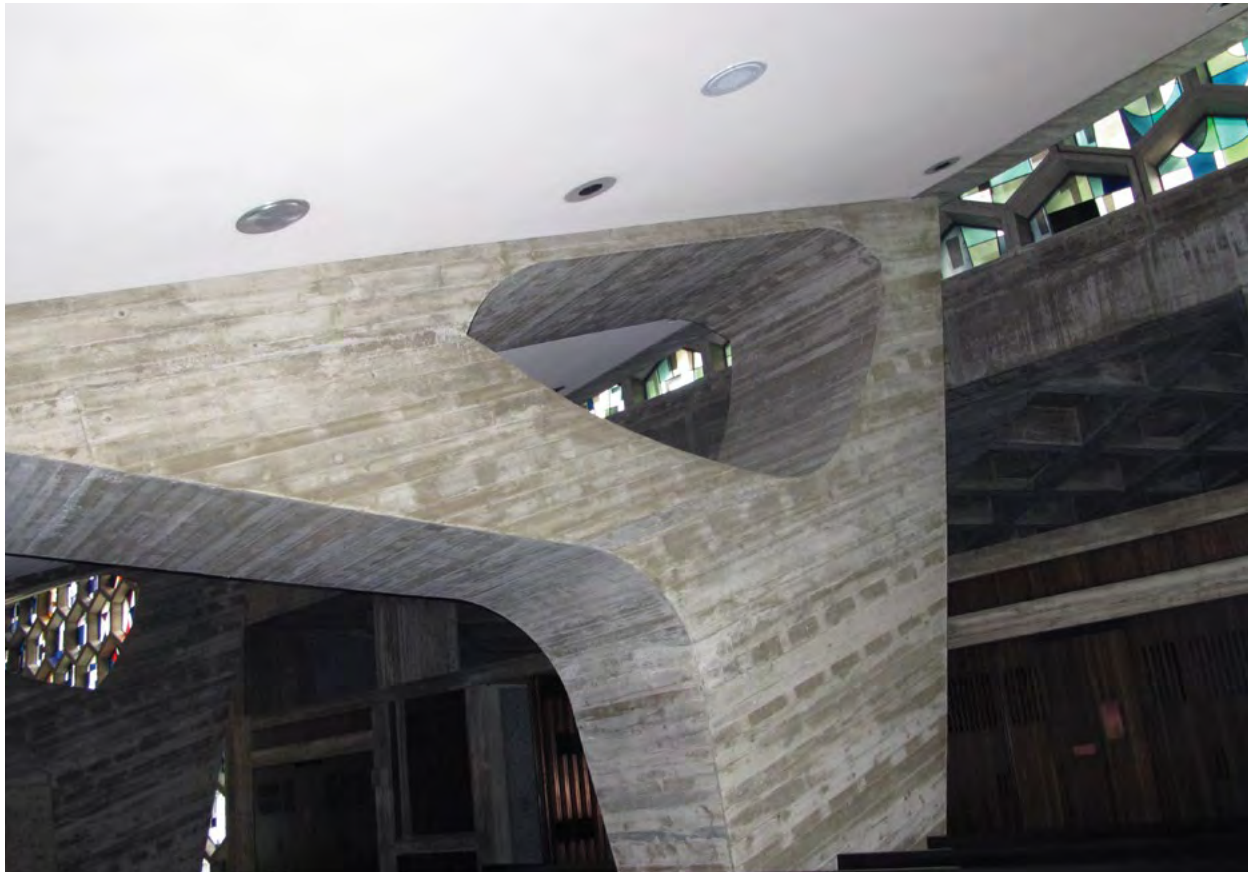
[17] Distinctive examples of traditional construction techniques should be preserved, such as this wooden peg, which is part of the structural system of this late-19th-century warehouse.

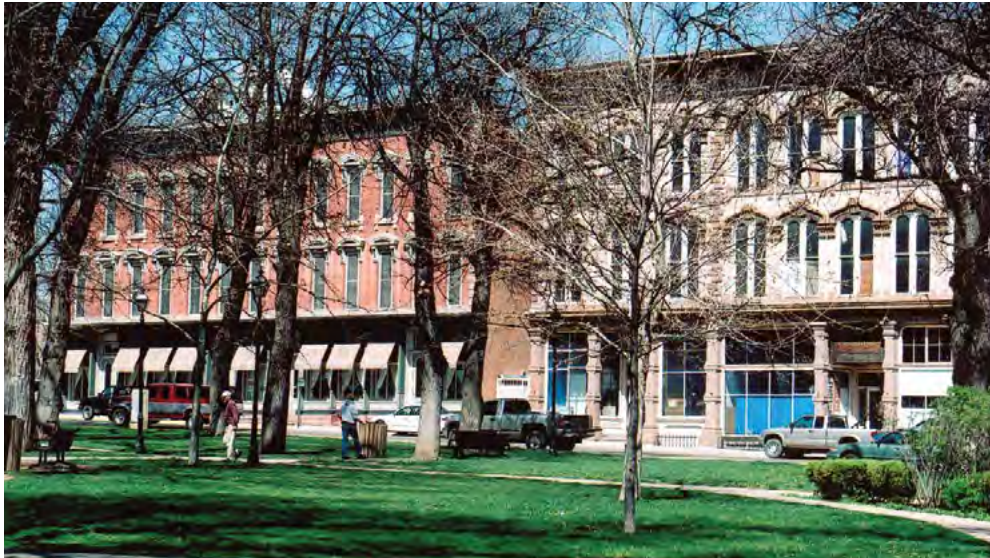
[23] The city square is important in defining the character of the historic setting in this small town.

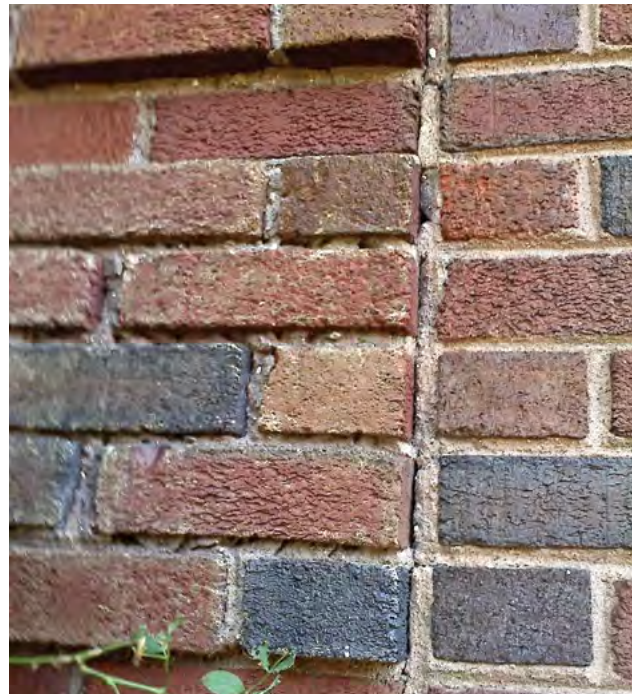
## MASONRY: STONE, BRICK, TERRA COTTA, CONCRETE, ADOBE, STUCCO, AND MORTAR

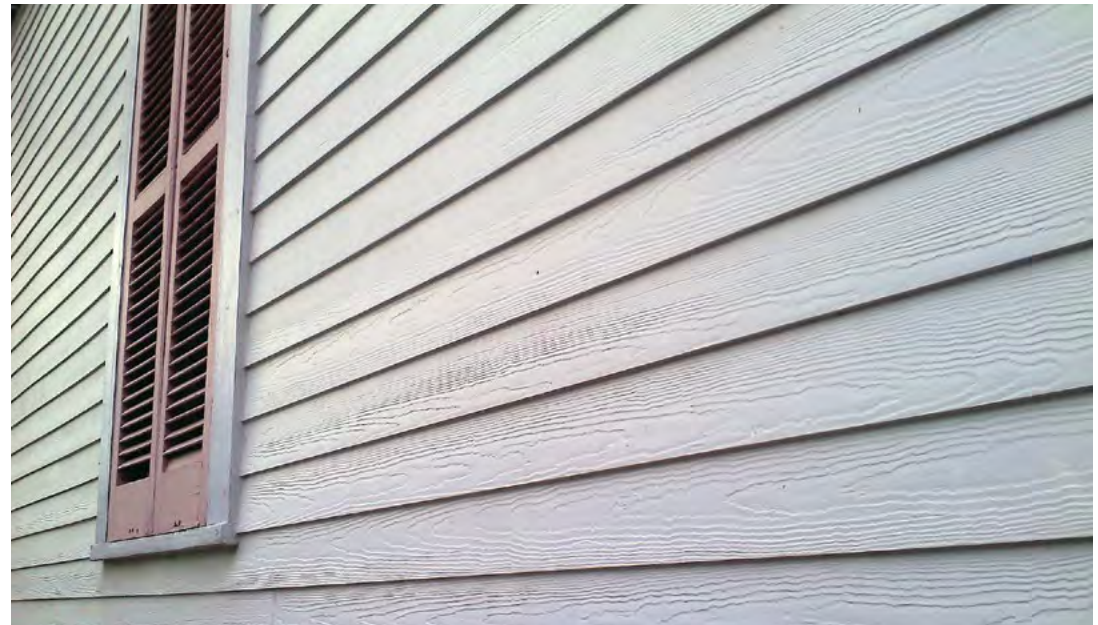
**WOOD: CLAPBOARD, WEATHERBOARD, SHINGLES, AND OTHER FUNCTIONAL AND DECORATIVE ELEMENTS**

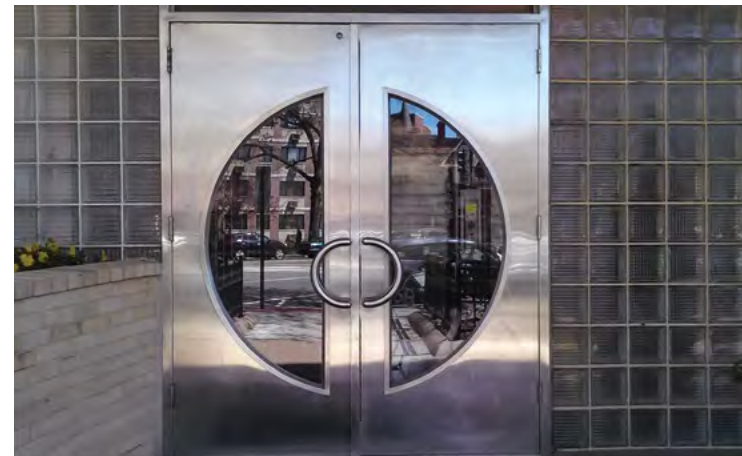
**METALS: WROUGHT AND CAST IRON, STEEL, PRESSED METAL, TERNEPLATE, COPPER, ALUMINUM, AND ZINC**

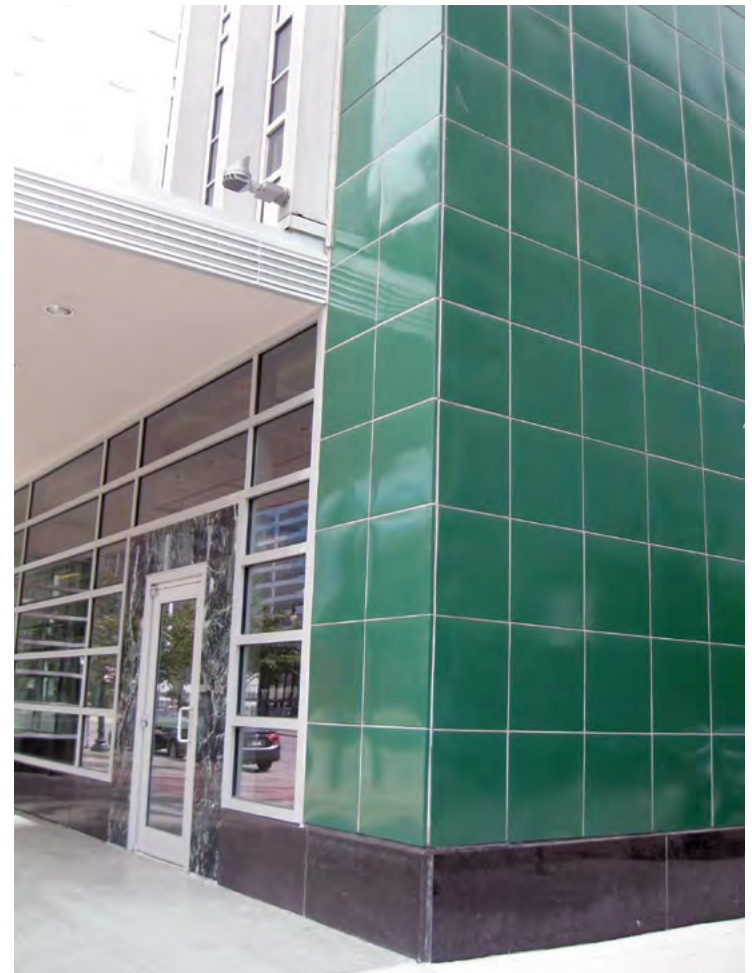
[15] New enameled-metal panels were replicated to replace the original panels, which were too deteriorated to repair, when the storefront of this early 1950s building was recreated.

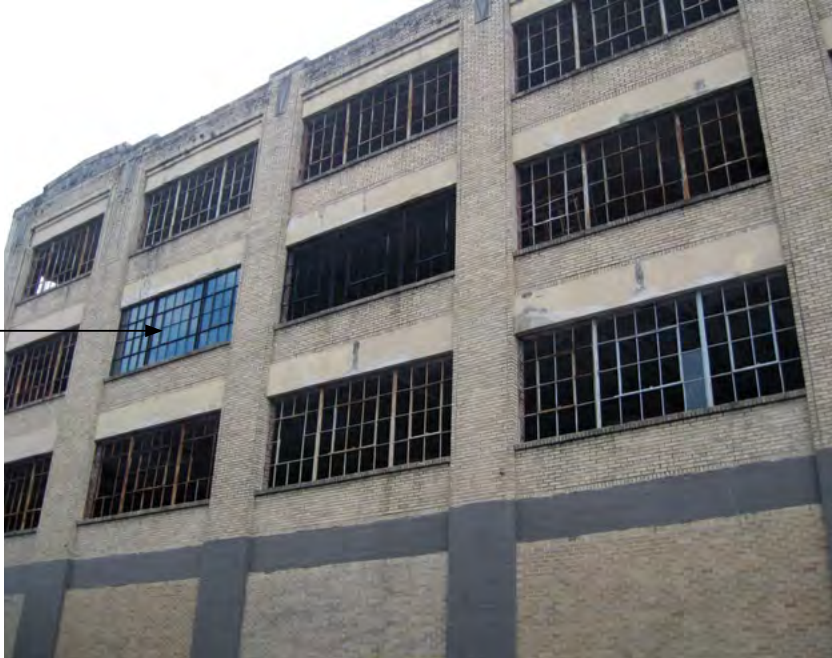
[19] Installing a mockup of a proposed replacement window can be helpful to evaluate how well the new windows will match the historic windows that are missing or too deteriorated to repair.

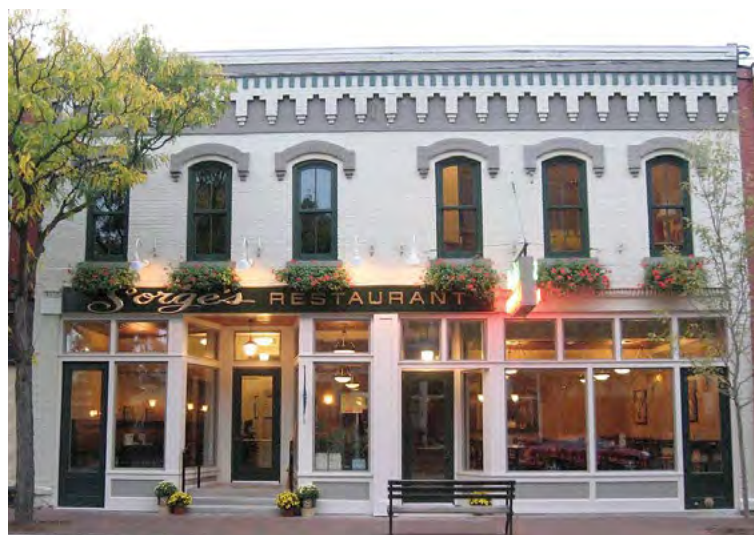
[28] This new storefront, which replaced one that was missing, is compatible with the historic character of the building.

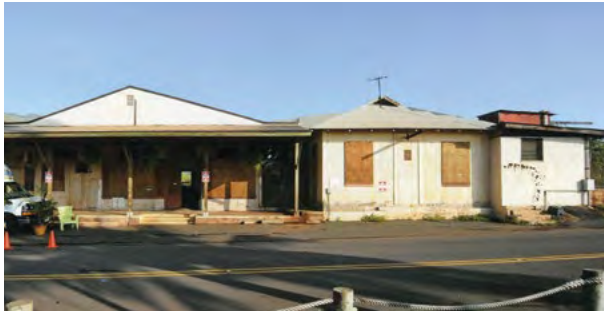
[29] The rehabilitation of the 1910 Māālaea General Store (a), which served the workers' camp at the Wailuku Sugar Company on the Hawaiian island of Maui, included the reconstruction of the original parapet (b).

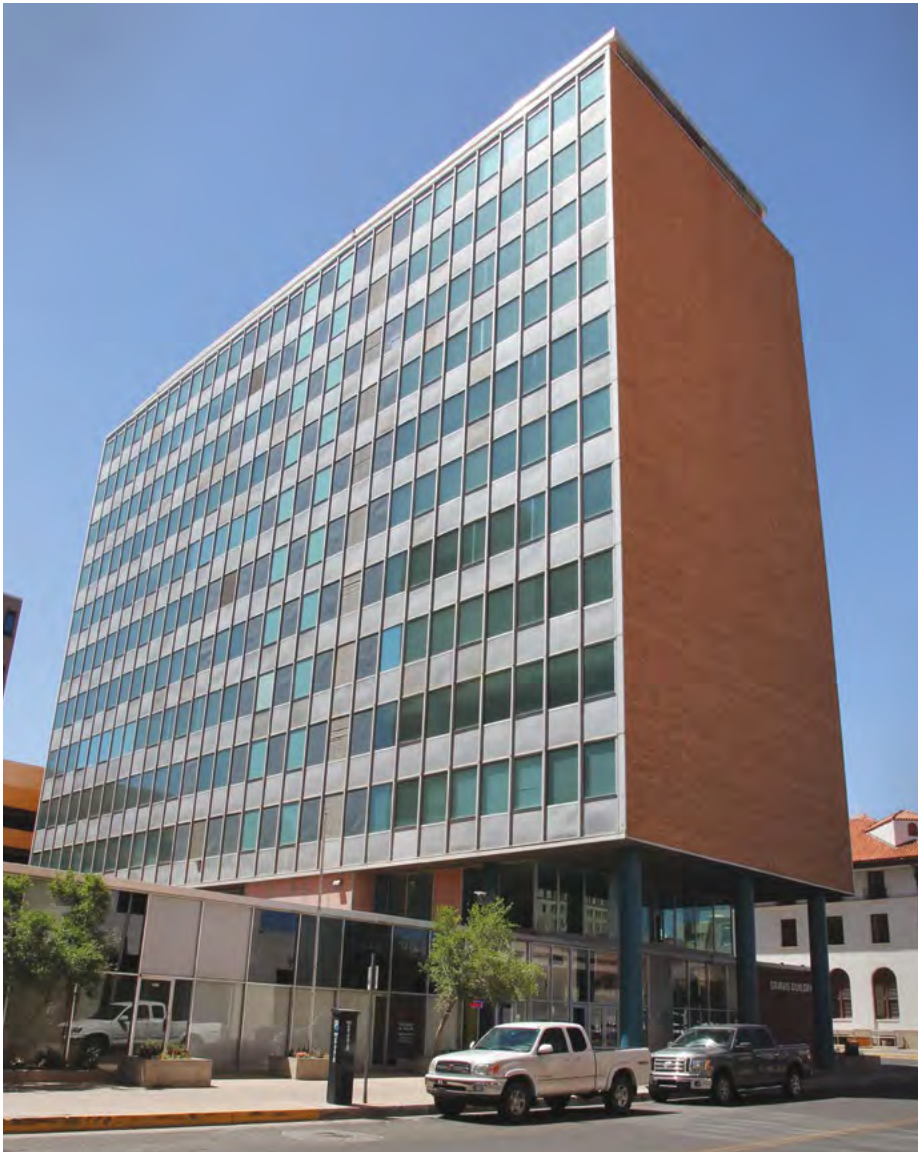
[30] Rather than replace the original curtain wall system of the 1954 Simms Building in Albuquerque, NM, with a different color tinted glass or coat it with a non-historic reflective film, the HVAC system was updated to improve energy efficiency. Photo: Harvey M. Kaplan.

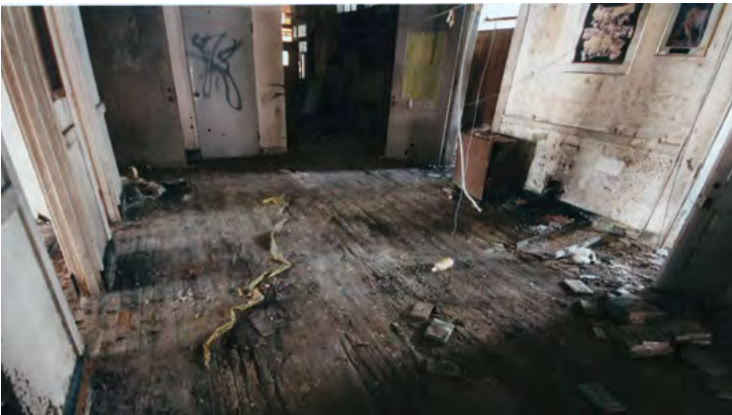
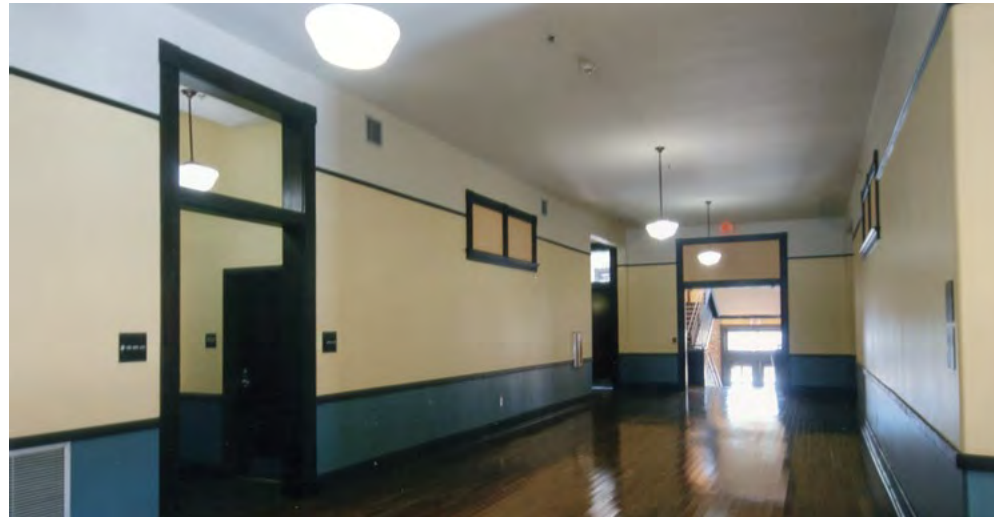
[35] (a) Although deteriorated, the historic school corridor, shown on the left, with its character-defining features, including doors and transoms, was retained and repaired as part of the rehabilitation project (b).

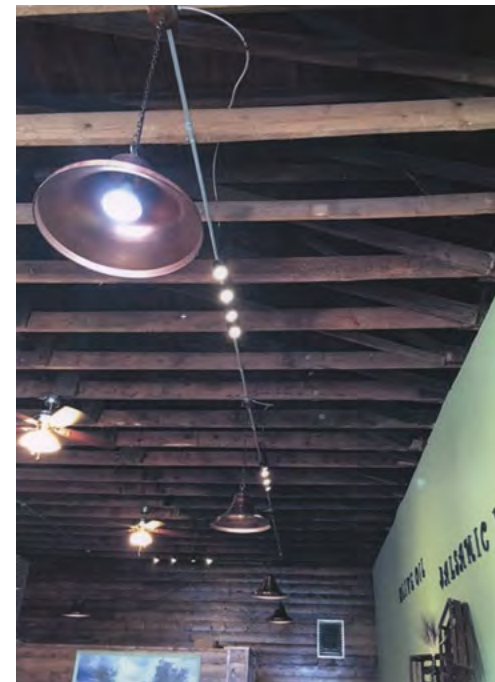
**INTERIOR SPACES, FEATURES, AND FINISHES**

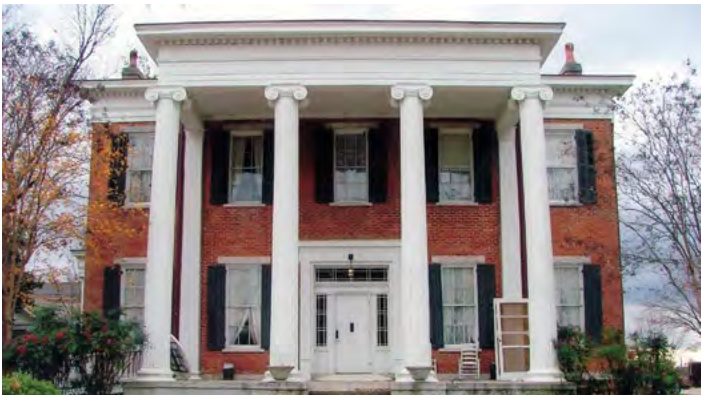
[44] **Not Recommended:** (a-b) The historic character of this plantation house (marked in blue on plan on opposite page) and its site was diminished and adversely impacted when multiple new buildings like this (#3 on plan) were constructed on the property (c).

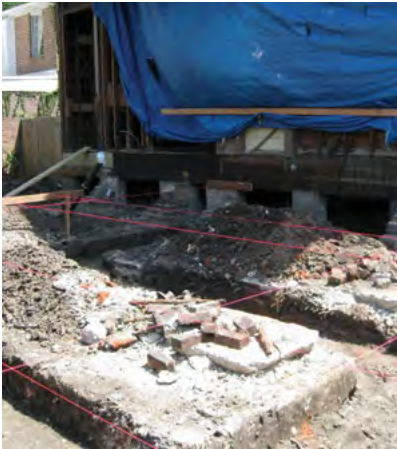
[45] Undertaking a survey to document archeological resources may be considered in some rehabilitation projects when a new exterior addition is planned.

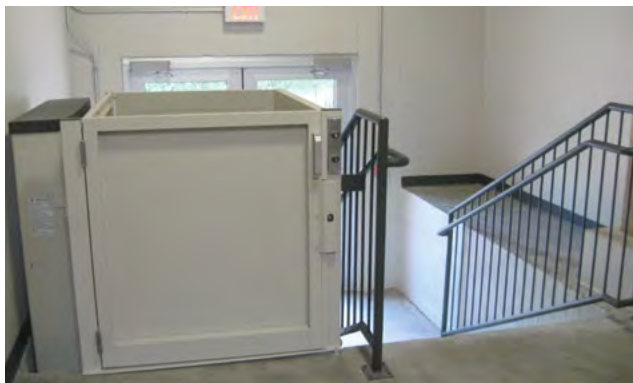
[55] The lift is compatible with the industrial character of this former warehouse.
