**Job Order Title:** Home Demo

**Location:** Home Demo  
7702 Railroad Ave  
Snoqualmie, WA 98065

## **Hazardous Materials Survey**

7702 Railroad Ave SE  
Snoqualmie, WA 98065

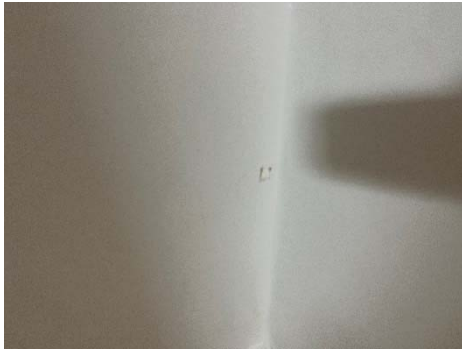
##### 1. Joint compound with paint

Sample number: 2024-0064-3-1

There is an unknown quantity of asbestos-containing joint compound with paint associated with the interior drywall wall/ceiling system of the residence.

However, as per in WRD 23.30, this material is a part of the composite wall system and is considered to be less than 1% asbestos containing for demolition purposes only.
