2021 PARK SYSTEM PLAN

City of Spring Lake Park, Minnesota
February 22, 2022

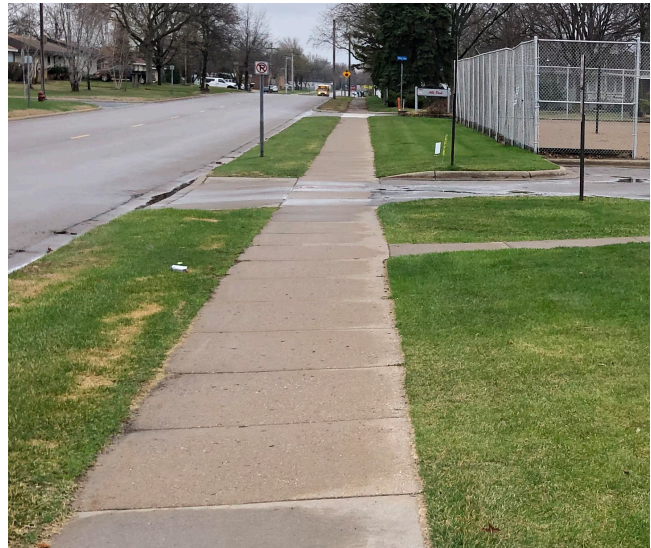
Walking trails along Able Park

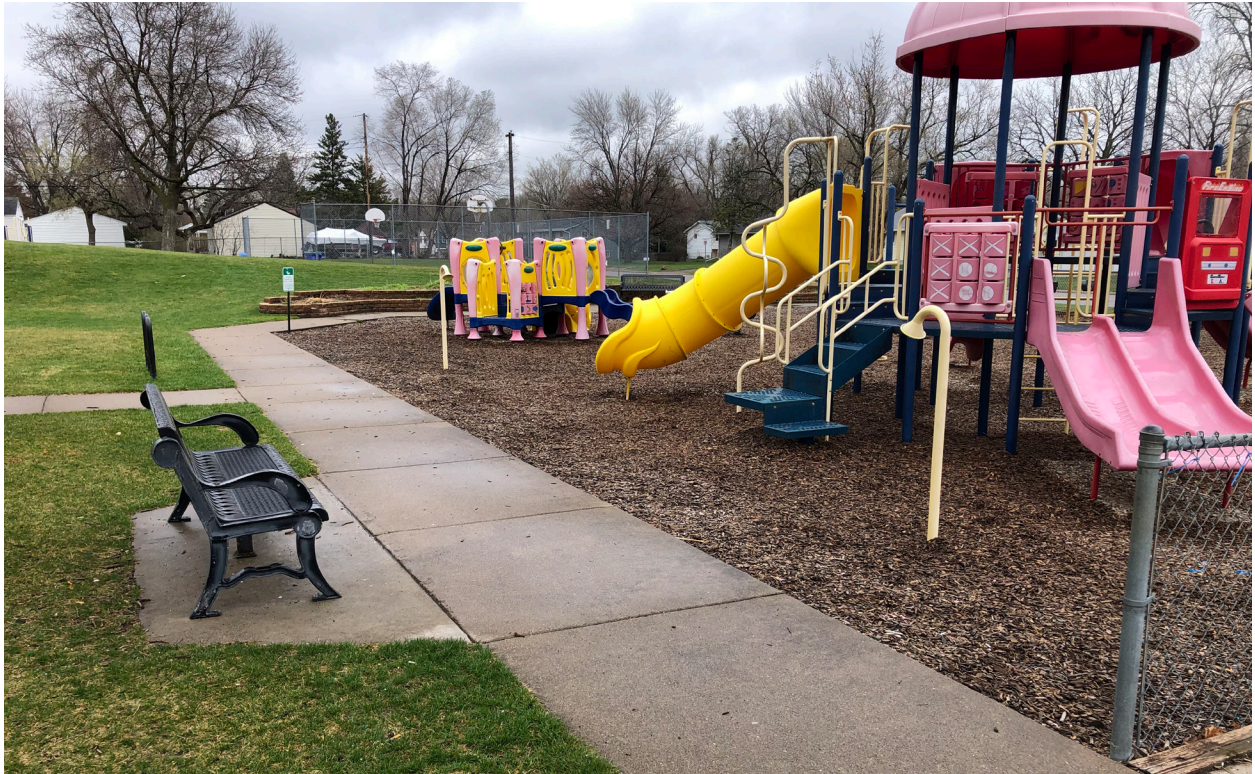
Playground area near eastern park entrance

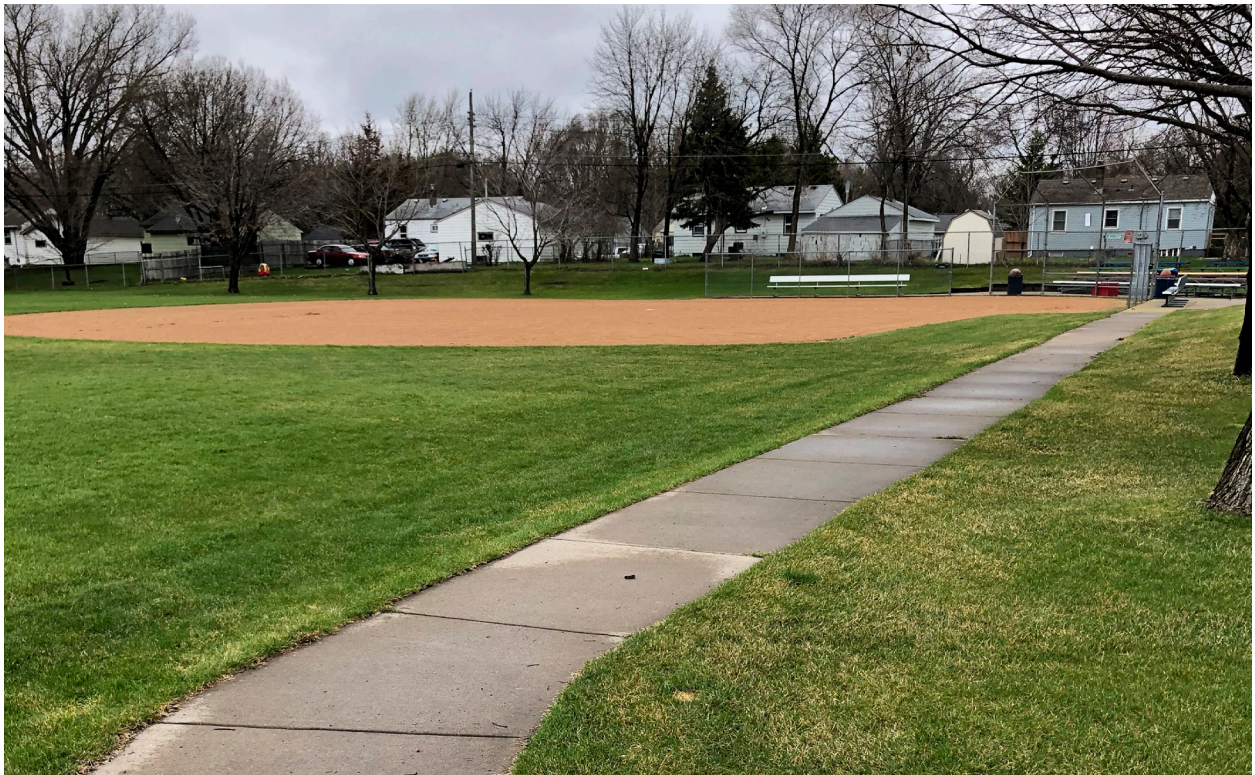
Trail from parking lot to west ballfields

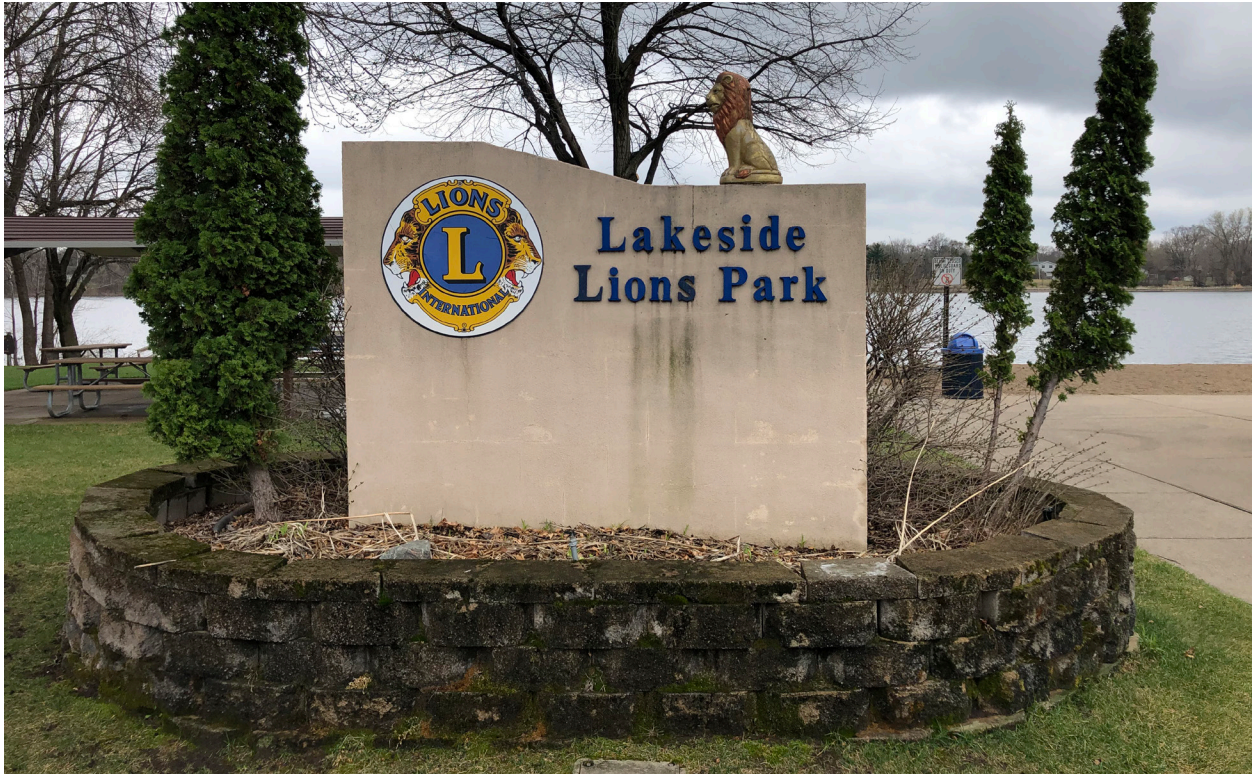
Monument sign

It features three picnic shelters with grills, fishing pier, playground, sand volleyball courts, softball field and a walking trail loop. Also has mulched trail loop through wooded area at point. Has drainage issue from parking lot towards play. Lakeside is owned and operated by both Mounds View and Spring Lake Park. Wayfinding and Lions park sign is aged. The retaining wall block below the sign is deteriorated. Water level has changed at beach.

Recommendations

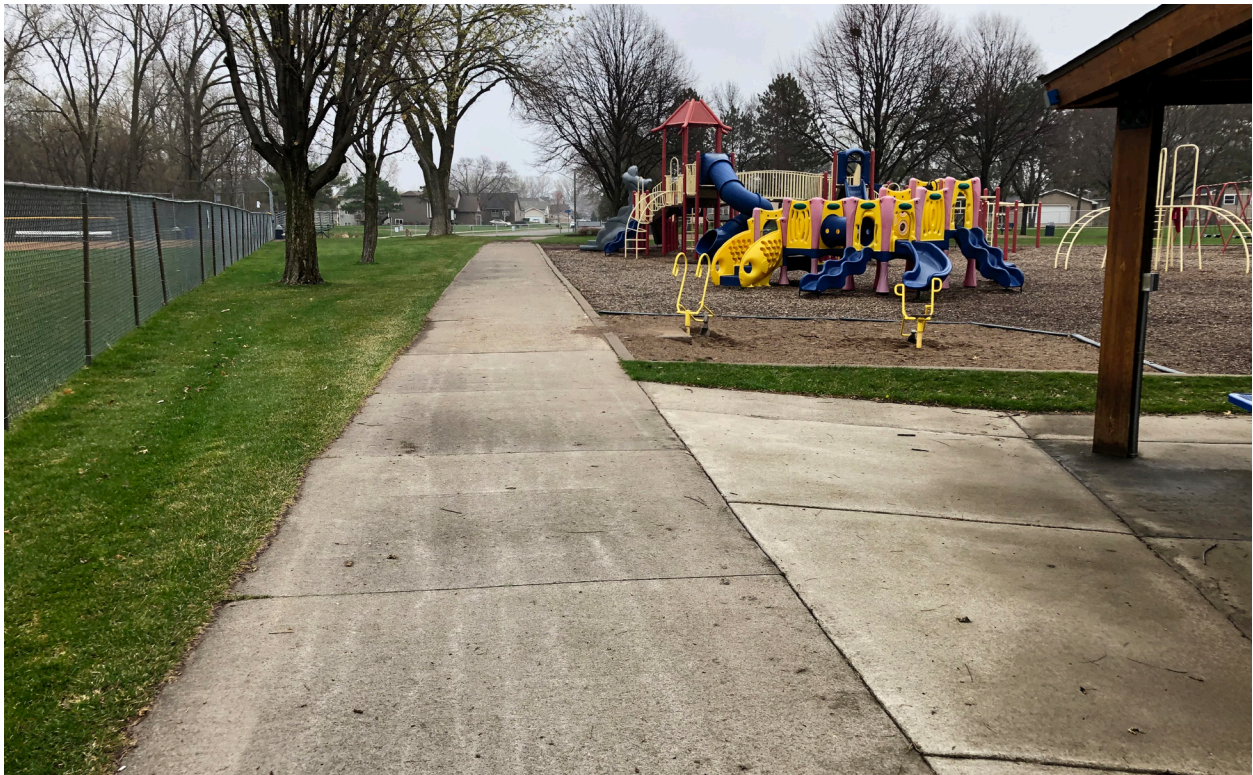
Trail between ballfield and playground area

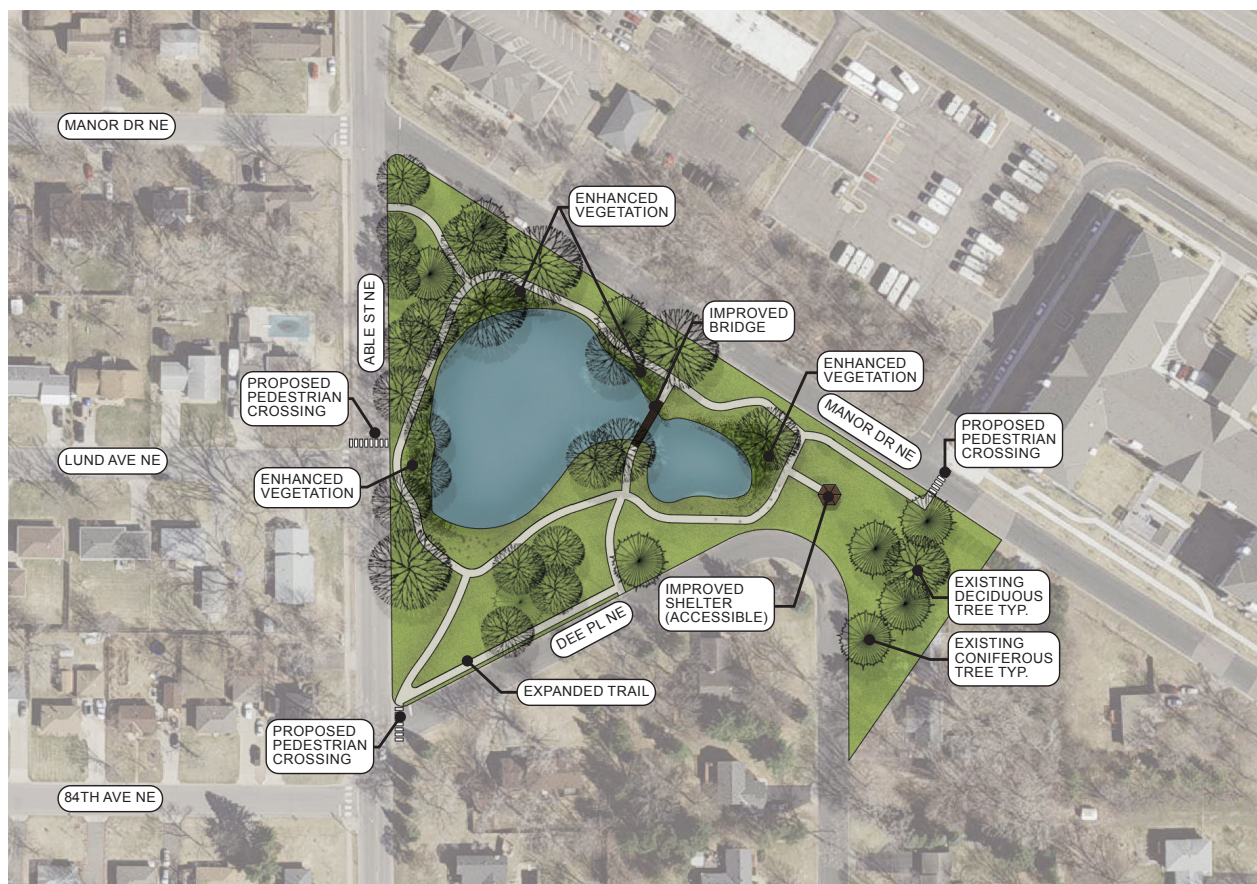
Concept Plan 4.5: Triangle Park

- » Improve accessibility and trail connections to adjacent sidewalks
- » Enhance vegetative buffer on west side of the park
- » Improve bridge materials and structure for safety
- » Improve existing gazebo shelter accessibility
- » Improve drainage on west side of the park

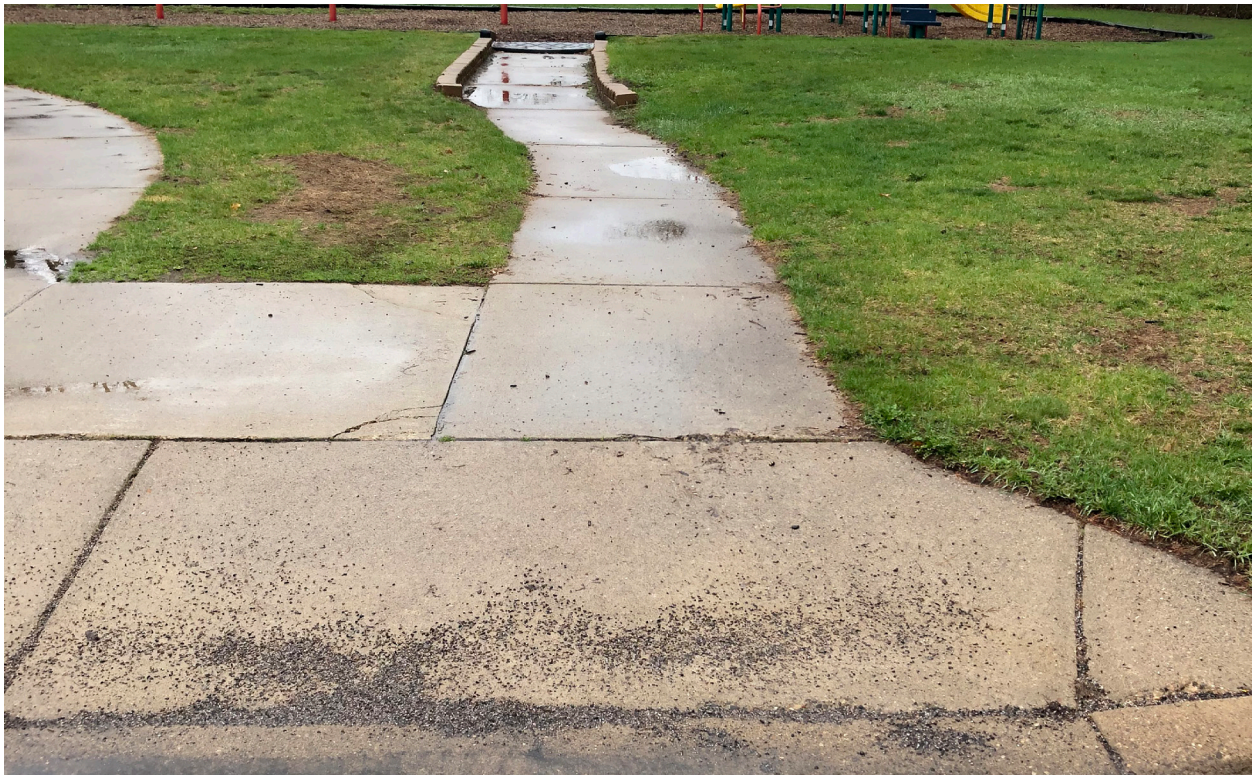
Park trail entrance

The park is quiet and small. It feels secluded and hidden between private homes. This neighborhood park has a ball field, picnic shelter and playground. Wayfinding signage needs replacement. On street parking is offered and may not be ADA accessible to standards.

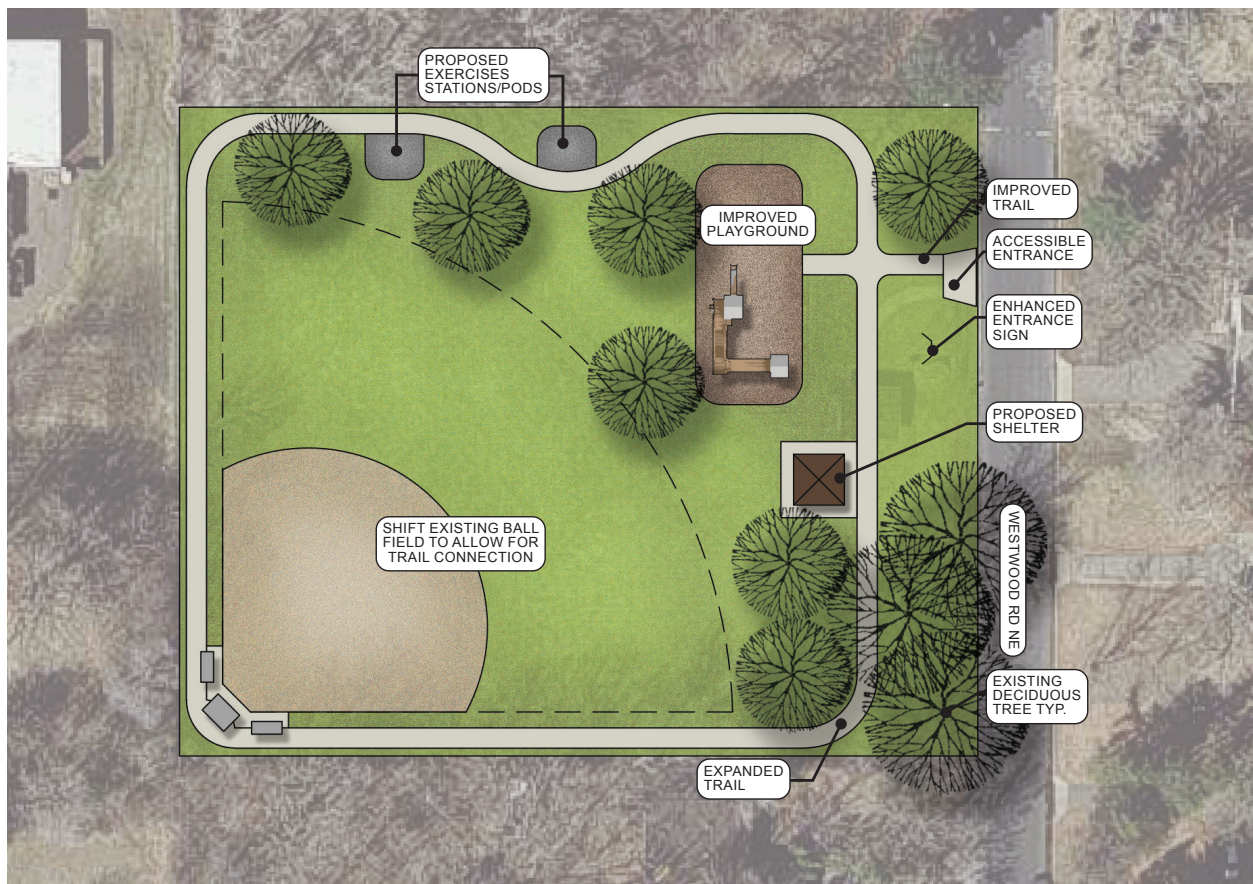
Concept Plan 4.6: Westwood Park

- » Improve accessibility and trail connections to park
- » Relocated ballfield so a trail loop could be added around the perimeter of the park
- » Improve shelter and entrance signage
- » Improve outdated playground equipment and improve accessibility
- » Add exercise stations to expand park activities

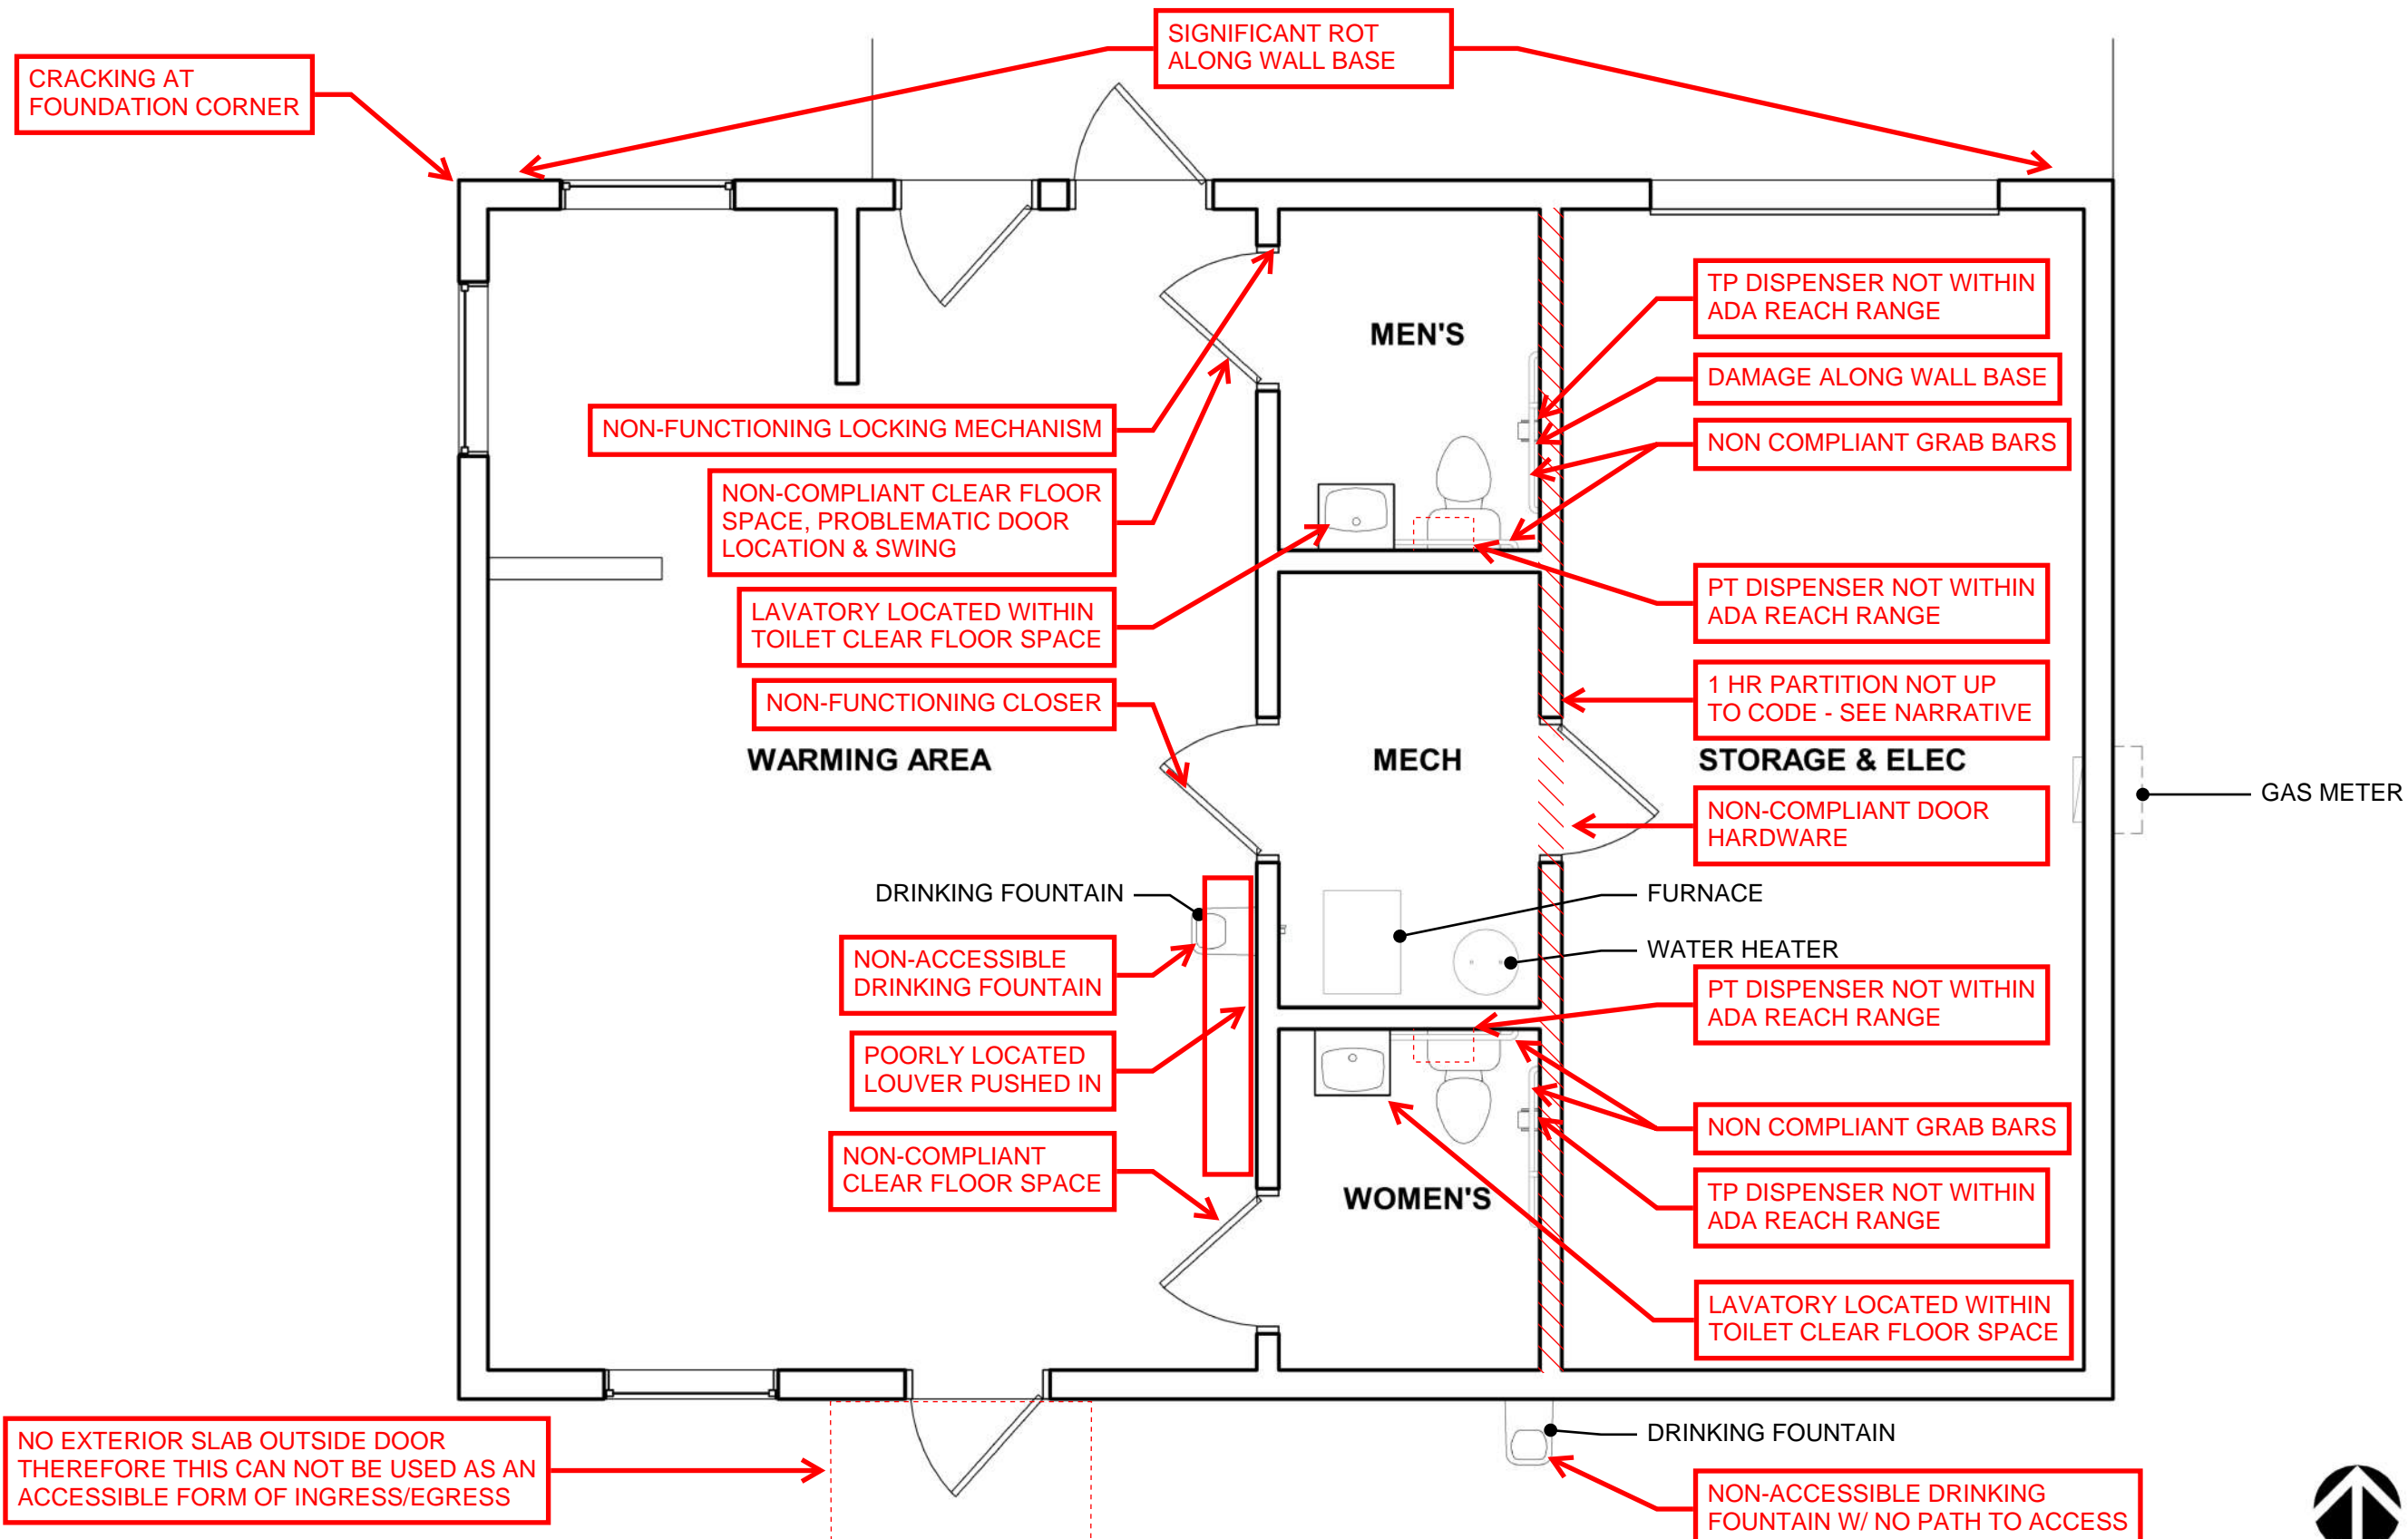
1 TERRACE PARK FLOOR PLAN
 1/4" = 1'-0"

- GENERAL OBSERVATIONS:**
- RUBBERIZED FLOORING HAS REACHED THE END OF ITS USEFUL LIFE.
 - ROOF SYSTEM IS ALSO APPROACHING THE END OF ITS USEFUL LIFE.
 - THERE ARE MULTIPLE ACCESSIBILITY VIOLATIONS IN AND AROUND THE TOILET ROOMS - SEE NARRATIVE.
 - PAINTED WOOD SIDING AND TRIM IS CRACKING AND PEELING. THERE ARE ALSO SEVERAL OPENINGS IN THE SIDING, EITHER DUE TO DAMAGED OR MISSING FIXTURES, OLD MAINTENANCE LINES OR ANIMAL INTRUSION.
 - THE MAJORITY OF THE DOORS AND FRAMES ARE SHOWING SIGNS OF RUST AND SIGNIFICANT WEAR. ESPECIALLY AT THE BUILDING EXTERIOR.
 - IT APPEARS THE WINDOW GLAZING HAS BEEN REPLACED WITH ACRYLIC SHEETING RESULTING IN POOR VISIBILITY AND POTENTIAL SAFETY ISSUES.

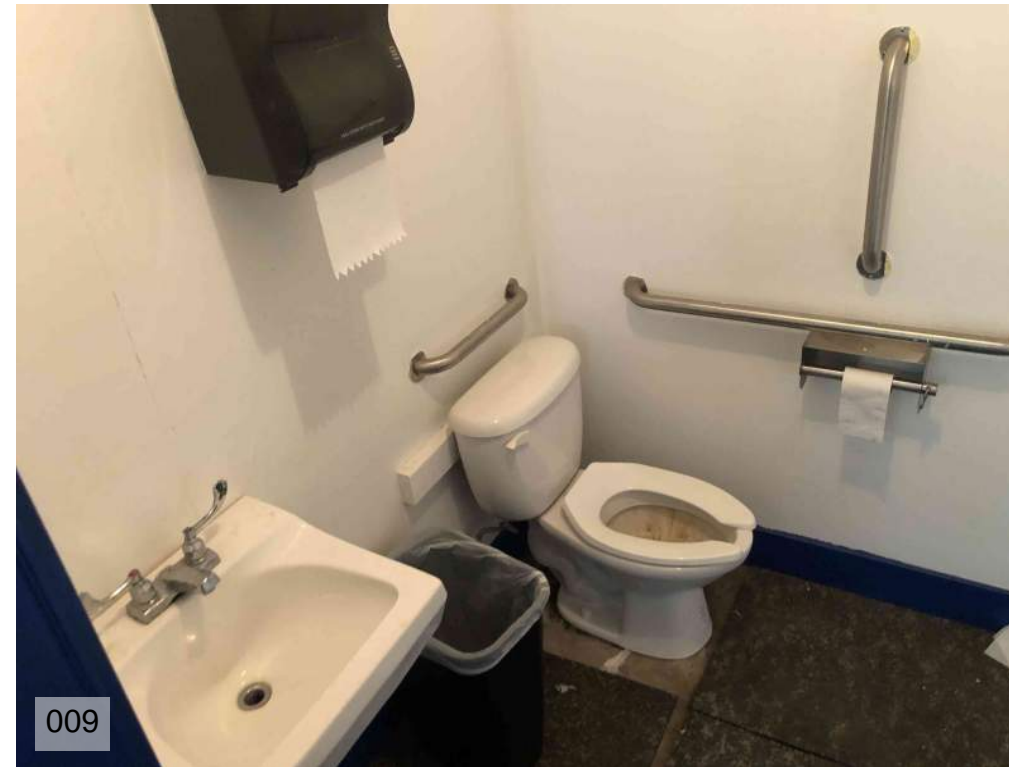
009

- Staining at Wall Base (009)
 - Option 1: Paint over stained portion
- Rubberized Flooring (009)
 - Option 1: Replace damaged tiles and secure with adhesive
 - Option 2: Remove all tiles and replace with rubberized sheet system
- Floor Drain ADA Compliance Issues (009)
 - Option 1: Raise floor drain cover and reduce slope to within allowable height differentials
- Lavatory ADA Compliance Issues (009)
 - Option 1: Relocate lavatory to a compliant location within restroom per (2015 MN Accessibility code Section 604.3.3), Insulate plumbing per (2015 MN Accessibility code Section 606), and provide the required faucet hardware

- Option 2: Remove lavatory and associated components and replace with ADA compliant fixture and components located outside of toilet clear floor space
- Grab Bar ADA Compliance Issues (009)
 - Option 1: Provide Compliant grab bars per (2015 MN Accessibility code Section 604.5)
- Toilet Paper Dispenser ADA Compliance Issues (009)
 - Option 1: Relocate dispenser per (2015 MN Accessibility Code Figure 604.7)
- Paper Towel Dispenser ADA Compliance Issues
 - Option 1: Lower dispenser to within accessible reach ranges per (2015 MN Accessibility Code Section 308)
- No Coved Base (009)
 - Option 1: Retrofit coved base to run over top of rubberized flooring
 - Option 2: Remove wood base and provide coved base course of tile or rubberized cove base

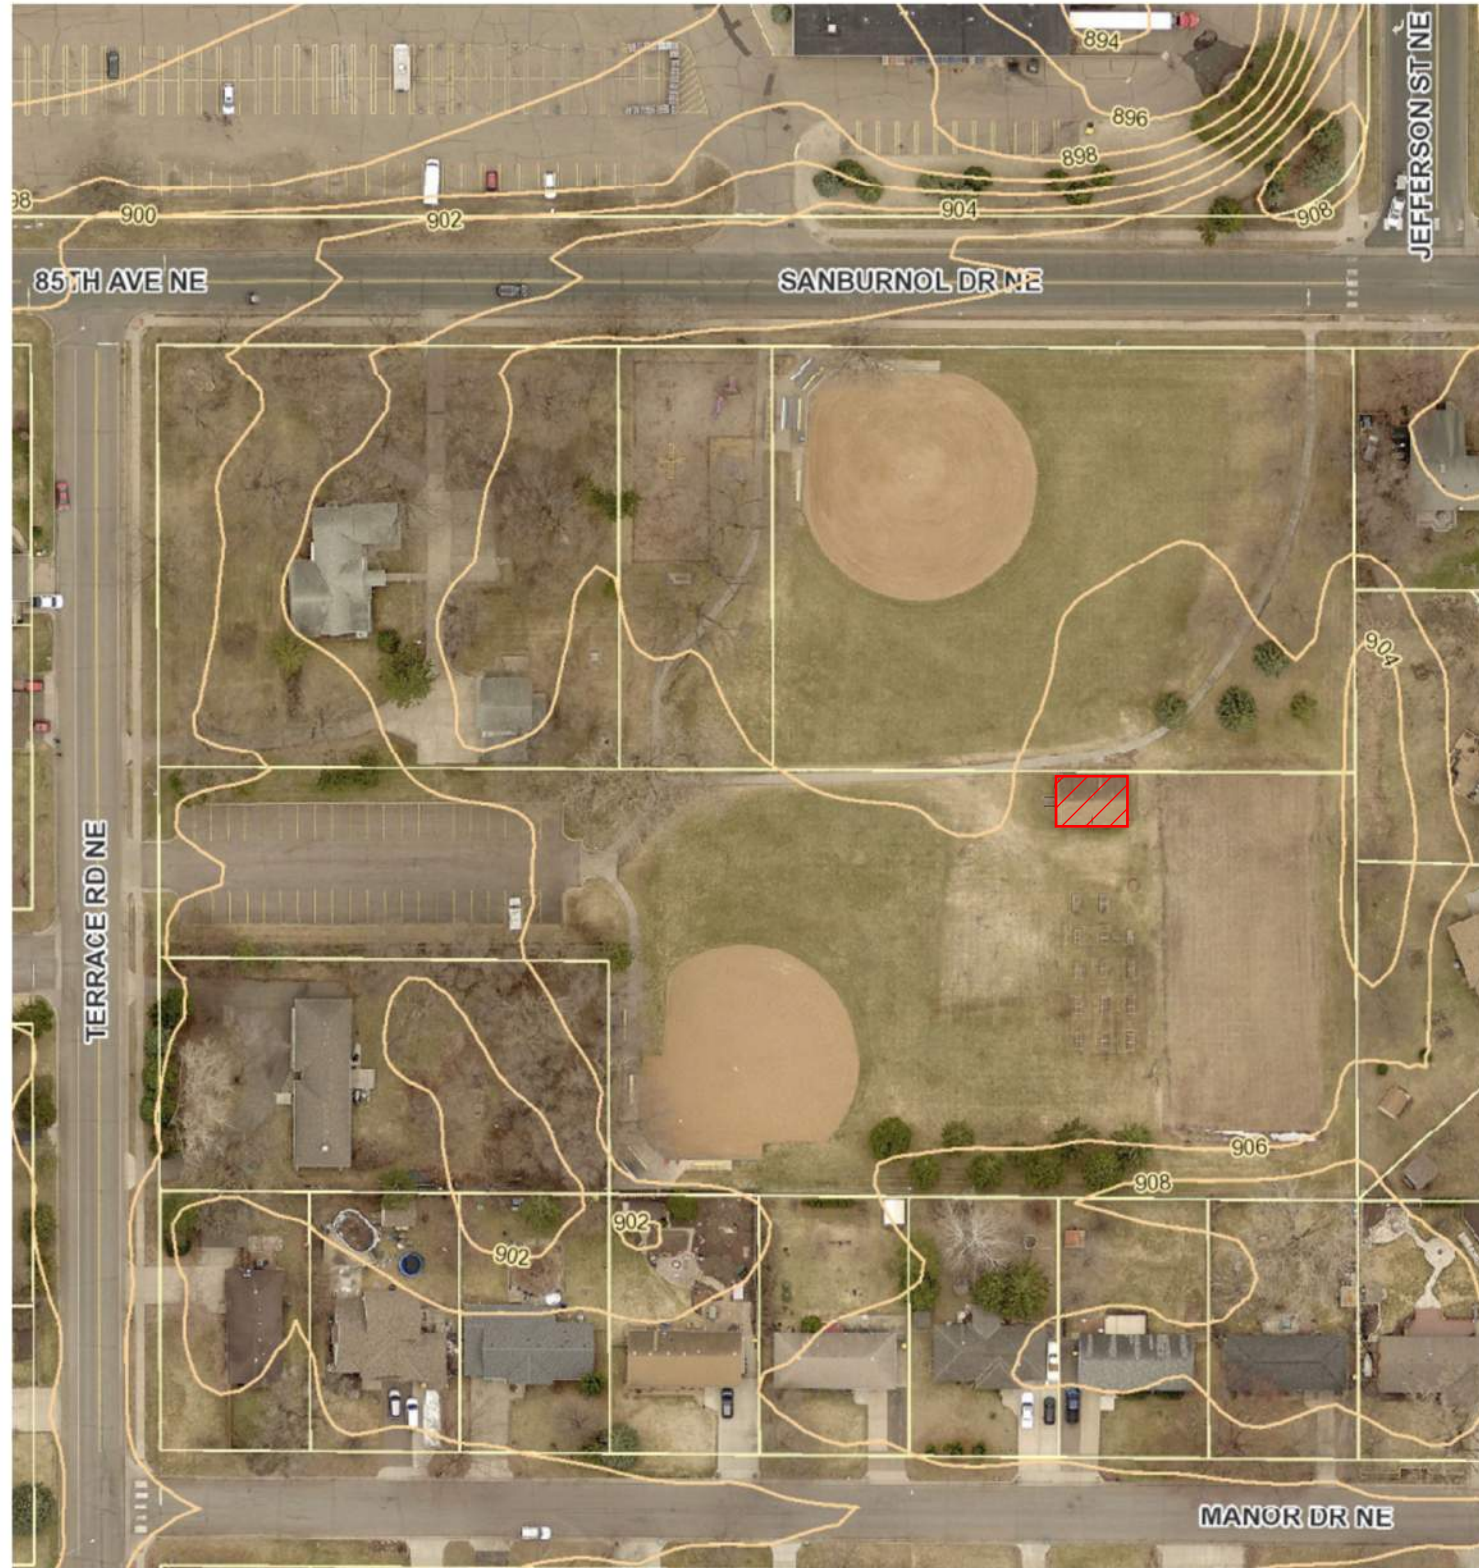
- GENERAL OBSERVATIONS:**
- RUBBERIZED FLOORING HAS REACHED THE END OF ITS USEFUL LIFE.
 - ROOF SYSTEM IS ALSO APPROACHING THE END OF ITS USEFUL LIFE.
 - THERE ARE MULTIPLE ACCESSIBILITY VIOLATIONS IN AND AROUND THE TOILET ROOMS - SEE NARRATIVE.
 - PAINTED WOOD SIDING AND TRIM IS CRACKING AND PEELING. THERE ARE ALSO SEVERAL OPENINGS IN THE SIDING, EITHER DUE TO DAMAGED OR MISSING FIXTURES, OLD MAINTENANCE LINES OR ANIMAL INTRUSION.
 - THE MAJORITY OF THE DOORS AND FRAMES ARE SHOWING SIGNS OF RUST AND SIGNIFICANT WEAR. ESPECIALLY AT THE BUILDING EXTERIOR.
 - IT APPEARS THE WINDOW GLAZING HAS BEEN REPLACED WITH ACRYLIC SHEETING RESULTING IN POOR VISIBILITY AND POTENTIAL SAFETY ISSUES.

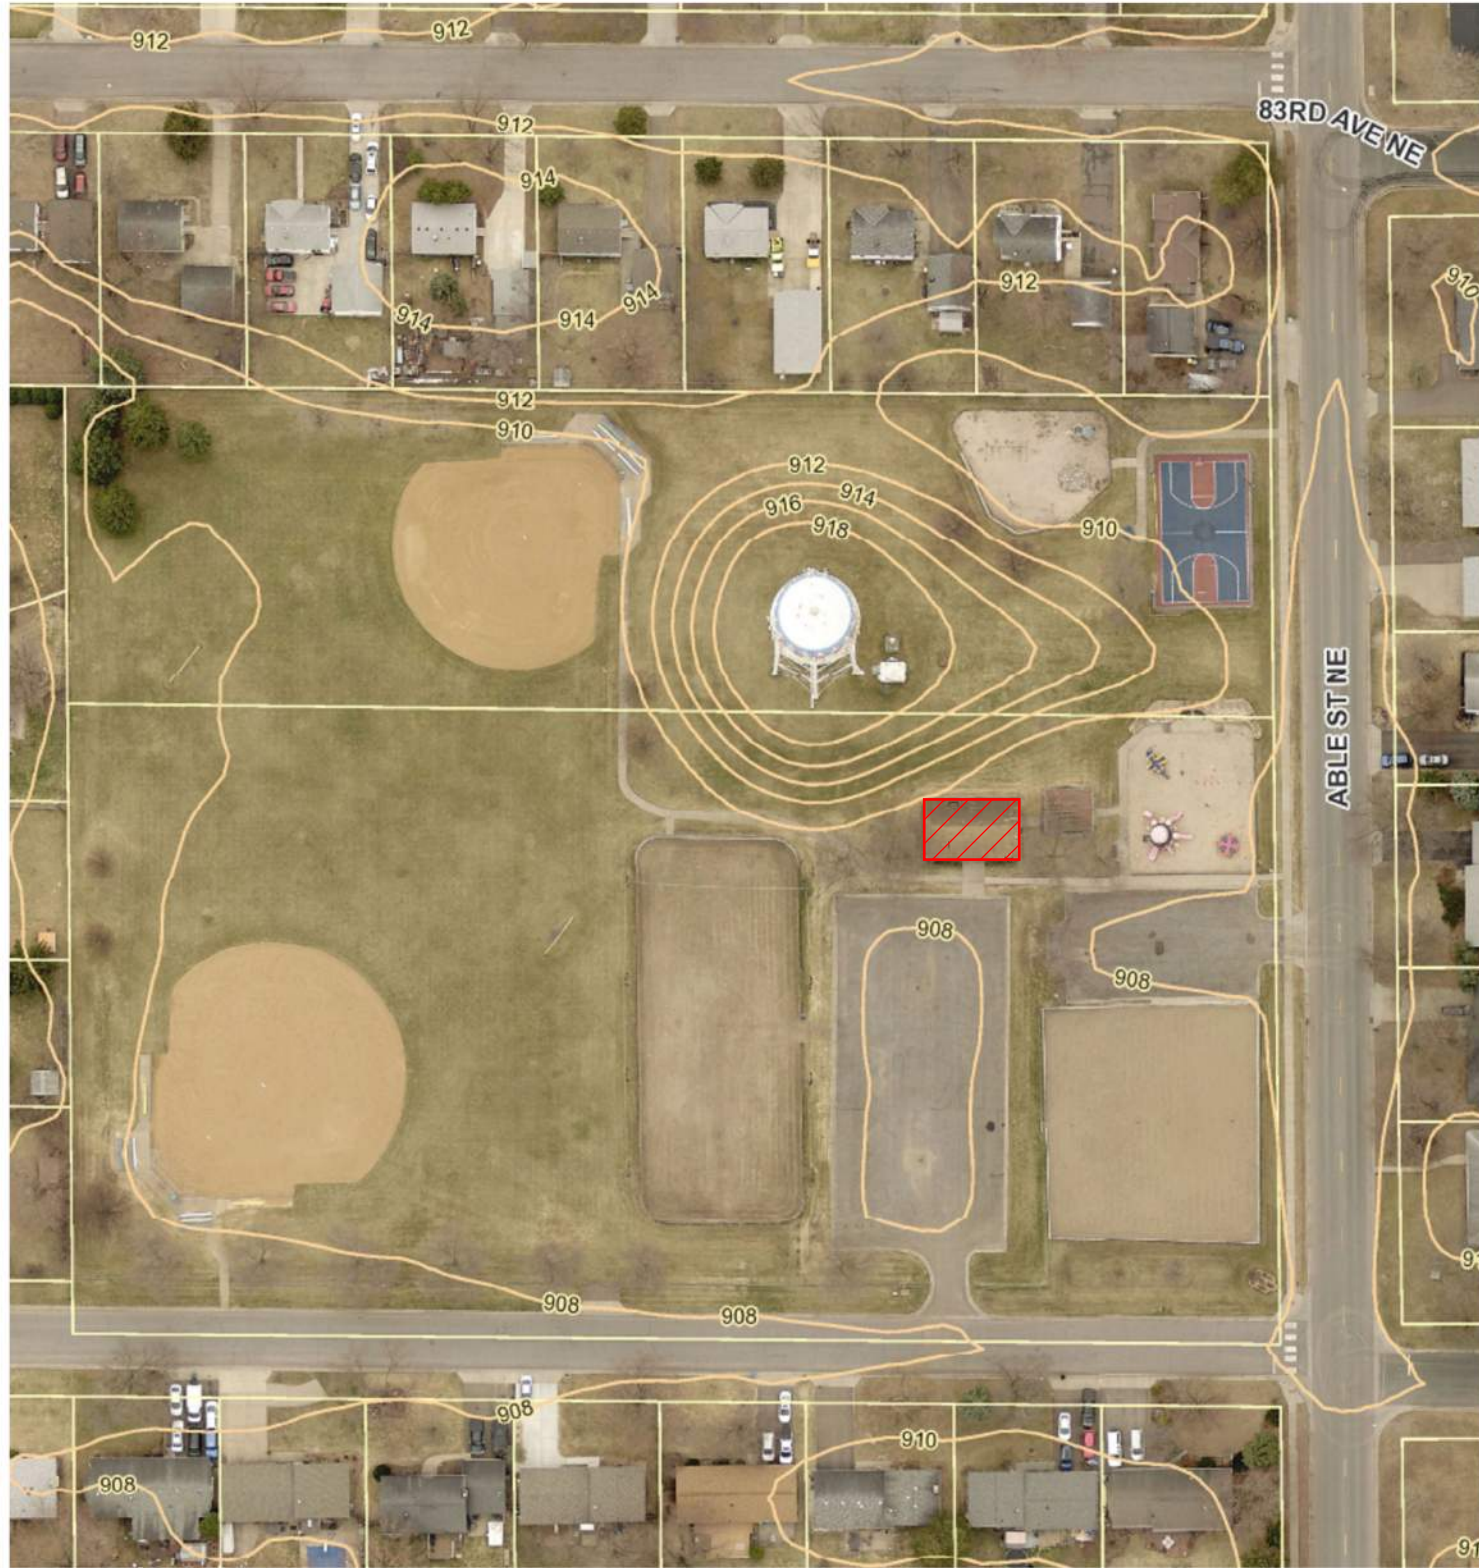
- GENERAL OBSERVATIONS:**
- RUBBERIZED FLOORING HAS REACHED THE END OF ITS USEFUL LIFE.
 - ROOF SYSTEM IS ALSO APPROACHING THE END OF ITS USEFUL LIFE.
 - THERE ARE MULTIPLE ACCESSIBILITY VIOLATIONS IN AND AROUND THE TOILET ROOMS - SEE NARRATIVE.
 - PAINTED WOOD SIDING AND TRIM IS CRACKING AND PEELING. THERE ARE ALSO SEVERAL OPENINGS IN THE SIDING, EITHER DUE TO DAMAGED OR MISSING FIXTURES, OLD MAINTENANCE LINES OR ANIMAL INTRUSION.
 - THE MAJORITY OF THE DOORS AND FRAMES ARE SHOWING SIGNS OF RUST AND SIGNIFICANT WEAR. ESPECIALLY AT THE BUILDING EXTERIOR.
 - IT APPEARS THE WINDOW GLAZING HAS BEEN REPLACED WITH ACRYLIC SHEETING RESULTING IN POOR VISIBILITY AND POTENTIAL SAFETY ISSUES.
