June 17, 2020

RE: Rock Creek Cove Hospitality Site - Critical Areas Review

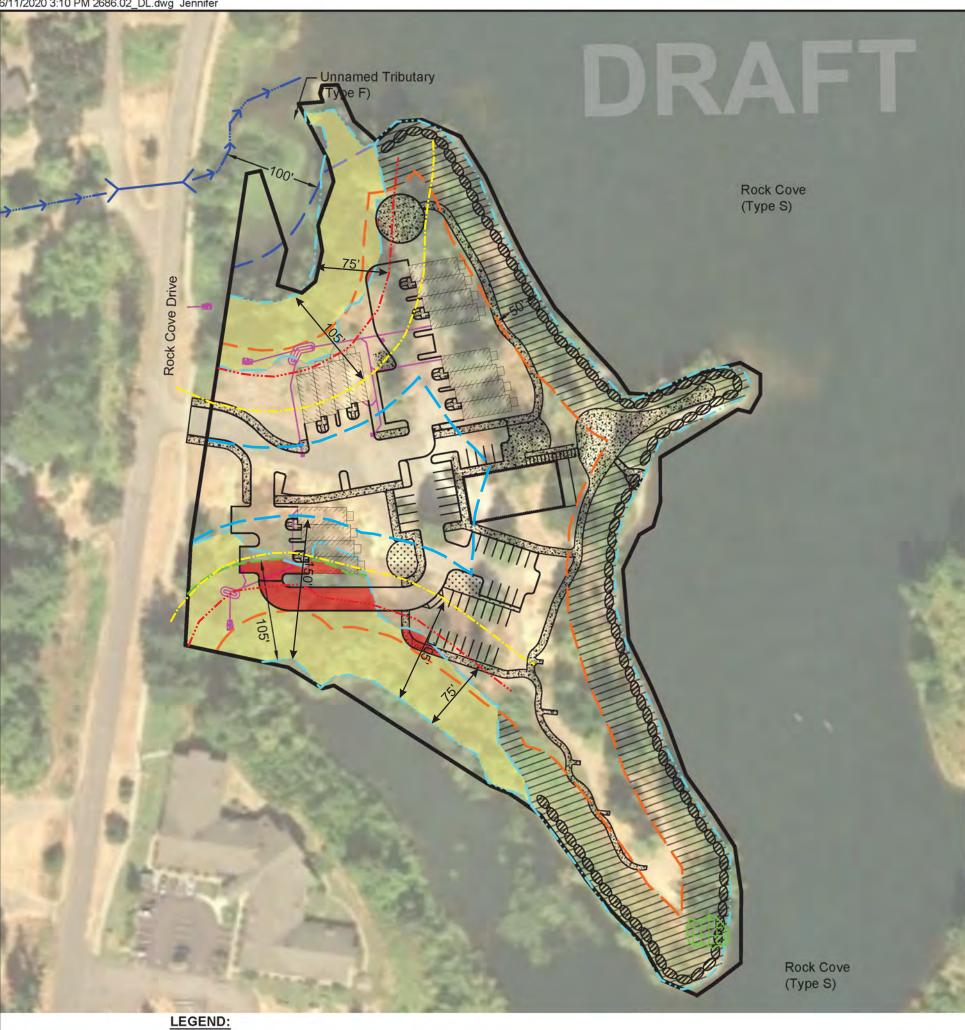
- Site Boundary
- OHWM
- Stream with Flow Direction
- FWHCA Buffer for Type F
- Functionally Isolated FWHCA Buffer for Type S

OE concurs that based on this definition the riprap functionally isolates the 150 foot buffer as shown if Figure 2. The maintained vegetation areas may functionally isolate however more detail needs to be provided to make that justification.

The remaining buffer in the riprap areas is less than 50 percent (75') of the base buffer (150'). If the maintained vegetation areas are considered functionally isolated the remaining buffer area north of the existing entrance and a portion of the buffer in the south-central portion of the project area are less than 50 percent (see attached graphic).
