Re: Critical areas report and conceptual mitigation plan for the Rock Creek Cove Hospitality proposal

Ecological Land Services (ELS) has prepared the following critical areas report and conceptual mitigation plan for FDM Development (the applicant) as a component of the proposed mixed-use hospitality development adjacent to Rock Creek Cove on parcels 02070100130300, 02070100130400, and 02070100130200 (study area) in the City of Stevenson, Skamania County, Washington. The study area is in the SW $\frac{1}{4}$ of the NW $\frac{1}{4}$ of Section 1, Township 2 N, and Range 7 East of the Willamette Meridian, coordinates 45.6890, -121.8992, and is accessed from SW Rock Cove Dr (Figure 1). The study area's zoning is "Commercial" (C1). This report provides a description of existing critical areas on the proposed development site, a summary of proposed impacts from development, and a conceptual compensatory mitigation plan for unavoidable impacts.

Figure 2
 EXISTING CONDITIONS SITE MAP
 Rock Cove CAR
 FDM Development
 City of Stevenson, Skamania County, Washington
 Section 1, Township 2N, Range 7E, W.M.

Figure 3
PROPOSED CONDITIONS MAP
 Rock Cove CAR
 FDM Development
 City of Stevenson,

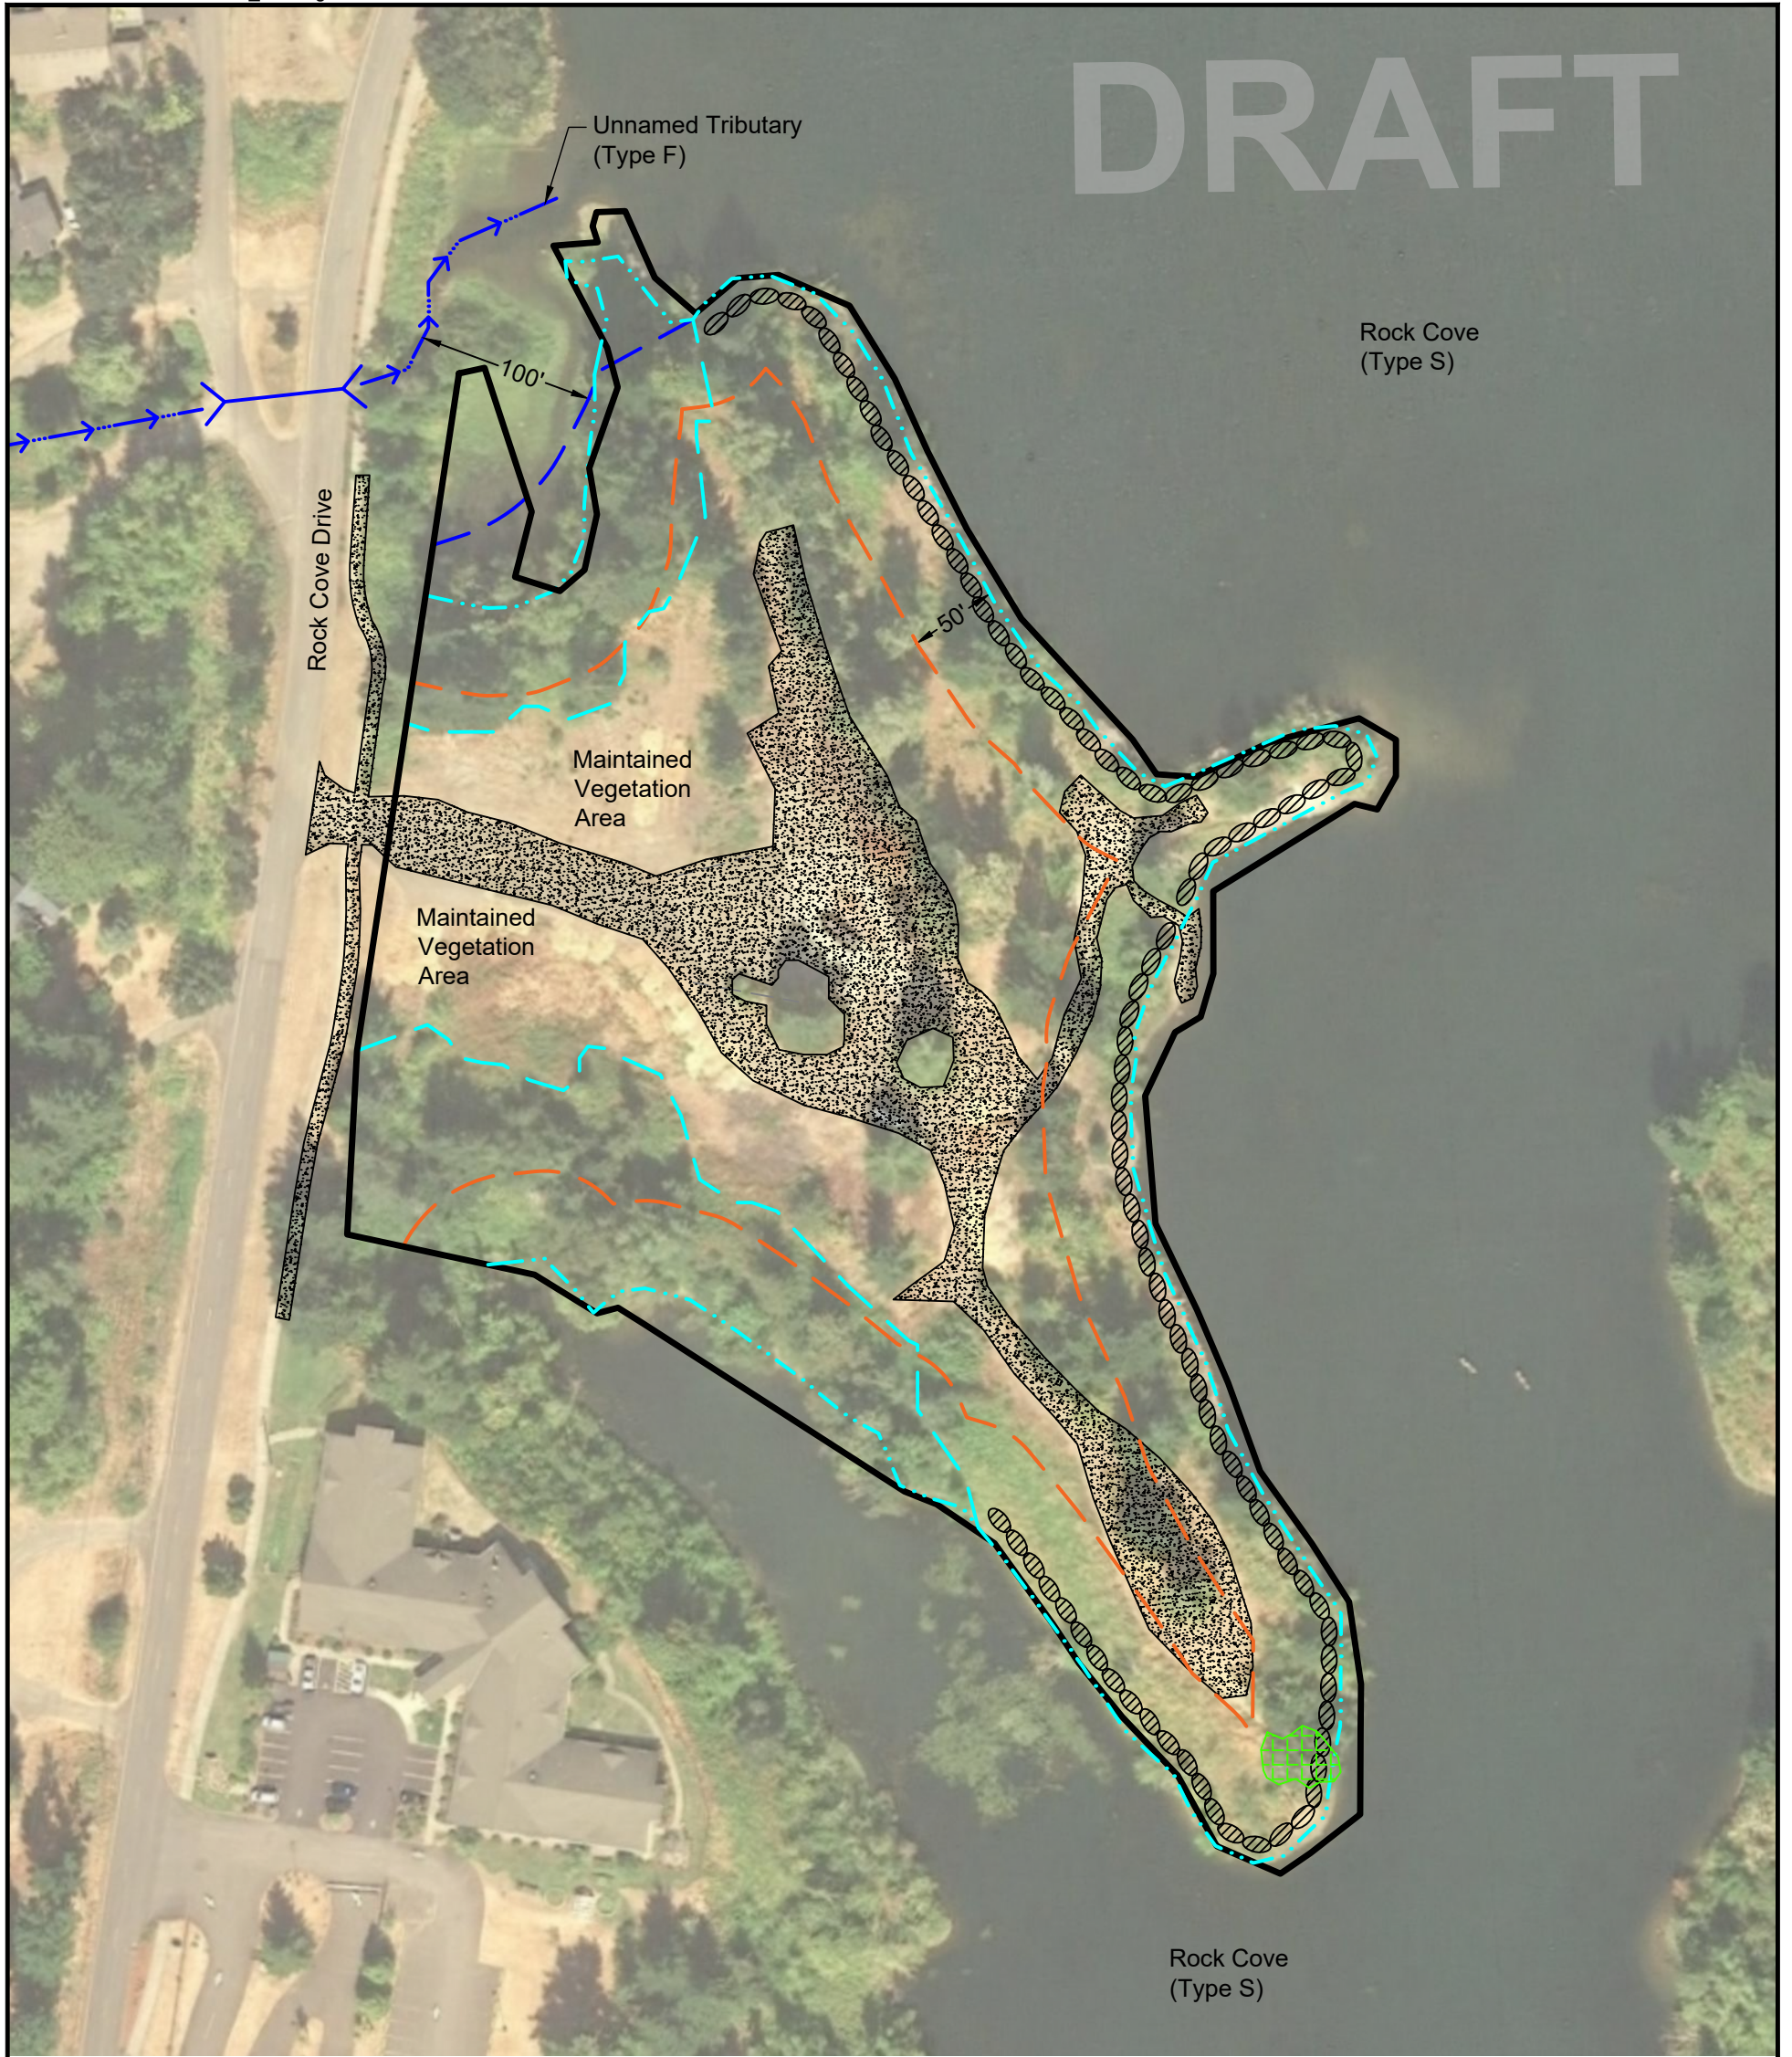
1. Aerial from Google Earth™.
2. OHWM line was determined through a joint effort by Ecological Land Services and Washington Department of Ecology on December 30, 2019. OHWM flags were professionally surveyed by S&F Land Services December 30-31, 2019.

ELS and Ecology identified one unnamed tributary to the Columbia River north of the study area (Figures 2 and 3). The tributary is identified as a Type F (fish-bearing) water by Washington Department of Natural Resources (DNR) (Figure 4). Rock Cove, a side channel of the Columbia River, surrounds the study area on three sides. The Columbia River is designated Type S and is a shoreline of statewide significance. One Oregon white oak (*Quercus garryana*) is rooted above the OHWM at the northeast end of the study area. It is considered a Priority Habitat by Washington State Dept of Fish and Wildlife (DFW) and is recommended for protection. SMC provides guidance for Oregon white oak protection in Table 18.13.095-2 *Mitigation for Vegetation Removal within Riparian Habitat Areas*. No other priority habitats or critical areas⁵ were identified in the study area.

In most places the transition from top-of-bank to the OHWM is relatively steep. Erosion control in the steeper portions of the shoreline has been historically achieved with riprap-like armoring. Approximately 65 percent of the shoreline is armored with material that consists of loose stones, gravel, fragments of concrete, and large pieces of metal (i.e. rebar, logging cable, and non-specific steel remnants). Derelict in-water pilings are located along the southeast shoreline of the study area and formerly supported timber industry infrastructure.

armoring meets the description of a preexisting structure that that does afford protection from adverse impacts. It lacks pervious surfacing for detaining and/or filtering sediment loads in surface runoff, an established and diverse native vegetation community able to provide forage, screening, refuge, or denning opportunities for wildlife species, and over-water shading for near-shore aquatic wildlife in the Columbia River. Accordingly, those portions of the study area that contain armoring satisfy the buffer exemption criteria per SMC 18.13.095(B)(3) (Figure 2).

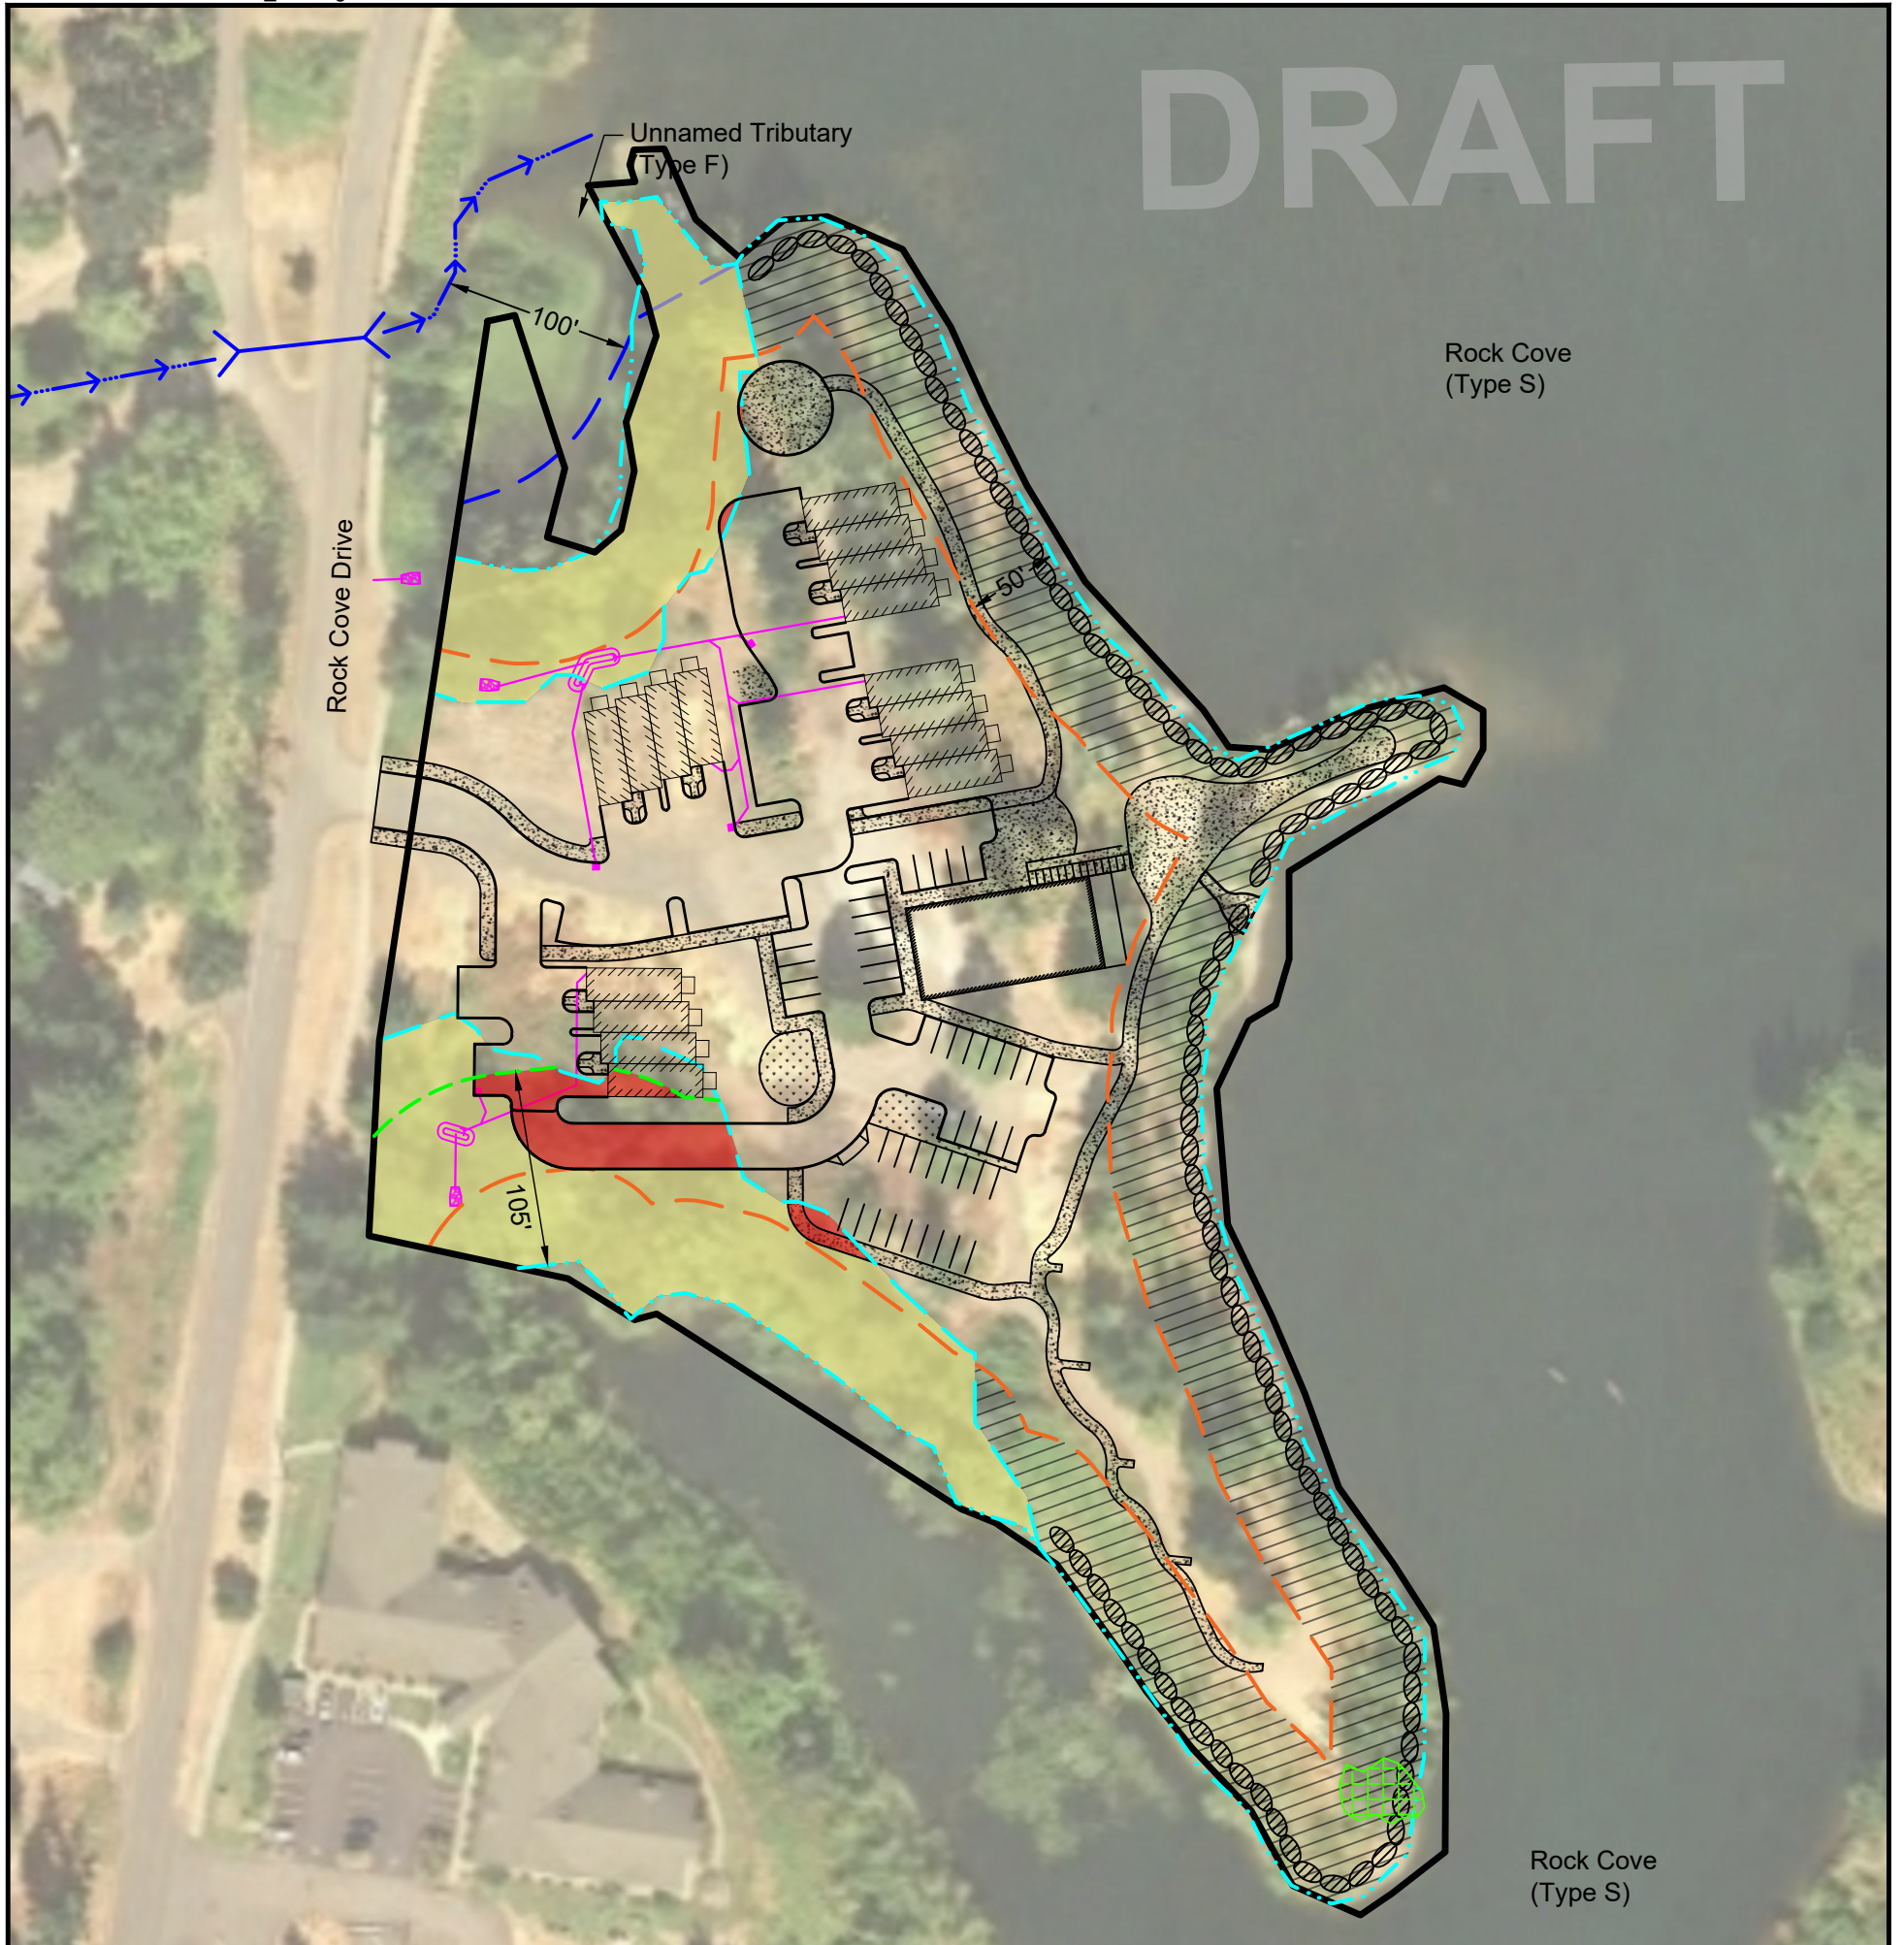
1. Aerial from Google Earth™.
2. OHWM line was determined through a joint effort by Ecological Land Services and Washington Department of Ecology on December 30, 2019. OHWM flags were professionally surveyed by S&F Land Services December 30-31, 2019. .
3. Site Plan provided by FDM Development, Inc.

The applicant’s proposal follows the standard mitigation sequencing protocol of avoidance, minimization, and compensation for unavoidable impacts to critical areas. Critical areas associated with the proposal include the FWHCA for the unnamed tributary and the Columbia River, and one Oregon white oak tree. Phases 1 and 3 completely avoid FWHCA impacts and the oak tree will not be disturbed by development; however, Phase 2 of the development impacts approximately 0.12-acre of the Columbia River’s FWHCA in an area where it is not functionally isolated by armoring (Figure 3). The proposed impact area is partially degraded by remnant debris that appears to consist of almost entirely of sawdust stockpiling.

Mitigation for buffer impacts is proposed as a combination of reduction and enhancement in accordance with SMC 18.13.095(D)(5). After reduction at the proposed impact site, all remaining buffer in the study area will be enhanced by removing non-native Himalayan blackberry (which currently has a dominant presence in shoreline vegetation) and installing native shrubs and herbaceous plants. A conservation covenant will be established for the entire enhancement area. Most buffer enhancement actions will take place in areas that are not functionally isolated by armoring to maximize functional and relevant habitat improvements. These portions of the FWHCA total approximately 1.03 acres in the study area and achieve an enhancement ratio of approximately 8:1 for the impacts’ mitigation (Figure 3). The applicant is also proposing to enhance portions of the 50-foot shoreline setback in the same manner (blackberry removal and native plant installation) to improve overall habitat function and ecological health in the study area. These proposed enhancement actions are anticipated to increase, diversify, and improve critical area functions above and beyond those provided by existing buffer conditions.

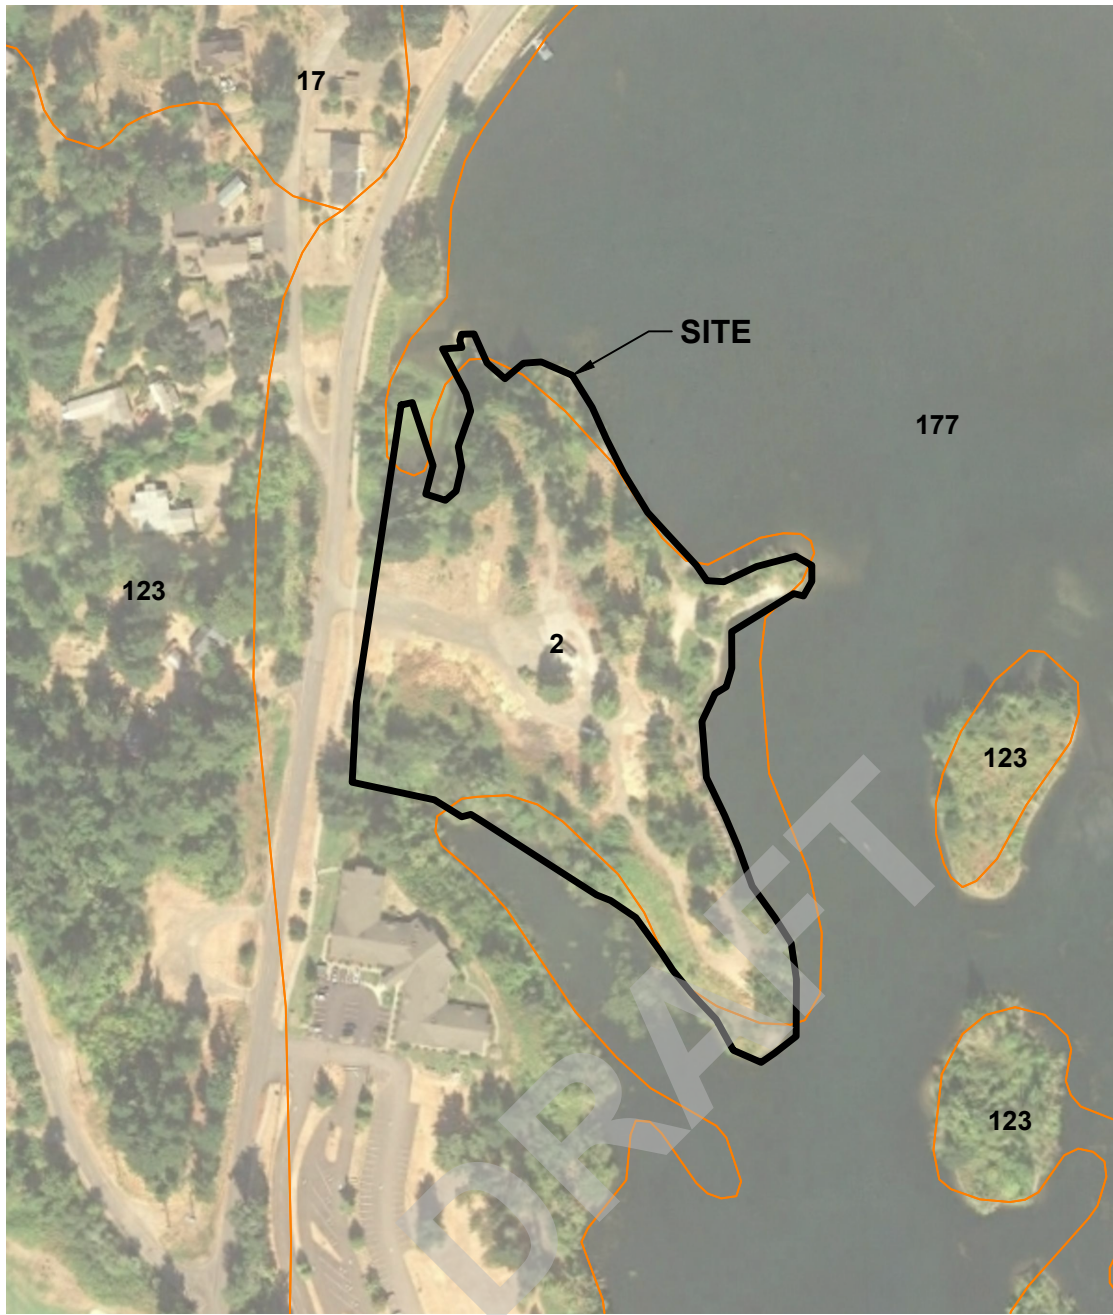
Figure 4
NRCS SOIL SURVEY
Rock Cove CAR
FDM Development
City of Stevenson, Skamania County, Washington
Section 1, Township 2N, Range 7E, W.M.

- 2** Arents, 0 to 5 percent slopes. Not hydric.
- 17** Bonneville stony sandy loam. Not hydric.
- 123** Steever stony clay loam, 2 to 30 percent slopes. Not hydric.
- 177** **Water.**

ELS uses the Natural Resource Conservation Service (NRCS) map unit descriptions to gather baseline soil data. NRCS identifies soils in the study area as Arents 0 to 5 percent slopes. Arents is described by NRCS as a well-drained, terraced soil with more than 80 inches depth to the groundwater table. A typical profile includes gravelly sandy loam from 0 to 24 inches and extremely gravelly sandy loam between 24 and 60 inches. Arents do not have diagnostic horizons because they have been deeply mixed by plowing, spading, or other methods of moving by humans (NRCS 2020).

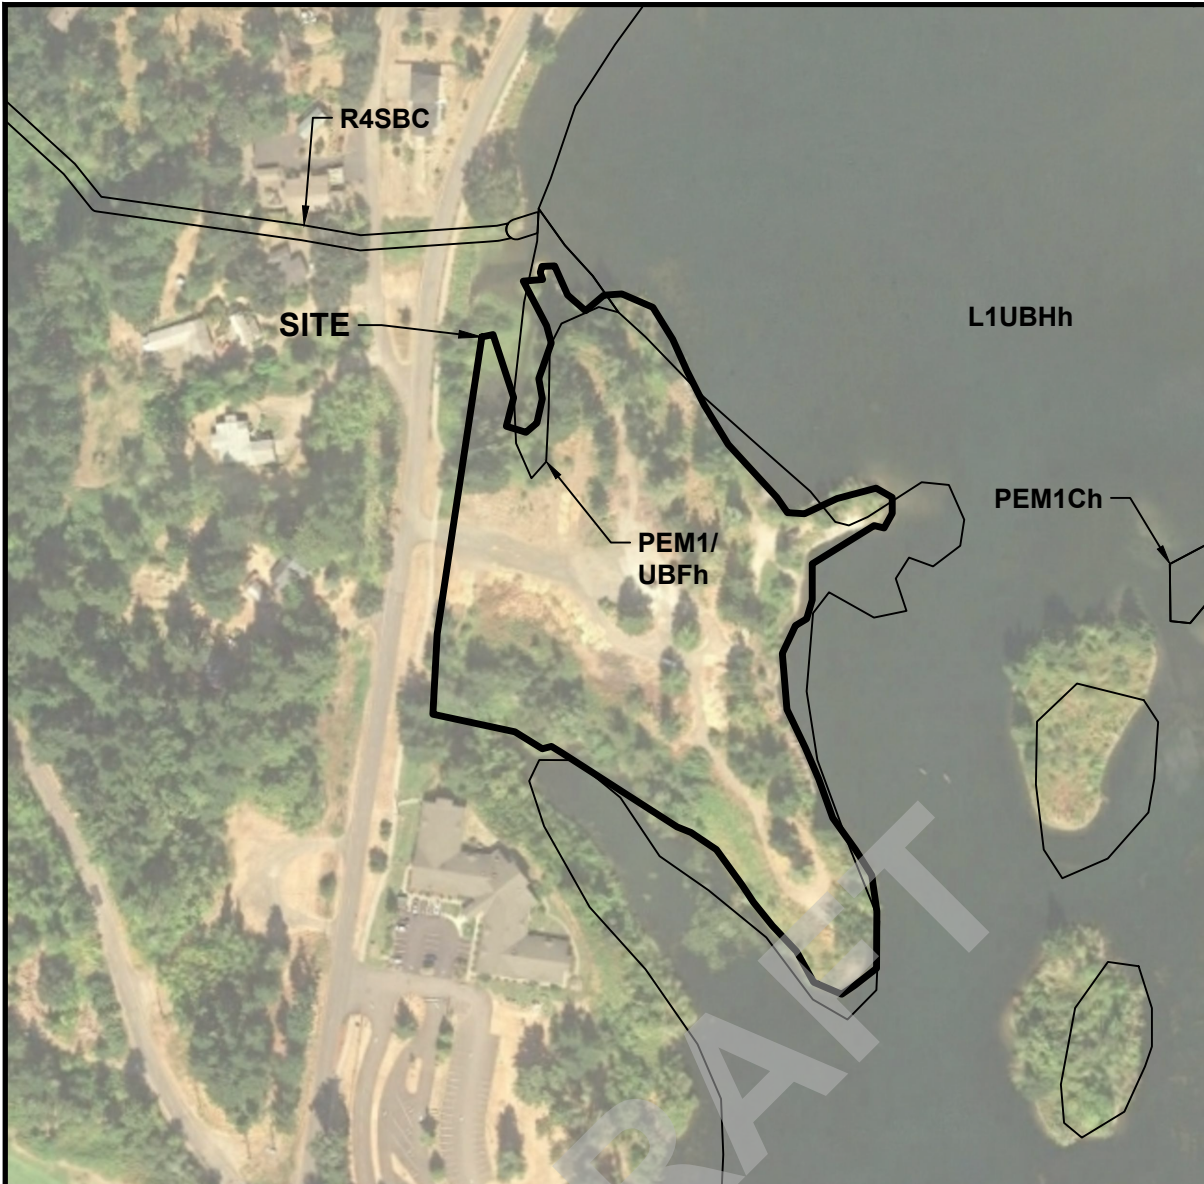
Figure 5
NATIONAL WETLANDS INVENTORY
 Rock Cove CAR
 FDM Development
 City of Stevenson, Skamania County, Washington
 Section 1, Township 2N, Range 7E, W.M.

Mapped wetlands indicated onsite by US Fish & Wildlife Service.

- PEM1Ch** Palustrine, Emergent, Persistent, Seasonally Flooded, Diked/ Impounded.
- PEM1/UBFh** Palustrine, Emergent, Persistent, Unconsolidated Bottom, Semipermanently Flooded, Diked/ Impounded.
- L1UBHh** Lacustrine, Limnetic, Unconsolidated Bottom, Permanently Flooded, Diked/ Impounded.
- R4SBC** Riverine, Intermittent, Streambed, Seasonally Flooded.

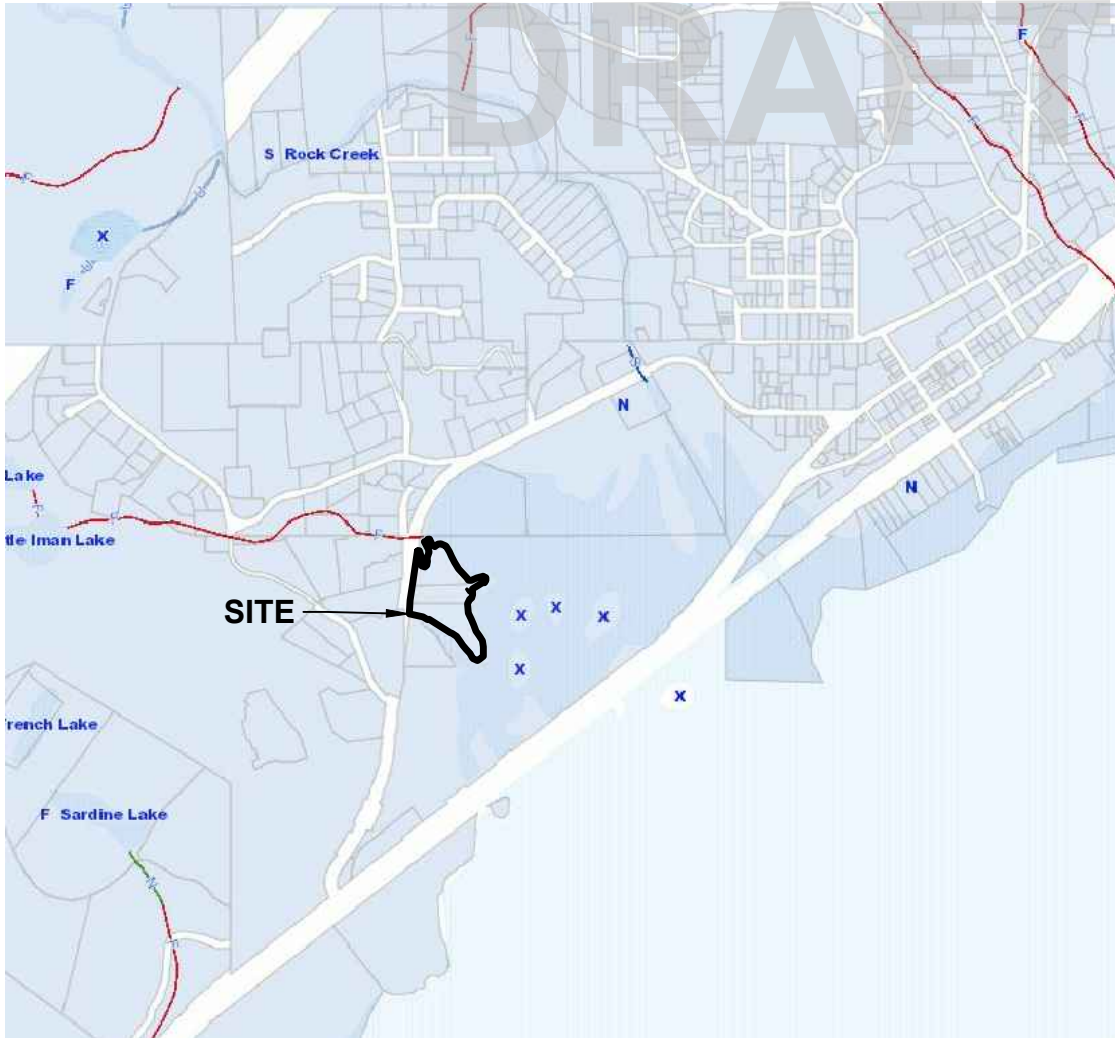
Figure 6
DNR STREAM TYPE MAP
 Rock Cove CAR
 FDM Development
 City of Stevenson, Skamania County, Washington
 Section 1, Township 2N, Range 7E, W.M.

No mapped streams indicated onsite by the Washington State Department of Natural Resources (DNR).

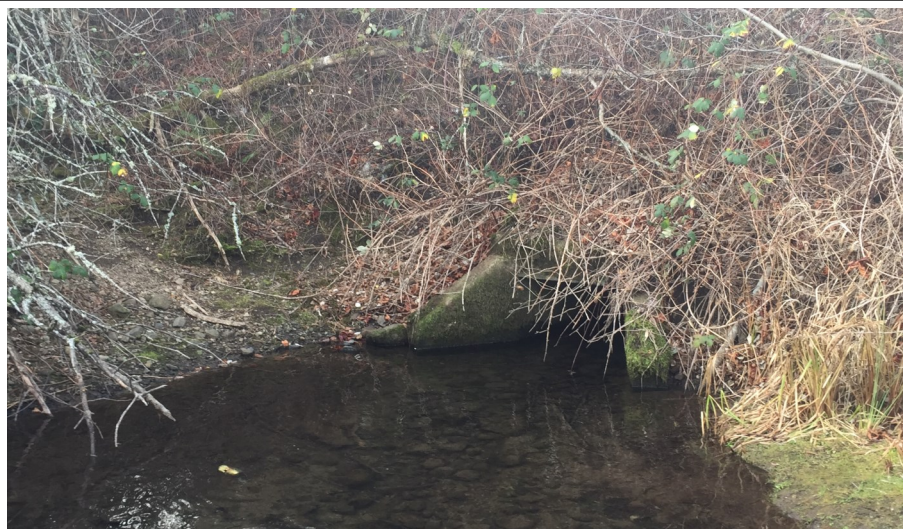
Photo 1. Inflow point of the unnamed tributary via concrete culvert.

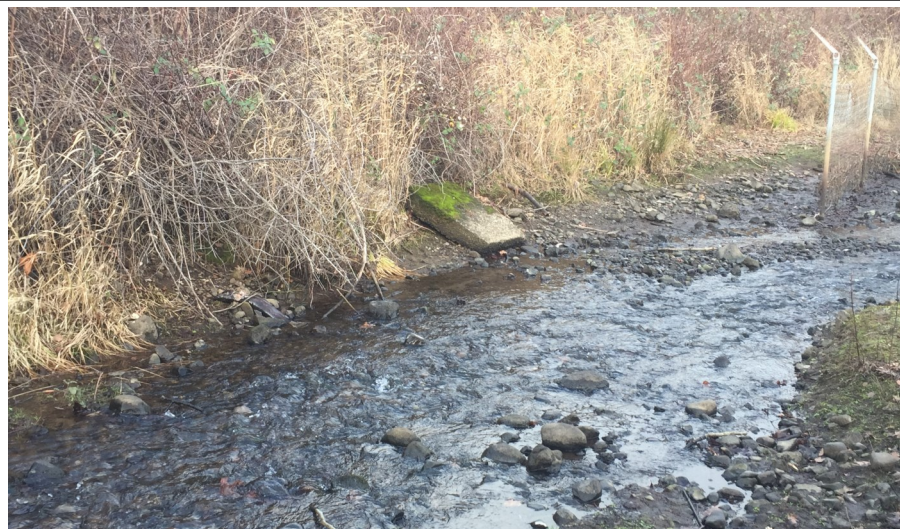
Photo 2. Unnamed tributary flowing toward Rock Cove.

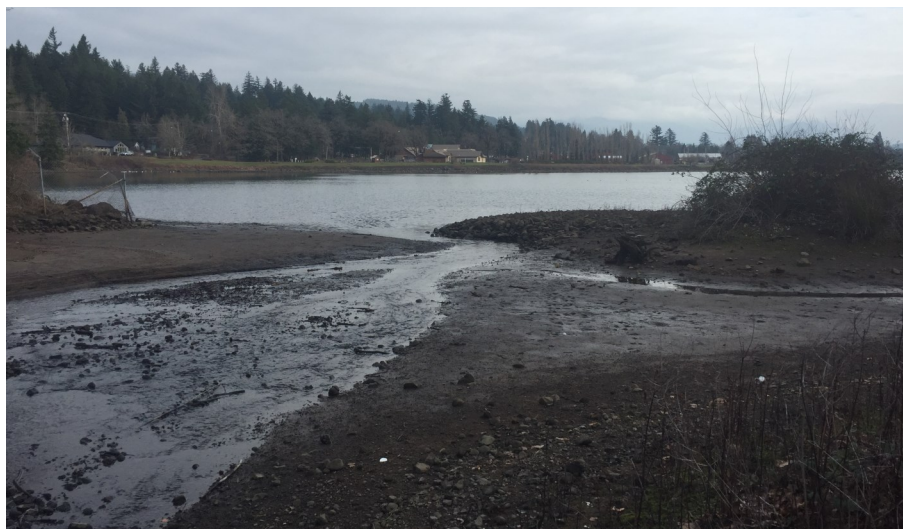
Photo 3. Overview of unnamed tributary's confluence with Rock Cove.

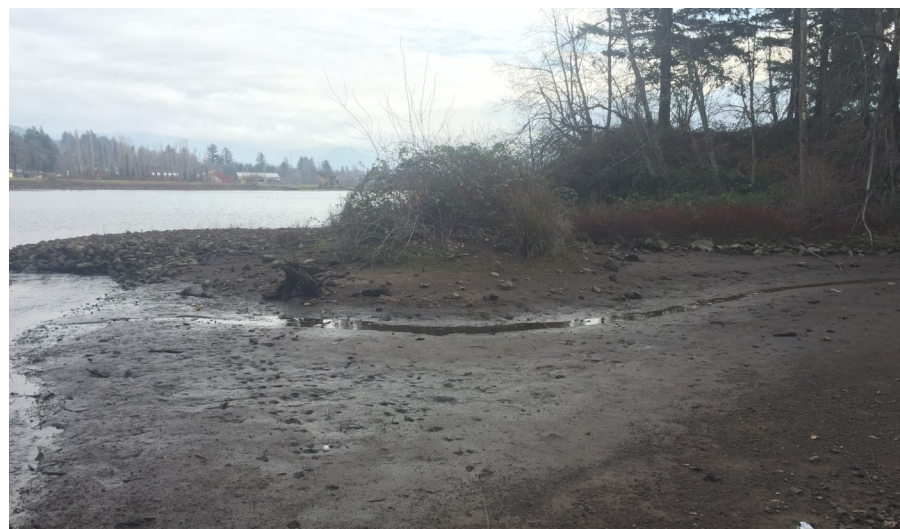
Photo 4. Mud flat adjoining Rock Cove.

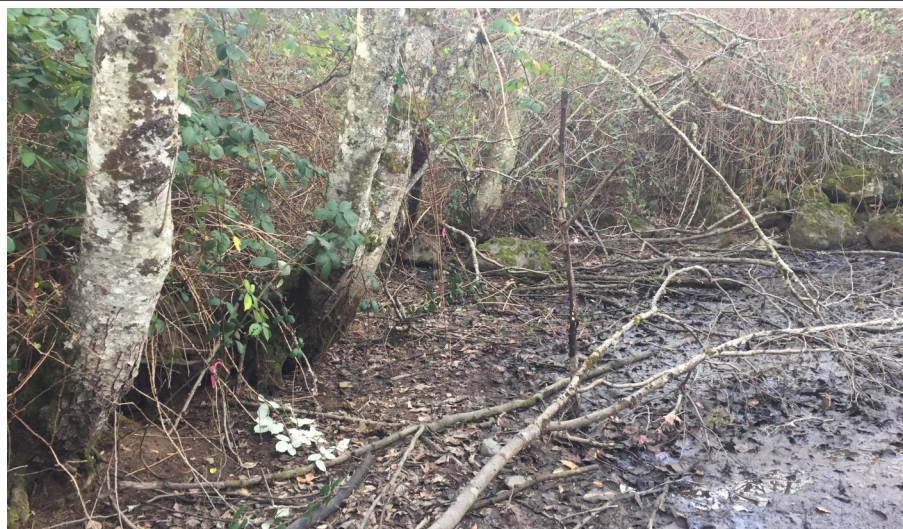
Photo 1. Vegetated shoreline on the north end of the study area.

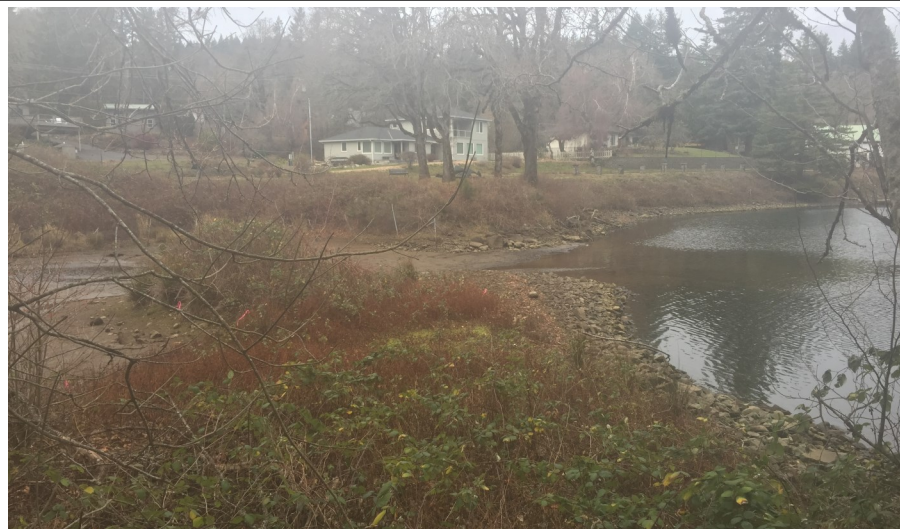
Photo 2. Vegetated shoreline extending toward the unnamed tributary.

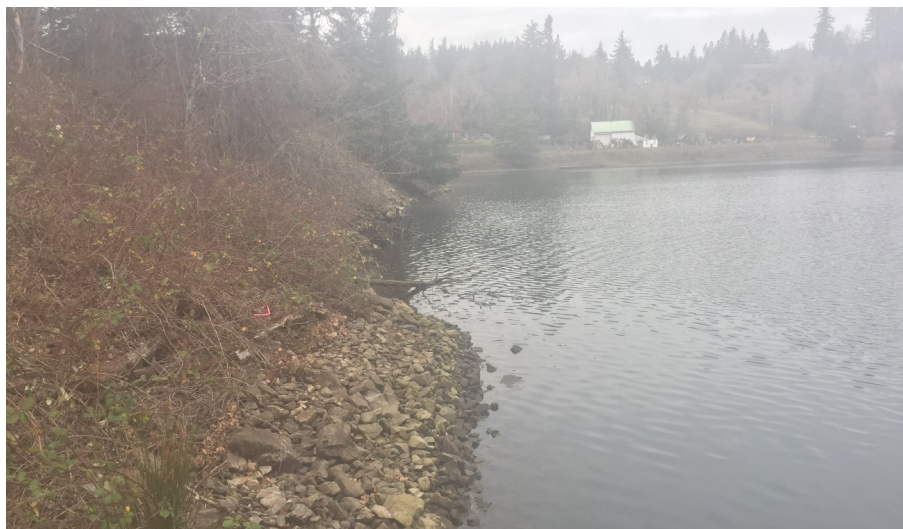
Photo 3. Riprap on the eastern shoreline, facing north.

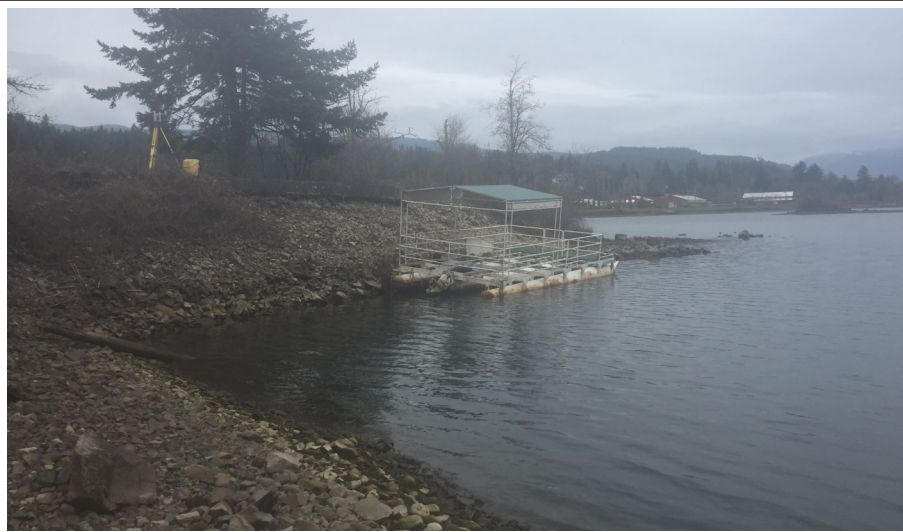
Photo 1. Graveled boat launch on the east side of the study area.

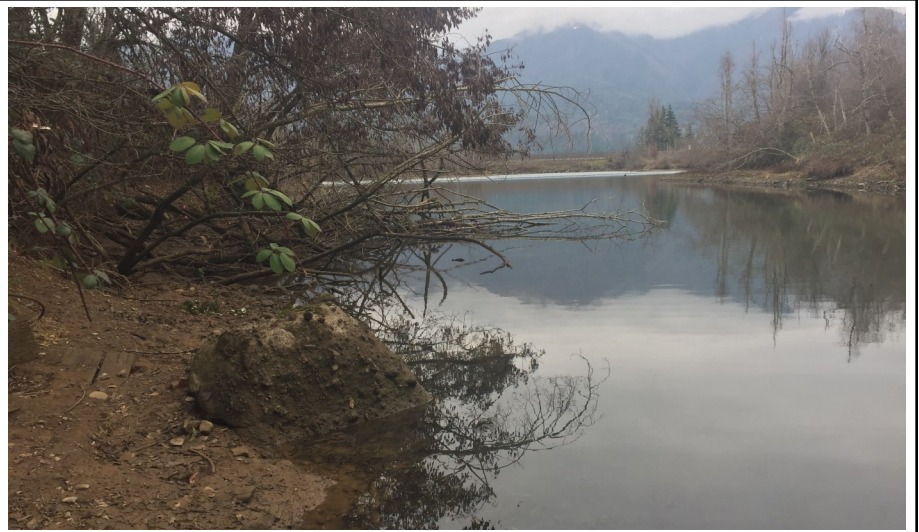
Photo 2. Vegetated shoreline on the west side, facing south.

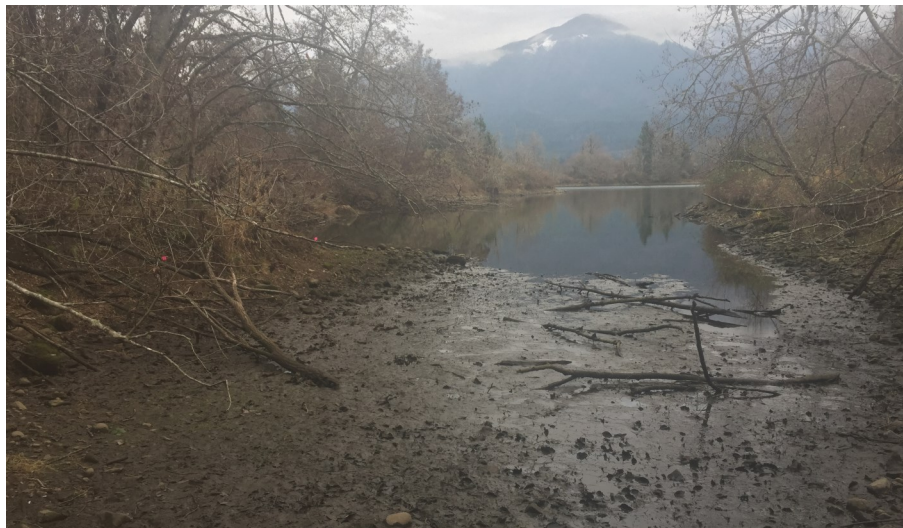
Photo 3. Vegetated shoreline and mud flat in the southwest portion of the study area, facing south.

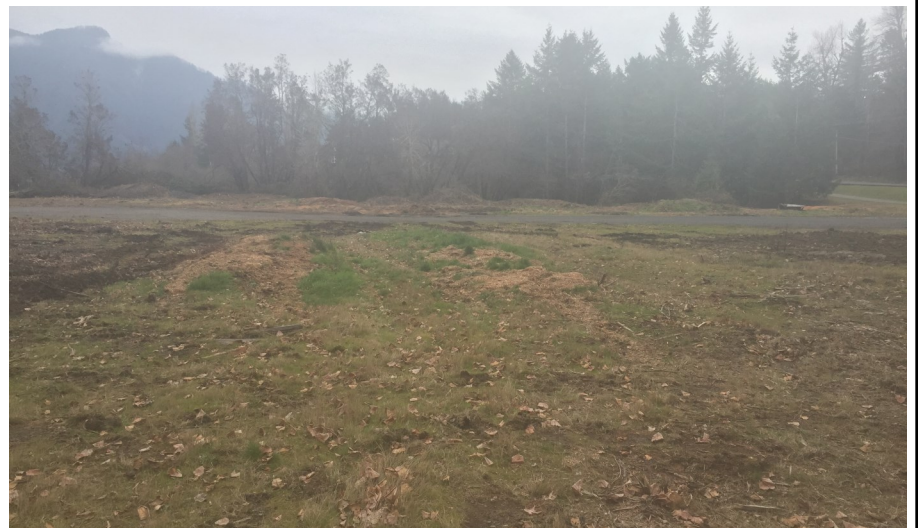
Photo 4. Groomed vegetation in the center of the study area.

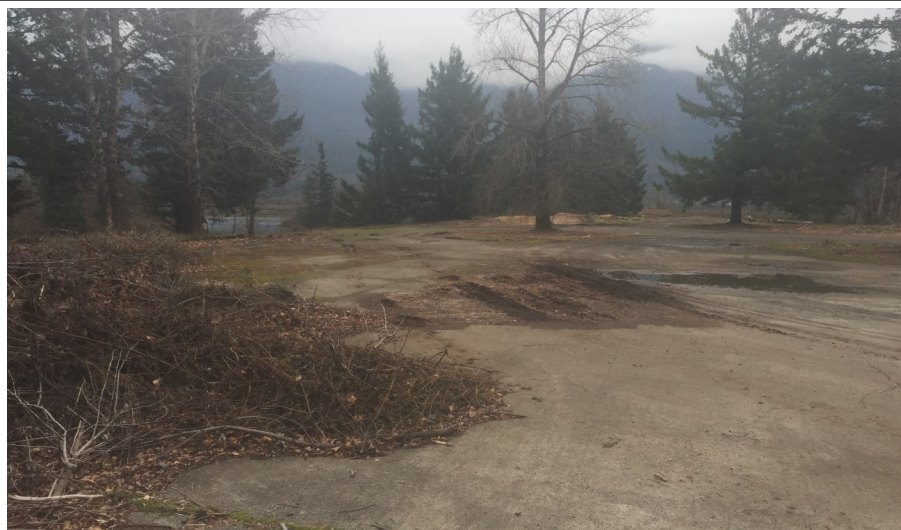
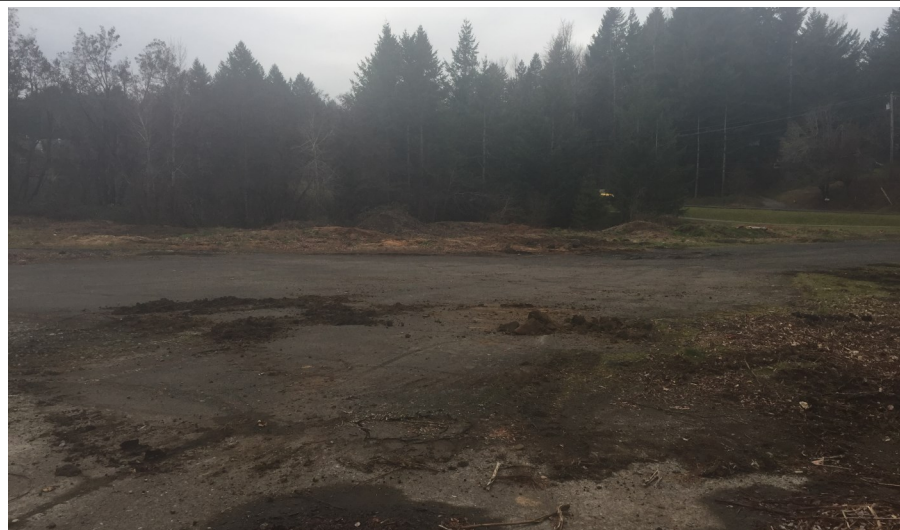
Photo 1. Existing concrete and gravel surfacing.

Photo 2. Existing concrete and gravel surfacing.

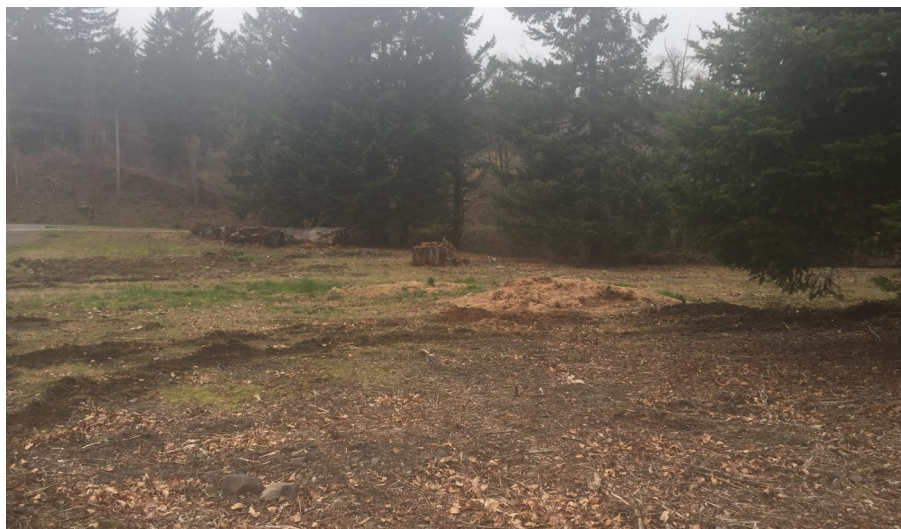
Photo 3. Groomed vegetation in the center of the study area.

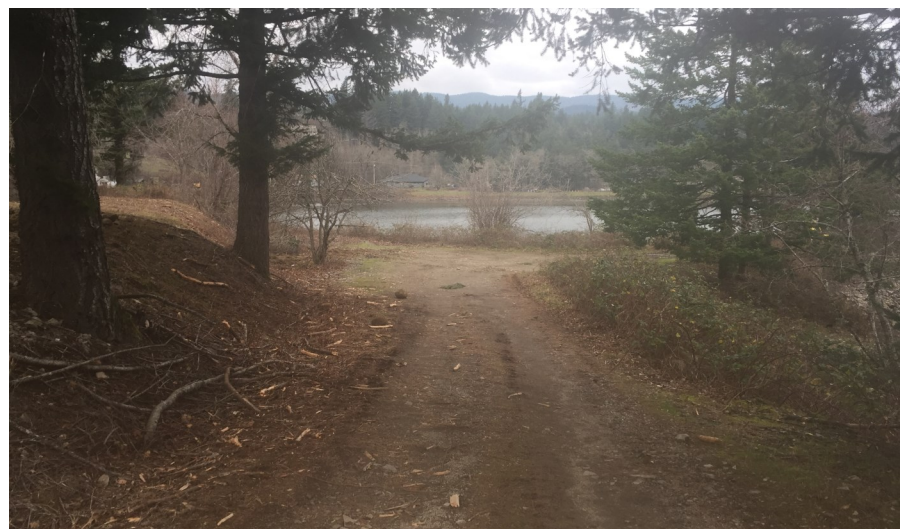
Photo 4. Existing gravel road.
