Re: Critical areas report and conceptual mitigation plan for the Rock Creek Cove Hospitality proposal

Ecological Land Services (ELS) has prepared the following critical areas report and conceptual mitigation plan for FDM Development (the applicant) as a component of the proposed mixed-use hospitality development adjacent to Rock Creek Cove on parcels 02070100130300, 02070100130400, and 02070100130200 (study area) in the City of Stevenson, Skamania County, Washington. The study area is in the SW $\frac{1}{4}$ of the NW $\frac{1}{4}$ of Section 1, Township 2 N, and Range 7 East of the Willamette Meridian, coordinates 45.6890, -121.8992, and is accessed from SW Rock Cove Dr (Figure 1). The study area's zoning is "Commercial" (C1). This report provides a description of existing critical areas on the proposed development site, a summary of proposed impacts from development, and a conceptual compensatory mitigation plan for unavoidable impacts.

Figure 2
 EXISTING CONDITIONS SITE MAP
 Rock Cove CAR
 FDM Development
 City of Stevenson, Skamania County, Washington
 Section 1, Township 2N, Range 7E, W.M.

Figure 3
PROPOSED CONDITIONS MAP
 Rock Cove CAR
 FDM Development
 City of Stevenson,

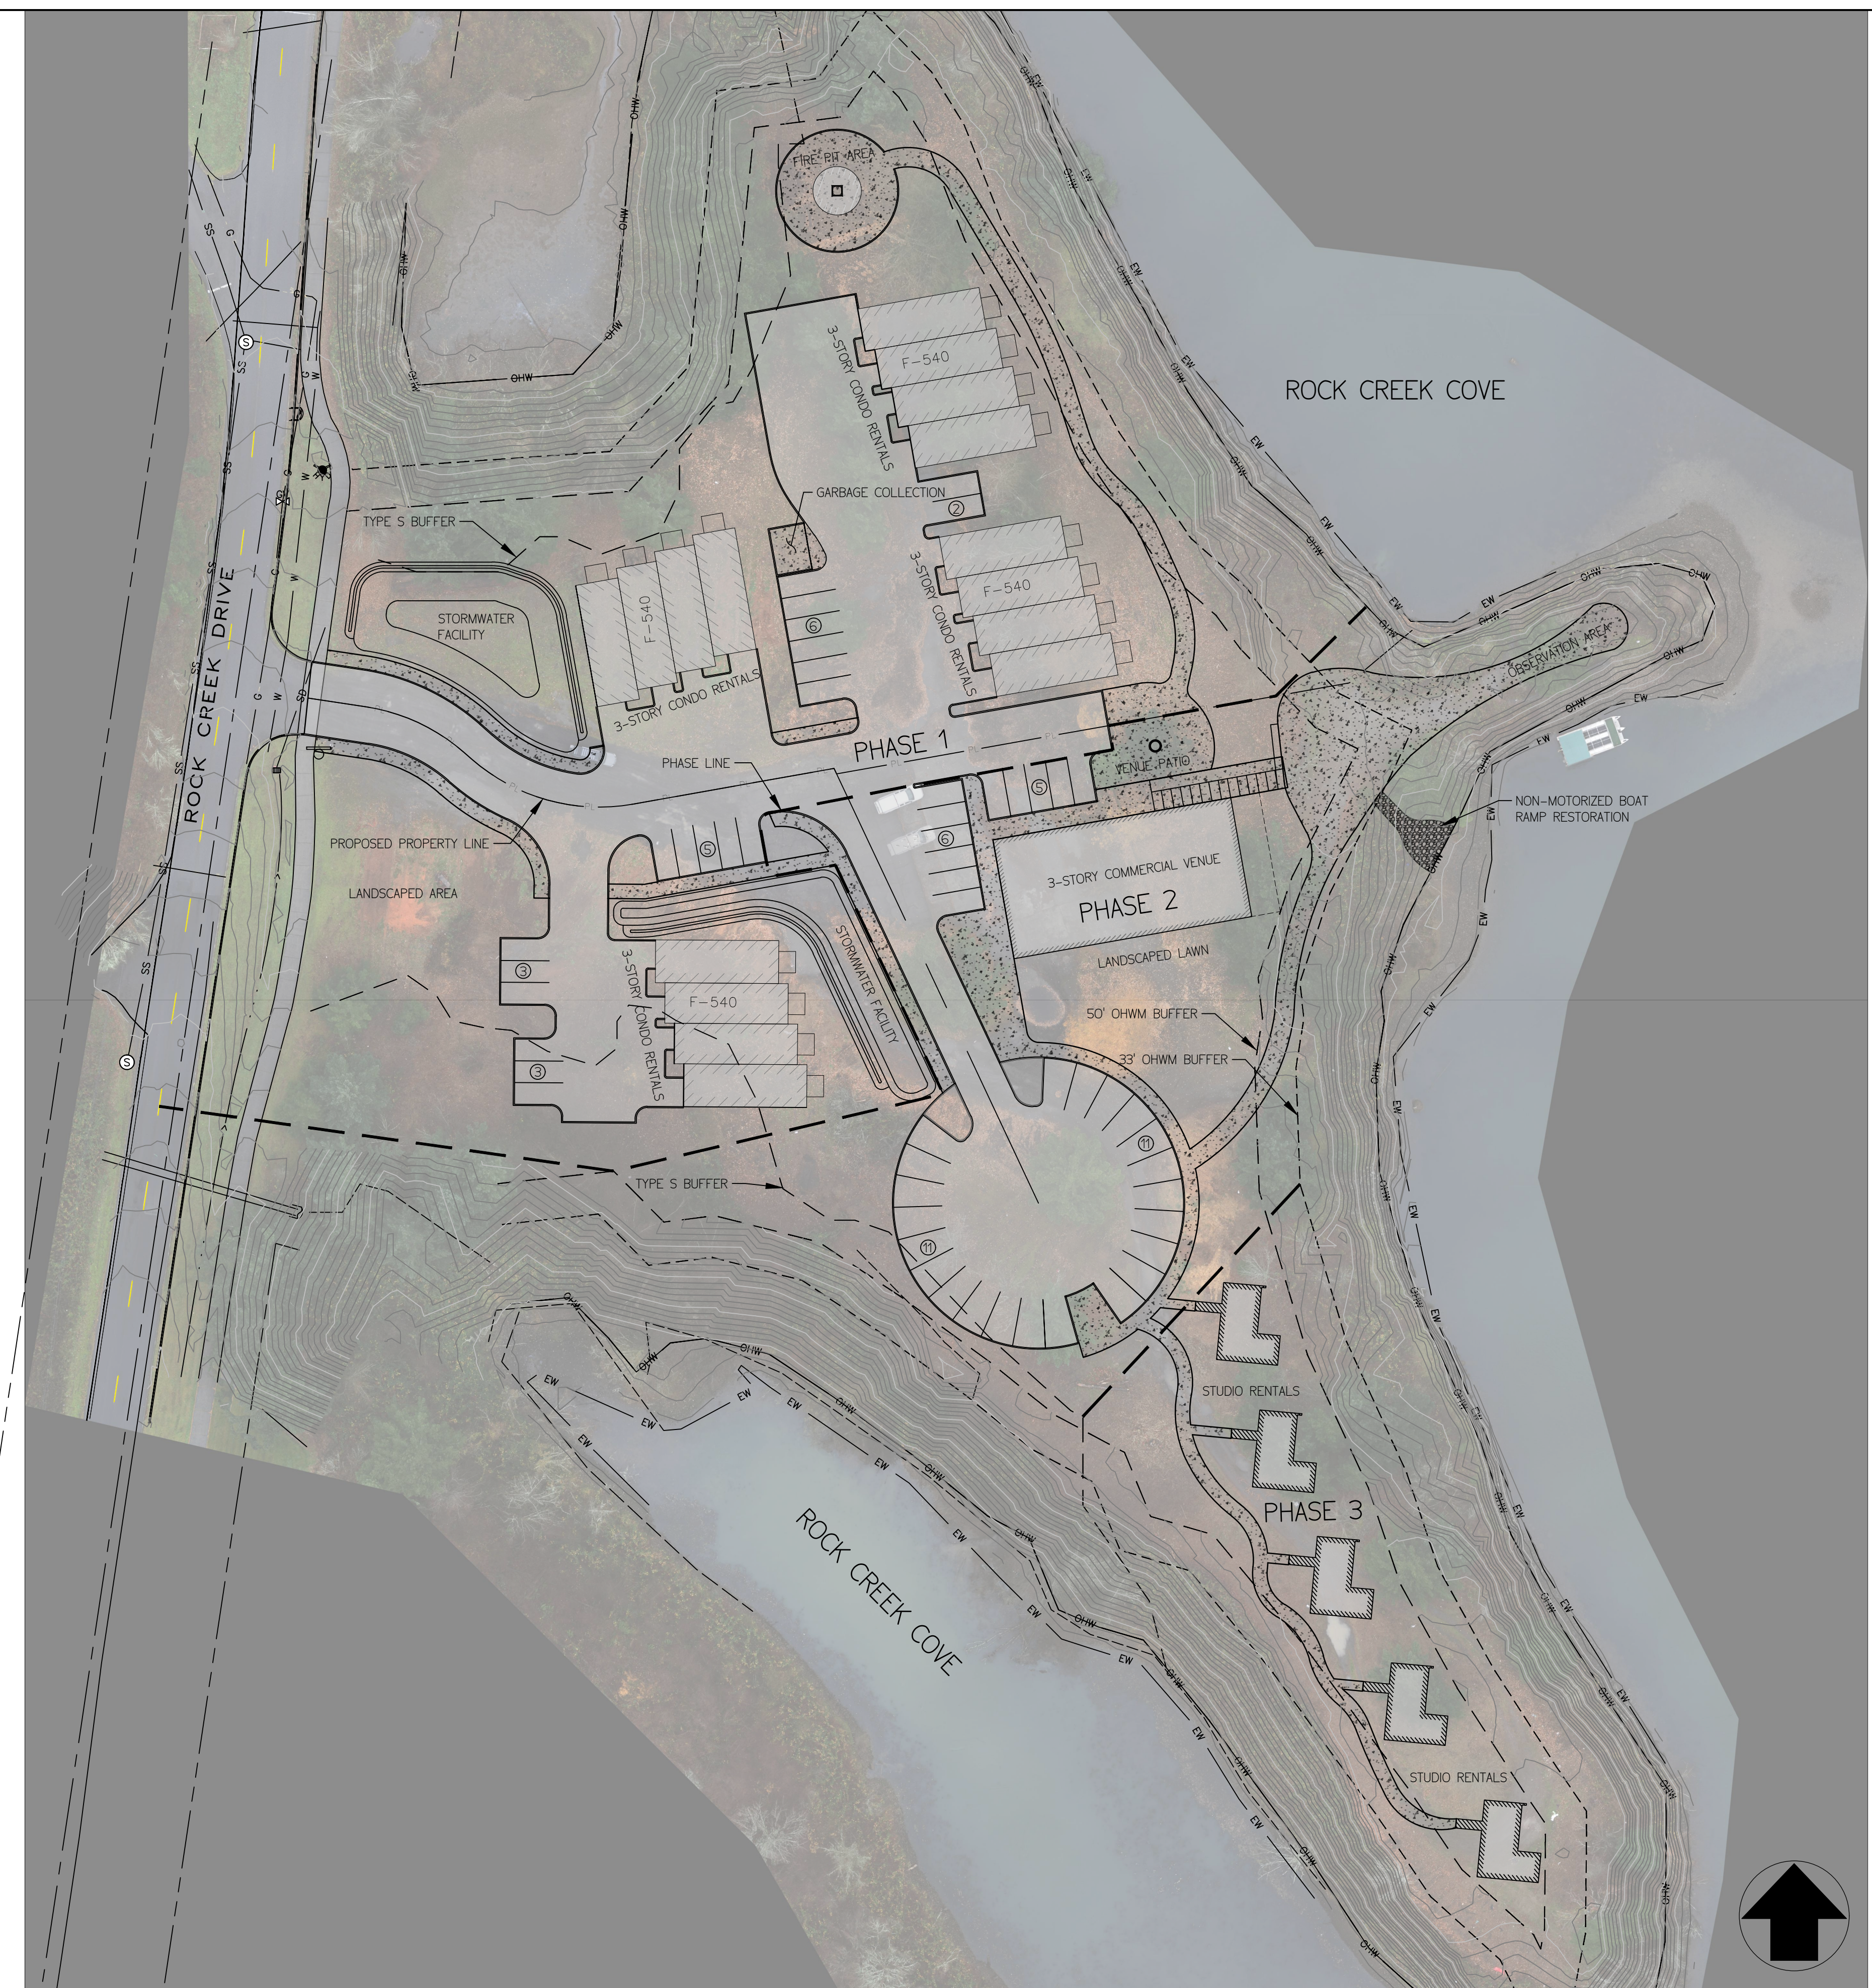
SHEET TITLE
SITE PLAN
 SHEET
 C2.0

PHASE 1
 16 3-BEDROOM CONDO UNITS OPERATED AS HOTEL
 TOTAL 48 BEDROOMS
 TOTAL 32,950 SF
 PEDESTRIAN ACCESS TO NORTHERN PENINSULA
 COVERED FIRE PIT
 LANDSCAPE IMPROVEMENTS
 STORMWATER FACILITIES CONSTRUCTION
 MASS GRADING
 TYPE S BUFFER OFF-SITE MITIGATION
 BOUNDARY LINE ADJUSTMENT

PHASE 2
 15,000 SQ FT COMMERCIAL VENUE SPACE
 LANDSCAPE IMPROVEMENTS
 OBSERVATION AREA AND BOAT RAMP RESTORATION AND
 SAFETY IMPROVEMENTS

PHASE 3
 5 STUDIO RENTALS
 LANDSCAPE IMPROVEMENTS
