TO: City Council
FROM: Ben Shumaker
DATE: May 21st, 2020
SUBJECT: Rock Cove Hospitality Center Shoreline Substantial Development—Notice (SHOR2020-01)

SHORELINES PERMIT APPLICATION

This report has been prepared for the proposed Rock Creek Cove vacation homes project to be constructed at the vacant site located on Rock Creek Drive, east of the intersection with Attwell Road, in the City of Stevenson, Washington; site location is shown on the *Vicinity Map* (Figure 1, Appendix I). Our investigation was conducted to collect information regarding subsurface conditions and present recommendations for suitability of the subsurface materials to support the proposed building structures and allowable bearing capacity for the proposed construction.

RESULTS OF A CULTURAL RESOURCES STUDY OF THE PROPOSED ROCK CREEK COVE RESORT PROPERTY, STEVENSON, WASHINGTON

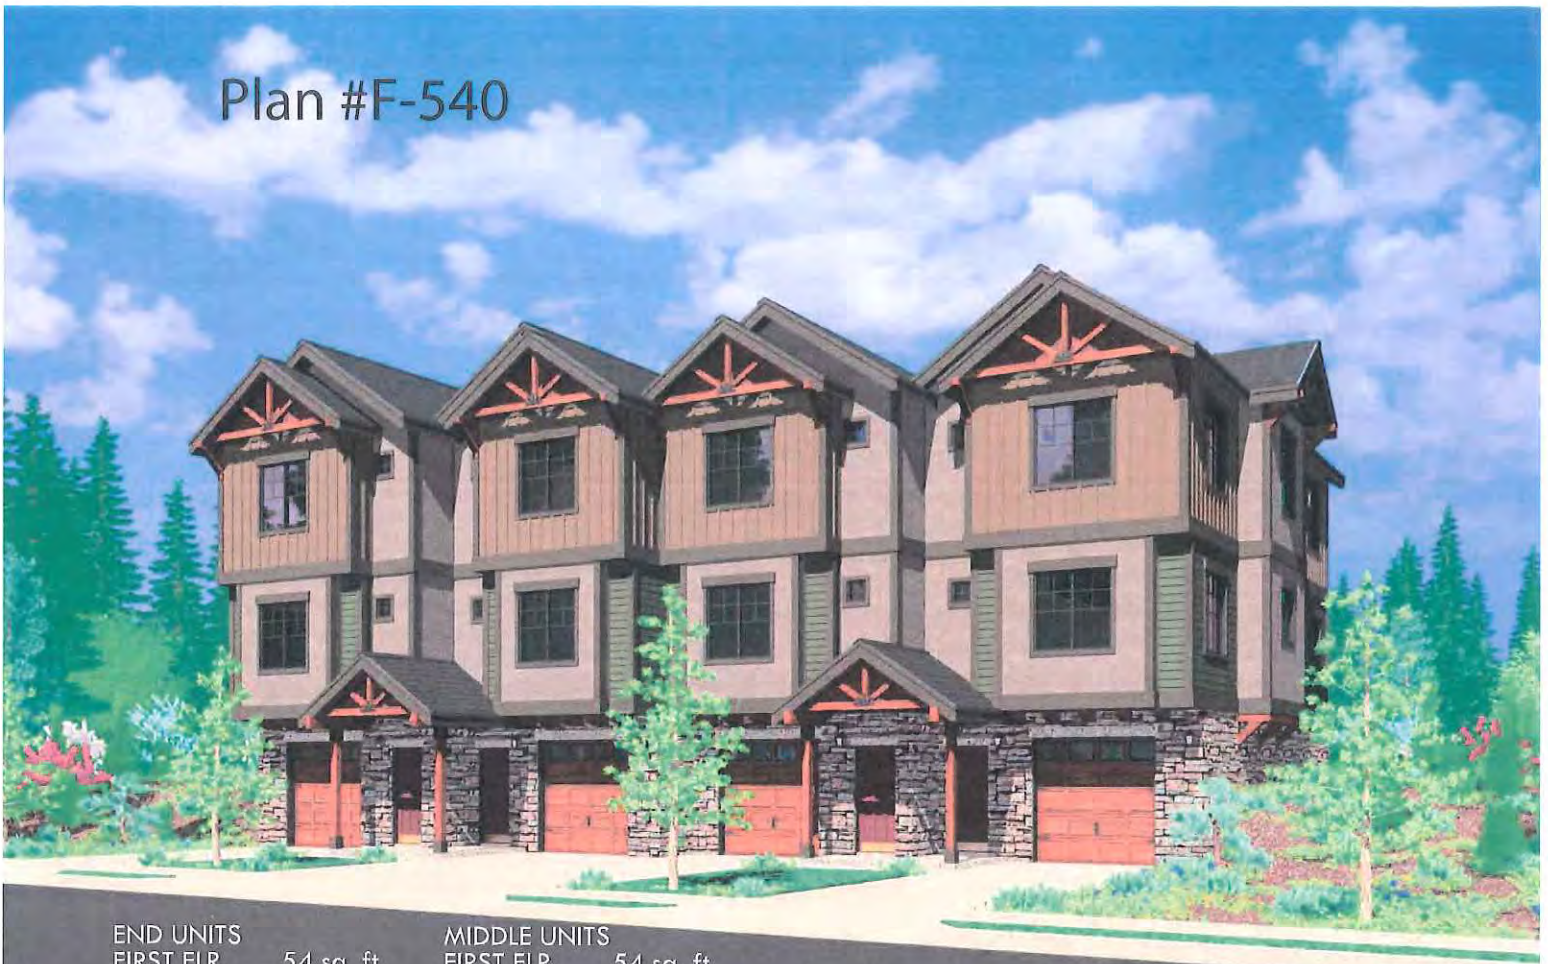
Plan #F-540

END UNITS		MIDDLE UNITS	
FIRST FLR.	54 sq. ft.	FIRST FLR.	54 sq. ft.
SECOND FLR.	752 sq. ft.	SECOND FLR.	692 sq. ft.
THIRD FLR.	715 sq. ft.	THIRD FLR.	651 sq. ft.
TOTAL	1521 sq. ft.	TOTAL	1397 sq. ft.
GARAGE	618 sq. ft.	GARAGE	583 sq. ft.

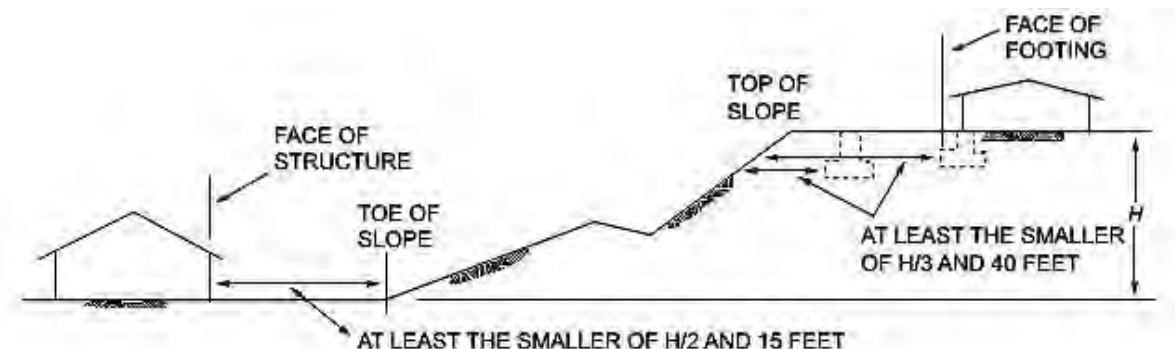
In accordance with IBC 2015 Section 1808.7 *Foundations on or Adjacent to Slopes*: “foundations on or adjacent to slope surfaces shall be founded in firm material with an embedment and setback from the slope surface sufficient to provide vertical and lateral support for the foundation without detrimental settlement.” IBC Figure 1808.7.1 (presented below) defines the appropriate minimum setbacks from ascending and descending slope surfaces:

Appropriate setbacks can be accommodated by lateral offset and/or increased embedment. The long-term performance of the structure near slopes is dependent on the protection of slopes from erosion or over steepening from subsequent slope grading. Slopes should be maintained to prevent erosion or undermining of the toe.

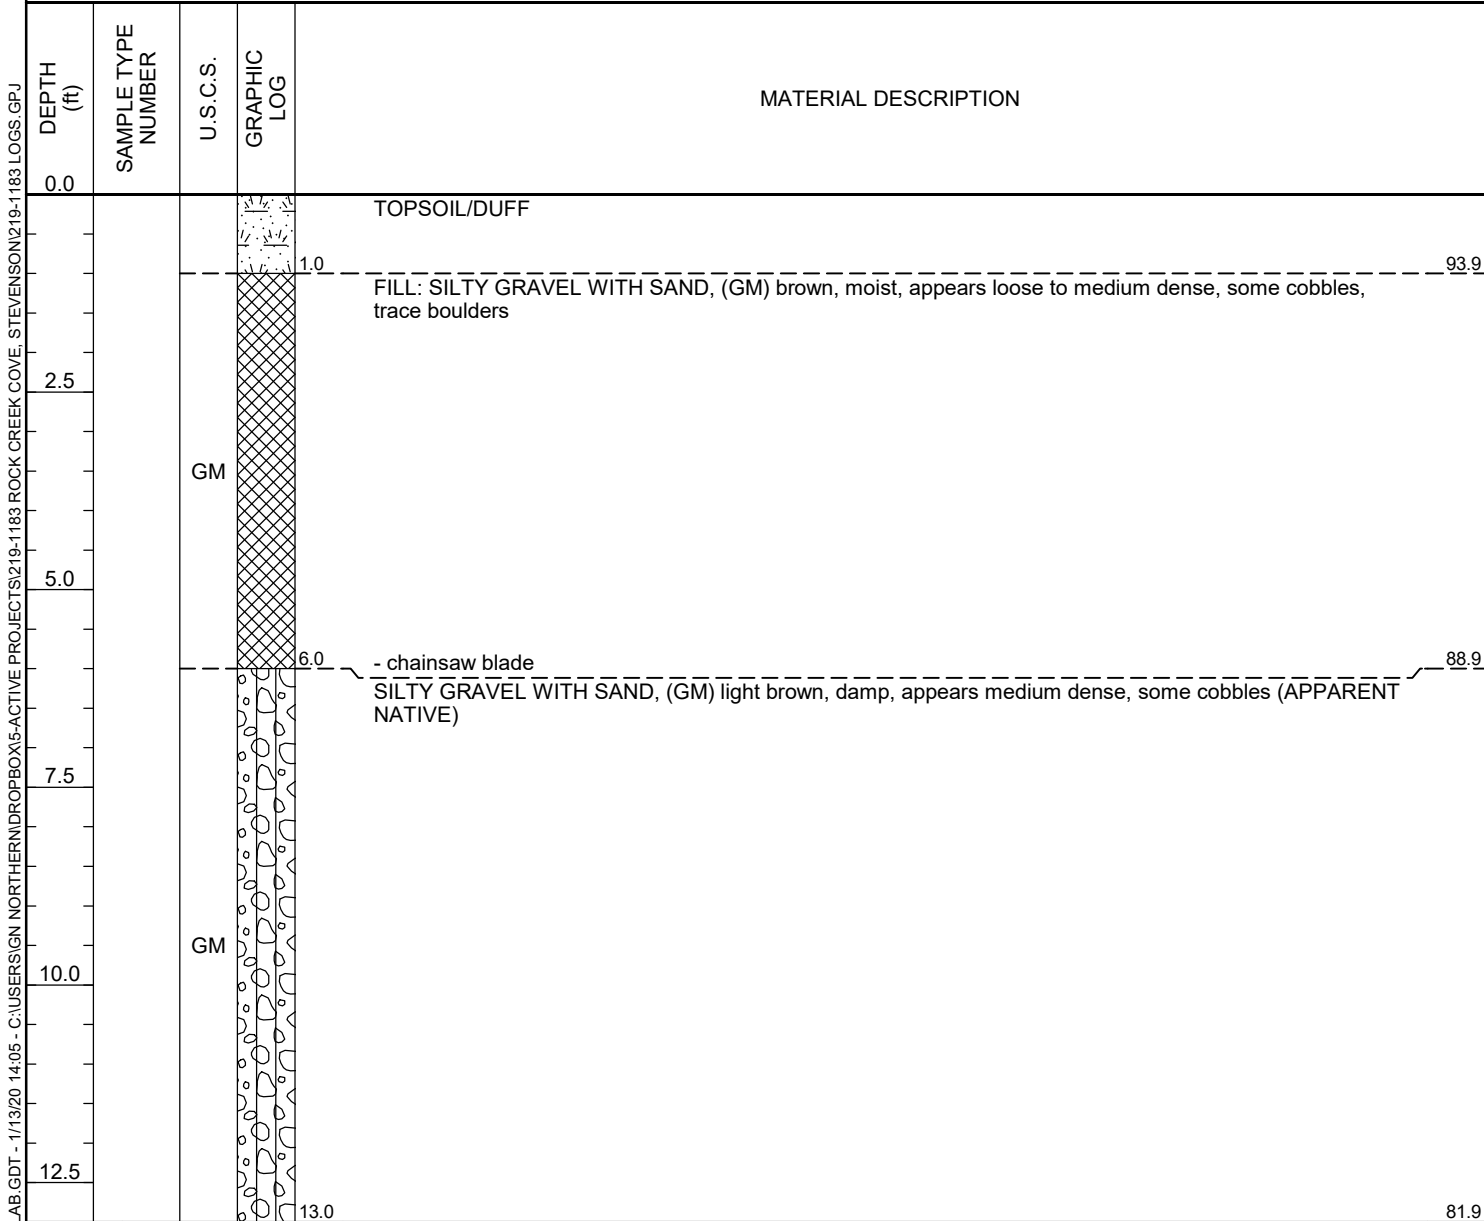
PROJECT NAME Proposed Rock Creek Cove Development
PROJECT LOCATION Rock Creek Drive, Stevenson, WA
GROUND ELEVATION 94.9 ft **TEST PIT SIZE** 36 x 96 inches
GROUND WATER LEVELS:
AT TIME OF EXCAVATION ---
AT END OF EXCAVATION ---
AFTER EXCAVATION ---

- Groundwater not encountered at time of excavation
 - Referenced elevations are approximate and based on Google Earth topography
 Bottom of test pit at 13.0 feet.

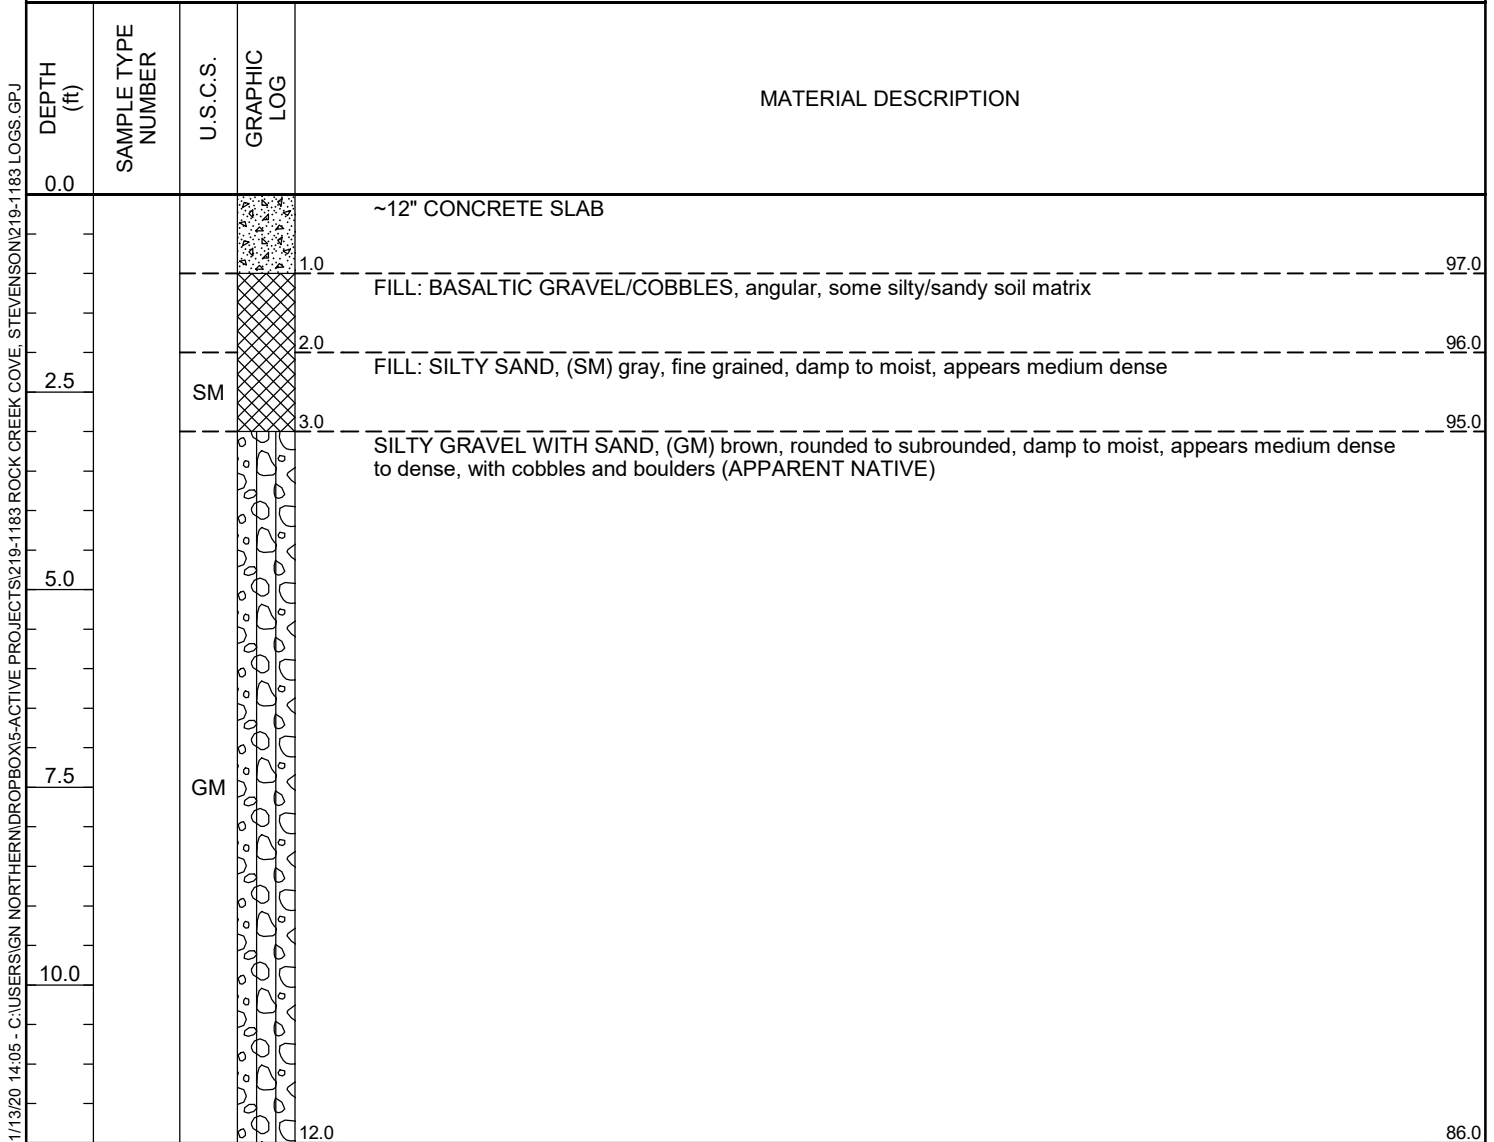
PROJECT NAME Proposed Rock Creek Cove Development
PROJECT LOCATION Rock Creek Drive, Stevenson, WA
GROUND ELEVATION 98 ft **TEST PIT SIZE** 36 x 96 inches
GROUND WATER LEVELS:
AT TIME OF EXCAVATION ---
AT END OF EXCAVATION ---
AFTER EXCAVATION ---

- Groundwater not encountered at time of excavation
 - Referenced elevations are approximate and based on Google Earth topography
 Bottom of test pit at 12.0 feet.

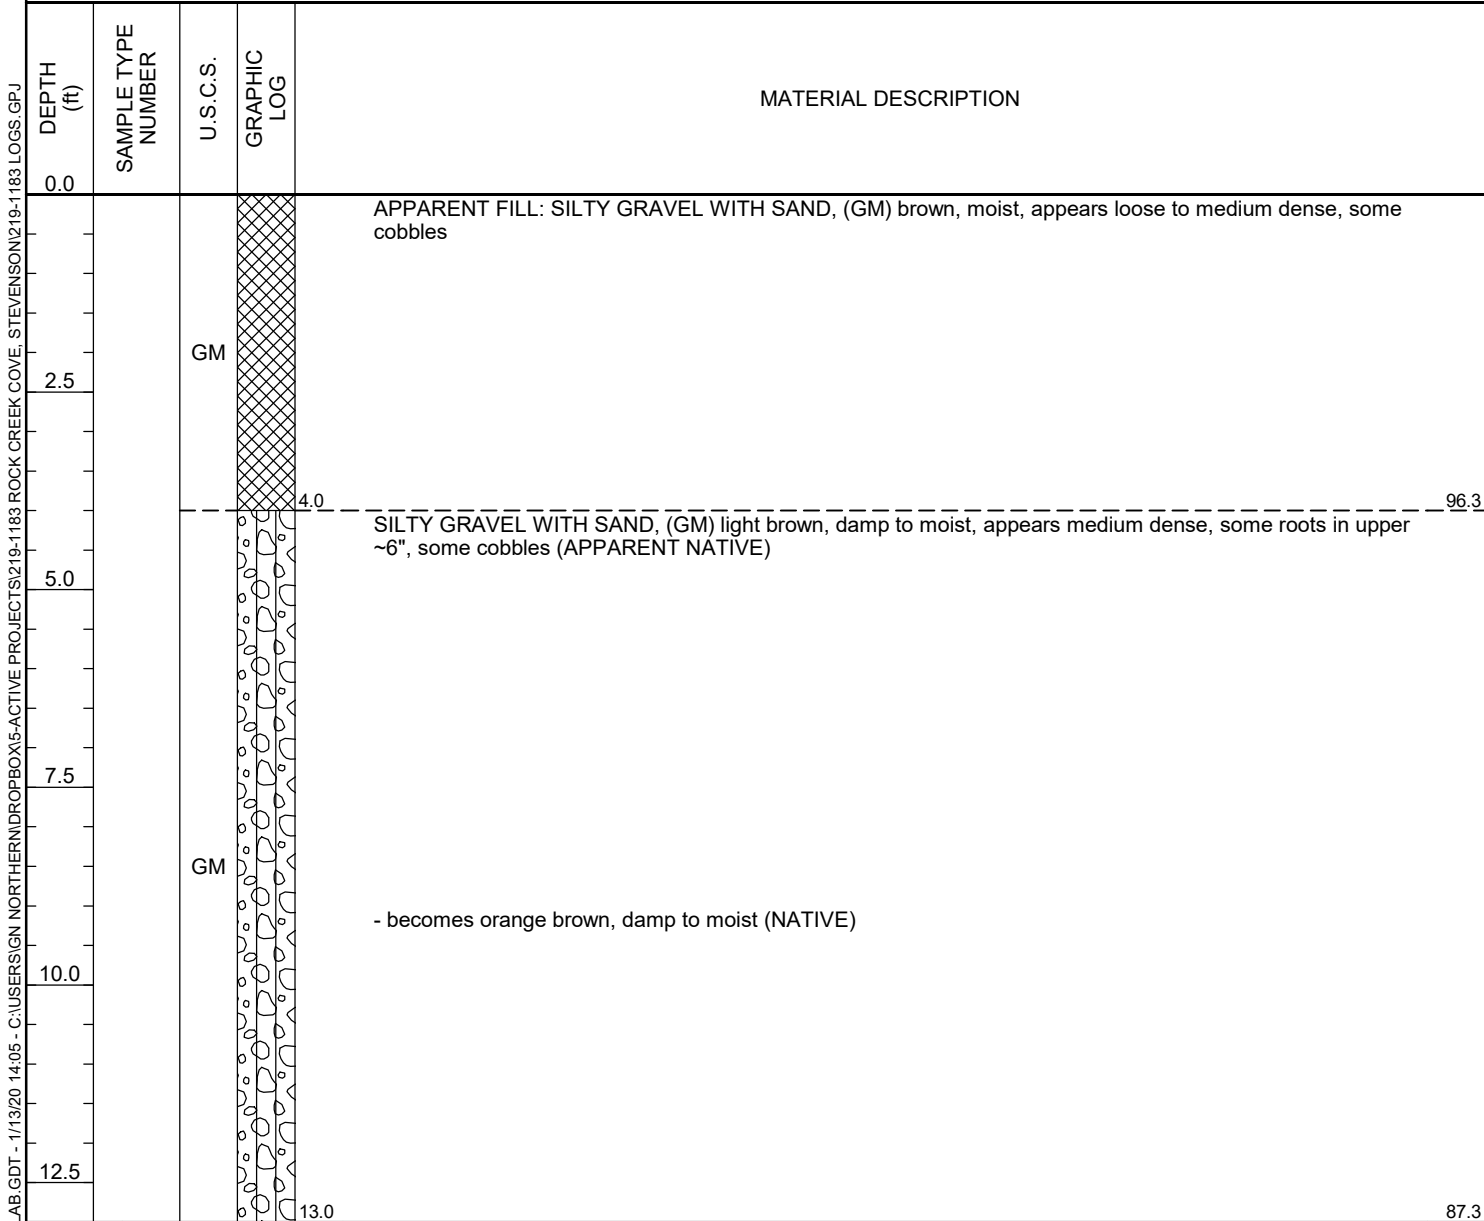
CLIENT FDM Development **PROJECT NAME** Proposed Rock Creek Cove Development
PROJECT NUMBER 219-1183 **PROJECT LOCATION** Rock Creek Drive, Stevenson, WA
DATE STARTED 12/23/19 **COMPLETED** 12/23/19 **GROUND ELEVATION** 100.3 ft **TEST PIT SIZE** 36 x 96 inches
EXCAVATION CONTRACTOR Riley Materials **GROUND WATER LEVELS:**
EXCAVATION METHOD Link-Belt 145x4 Excavator **AT TIME OF EXCAVATION** ---
LOGGED BY KAH **CHECKED BY** MYM **AT END OF EXCAVATION** ---
NOTES Approx. GPS Coords.: 45°41'15.46"N, 121°53'49.93"W **AFTER EXCAVATION** ---

- Groundwater not encountered at time of excavation
 - Referenced elevations are approximate and based on Google Earth topography
 Bottom of test pit at 13.0 feet.

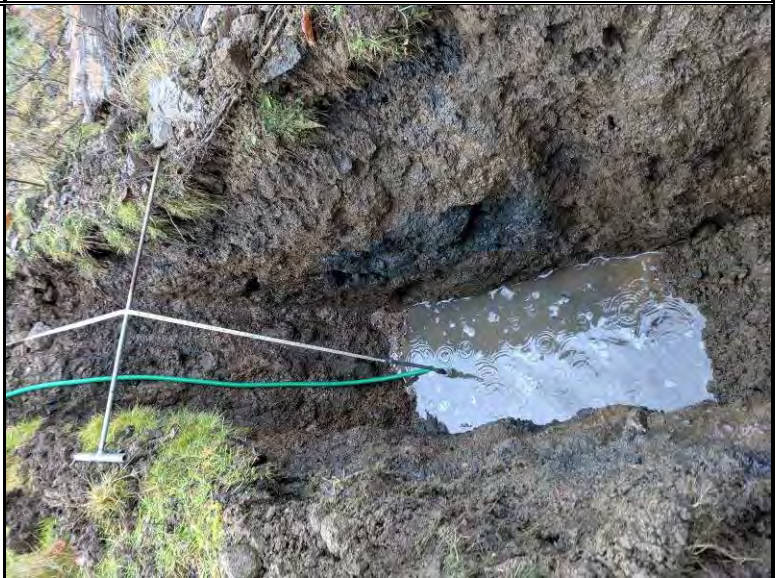
Infiltration test setup at test-pit P-1

A single infiltration test was performed on the north side of the existing entrance drive at a depth of approximately 5.5 feet BGS using a small-scale Pilot Infiltration Test (PIT). To the degree possible, care was exercised during excavation to attempt to maintain relatively uniform side walls, and the resulting size and geometry of the finished test-pit was carefully recorded in the field. Water was introduced into the test-pit using a garden hose connected to a nearby fire hydrant. The water flow into the test-pit was continued until the soils with the test-pit were saturated and a

Test ID	Approximate Location (GPS Coordinates)	Soil Tested	Field Infiltration Rate
P-1	45°41'20.69"N, 121°53'56.06"W	Silty Gravel	4 inches/hour
