CRITICAL AREAS AND FWHCA REPORT

Rock Creek Cove Hospitality *Stevenson, Washington*

1157 3rd Avenue, Suite 220A • Longview, WA 98632
(360) 578-1371 • Project Number 2682.02

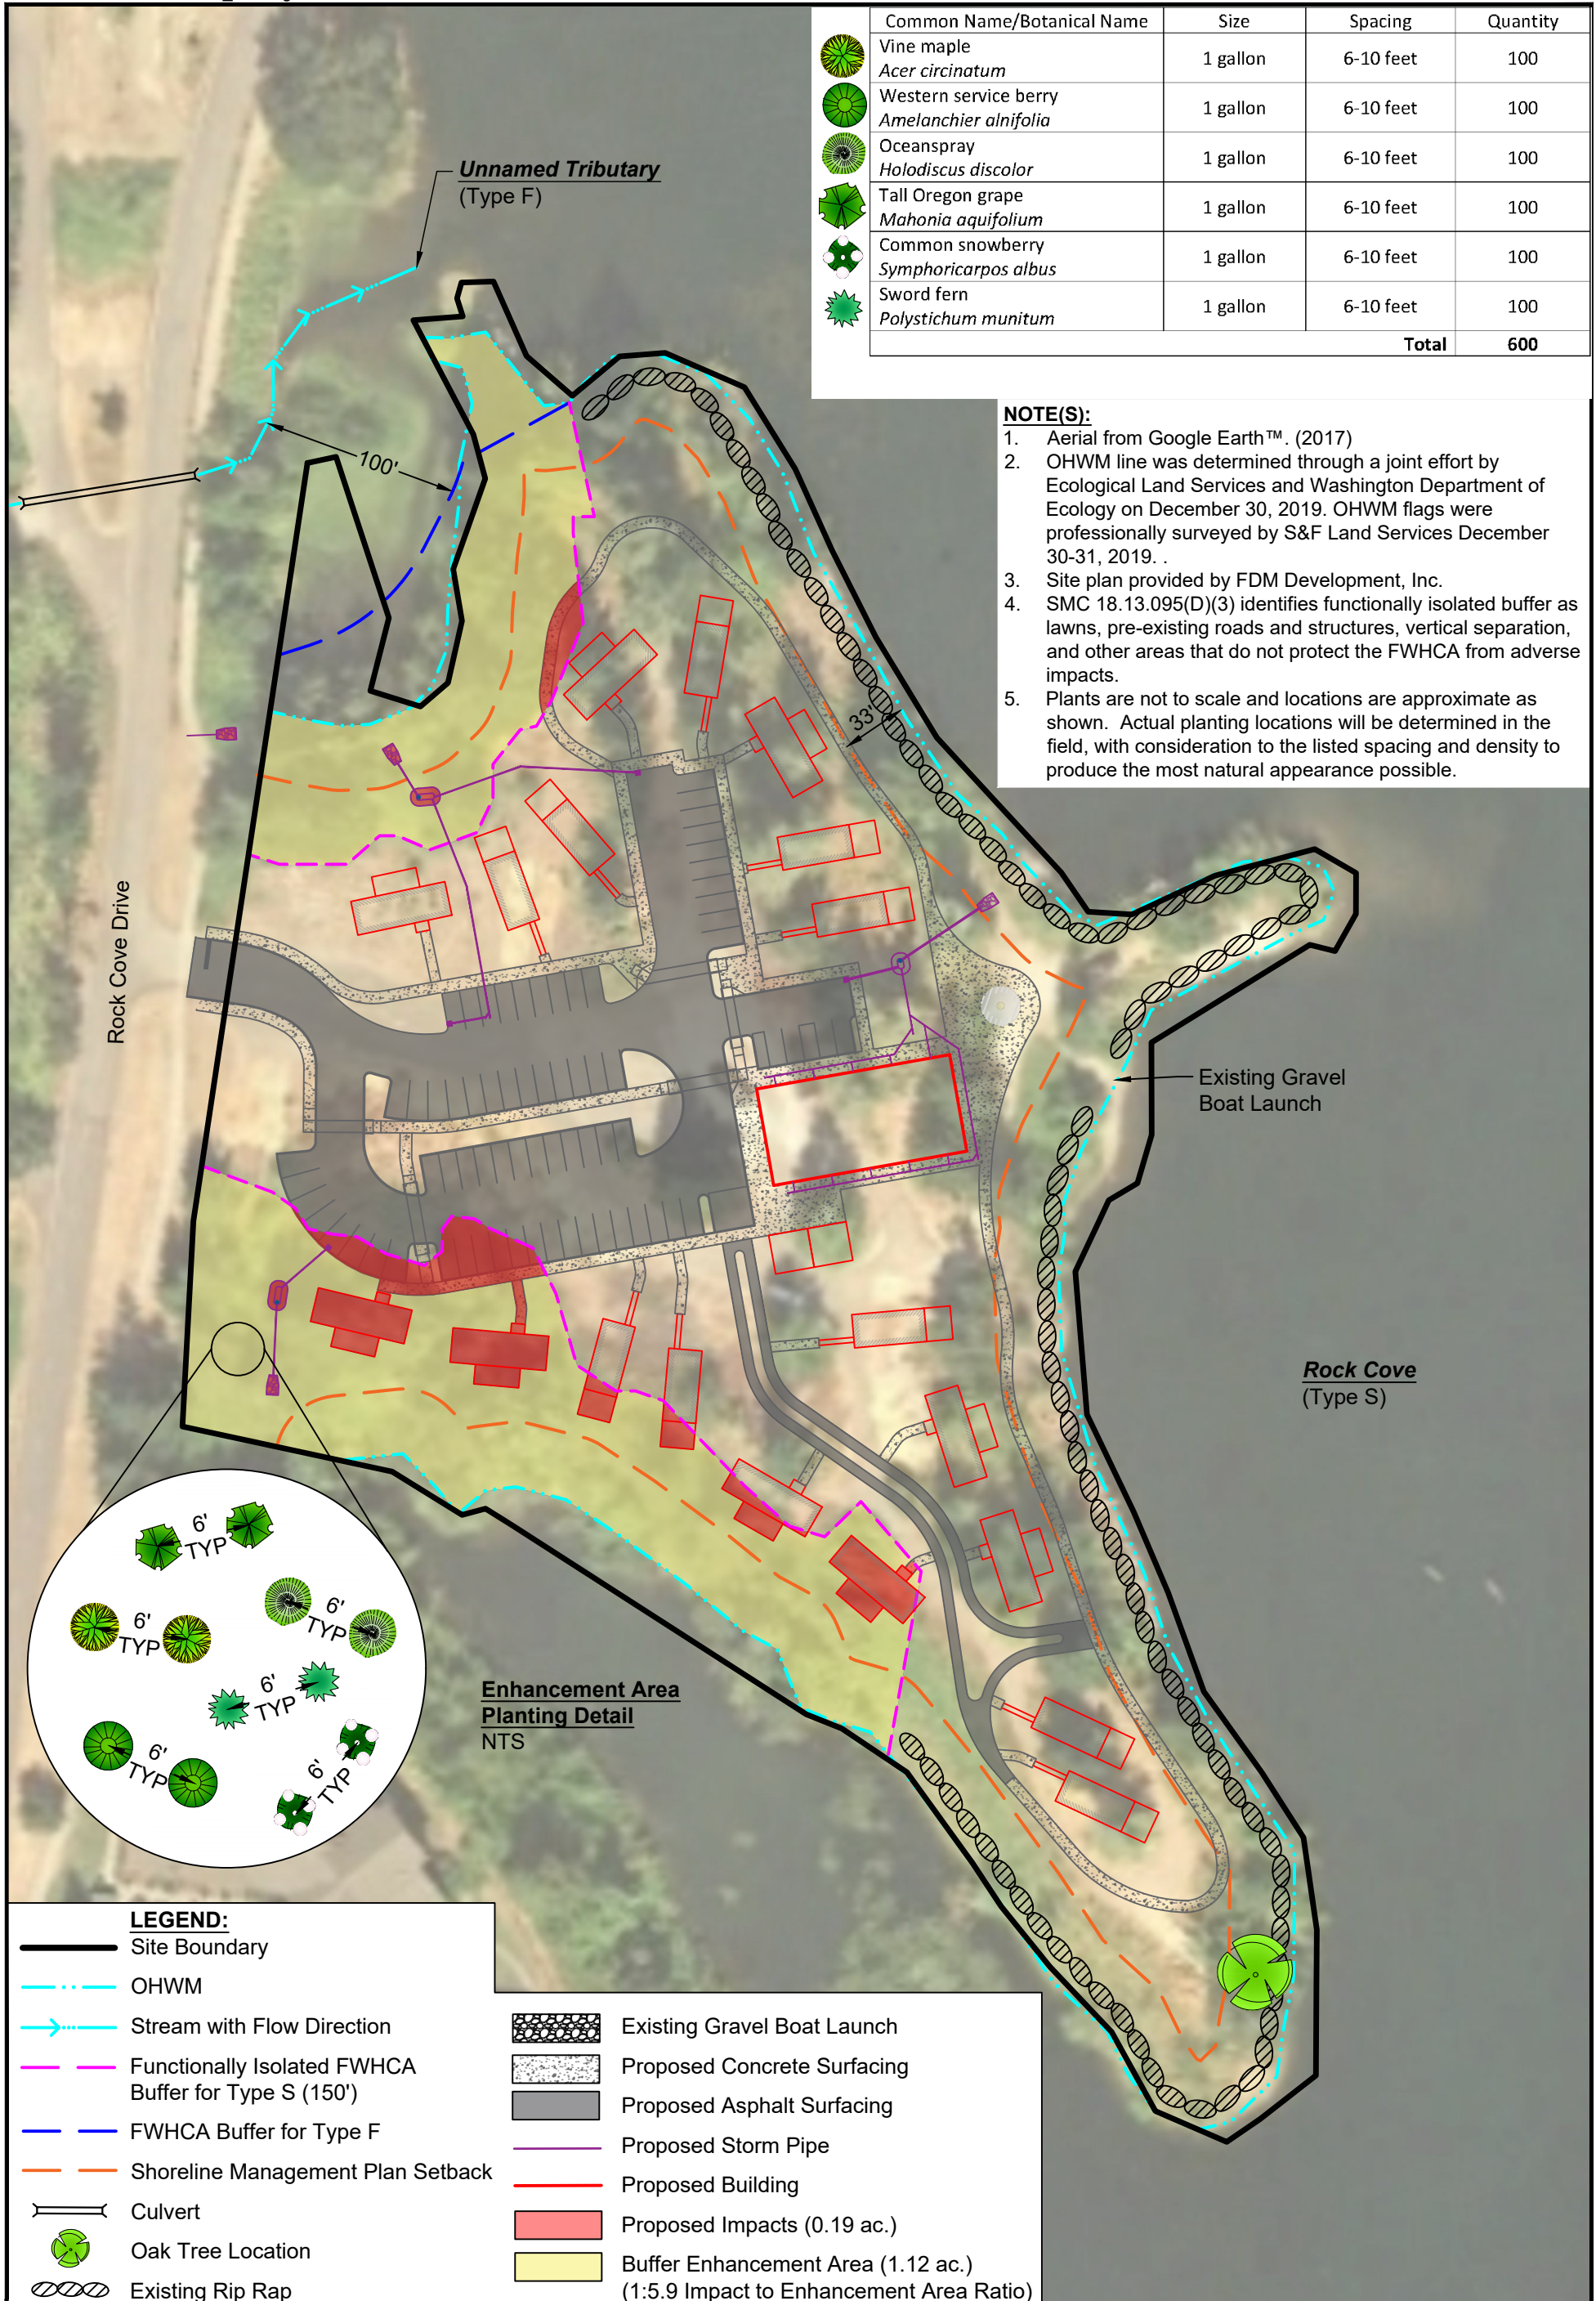
Figure 5
MITIGATION PLAN
Rock Cove CAR
FDM Development
City of Stevenson, Skamania County, Washington
Section 1, Township 2N, Range 7E, W.M.

1. Aerial from Google Earth™. (2017)
2. OHWM line was determined through a joint effort by Ecological Land Services and Washington Department of Ecology on December 30, 2019. OHWM flags were professionally surveyed by S&F Land Services December 30-31, 2019. .
3. Site plan provided by FDM Development, Inc.
4. SMC 18.13.095(D)(3) identifies functionally isolated buffer as lawns, pre-existing roads and structures, vertical separation, and other areas that do not protect the FWHCA from adverse impacts.
5. Plants are not to scale and locations are approximate as shown. Actual planting locations will be determined in the field, with consideration to the listed spacing and density to produce the most natural appearance possible.

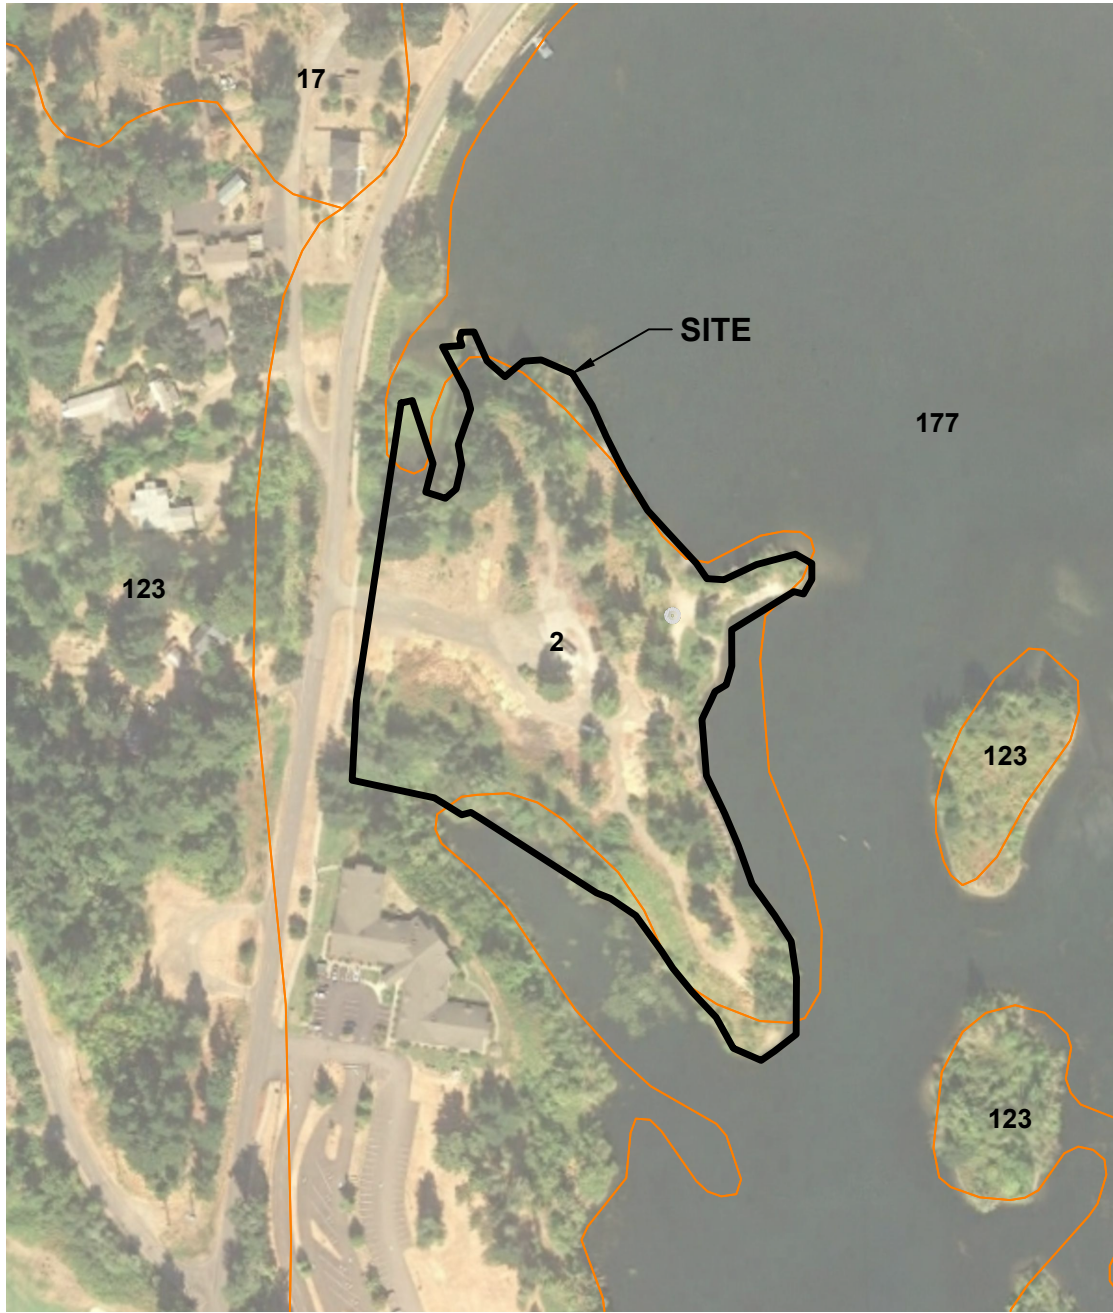
Figure 6
NRCS SOIL SURVEY
Rock Cove CAR
FDM Development
City of Stevenson, Skamania County, Washington
Section 1, Township 2N, Range 7E, W.M.

- 2** Arents, 0 to 5 percent slopes. Not hydric.
- 17** Bonneville stony sandy loam. Not hydric.
- 123** Steever stony clay loam, 2 to 30 percent slopes. Not hydric.
- 177** **Water.**

ELS uses the Natural Resource Conservation Service (NRCS) map unit descriptions to gather baseline soil data. NRCS identifies soils in the study area as Arents 0 to 5 percent slopes. Arents is described by NRCS as a well-drained, terraced soil with more than 80 inches depth to the groundwater table. A typical profile includes gravelly sandy loam from 0 to 24 inches and extremely gravelly sandy loam between 24 and 60 inches. As mentioned previously, Arents do not have diagnostic horizons because they have been deeply mixed by plowing, spading, or other methods of moving by humans (NRCS 2020). ELS did not collect soils data additional to the existing NRCS mapping data due to the prevalence of impervious and disturbed soil conditions, and consensus with Ecology that collecting soils data to demonstrate the absence of wetlands was not necessary for Ecology's purposes in the study area.
