Subject: Rock Cove Hospitality Mitigation Addendum

Rock Cove Preliminary Critical Areas Assessment FDM Development, Inc. City of Stevenson, Washington

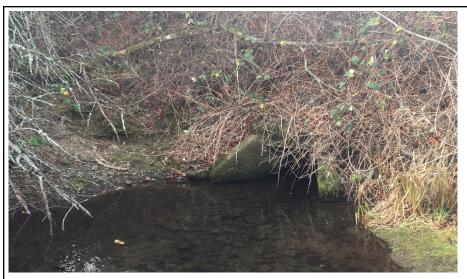
Photo 1. Inflow point of the unnamed tributary via concrete culvert.

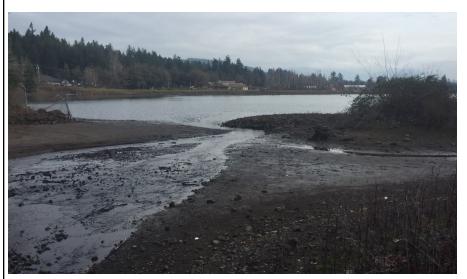
Photo 3. Overview of unnamed tributary's confluence with Rock Cove.

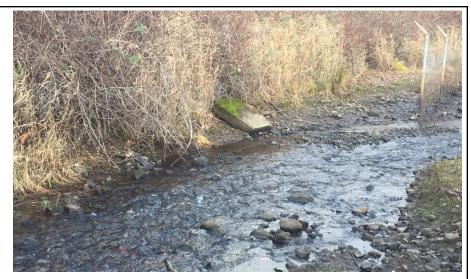
Photo 2. Unnamed tributary flowing toward Rock Cove.

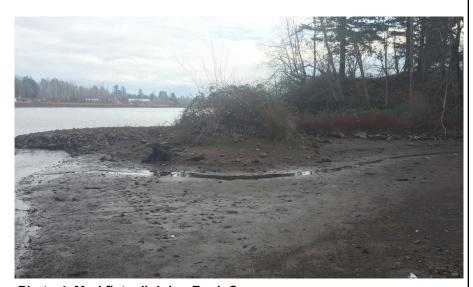
Photo 4. Mud flat adjoining Rock Cove.

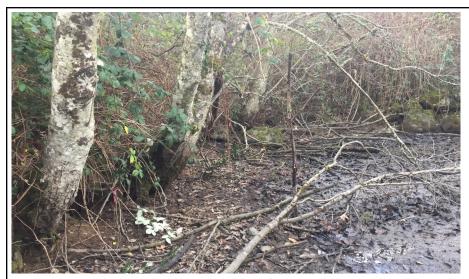
Photo 1. Vegetated shoreline on the north end of the study area.

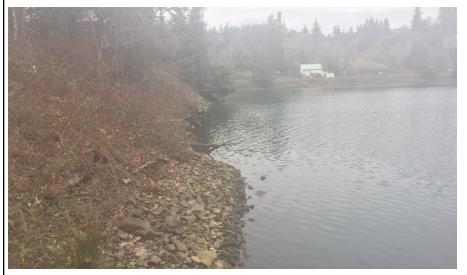
Photo 3. Riprap on the eastern shoreline, facing north.

- If the existing rip rap is being used as justification to lessen riparian protection, WDFW recommends further review to determine if the rip rap was legally permitted and installed. The existing rip rap is more than 10 years old and although ELS is not aware of when or if it was permitted, it is not being used as a justification to lessen riparian protection. Protection and enhancement of the entire remaining FWHCA buffer is proposed as part of this project. Removing the rip rap and replacing it with a bioengineered solution is not financially feasible nor is it a requirement by the SCO or the SMP. Additionally, removal of the rip rap would pose erosion and water quality hazards that could not feasibly be contained and would likely cause greater harm to the riparian and aquatic habitat.

Due to the presence of existing rip rap along the shoreline area that experiences greatest exposure to water movement, future erosion is unlikely. This site will not require any greater emergency protection than any other water related development in this area.

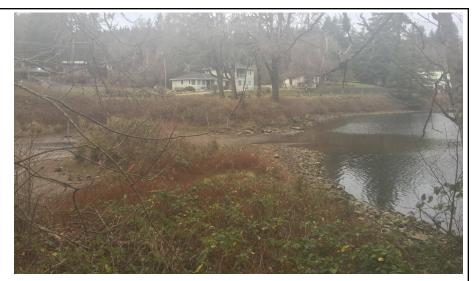
Photo 2. Vegetated shoreline extending toward the unnamed tributary.

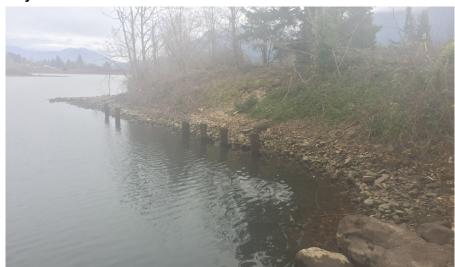
Photo 4. Riprap on the eastern shoreline, facing south.

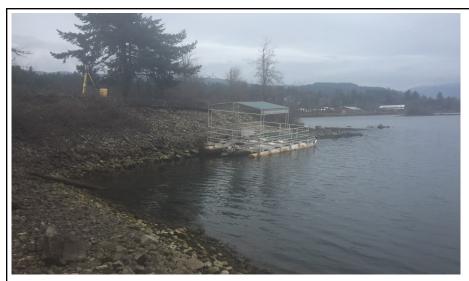
Photo 1. Graveled boat launch on the east side of the study area.

The proposed project is a public facility that will provide access to the public during daylight hours. The walking trails and boat launch area can be utilized by the public without reserving a recreational dwelling.

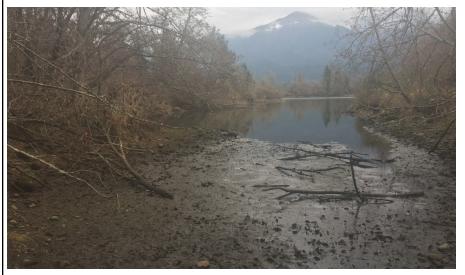
Photo 3. Vegetated shoreline and mud flat in the southwest portion of the study area, facing south.

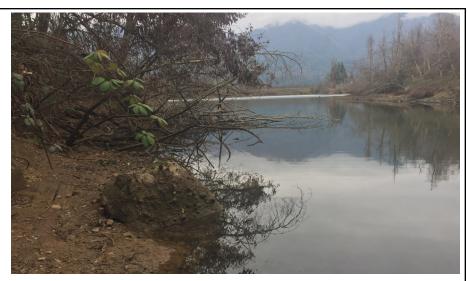
Photo 2. Vegetated shoreline on the west side, facing south.

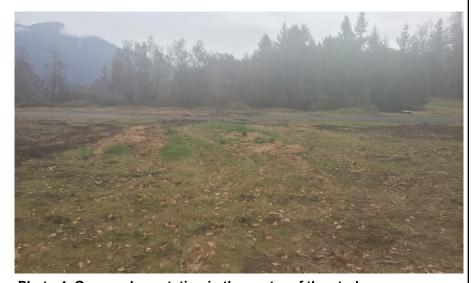
Photo 4. Groomed vegetation in the center of the study area.

- Ecology does not think the maintained vegetation areas shown in Figure 1 should qualify as functional isolation.
  - According to the SCO 18.13.095(D)(3), lawns and other mowed areas can be considered as functional separation from FWHCA buffers. These areas have been mowed and maintained since the year 2000 as can be seen on Google Earth aerial imagery. Additionally, these areas were photographed in January of 2020 in preparation of the original draft of the critical areas report by ELS (Photoplate 3 and 4). It is ELS' opinion that the provided evidence meets the requirement in the SCO and that these areas do indeed meet the definition of functional isolation.

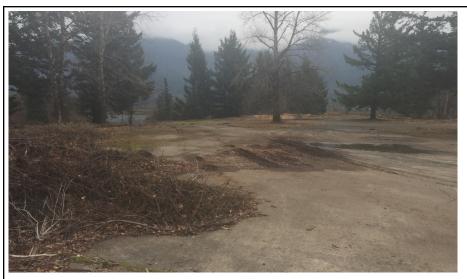
Photo 1. Existing concrete and gravel surfacing.

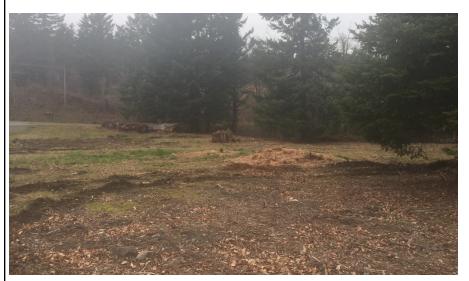
Photo 3. Groomed vegetation in the center of the study area.

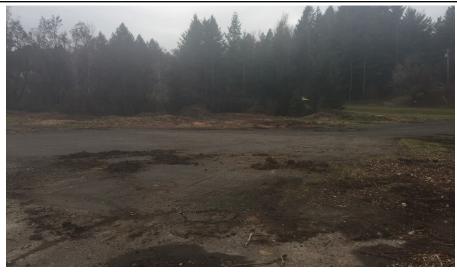
Photo 2. Existing concrete and gravel surfacing.

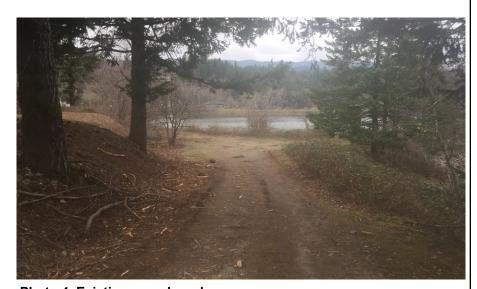
Photo 4. Existing gravel road.
