SHORELINES PERMIT APPLICATION

Substantial Development, Timber Cutting, Conditional Uses, Variances

This report has been prepared for the proposed Rock Creek Cove vacation homes project to be constructed at the vacant site located on Rock Creek Drive, east of the intersection with Attwell Road, in the City of Stevenson, Washington; site location is shown on the *Vicinity Map* (Figure 1, Appendix I). Our investigation was conducted to collect information regarding subsurface conditions and present recommendations for suitability of the subsurface materials to support the proposed building structures and allowable bearing capacity for the proposed construction.

RESULTS OF A CULTURAL RESOURCES STUDY OF THE PROPOSED ROCK CREEK COVE RESORT PROPERTY, STEVENSON, WASHINGTON

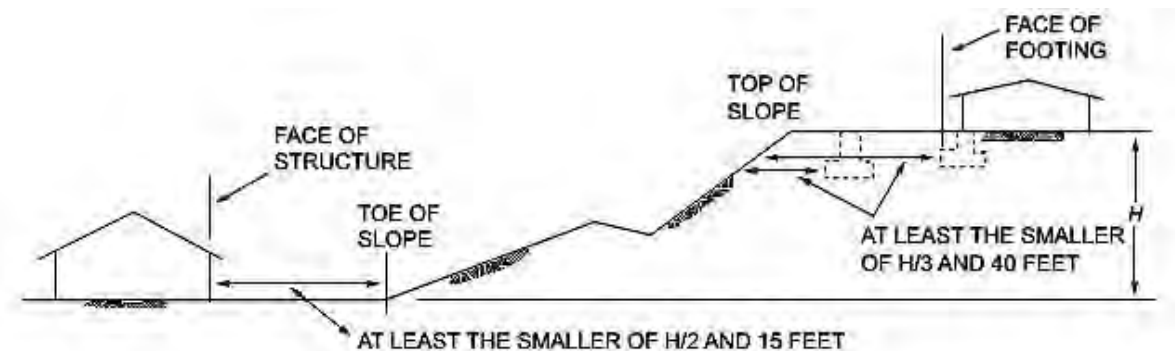
In accordance with IBC 2015 Section 1808.7 *Foundations on or Adjacent to Slopes*: “foundations on or adjacent to slope surfaces shall be founded in firm material with an embedment and setback from the slope surface sufficient to provide vertical and lateral support for the foundation without detrimental settlement.” IBC Figure 1808.7.1 (presented below) defines the appropriate minimum setbacks from ascending and descending slope surfaces:

Appropriate setbacks can be accommodated by lateral offset and/or increased embedment. The long-term performance of the structure near slopes is dependent on the protection of slopes from erosion or over steepening from subsequent slope grading. Slopes should be maintained to prevent erosion or undermining of the toe.

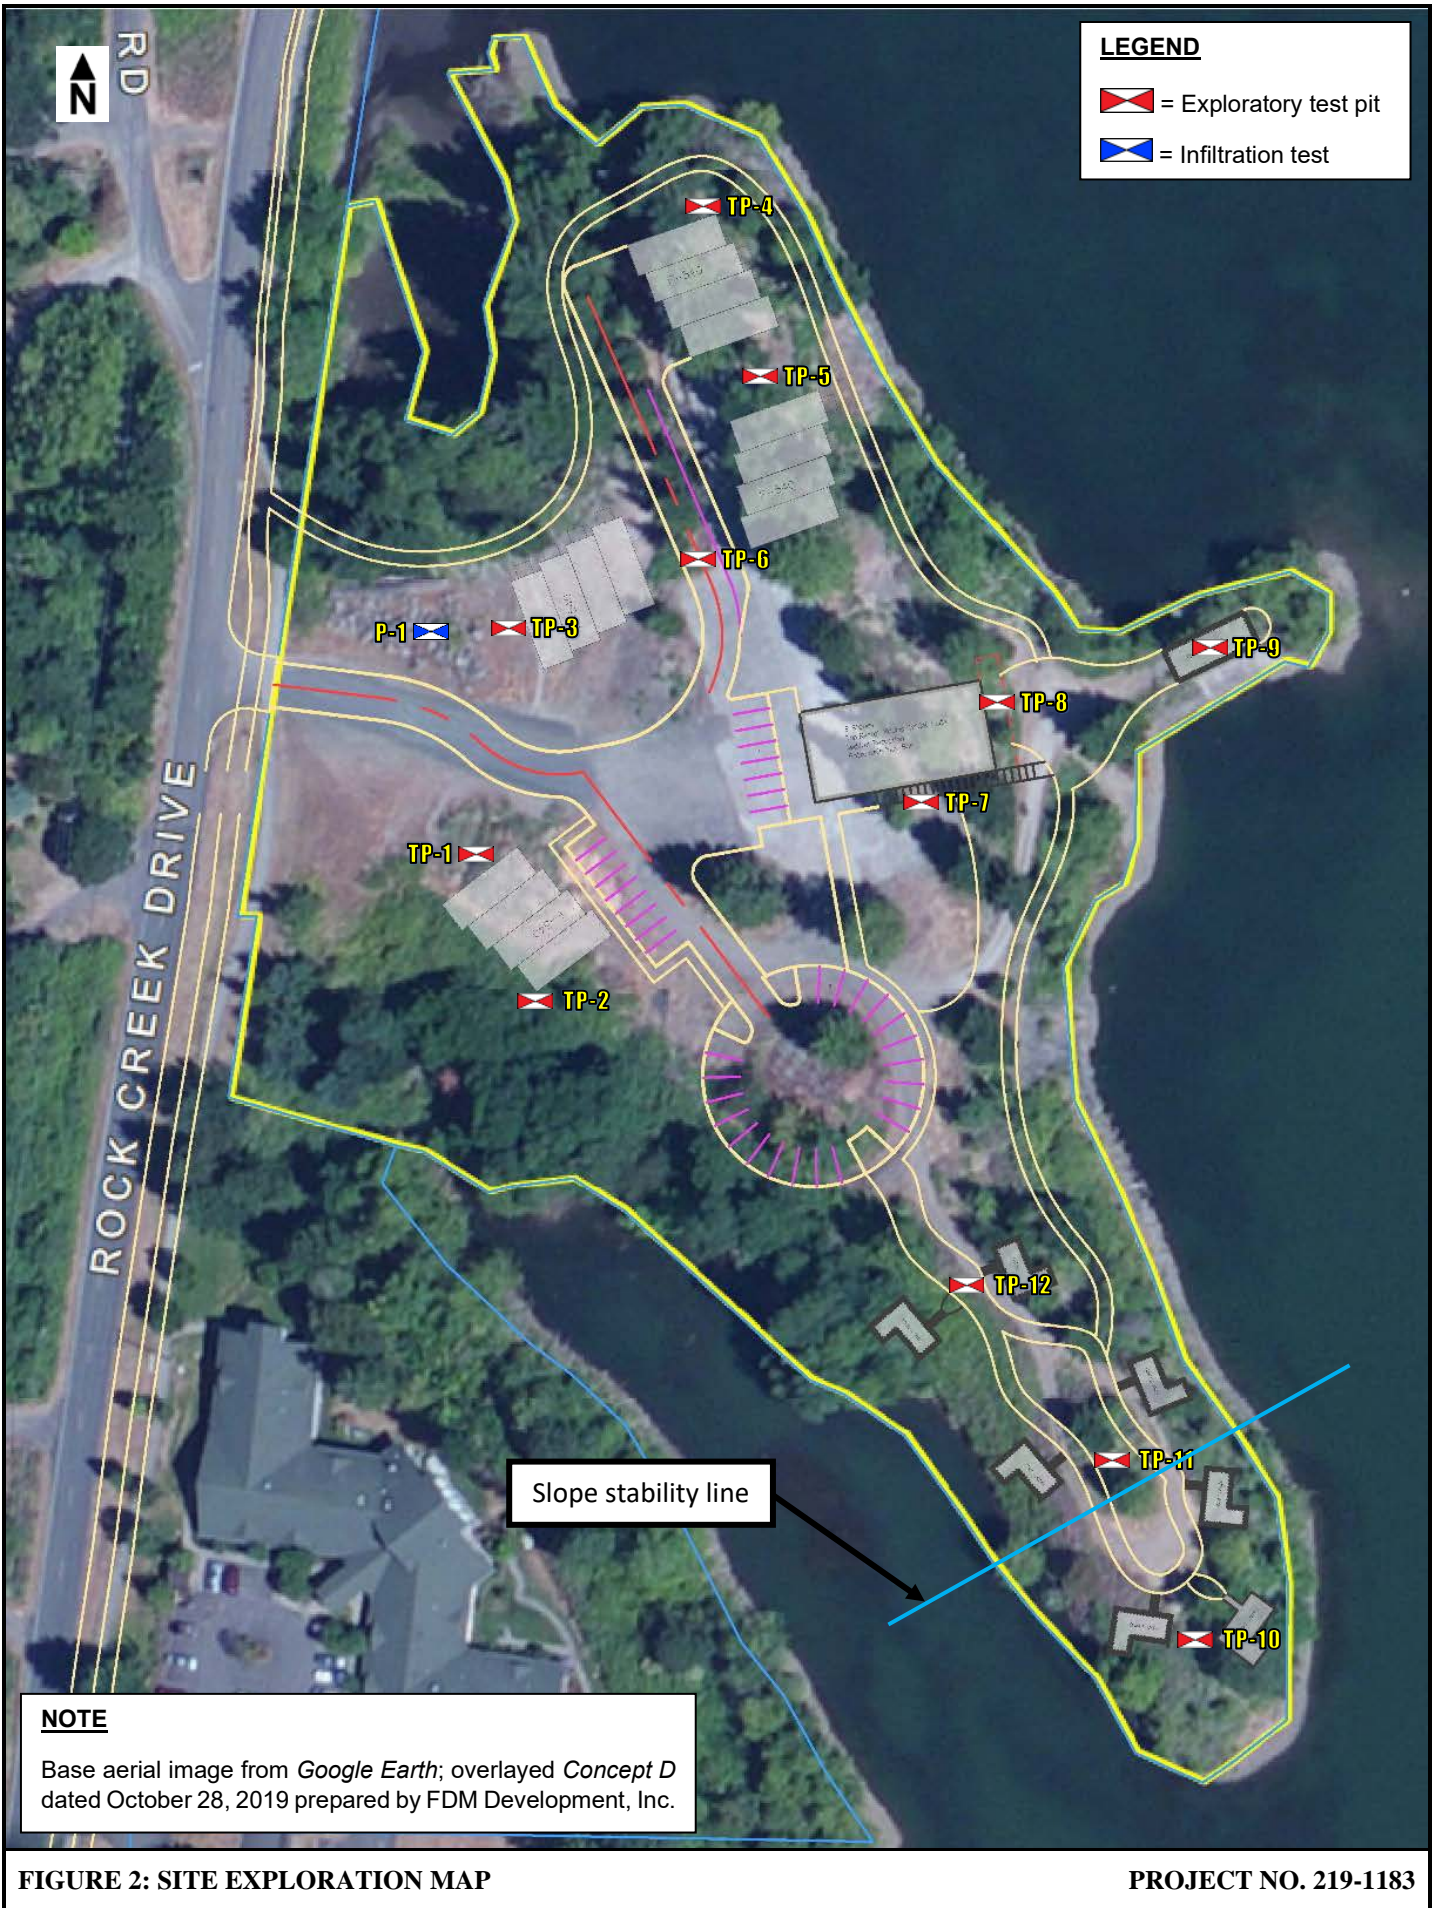
FIGURE 2: SITE EXPLORATION MAP

The field exploration was completed on December 23, 2019. A local public utility clearance was obtained prior to the field exploration. Twelve (12) exploratory test-pits were completed at various locations within the footprint of the proposed development. Test-pits were excavated by Riley Materials using a Link-Belt 145x4 excavator to depths of approximately 8 to 14.5 feet below existing ground surface (BGS) and logged by a GNN field geologist/engineer. Additionally, an infiltration test was performed on the north side of the entrance driveway. Upon completion, all excavations were loosely backfilled with excavation spoils. Test-hole locations are shown on *Site Exploration Map* (Figure 2)

A conceptual site plan (*Concept D*, prepared by FDM Development, dated 10/28/2019), along with a topographic survey of the project site (Lots 2, 3, and 4 of Rock Creek Cove, prepared by S&F Land Services, dated 12/11/2019), were provided by Mr. Pyle via email on December 17, 2019. Field exploration, consisting of twelve (12) test-pits and one (1) infiltration test, was completed on December 23, 2019. Locations of the exploratory test-pits and infiltration test are shown on the *Site Exploration Map* (Figure 2, Appendix I), and detailed test-pit logs are presented in Appendix II.

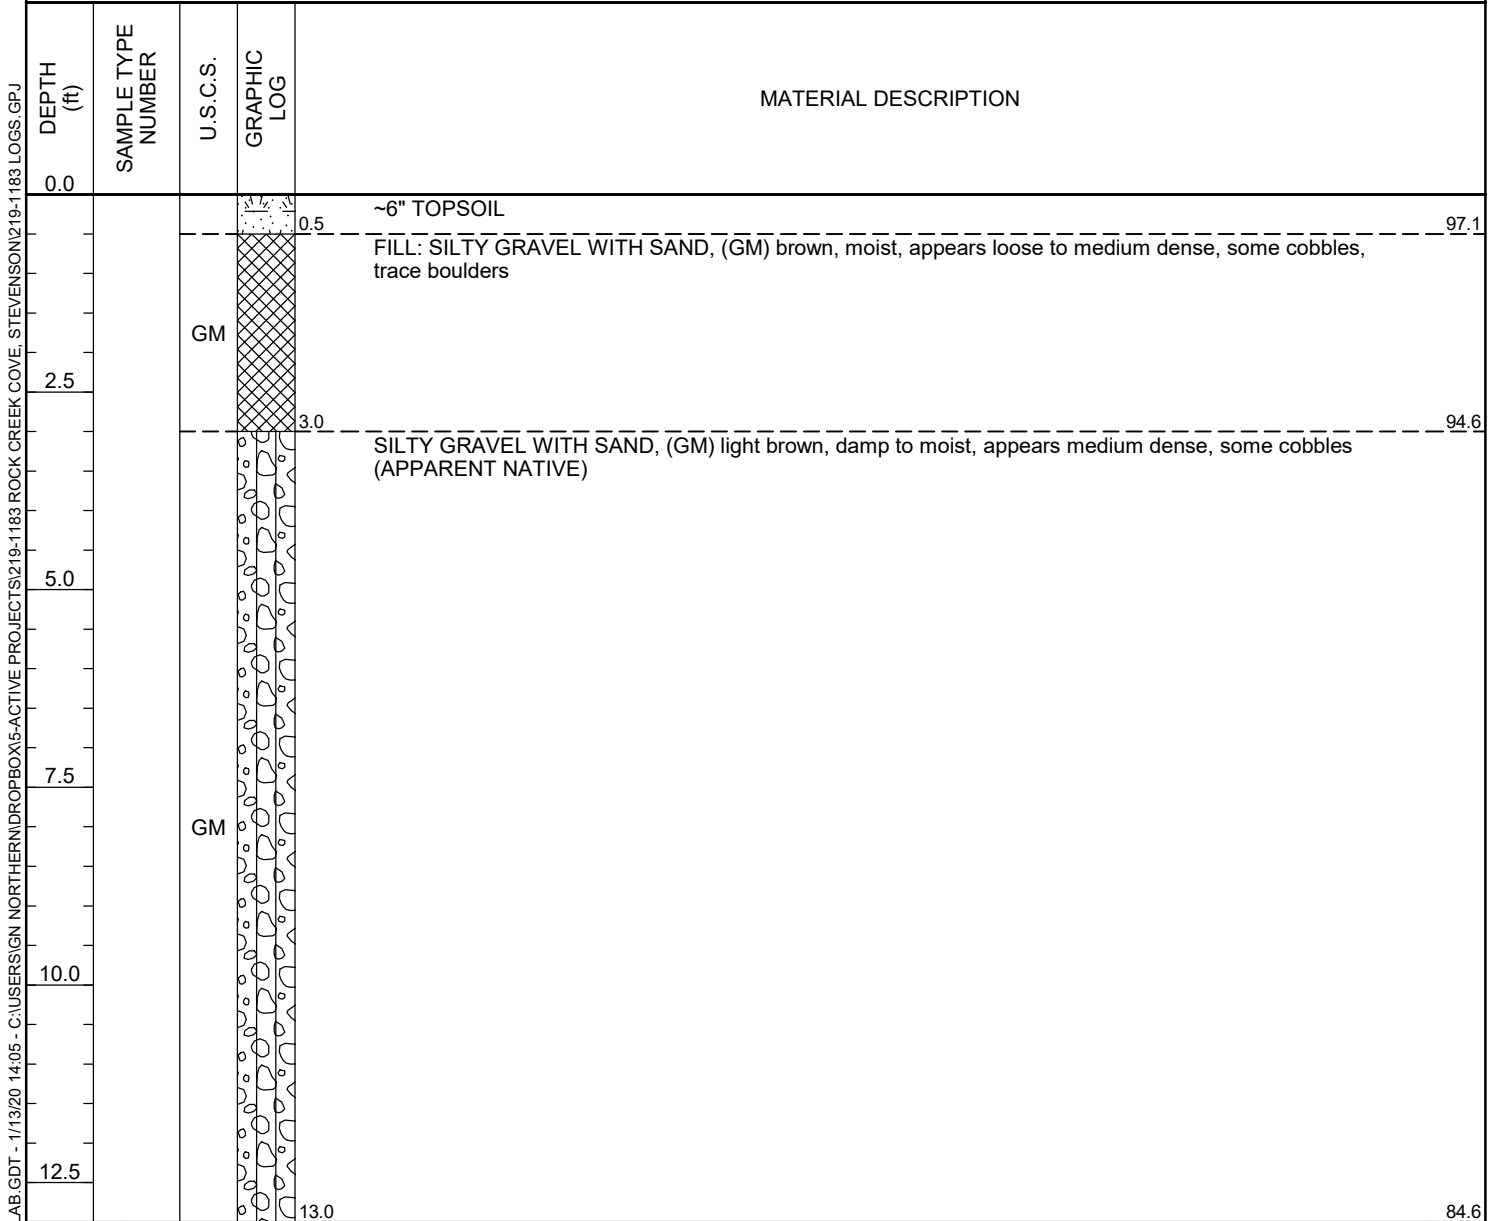
- Groundwater not encountered at time of excavation
 - Referenced elevations are approximate and based on Google Earth topography
 Bottom of test pit at 13.0 feet.

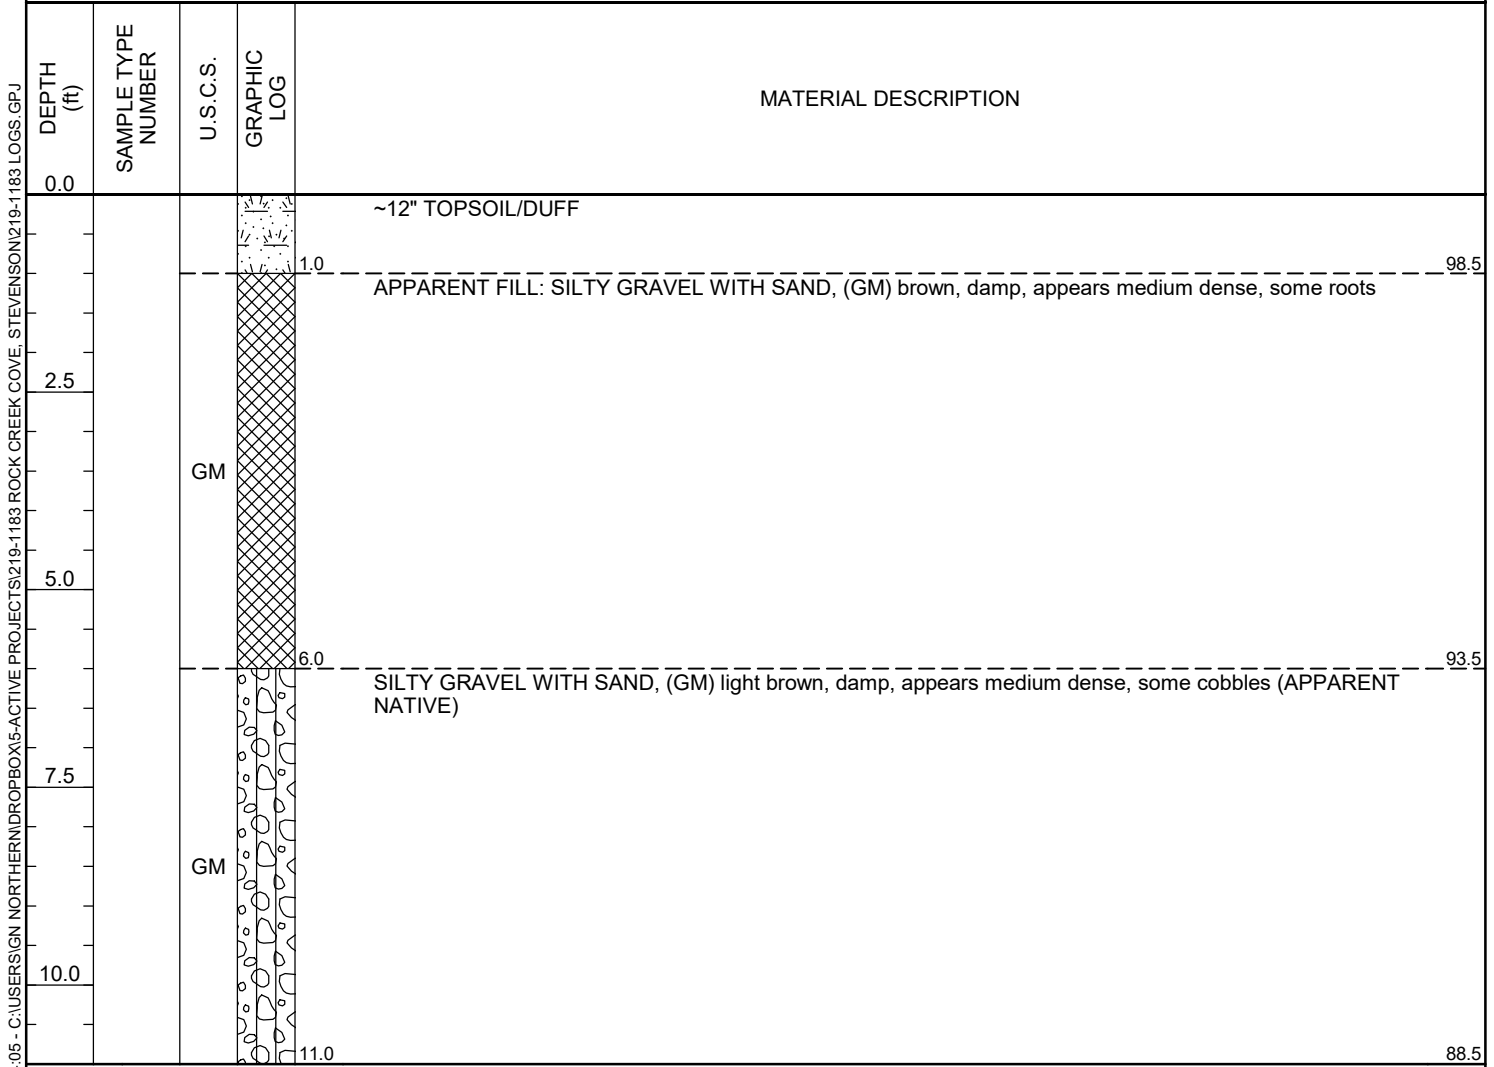
- Groundwater not encountered at time of excavation
 - Referenced elevations are approximate and based on Google Earth topography
 Bottom of test pit at 11.0 feet.

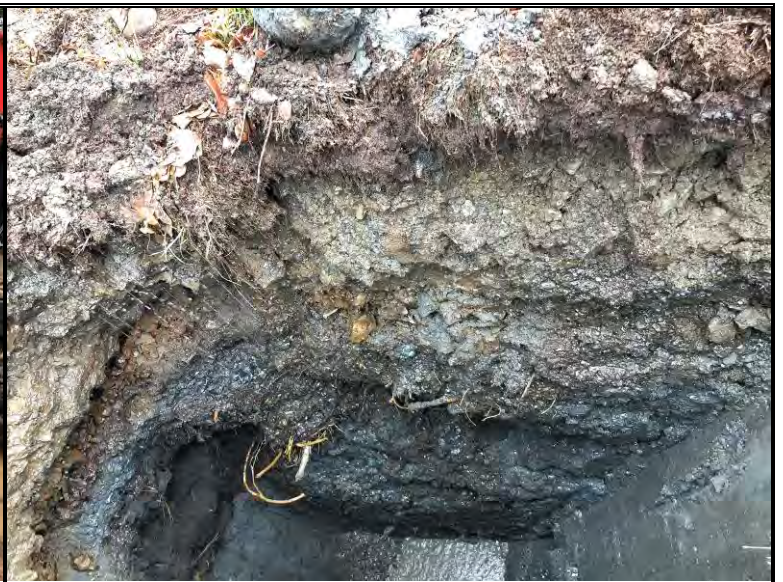
Exposed subsurface soil profile within test-pit TP-1

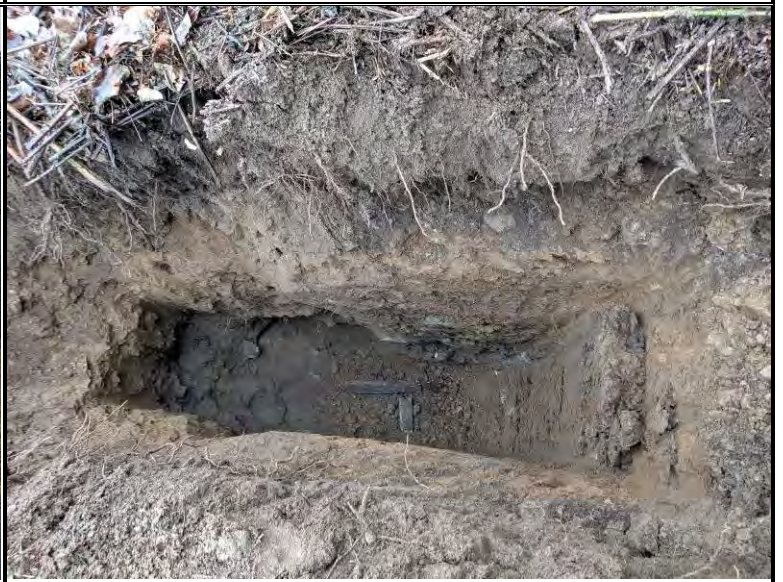
Exposed subsurface soil profile within test-pit TP-2

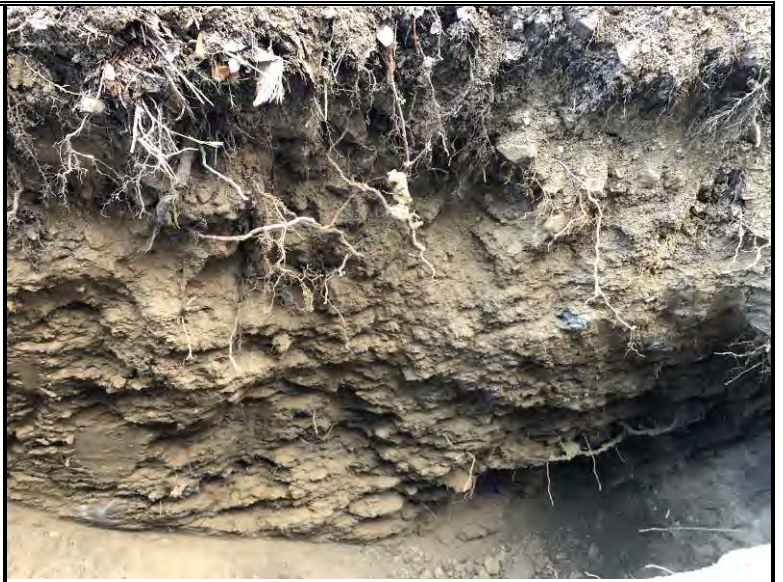
Exposed subsurface soil profile within test-pit TP-4

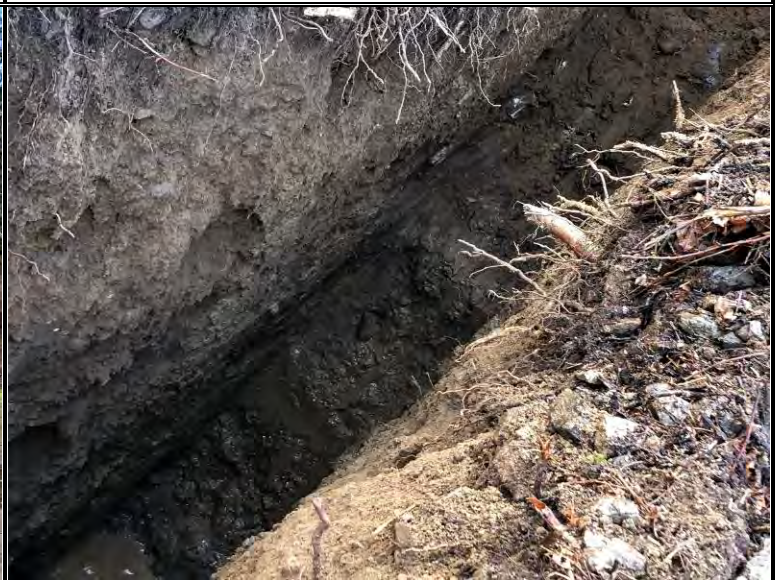
Exposed subsurface soil profile within test-pit TP-8

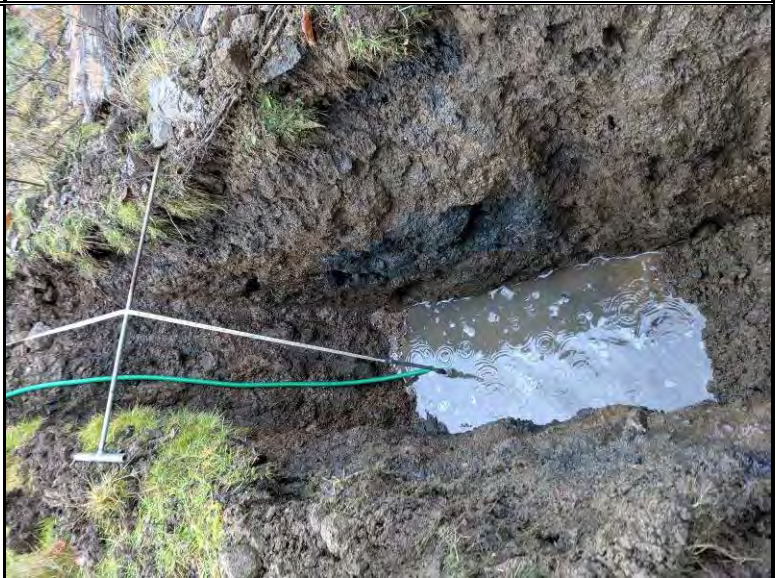
Infiltration test setup at test-pit P-1

A single infiltration test was performed on the north side of the existing entrance drive at a depth of approximately 5.5 feet BGS using a small-scale Pilot Infiltration Test (PIT). To the degree possible, care was exercised during excavation to attempt to maintain relatively uniform side walls, and the resulting size and geometry of the finished test-pit was carefully recorded in the field. Water was introduced into the test-pit using a garden hose connected to a nearby fire hydrant. The water flow into the test-pit was continued until the soils with the test-pit were saturated and a

constant flow rate was established. The stabilized inflow rate was measured and recorded, and the resulting un-factored infiltration rates are presented in the table below:

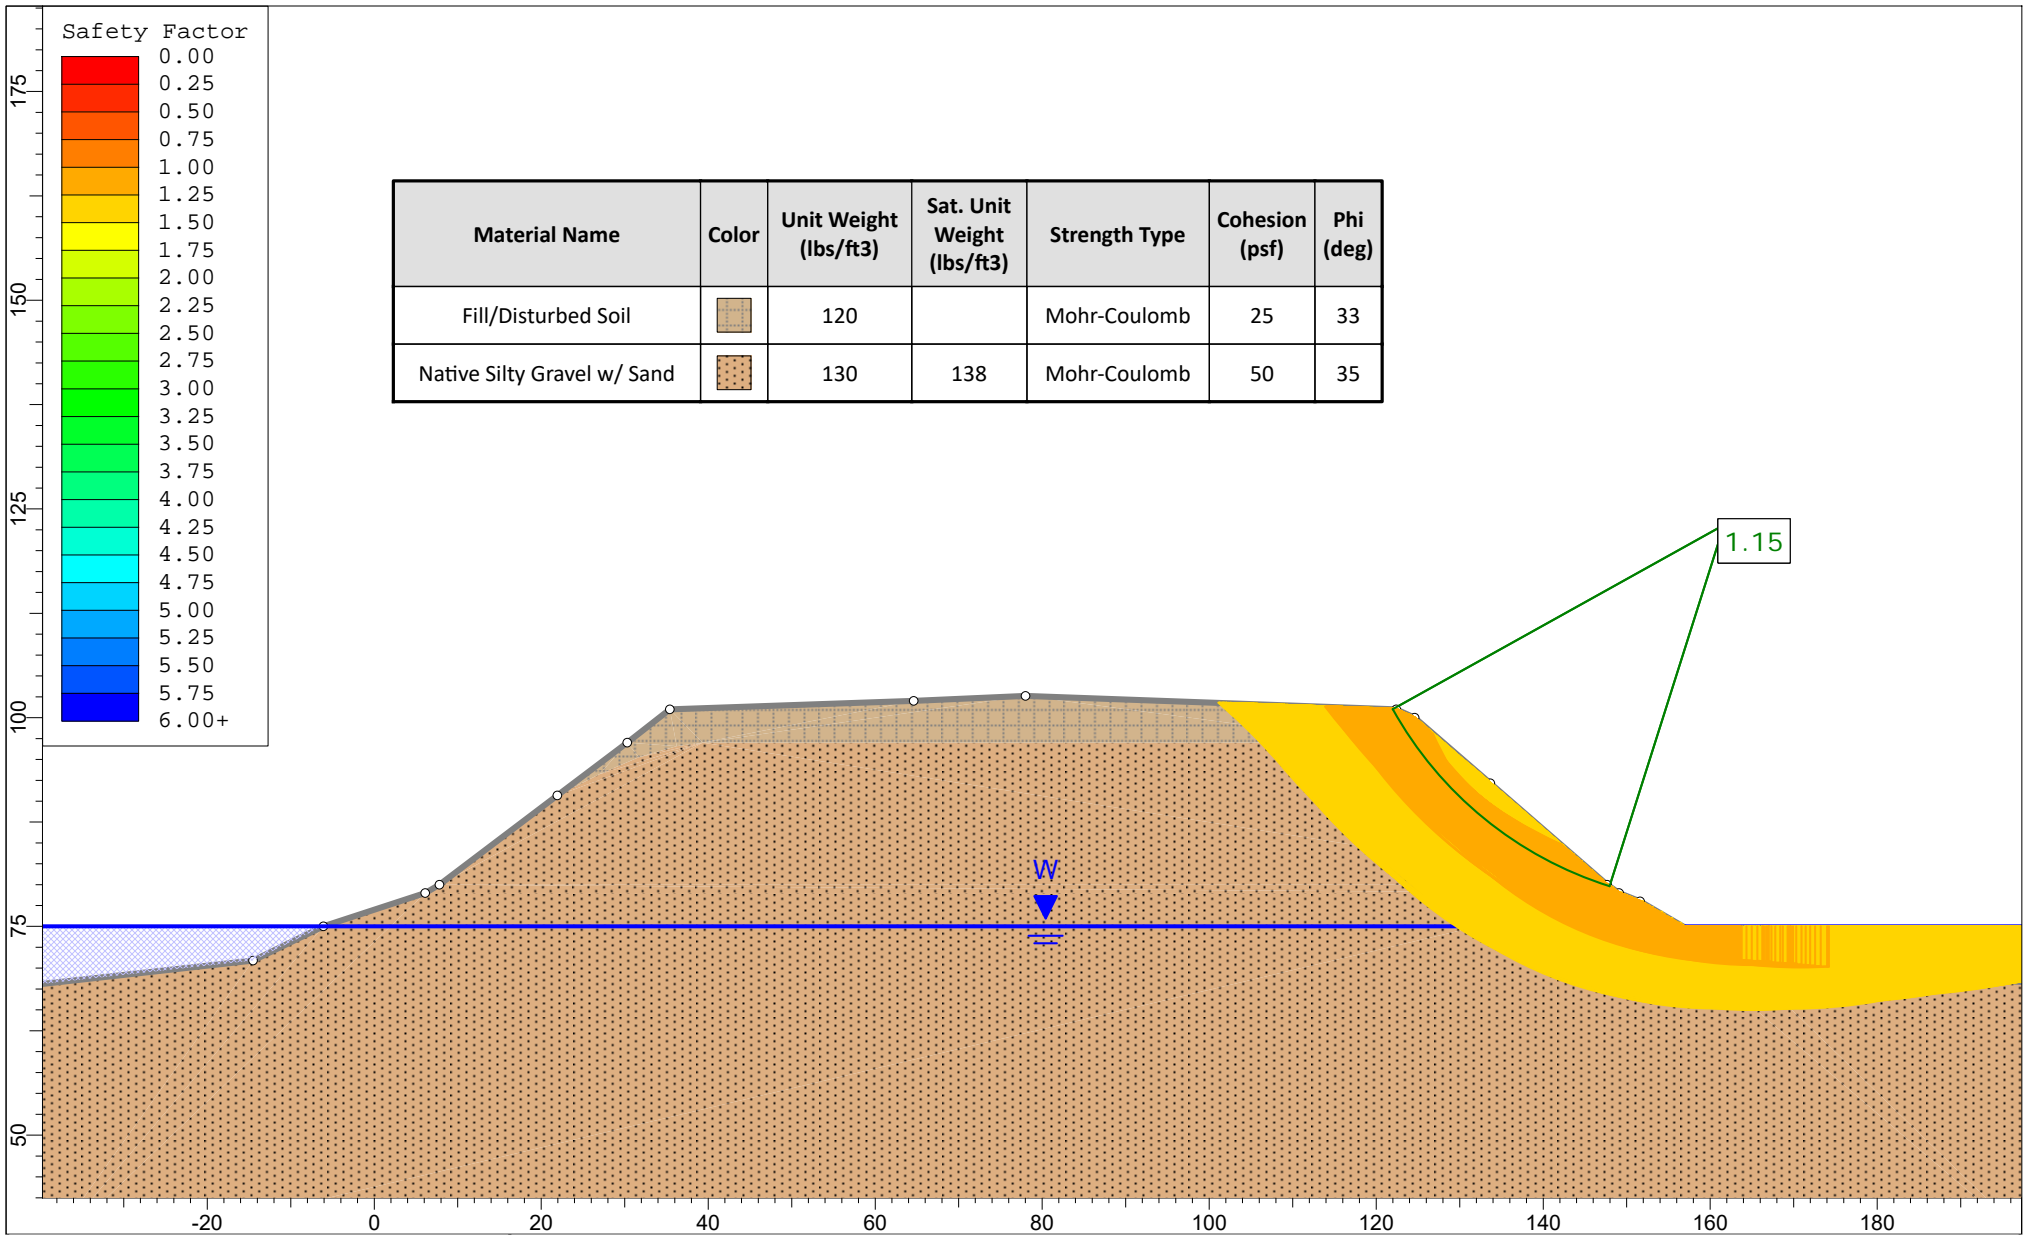
Appendix VI
Slope Stability Analysis

| Material Name | Color | Unit Weight (lbs/ft3) | Sat. Unit Weight (lbs/ft3) | Strength Type | Cohesion (psf) | Phi (deg) |
| Fill/Disturbed Soil | | 120 | | Mohr-Coulomb | 25 | 33 |

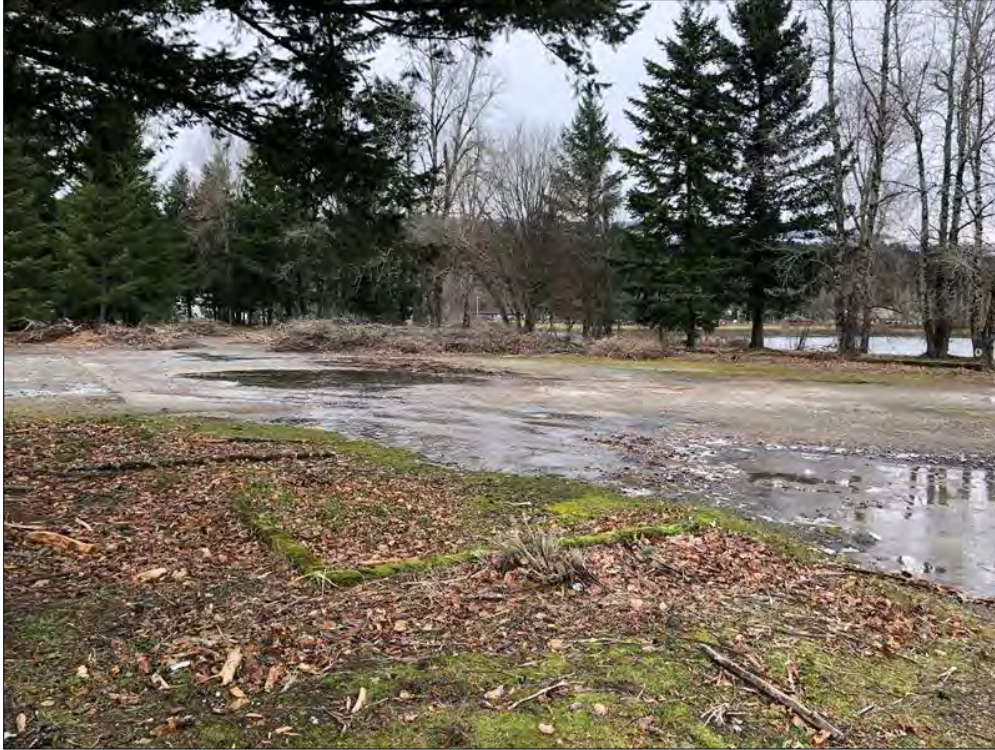
Figure 3. Photographic overview looking east at the concrete foundation of the main sawmill building of the HVM.

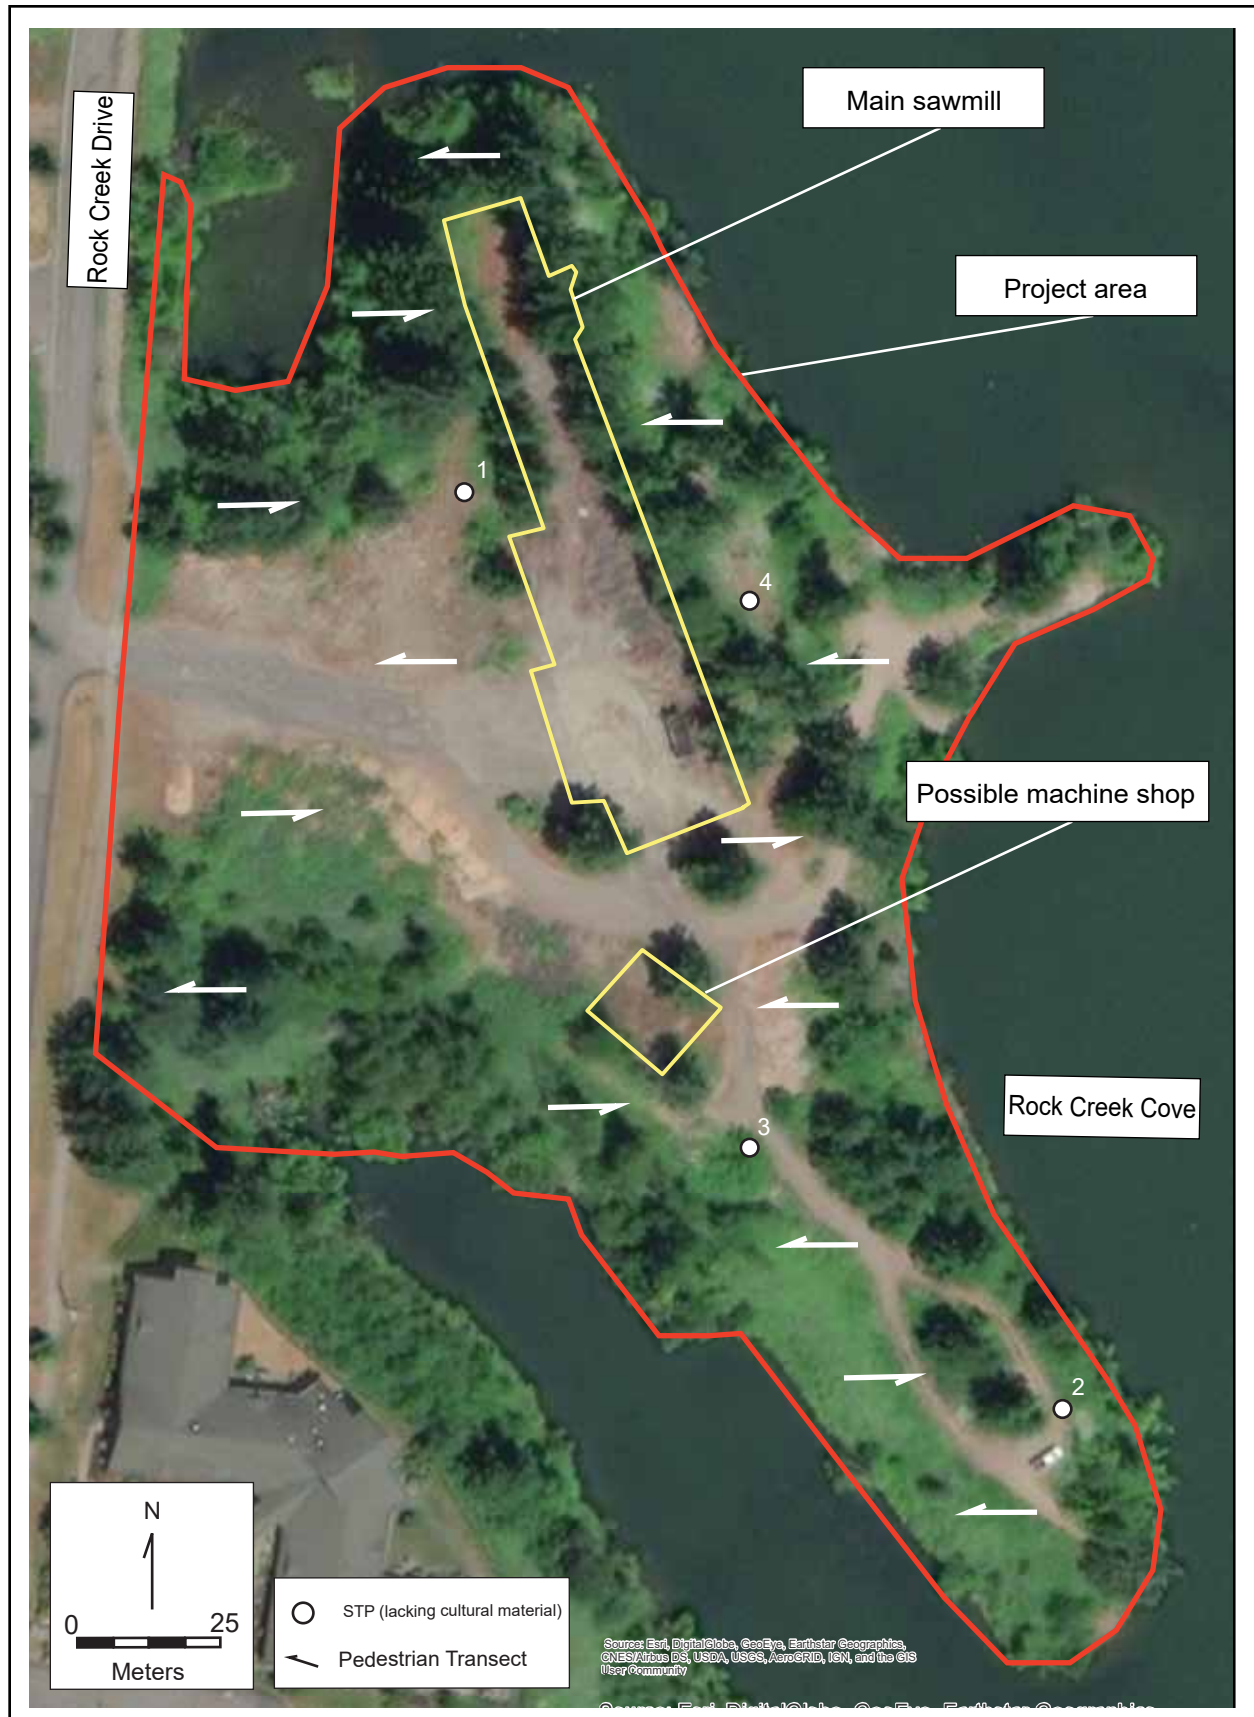
Figure 10. Aerial photomap of the project area showing the locations of the concrete slabs representing mill structures, STPs, and pedestrian transects walked.

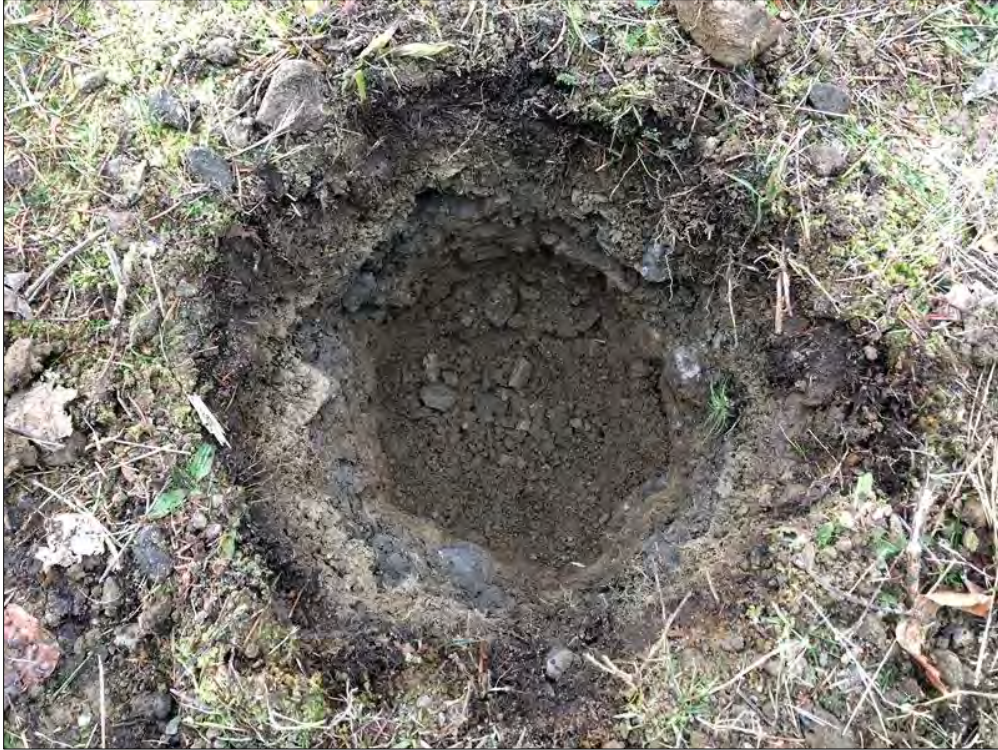
Figure 11. Representative view of the gravelly fill encountered in the STPs.

No artifacts were found in the STPs. Soil profiles encountered during the excavations consisted entirely of fill material, which matched the description of Arents, 0 to 5 percent slopes mapped on the property. Profiles generally included a 5- to 20-cm-thick organic layer of very dark brown (7.5YR 2/2) sandy loam, which capped a 10- to 45-cm-thick layer of brown (10YR 4/3), sandy loam (Figure 11). At least three quarters of the soil matrix in the latter layer contained angular gravel intermixed with small to medium angular cobbles (Figure 12). STP 3 and 4 terminated at 20 cmbs due to an impenetrable layer of angular cobbles (Table 2).

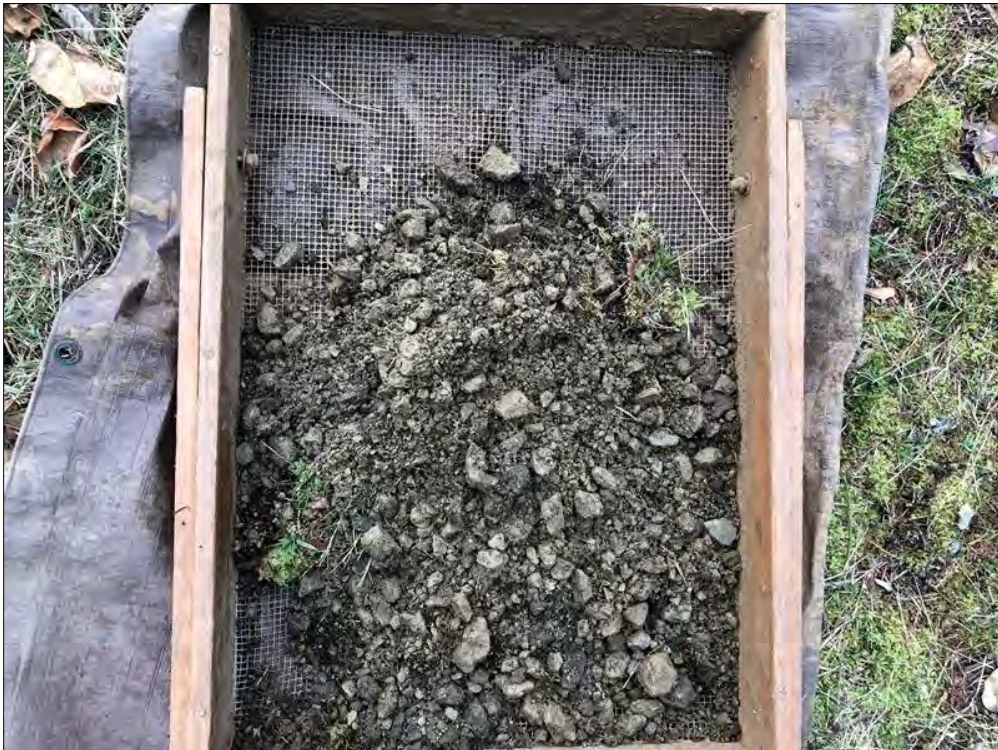
Figure 12. Representative view showing the amount of rock found in the STPs.

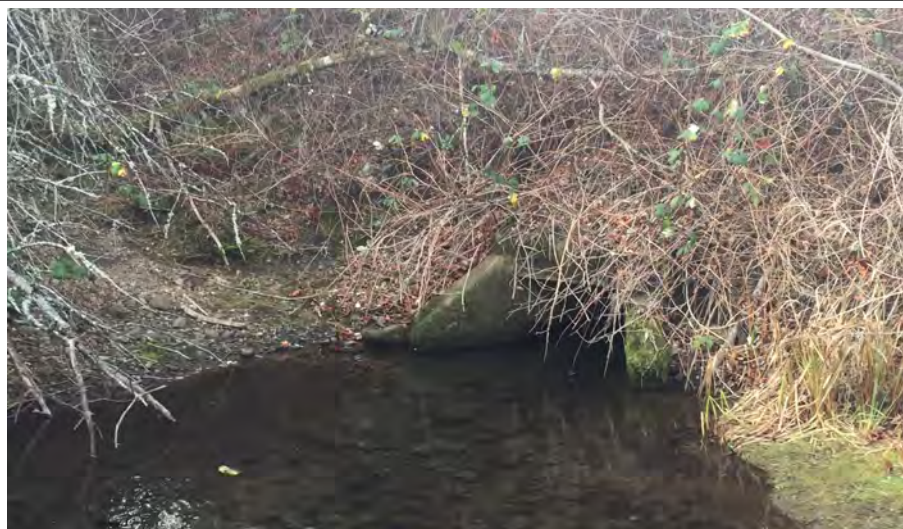
Photo 1. Inflow point of the unnamed tributary via concrete culvert.

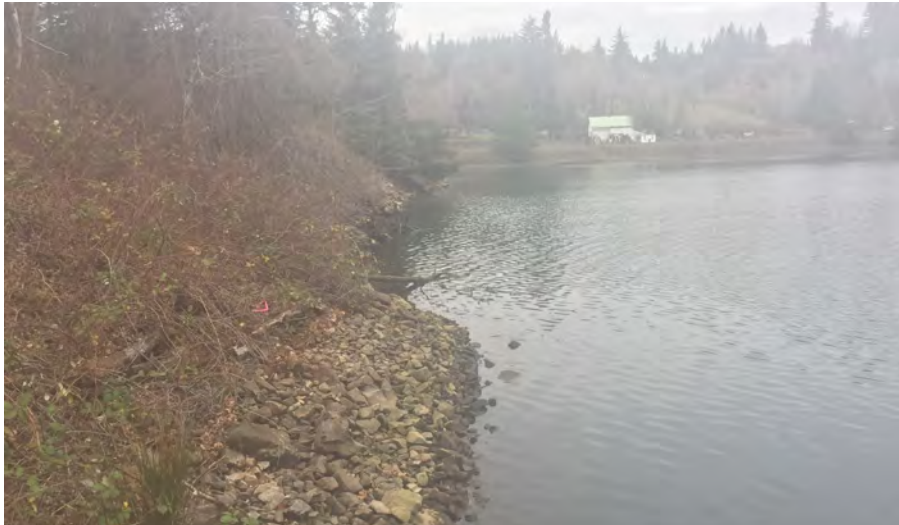
Photo 3. Riprap on the eastern shoreline, facing north.

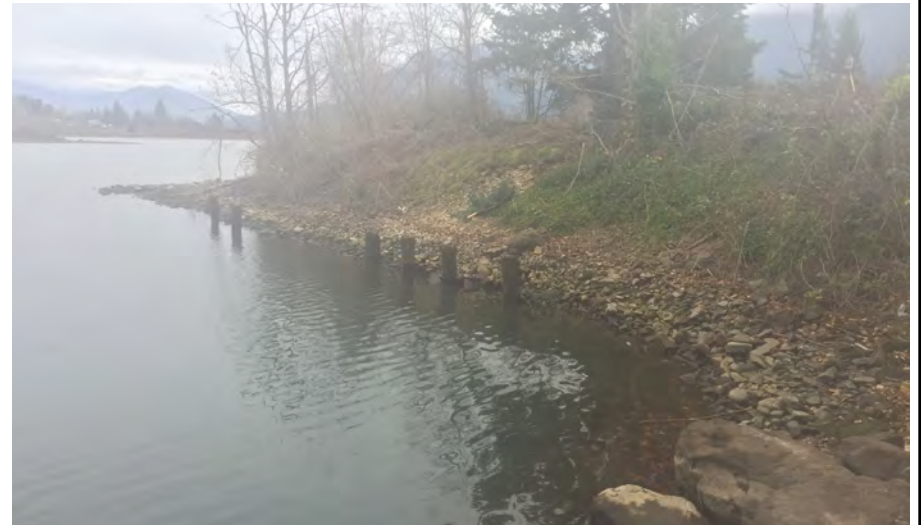
Photo 4. Riprap on the eastern shoreline, facing south.
