TO: City Council
FROM: Ben Shumaker
DATE: June 18th, 2020
SUBJECT: Addenda to City Administrator's Report (SHOR2020-01)

Phase II Environmental Site Assessment
 Former Hegewald Timber Mill
 Stevenson, Washington

Figure 2
 EXISTING CONDITIONS SITE MAP
 Rock Cove CAR
 FDM Development
 City of Stevenson, Skamania County, Washington
 Section 1, Township 2N, Range 7E, W.M.

ROCK CREEK COVE HOSPITALITY
 MASTER PLAN
 FDM DEVELOPMENT, INC.
 STEVENSON, WA

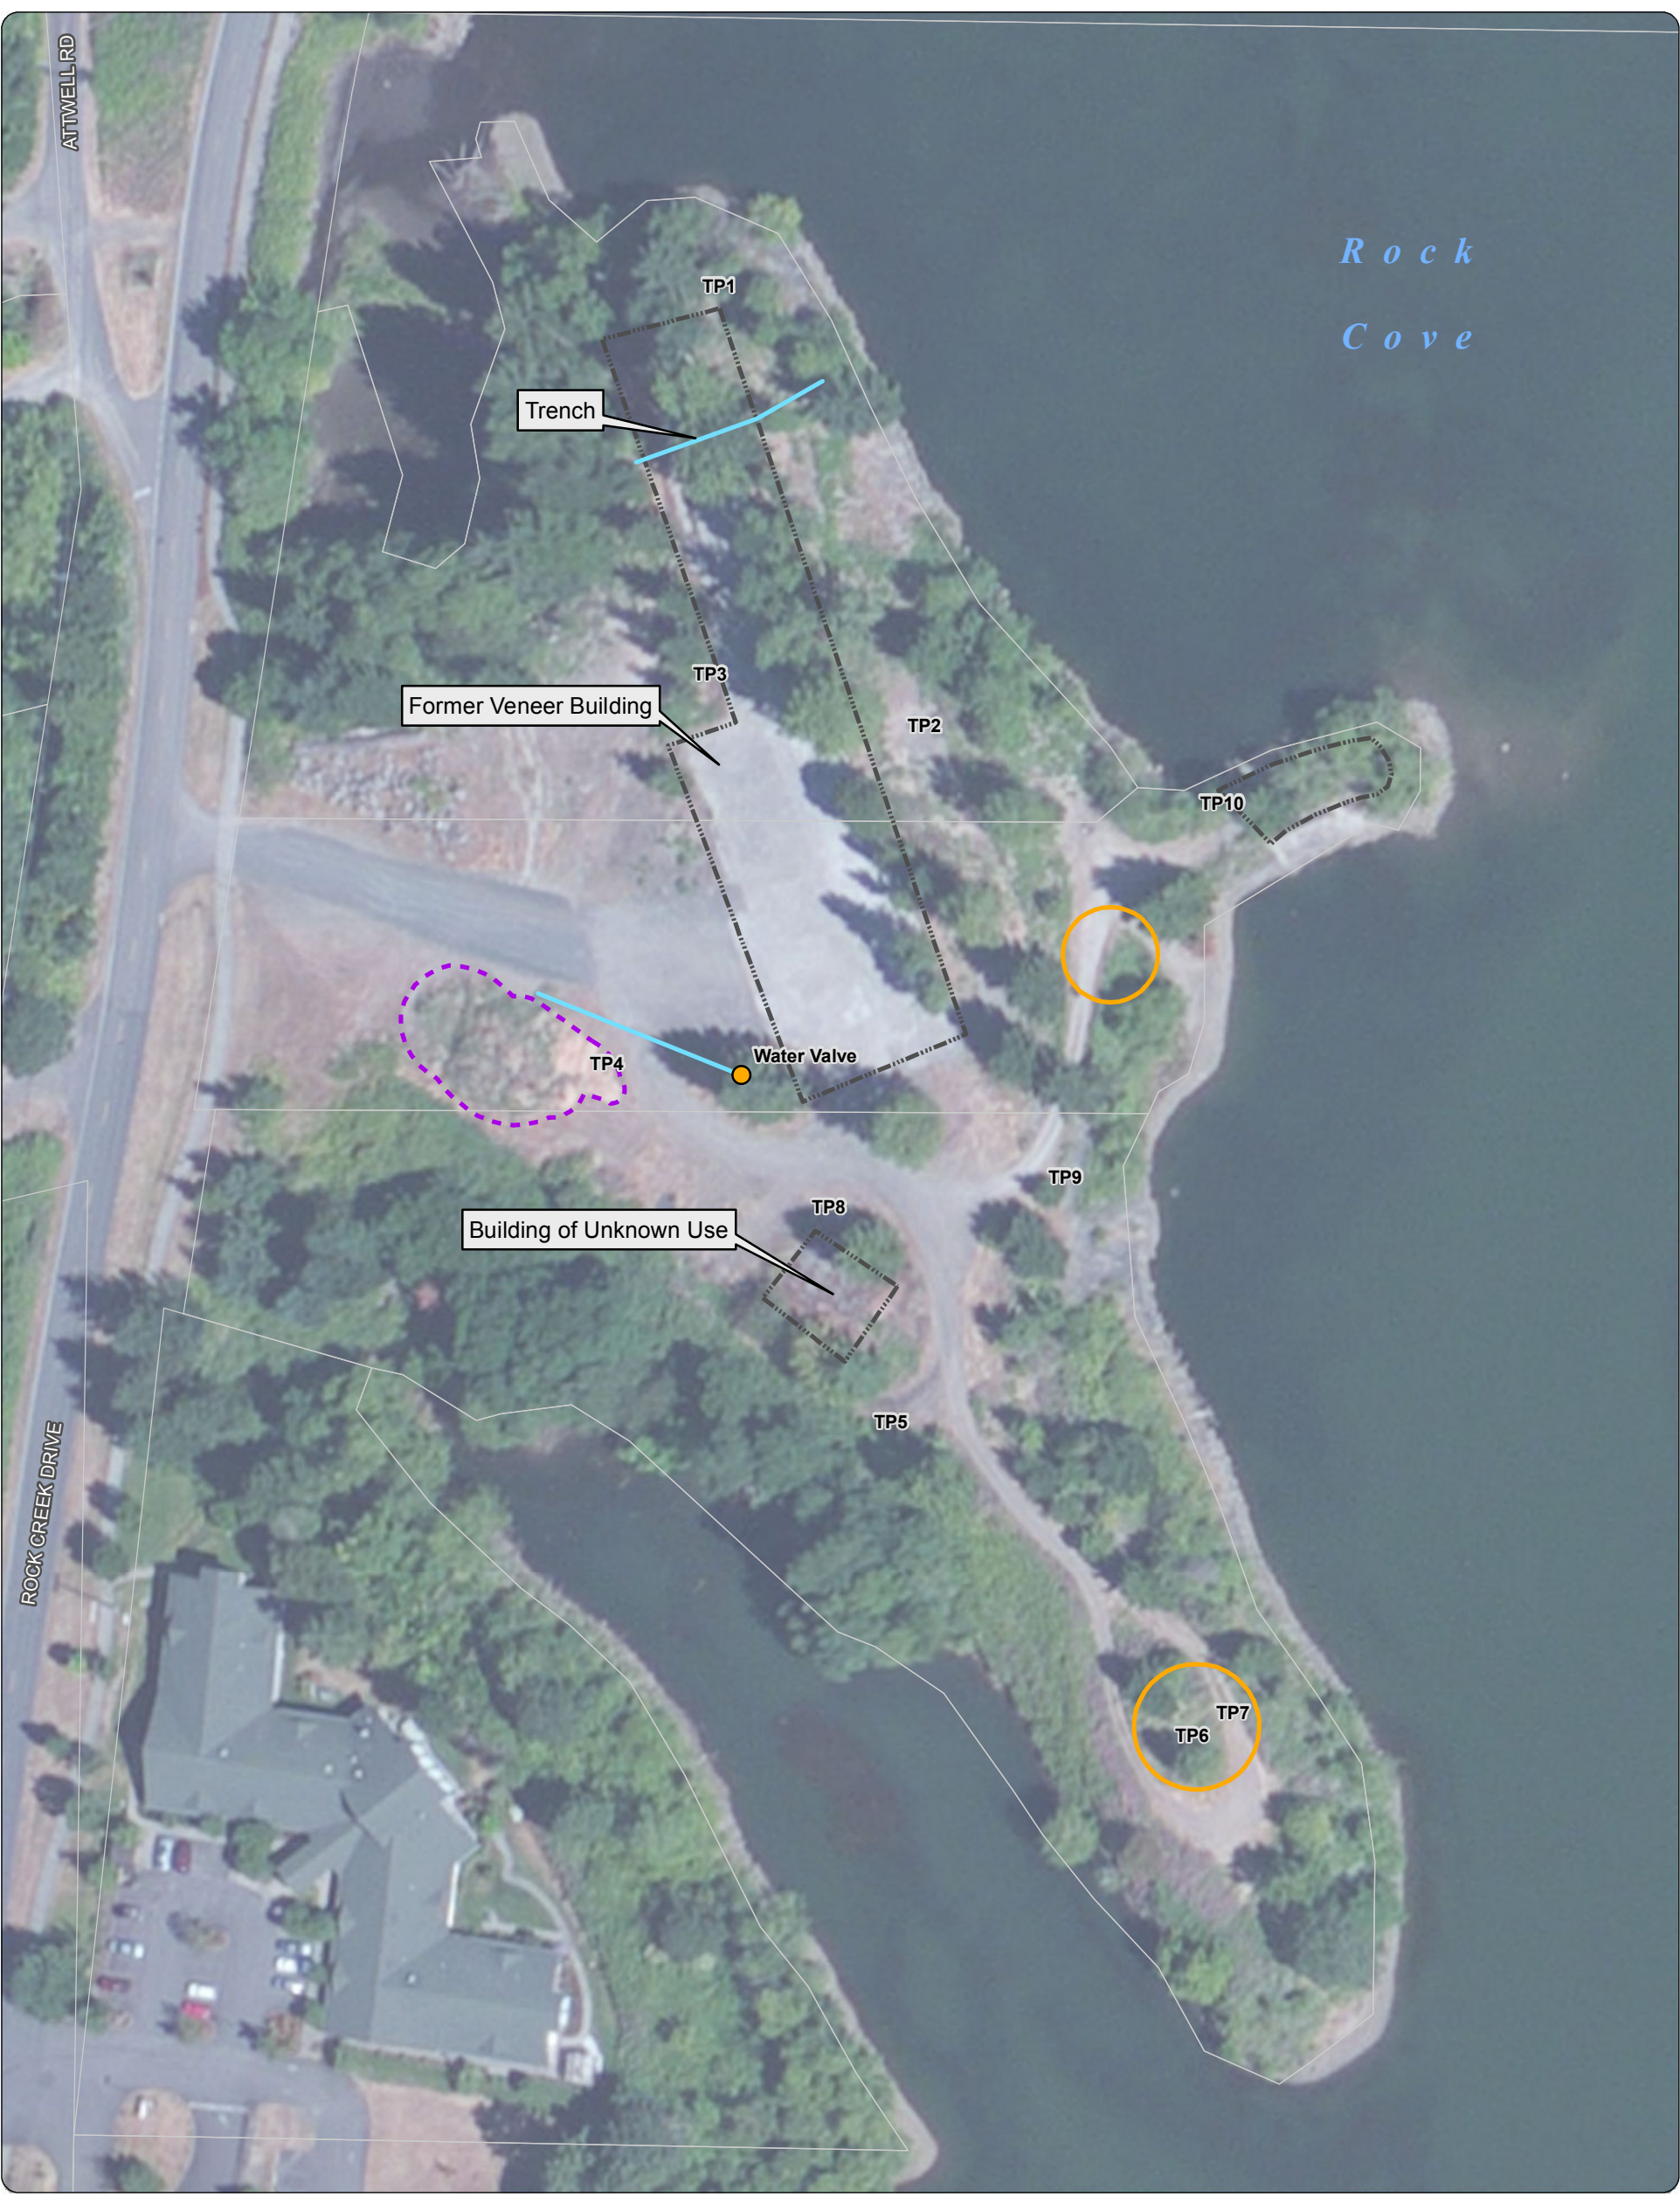
Investigation locations are shown on Figure 2. These locations were selected based on the findings of the geophysical survey and known site features (e.g., former wigwam burner locations, former building locations, fill material locations). Consistent with the work plan, the test pits were advanced to 8 to 10 feet bgs.

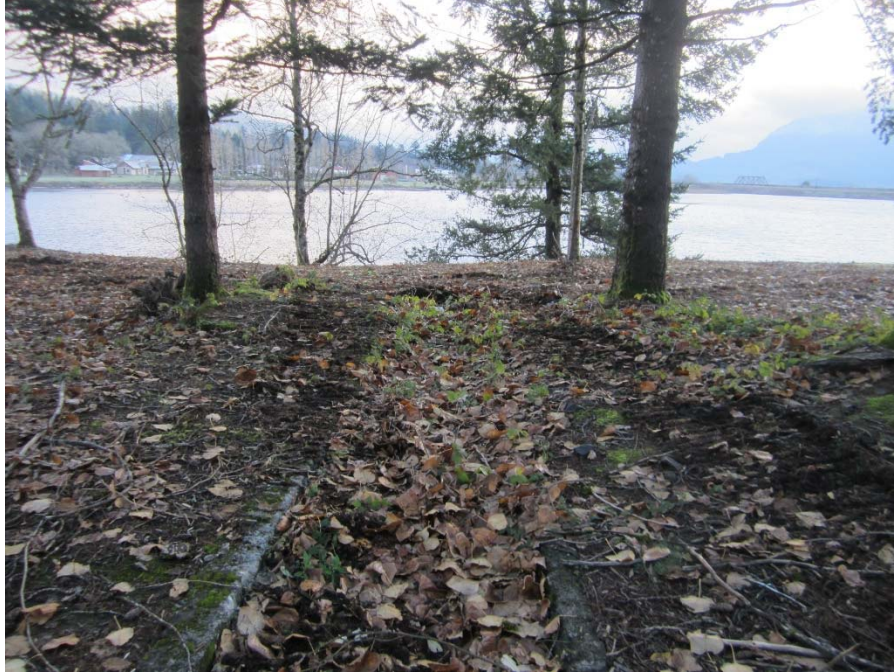
Photograph 1: Trench feature that crosses the northern part of the large building foundation. Photograph taken facing east.

- **TP1:** Adjacent to the northeastern corner foundation of the former large building, near Anomaly A, identified in the geophysical survey. Anomaly A is in the vicinity of a trench and pipe feature; therefore, TP1 was advanced north of Anomaly A.

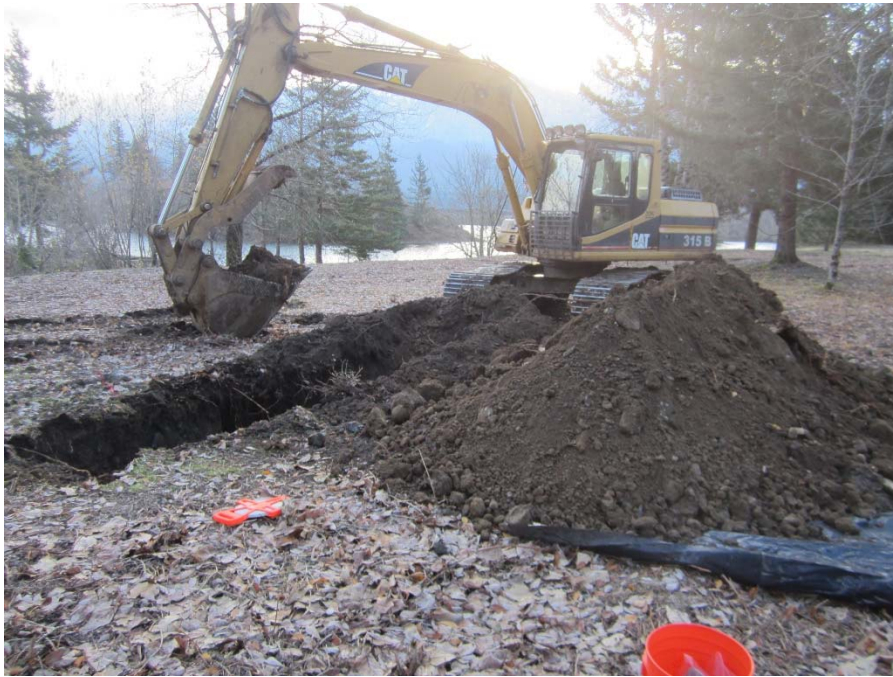
Photograph 3: Excavation TP2 along the eastern foundation of the large building.
Photograph taken facing south.

- **TP2:** Adjacent to the eastern foundation boundary of the former large veneer building.
- **TP3:** Adjacent to the western foundation boundary of the former large building in an area identified in the geophysical survey as Anomaly D.

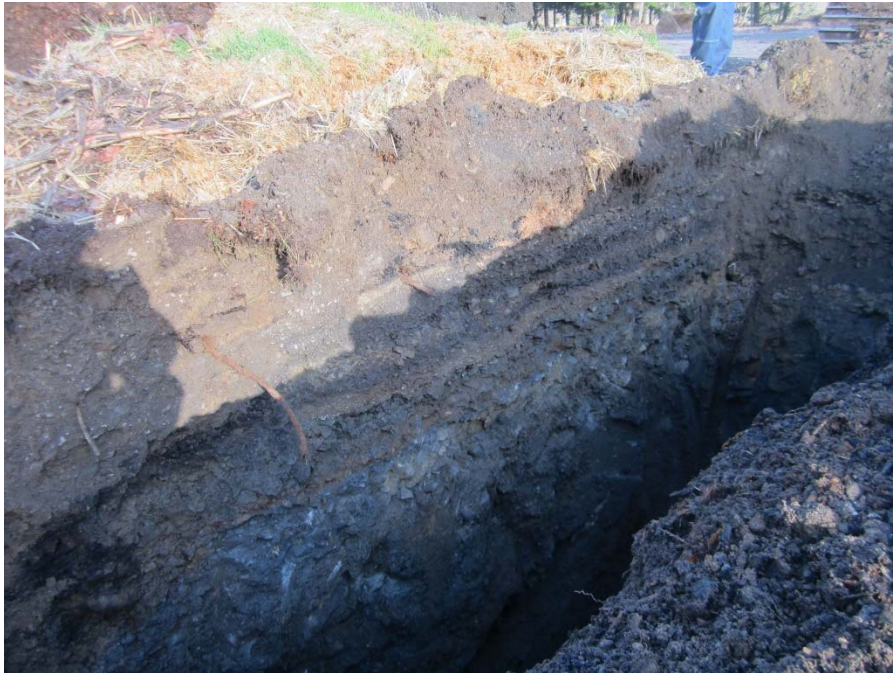
Photograph 4: Western sidewall of TP4, showing varied soil lenses in the upper 3 feet.
Photograph taken facing northwest.

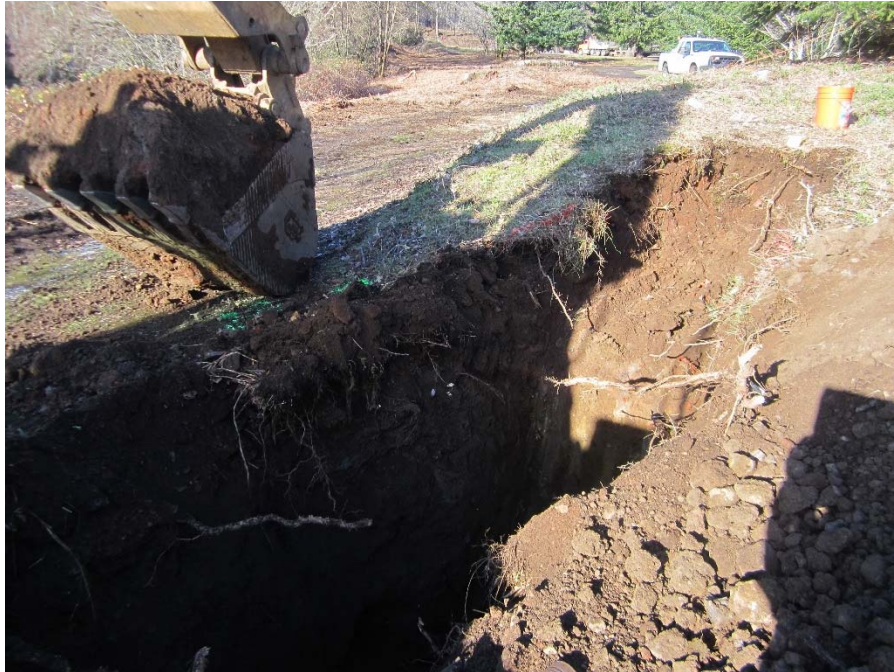
Photograph 5: Excavation of TP6 within the footprint of the southern former wigwam burner. The shelf feature in the photograph is a concrete slab encountered during advancement of the test pit. Photograph taken facing northwest.

- **TP6:** Within or near the footprint of the southern former wigwam burner near an area identified in the geophysical survey as Anomaly J. A large slab of concrete assumed to be associated with the former wigwam burner foundation was encountered approximately 2.5 feet bgs during the advancement of TP6.

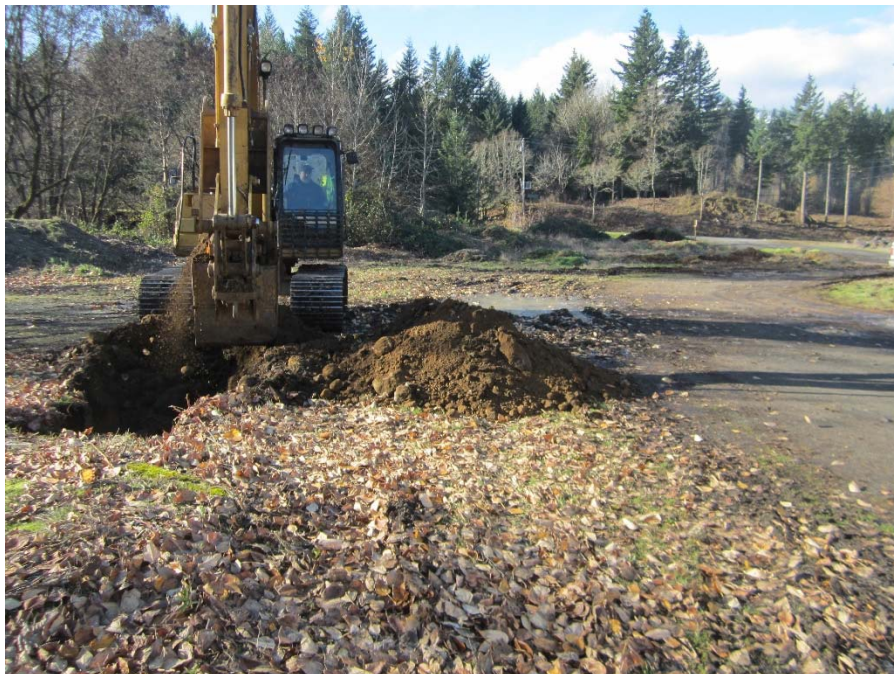
Photograph 6: Excavation TP8 adjacent to the northeast corner of the small structure foundation. Photograph taken facing west.

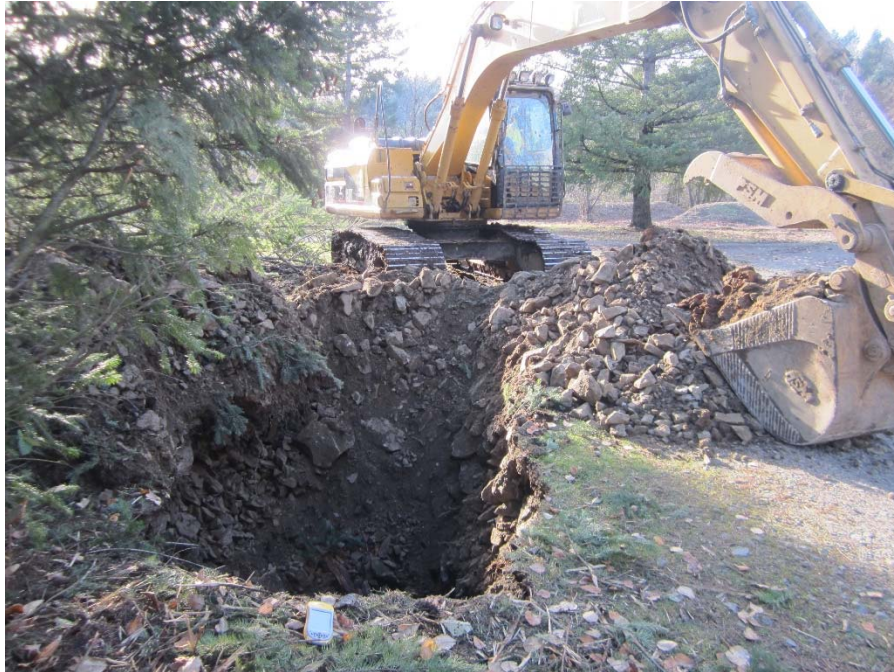
Photograph 7: Excavation TP9, which had angular cobble fill from surface to approximately 5 feet below ground surface. Photograph taken facing south.

- **TP9:** Near the northern former wigwam burner in an area identified in the geophysical survey as Anomaly G. Approximately 5 feet of angular cobbles and boulders was encountered when advancing this test pit.

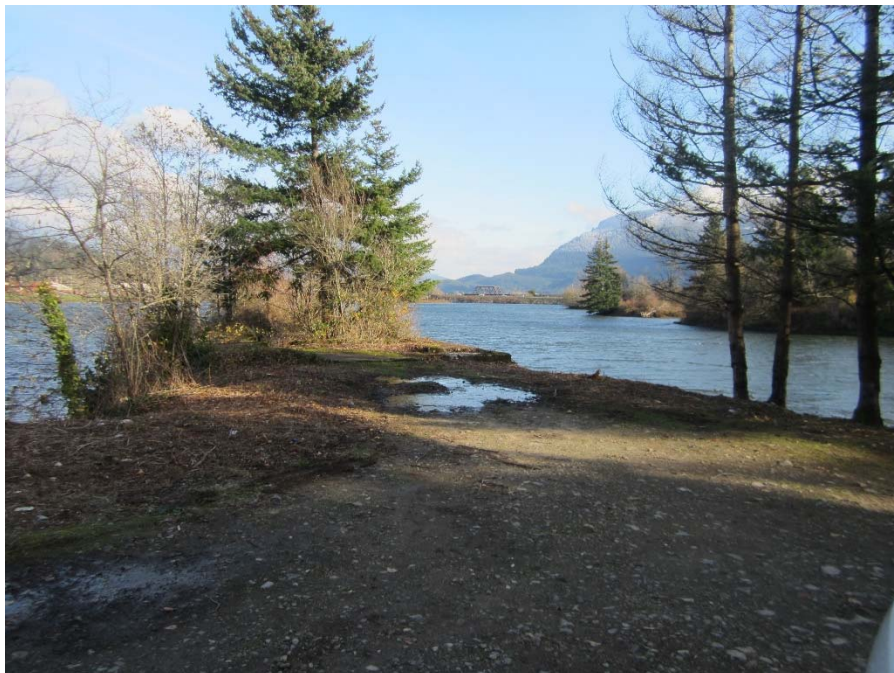
Photograph 8: Small peninsula, on the eastern boundary of the Property, that extends into Rock Cove. TP10 was advanced to the west of the foundation. Photograph taken facing east.

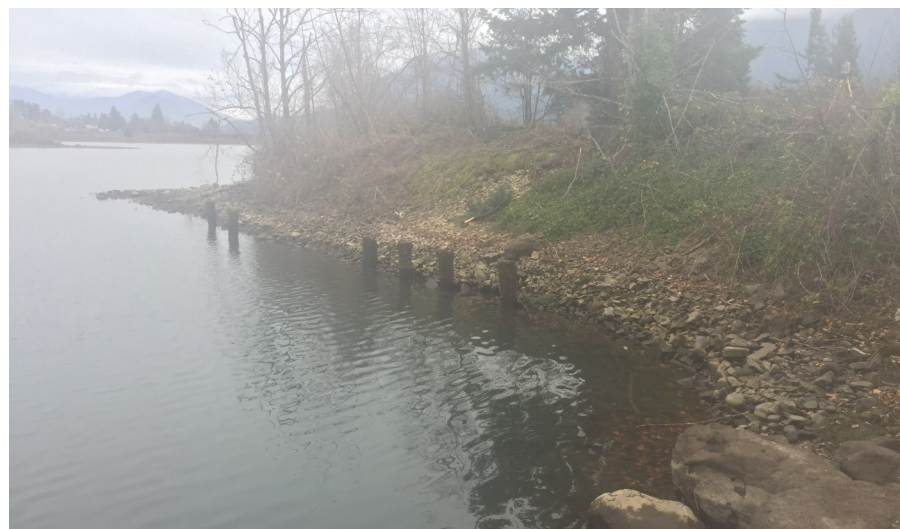
Photo 4. Riprap on the eastern shoreline, facing south.
