2025 ANNUAL REPORT

City of
St. Francis
PUBLIC WORKS DEPARTMENT

2025 WATER & WASTEWATER FINAL REPORT

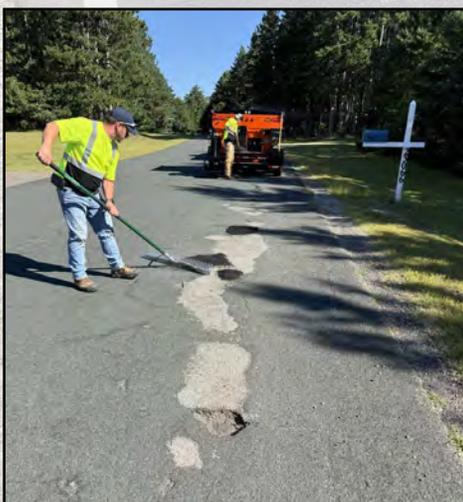
Our new patch trailer showed up during the late summer. This is a new piece of equipment Public Works added this past year. Before, staff was ordering a product called cold patch that came on a pallet in bags. This product works great during a pinch when asphalt plants are closed during the winter months. The trailer allows us now to use hot patch sand mix which allows for a much better patch. Staff used this trailer throughout the remainder of the season spreading roughly 22.5 tons of patch. We spent roughly \$1845 dollars in hot patch. For this same amount in cold patch, it would have been \$13,252 dollars, with a savings of \$11,407 dollars. This trailer is expected to pay for itself within the next few years.

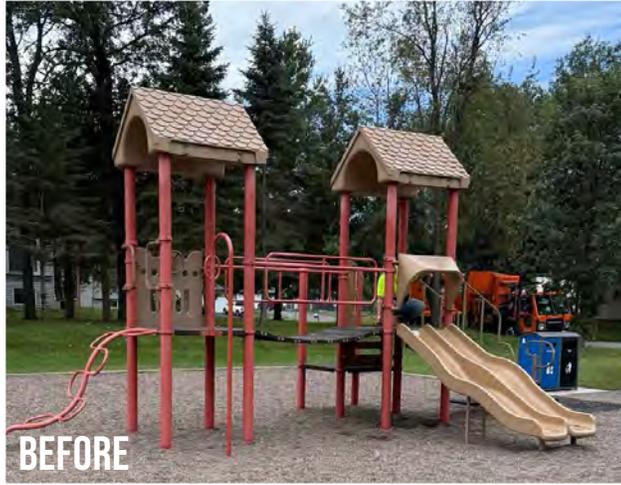
BEFORE

Our oldest playground at Rum River Woods Park was replaced this year. The playground was installed in 1997 making it 28 years old and 8 years past the recommended replacement of 20 years. Staff brought a couple of options to the park commission and let Staff did the removal and prepping of the site for the new playground. This involved removal of old structure and pee rock. The sand was regraded and the new structure was installed. Once the structure was installed the pee rock was brought back in and poly installed over the top. The final step was to have our playground mulch contractor come and blow in our mulch.

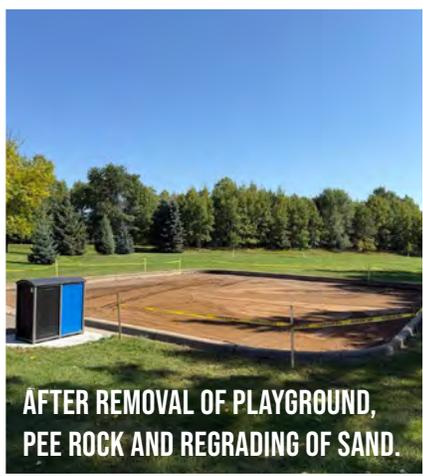
**AFTER REMOVAL OF PLAYGROUND,
PEE ROCK AND REGRADING OF SAND.**

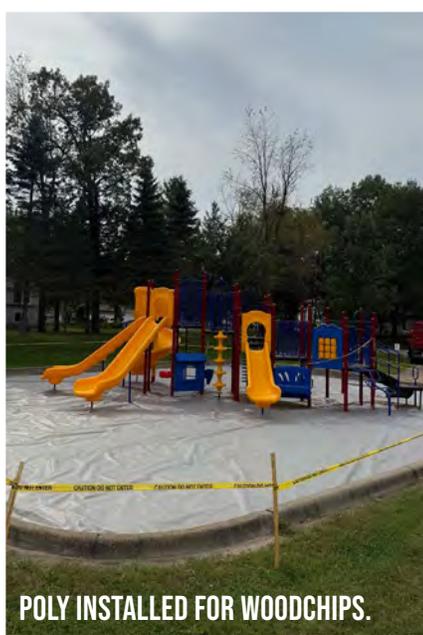
POLY INSTALLED FOR WOODCHIPS.

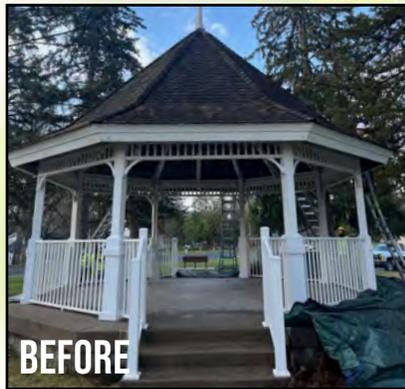
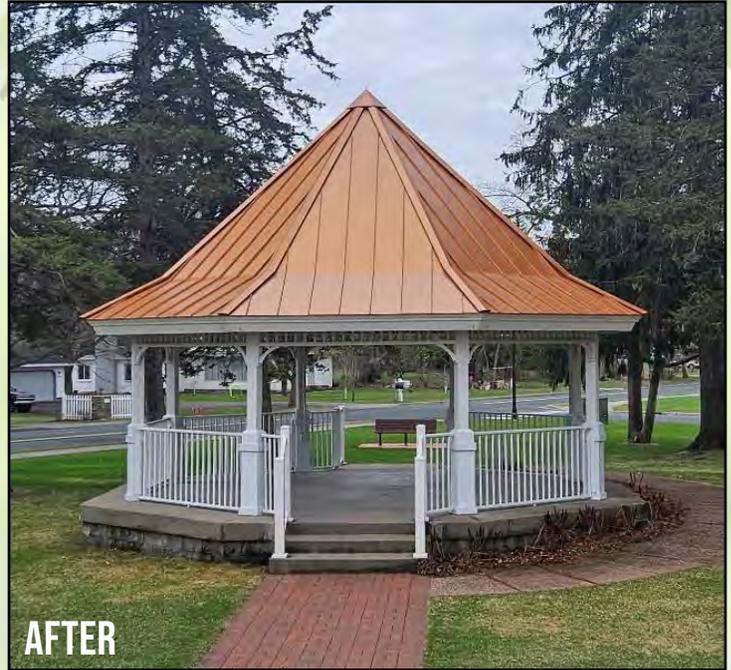
This past year the Woodbury Park gazebo roof park was replaced. This roof was overdue to for replacement of the old original cedar shacks. Staff was looking for a roof that would look good for sometime and was maintenance friendly. They new roof is constructed out of cooper penny color metal. This roof is expected to last roughly 50 years.

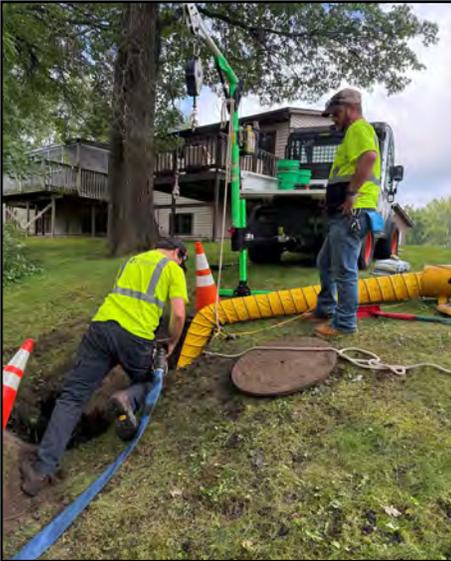
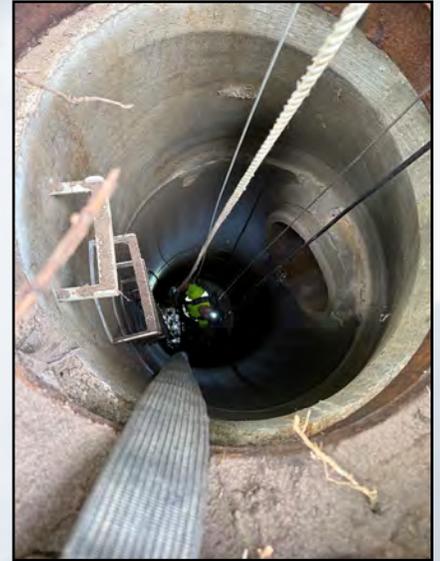
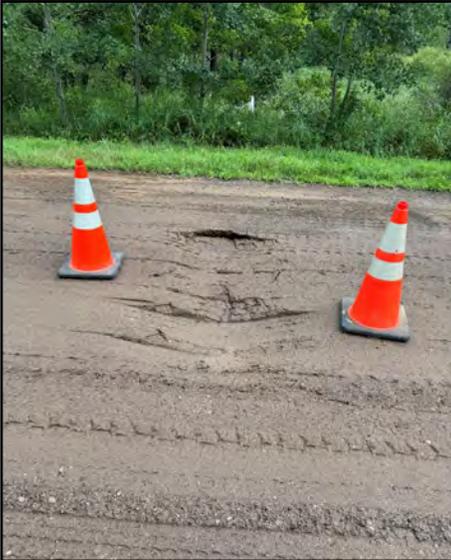
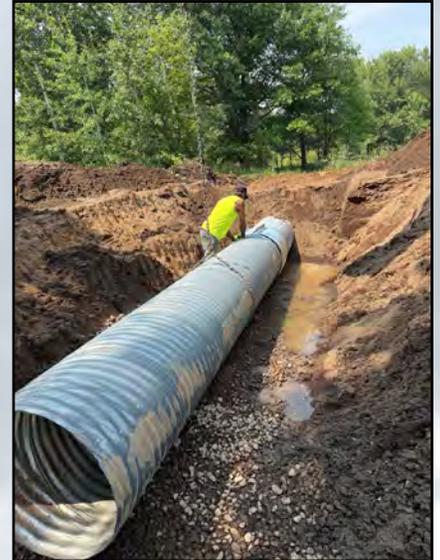
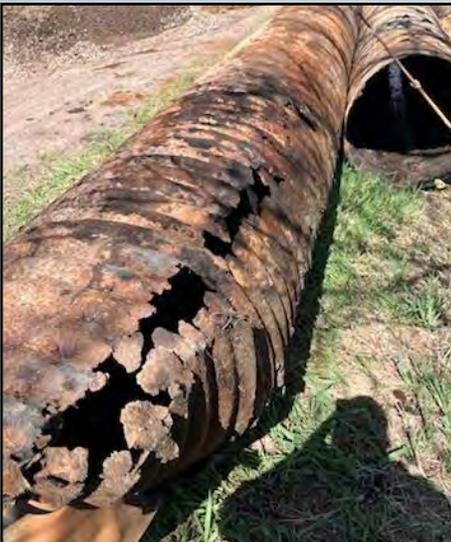
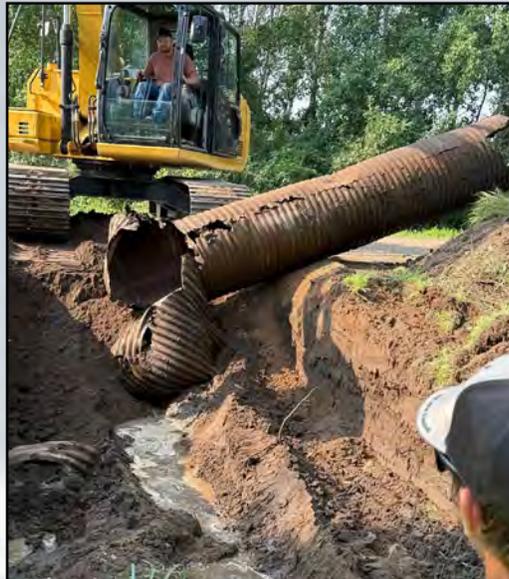
Staff had multiple stormwater projects this past year. The pictures are a few of the projects. The top two pictures are from a stormwater sink hole in a yard due to the grout failing around the pipe. This requires staff to use all the confined space entry equipment as the failure was about 20 feet down. The center pictures are from a failing culvert on 241st Avenue as you can see from the pictures the culvert starts to rot at the button cause the road to sink from gravel washing through the culvert. The bottom pictures are from 238th which had the same failure where the bottom of the culvert rotted out. This is very common as the galvanized culverts age. The culverts are designed to last 40 years give or take.

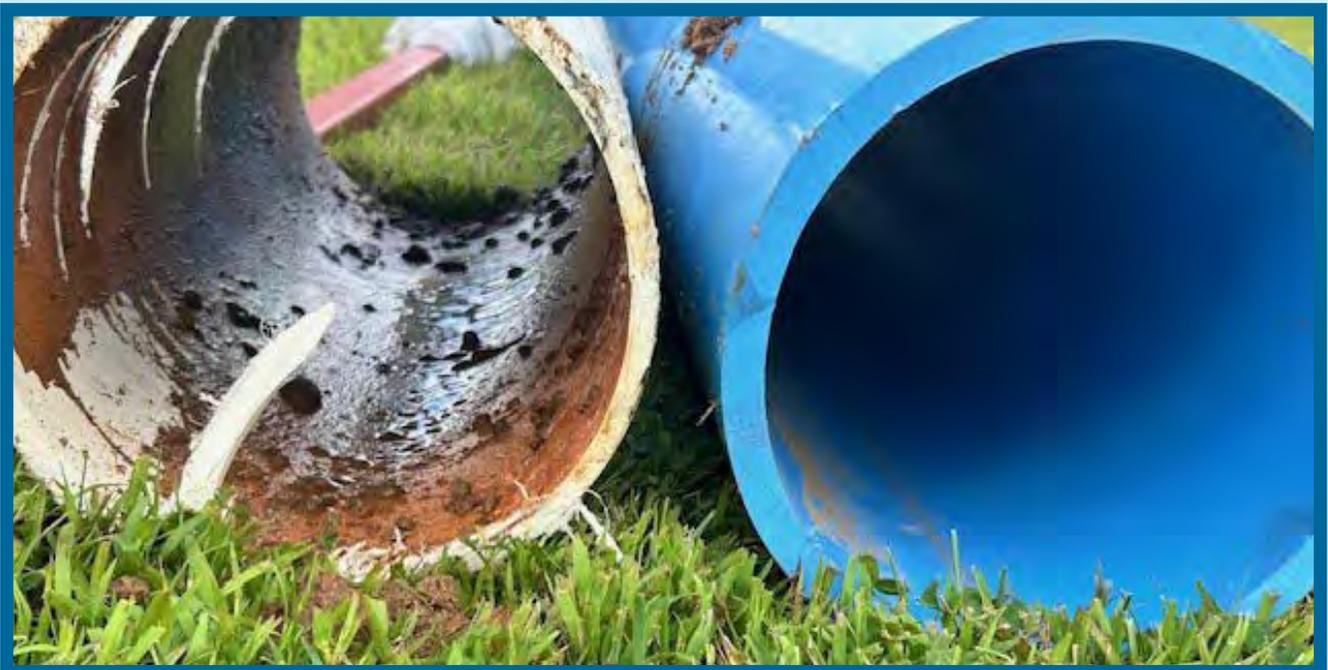
Original 6" water main compared to new 8" water main.

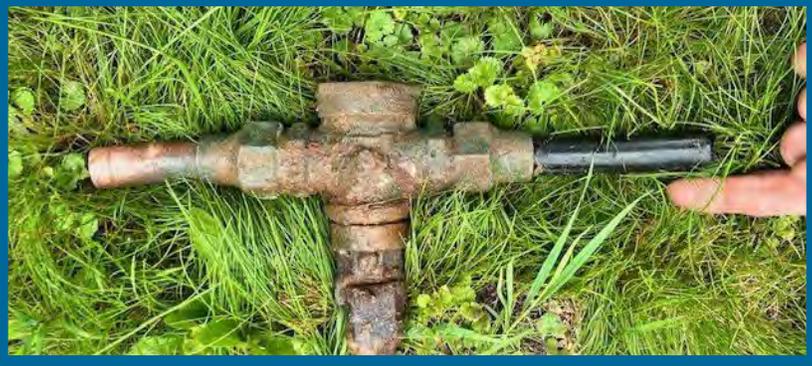
The picture to the left is an old service that was replaced including the curb stop. Notice the two different types of material? 5/8" Plastic on one side, 3/4" copper on the other side of the curb stop.

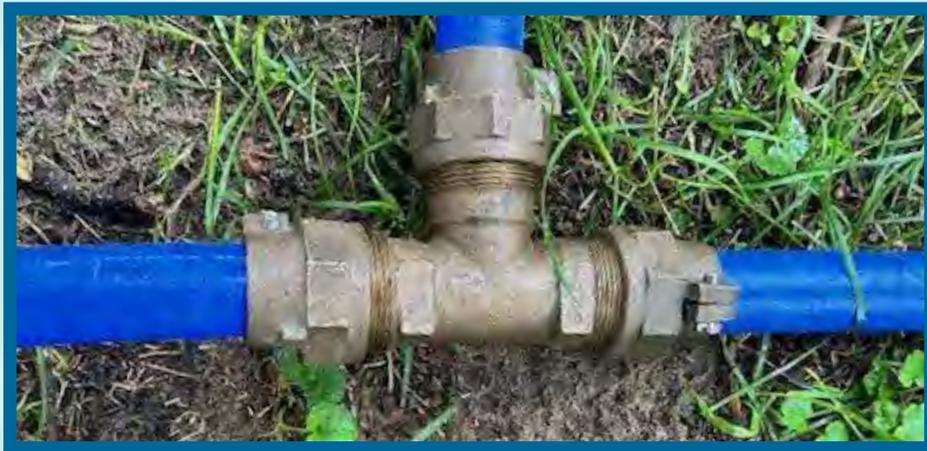
The picture below is a new 1" blue water service and curb stop.

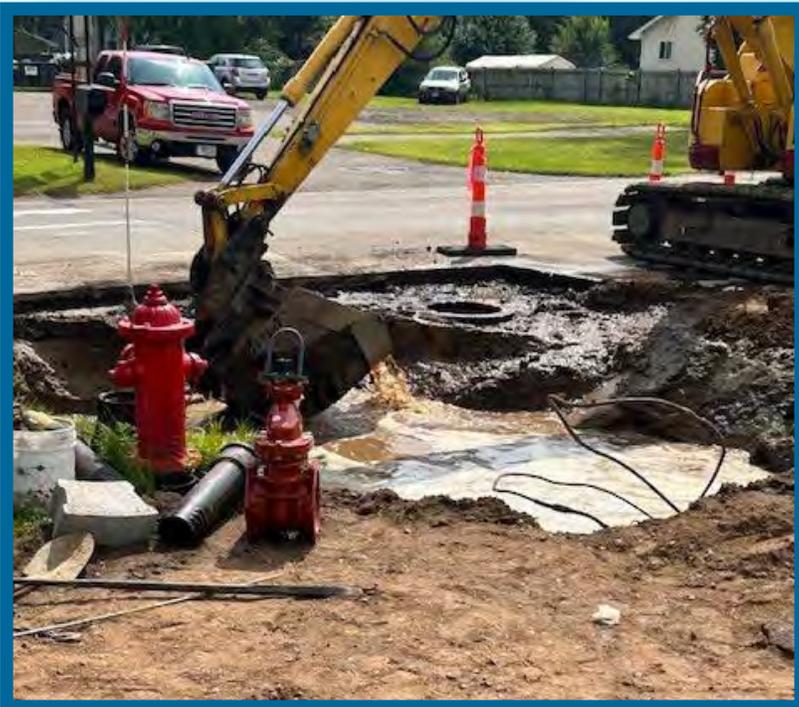
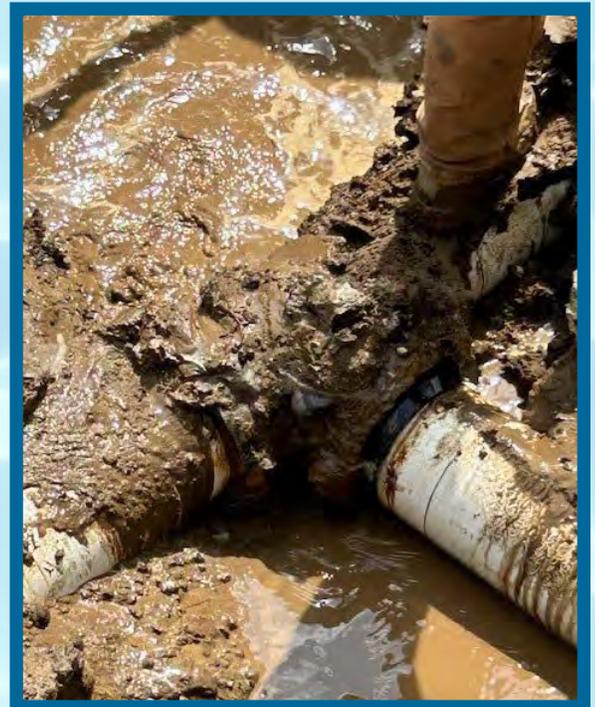
Not everything goes as planned...

The pictures above are from a watermain leak that accrued on the project. The problem was that a "push" on tee joint was used back in 1973, not a "bolted" tee joint. After crew's started to excavate, and the weight of the soil was removed, the pipe pulled apart. In the picture, you can see the black gasket was blown out.

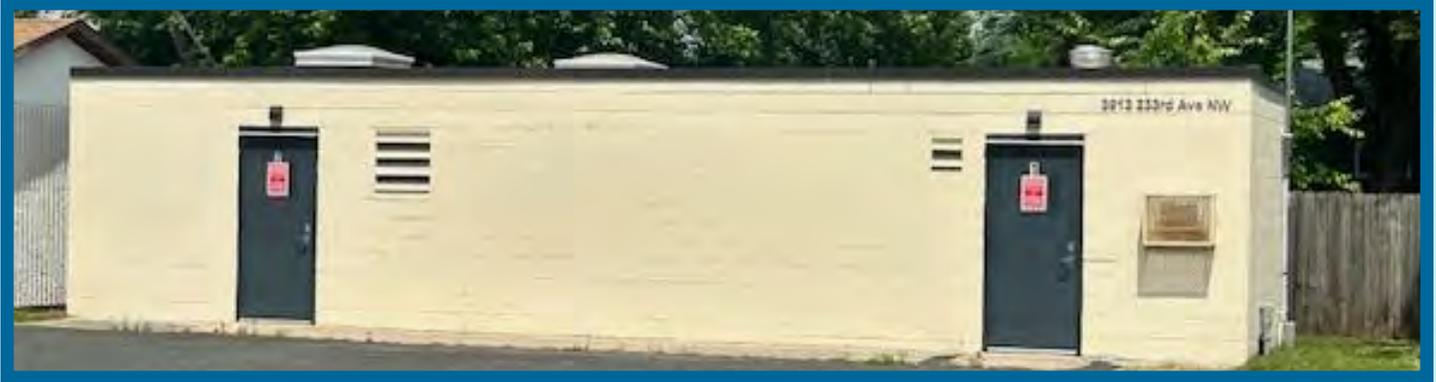
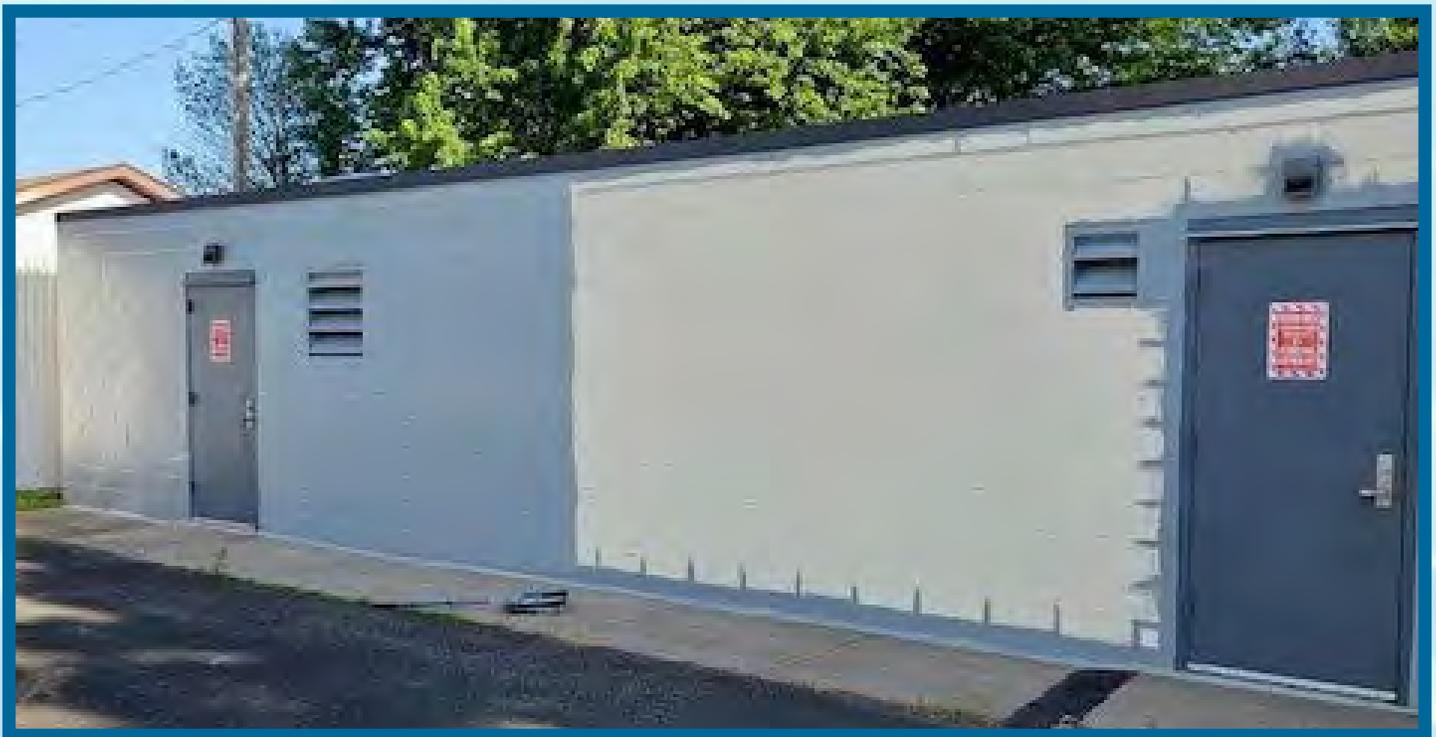
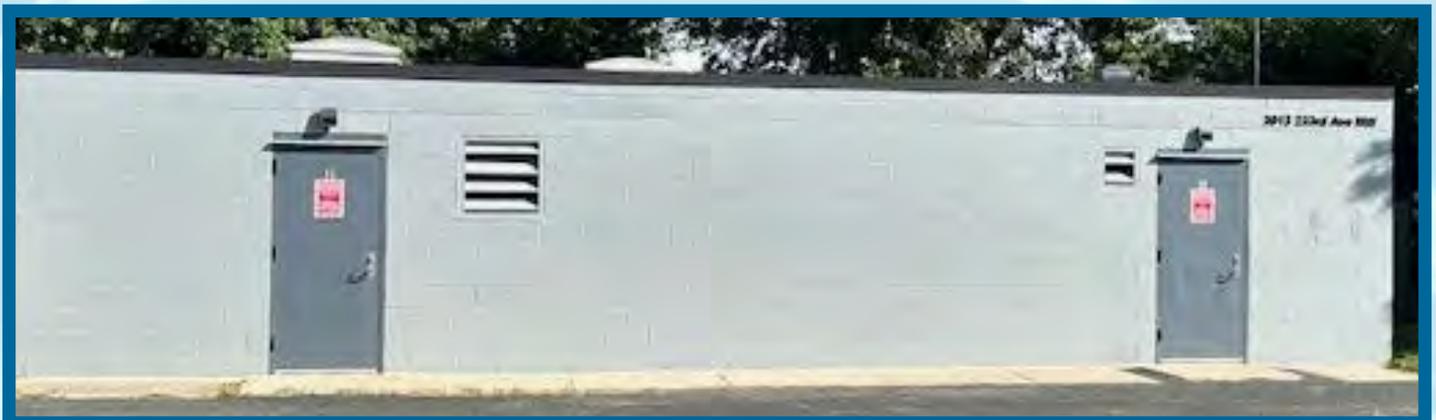
Wellhouse Exterior Refurbish

The exterior paint on the wellhouse was starting to chip, peel and fade.

The pictures do not do it justice! Staff did a great job!

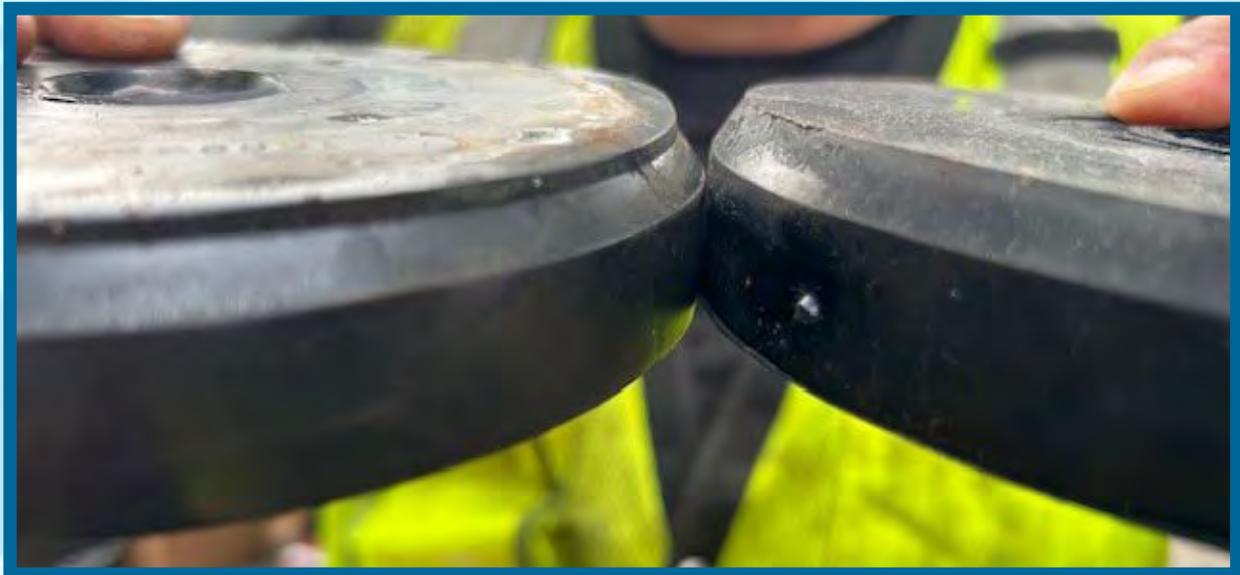
Butterfield Drive Hydrant

This summer, Streets and Parks staff discovered running water that was in a storm drain, which normally that's a good thing. The problem was that we hadn't received any rain in two weeks. We called a leak detection company to assist in finding the source of water and they discovered a hydrant seal that was leaking about 150 feet away. The original seal had a deformity that was allowing water to leak.

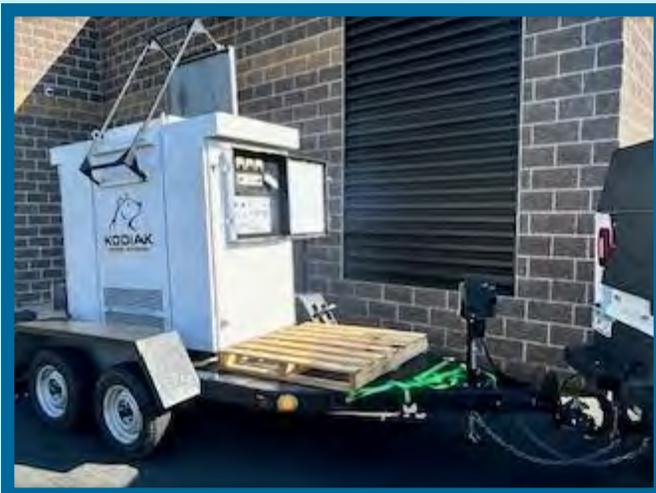
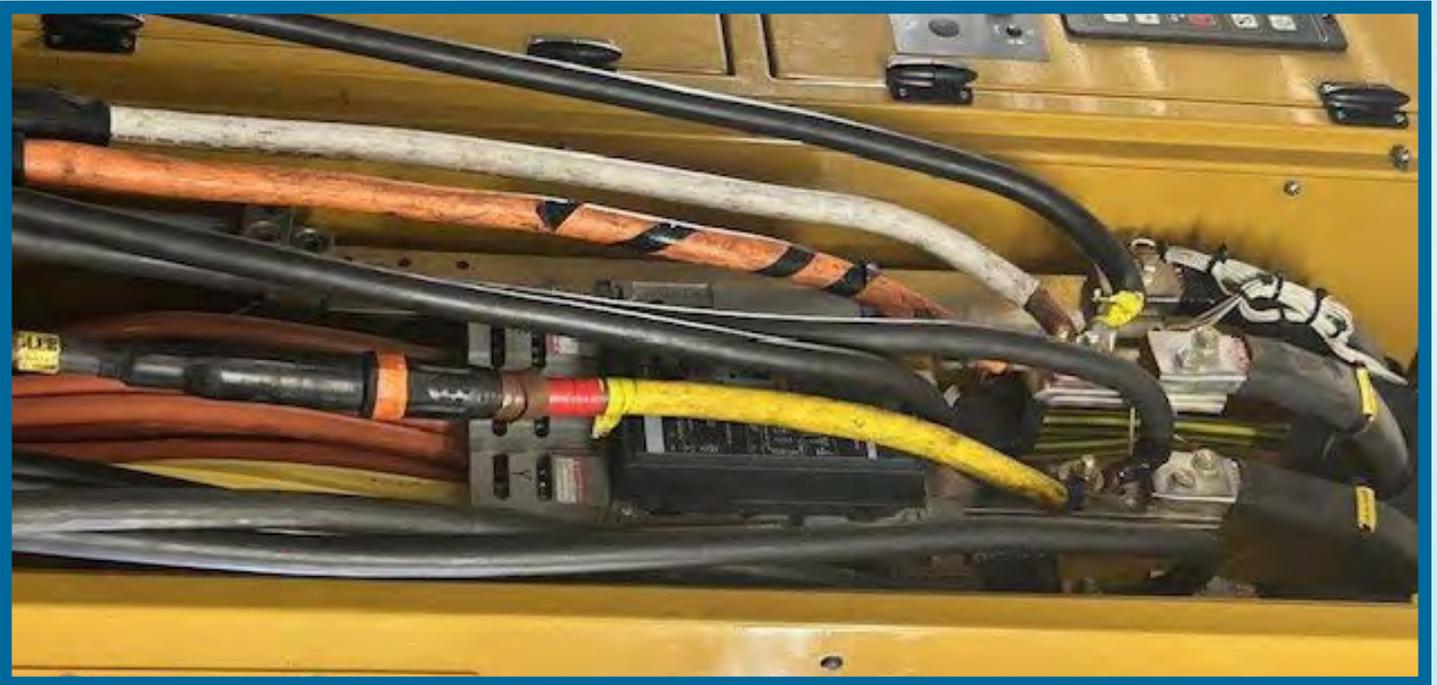
Generator Load Bank Testing

The city has nine generators that supply emergency power. When they are operating, they do not operate at full load which can cause problems with the diesel generators called “wet staking” or insufficient burn of diesel fuel.

Every three years or so, we have a company bring a load bank trailer or “big toaster” to max load the generators. The load bank trailer is wired directly to the generator, and it operates at full load amps for two hours.

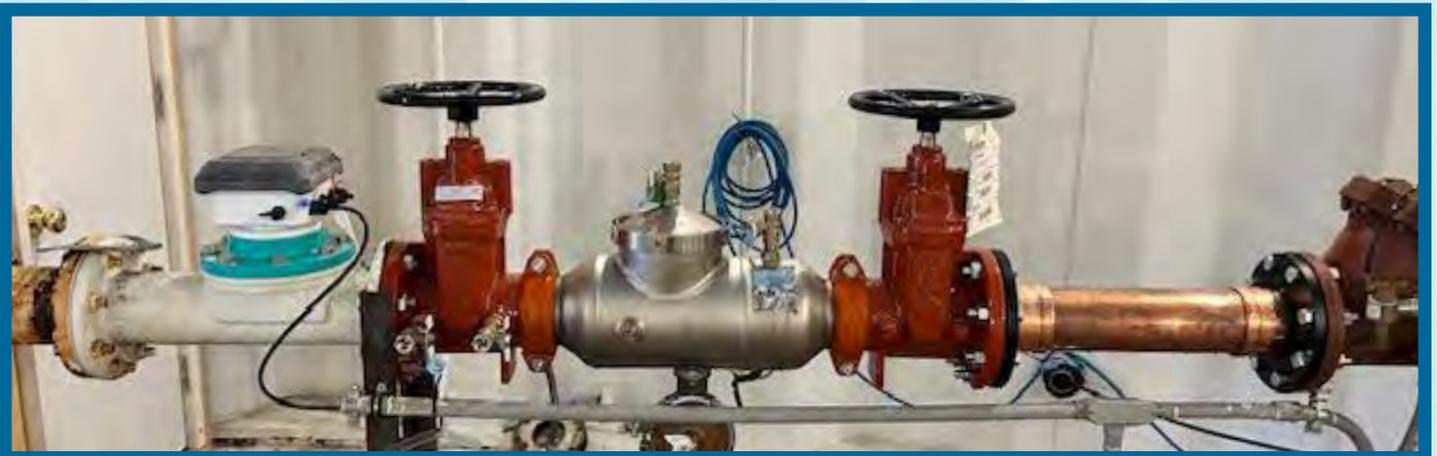
Water Tower Fill Line Back Flow Preventer

In April, our backflow preventer failed testing that is used with the fill station. This picture above is the new valves and preventer. RPZ and backflow preventers are required to be tested each year.

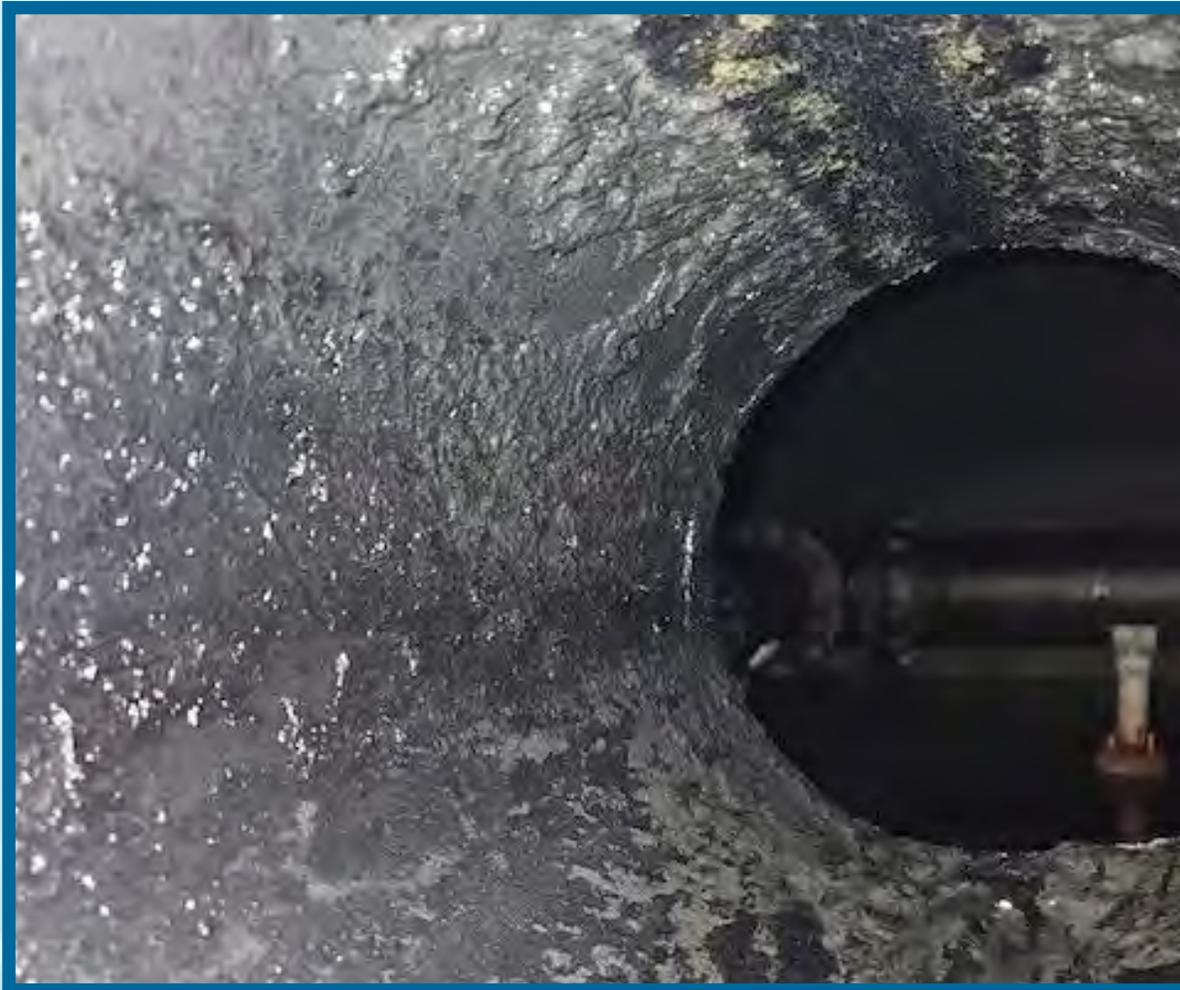
Earlier this fall, the flow meter failed at the Ambassador Lift Station and no flow was recorded. The style of meter that is in use is a mag meter. It uses two anodes to sense flow as water passes by. After discussion with the meter supplier, they mentioned that sometimes, the anodes can become dirty and do not sense flow. Staff removed the meter from the pipe and discovered that it was caked in wastewater debris.

This is the meter before cleaning the inside of the meter.

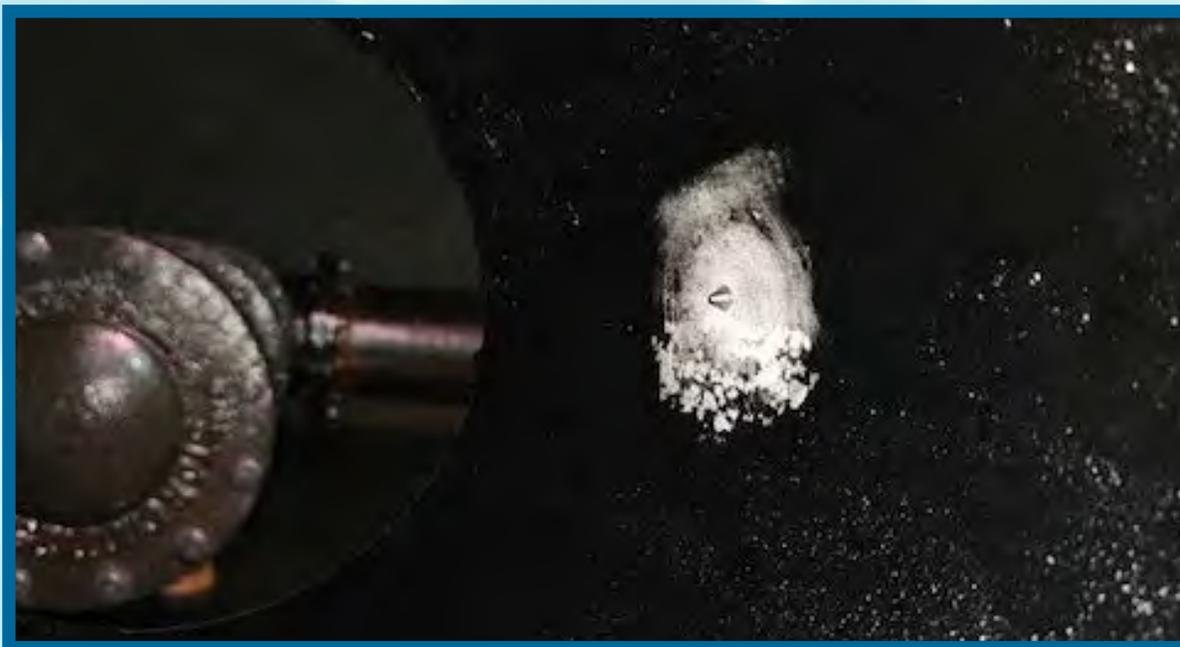
This is the meter after cleaning. Notice the anode? After the work was complete, the meter works like new.

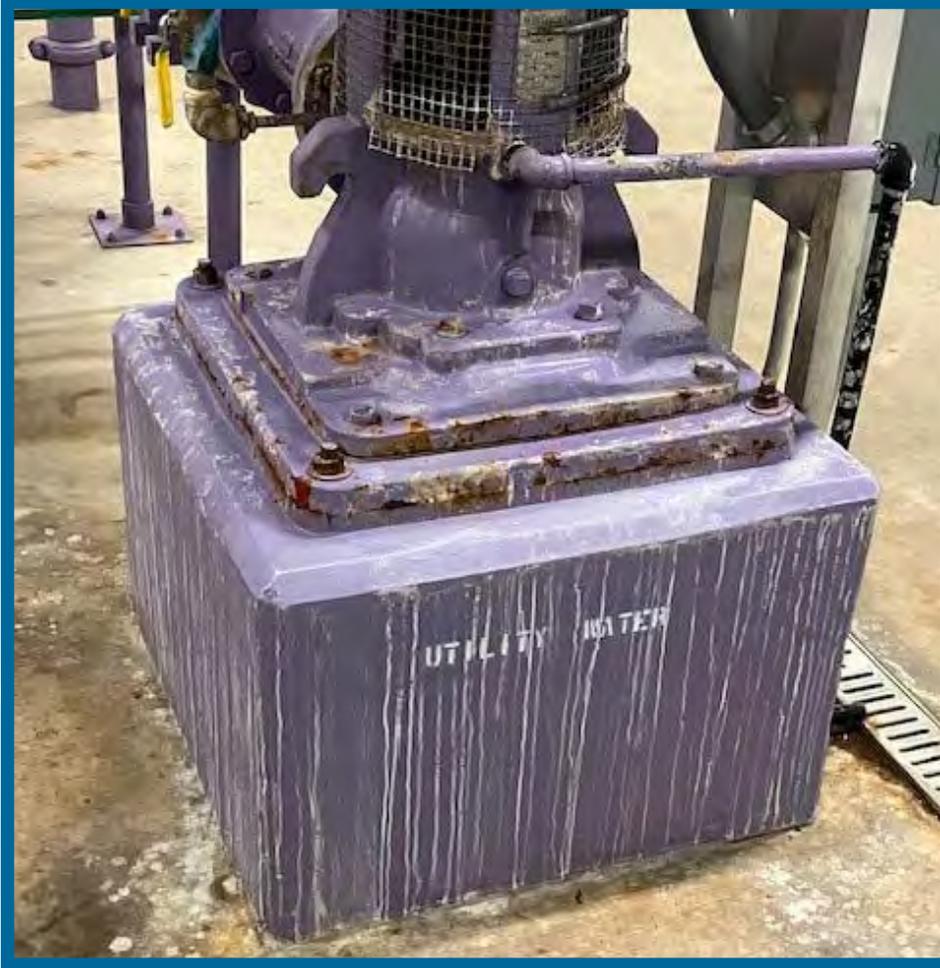
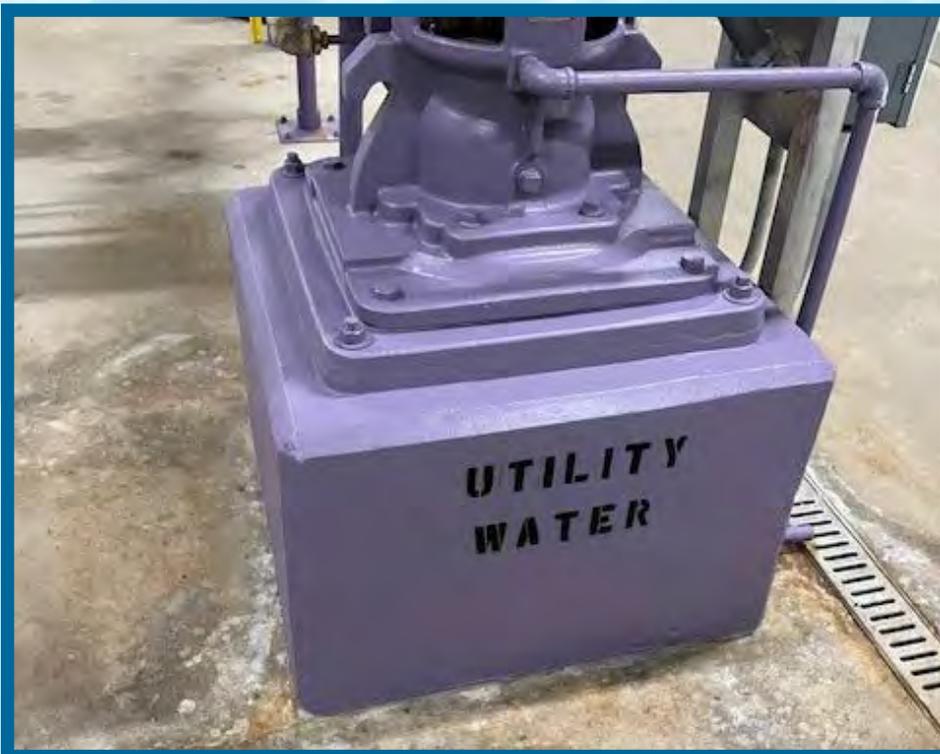
Sometimes, a good painting job makes a world of difference! This is a pump base and pump for one of our reuse pumps.

And the after...
Brand new!

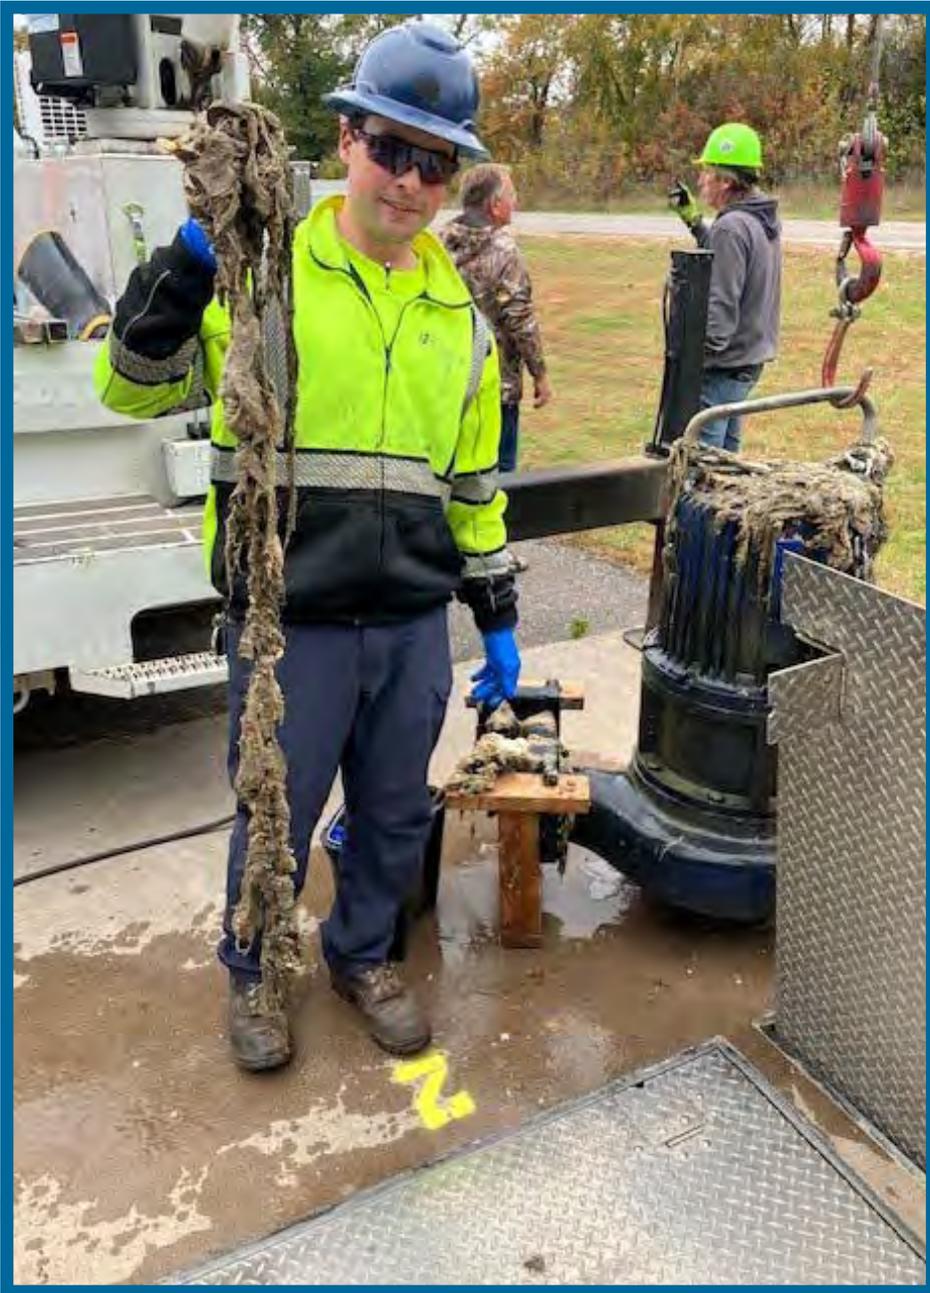
I think it will flush?...

This picture is an accumulation of non-flushable rags and waste bands that Plugged one of the Rivers Edge Lift Station pumps. This can create over current and other operational issues up to and including pump failure.
