### Public Works Quarterly Report November 2023

Water and Wastewater 3rd Quarter Report

### **Streets and Parks 3rd Quarter Report**

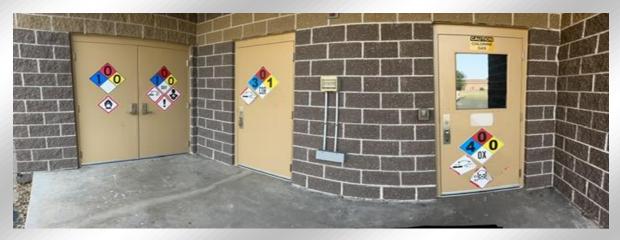
Before

Staff completed some well-needed aesthetic maintenance at the Water Treatment Facility. The doors in the picture below are for the chemical rooms (treatment aids). They were starting to look unsightly. The paint was starting to peel and the decals were starting to fade and peel from the door. The decals are required and make emergency personal aware of the potential hazard and chemicals in each room.

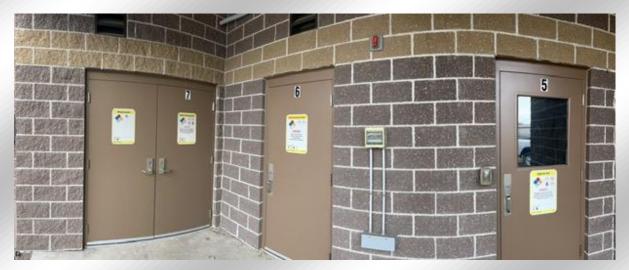
After

Staff did a really nice job! They also took care of some other Aesthetic issues that turned out great!

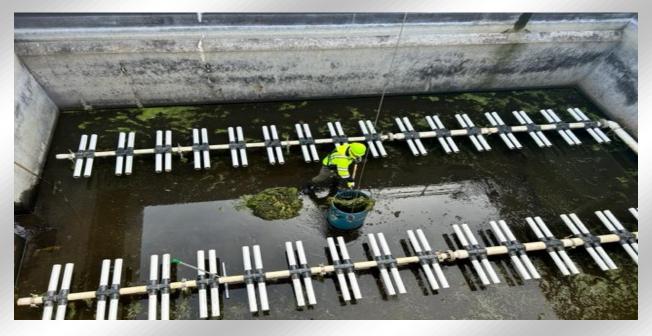
Due to the continuous usage and the environment they are in in, replacement of the rubber membranes is recommended at intervals of 5-6 years. There are 64 diffusers in this basin 1a and 64 in the basin 1b that were changed out this fall. Next year, the remaining 256 membranes will be replaced during tank alternation and cleaning. With staff doing this work on the three basins, and not the manufacturer, it is roughly a \$36,400 savings!

This is what the membranes look before installation. Essentially, they are perforated rubber that diffuses the air

supply allowing for a uniform treatment.

The picture to the right is the diffusers with the membranes installed and diffusers without.

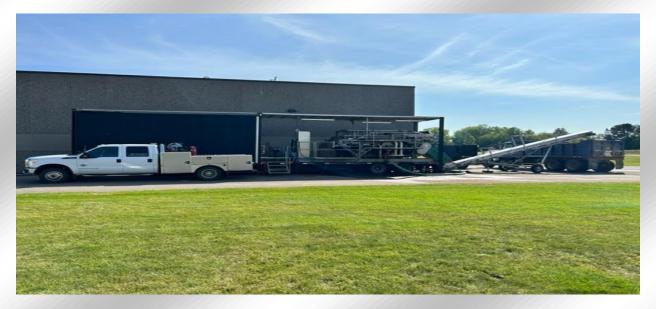
Fergus power pump processed about 900,000 gallons of liquid to produce about 300 tons of dry solids. The solids are pressed for a couple reasons, but the biggest reason is transportation. If a tanker transported the liquid for land application, it would take about 140 truckloads. By pressing the liquid to a solid, it only takes about 20 dump truck loads and costs a lot less.

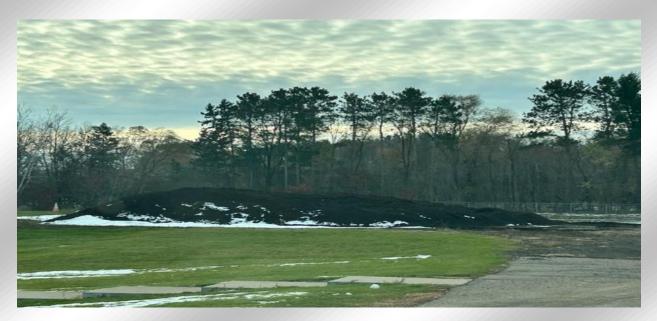
The picture above is the pressed bio solids. Either this fall or next spring, the solids will be hauled away and land applied.

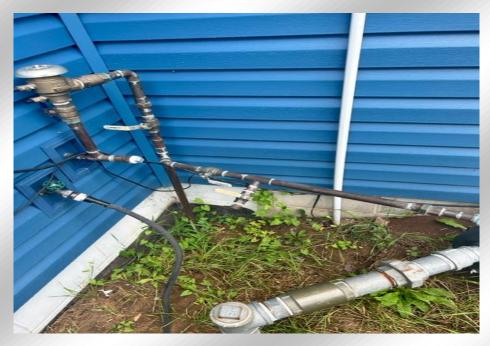
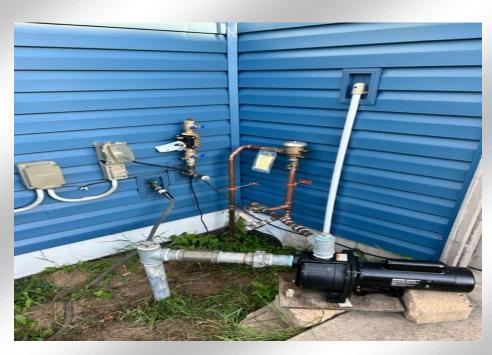
Thank you to our Building Offical for finding this cross conection. The picture below is a driven well, that has a pump used for irrigation. The supply line from that pump is connected to the potable water line coming from the house. Even with the backflow device and valves, this is not allowed and is a potential contamination source to our potable water supply. If the valves were left on, and the backflow device failed, back-siphonage or backflow could occur.

After contacting the homeowner, the necessary repair was made to correct the issue.

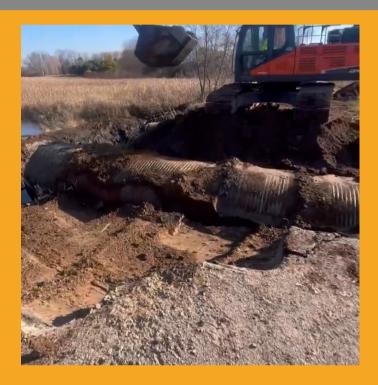
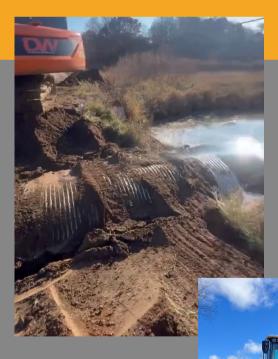
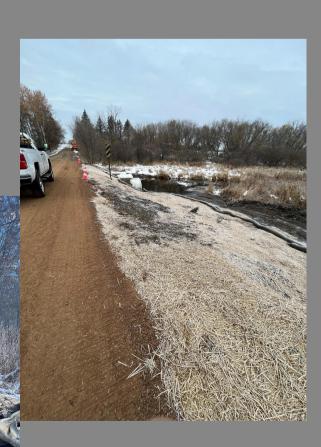
This past summer, the City of St. Francis and Stanford Township signed a shared road agreement. This allows the two entities to work on projects together. The first order of business was to tackle a much overdue project of three rotting culverts in the Seeyle Brook. These culverts over the years have slowly deteriorated causing failure of the road.

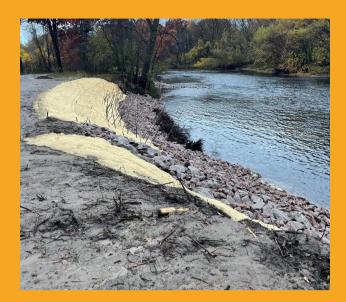
For a few years now the Rum River has been slowly eroding away the bank on portions of the Dellwood Trail. During a Storm water collaboration meeting it was brought to our attention that the Anoka County Conservation District (ACD) was looking for potential projects along the Rum River. In 2020, the ACD met with the city out on site, and it was determined that the site met all the qualifications. In 2022, the city partnered with the Anoka Conservation District to come up with a solution to stabilize the eroding bank along the Dellwood Trail. 85 percent of the cost of this project was grant funded and the city paid for the other 15 percent.

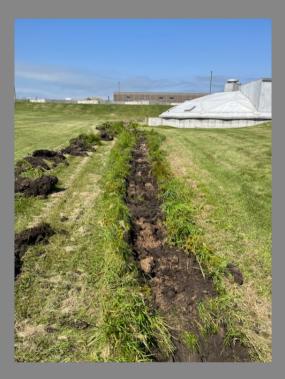
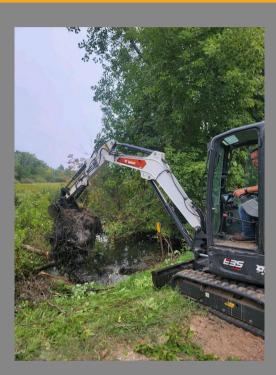
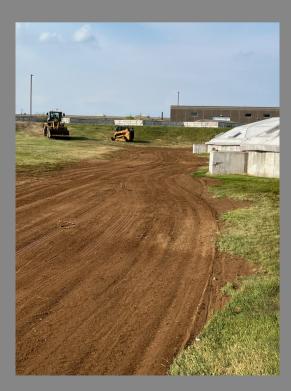
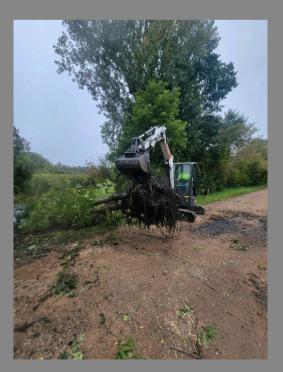
Photos to the left are a drain tile project at the waste water plant to improve drainage and make it easier for mowing. The photos to the left are culverts being dugout. These culverts were plugged with debris and trees.

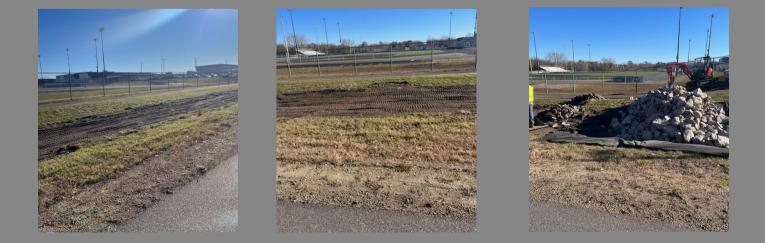
Rum River Boulevard Swale Stabilization Project

Staff worked with the St. Francis Area Schools, the Anoka Conservation District, and Anoka County to correct the long-standing storm water erosion problem on Rum River Blvd in the ditch next to the high school football field.
