City of St. Helens St. Helens Police Station City Council Update | 04.02.2025

Columbia West is pleased to submit this geotechnical report for the proposed City of St. Helens Public Safety Building in St. Helens, Oregon. The approximately 50,000-squre-foot site is located at 1771 Columbia Boulevard. The site is shown relative to surrounding physical features on Figure 1. Figure 2 shows the existing conditions of the site. Abbreviations and acronyms used herein are defined immediately following the Table of Contents.

CITY OF ST. HELENS PUBLIC SAFETY BUILDING ST. HELENS, OREGON

2003 BORING PLAN CITY OF ST. HELENS PUBLIC SAFETY BUILDING ST. HELENS, OREGON

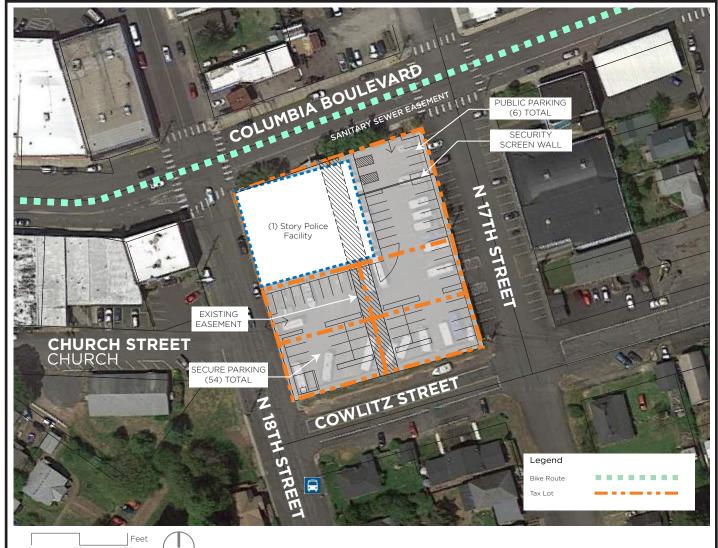
- CITY PLANNING STAFF RECOMMEND A ZONE CHANGE (FOR THE SOUTHERN 3/4 CURRENTLY ZONED AS GC) TO HBD ZONE SINCE IT PERMITS PUBLIC SAFETY AND SUPPORT FACILITIES OUTRIGHT
- ASSUMING ZONE CHANGE IS APPROVED, PROJECT WOULD REQUIRE SITE DEVELOPMENT REVIEW APPROVAL BY PLANNING DIRECTOR PRIOR TO BUILDING PERMITSW

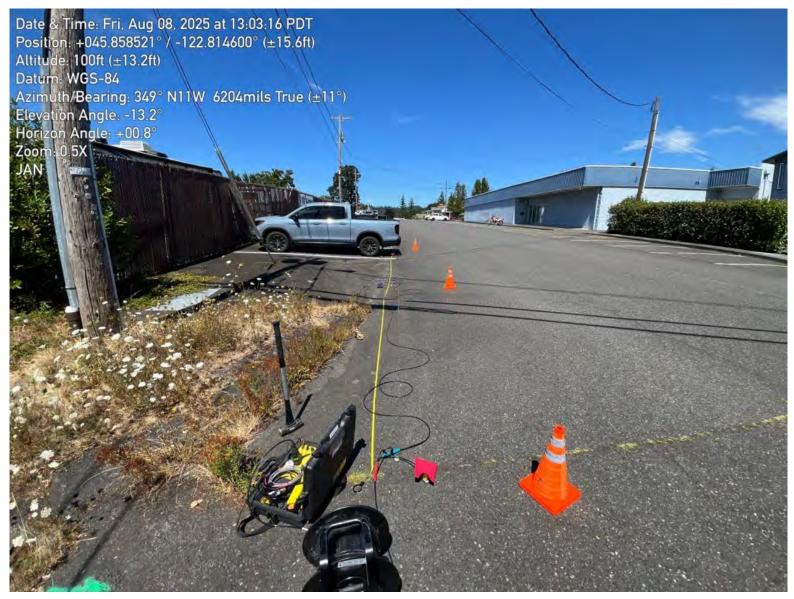
FIGURE C-1

# **REMI ARRAY LOCATION (LOOKING NORTH)**

In addition to the borings, one ReMi array (A-1) was completed to measure the shear wave velocity of the subsurface soil at the site to support the site-specific seismic hazard evaluation. ReMi array A-1 was completed at the location shown on Figure 2. The shear wave velocity test results are presented in Appendix C.

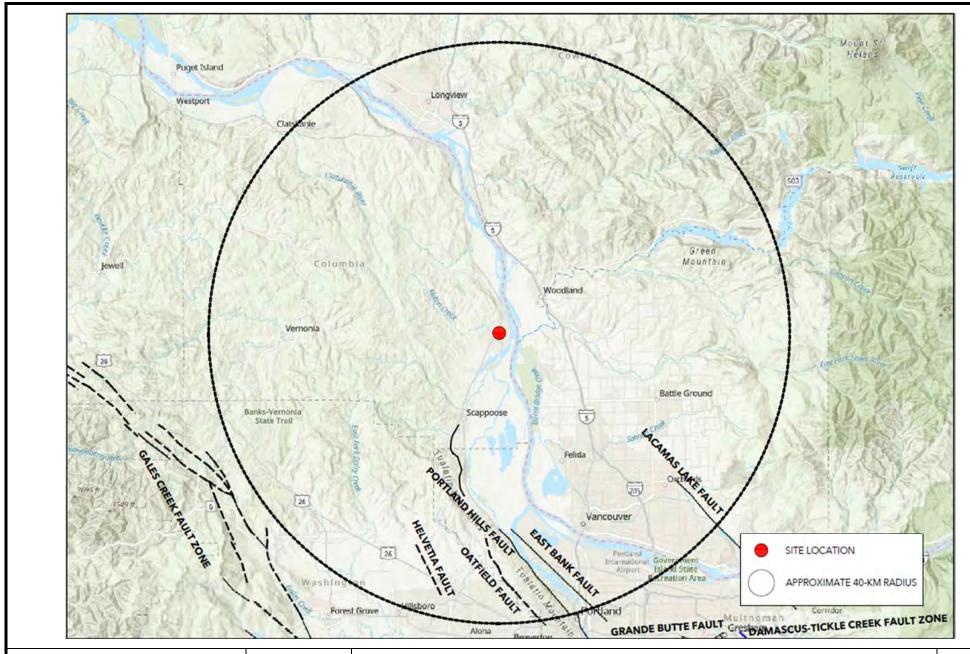
FIGURE D-1

QUATERNARY FAULT MAP
CITY OF ST. HELENS PUBLIC SAFETY BUILDING
ST. HELENS, OREGON

A discussion of other geologic hazards that could affect the site are discussed in the Site-Specific Seismic Hazard Evaluation presented in Appendix D.

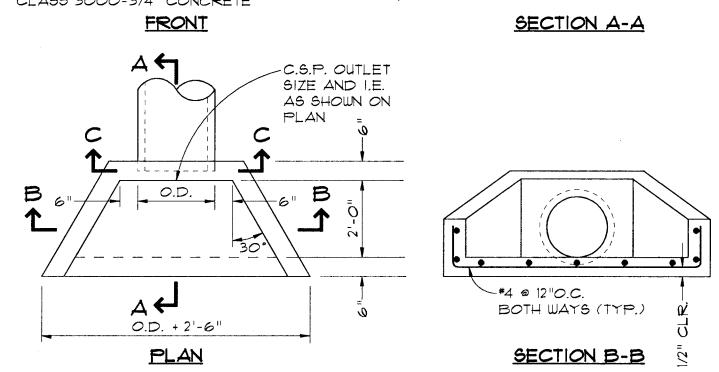
SECTION C-C

# OUTLET STRUCTURE DETAIL

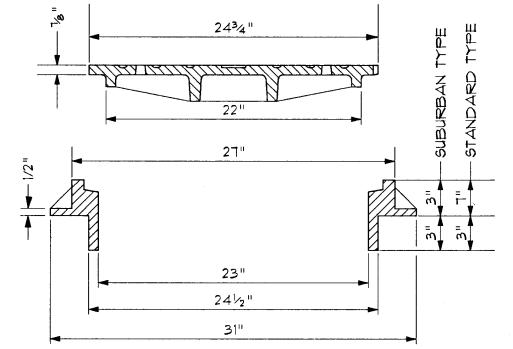
## STANDARD MANHOLE FRAME & COVER

- 1. HEAVY DUTY MANHOLE FRAMES AND COVERS ARE TO BE USED ON ALL MANHOLES UNLESS OTHERWISE APPROVED BY U.S.A.
- 2. SOLID LIDS MAY BE REQUIRED IN CERTAIN CASES. 3. COVER AND FRAME TO BE MACHINED TO A TRUE BEARING ALL AROUND
- 4. USE 16 HOLE LID FOR STORM SEWER 5. USE SUBURBAN TYPE IN NON-TRAFFIC AREAS ONLY

CONTRACTOR SHALL CONFORM TO U.S.A. DWG. NO. 120

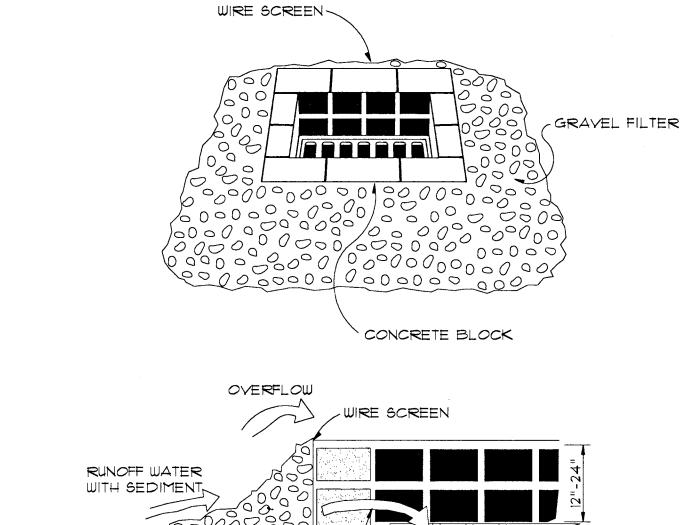
BLOCK & GRAVEL INLET BARRIER

FILTERED WATER

DROP INLET

WITH GRATE

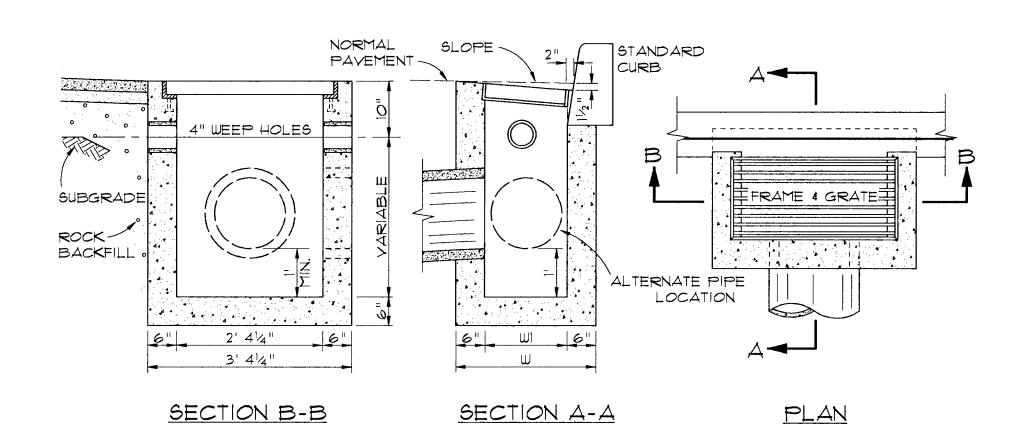
A MAXIMUM DEVIATION FROM PLAN DIMENSIONS OF ONE INCH, AT THE INLET FLOOR, SHALL BE ALLOWED FOR TAPERING OF FORMS USED IN CONSTRUCTION OF CONCRETE INLETS.
