Subject: RE: St Helens Public Safety Building: New Potential Sites - ROW Improvements and other Questions

ONSITE WETLAND DETERMINATION REPORT

WD#: 2020-0041

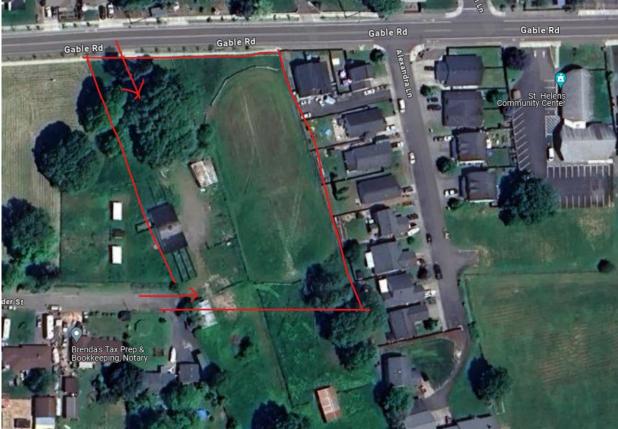
2675 Gable Road (see snapshot below, only interested in the top third of the site):

- 3. Any other zoning considerations for placing a Police Station on this site? There are wetlands on this property based on delineations of adjacent property. But none of these are "significant" to the city, so no buffer or other provisions of Chapter 17.40 SHMC. Just DSL and maybe USACOE. Wetland study is wise. I attached the wetland info for an adjacent property on the west side; this property is shaped like an ax, with the "blade" portion abutting and facing the subject property along the Gable Road side. I have no record of DSL concurrence; that property remains undeveloped.

But note the wetland in the ditch of Alder Street.
