# North 8<sup>th</sup> Street Planned Development

## SENSITIVE LANDS NARRATIVE

## **Attachment A: Schott and Associates Environmental Assessment**

Re: Environmental assessment for the proposed project site located at North 8<sup>th</sup> Street, St. Helens, OR

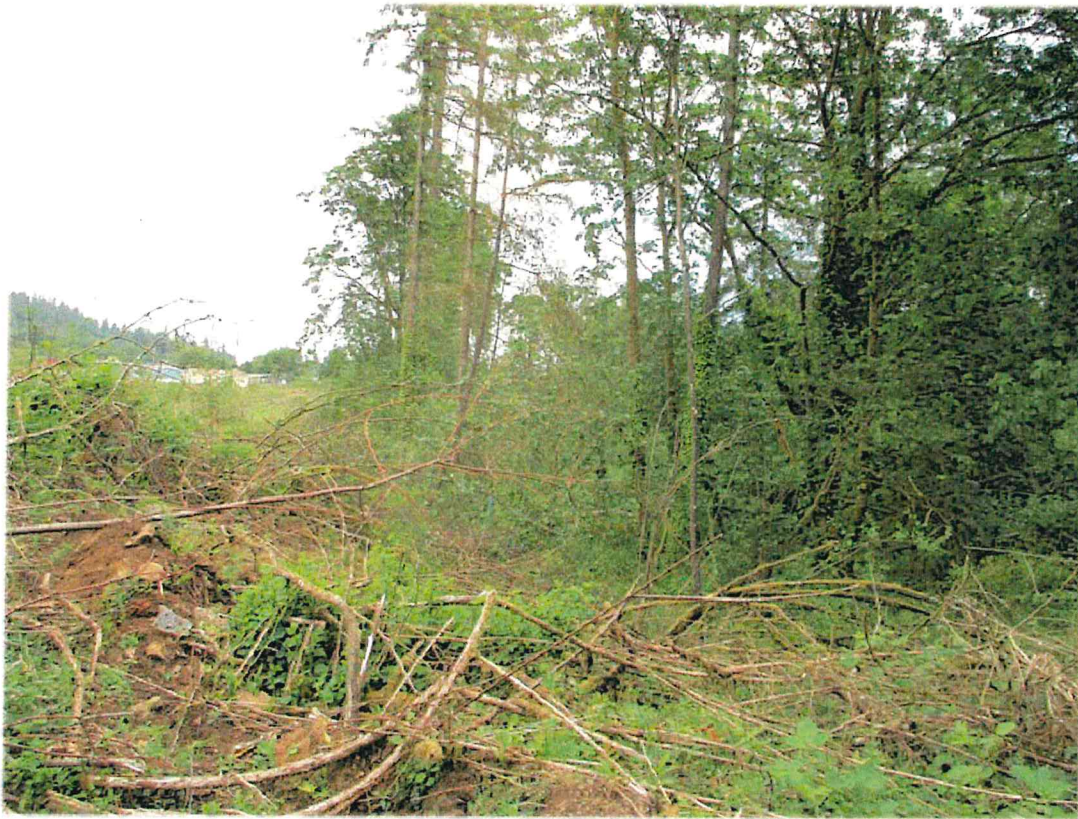
Photo Point 1. From boundary of the southwest portion of the protection zone of Pond 1 looking northeast at encroachment area.

Minor encroachments from site logging were noted along the southwest margin of the protection zone of Pond 1, including the removal of a cluster of five trees (one double-stemmed), defined by Chapter 17.132 of the SHMC as woody species 6" or greater in dbh, along with some shrub removal. Trees over 6" in dbh that were removed are listed in Table 1 below. Figure 2 shows the tree removal locations and Appendix A, photo point 1 shows the encroachment area.

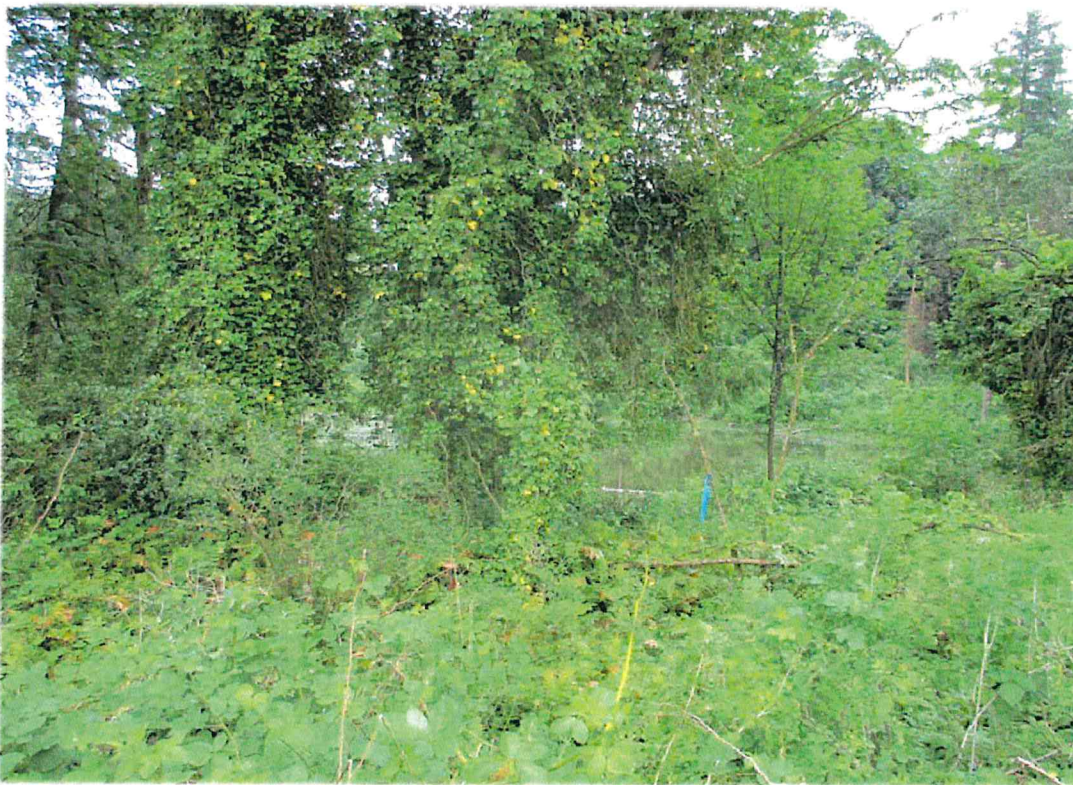
Photo Point 1. From boundary of the southwest portion of the protection zone of Pond 1 looking southeast at mixed coniferous-deciduous forest of intact protection zone.

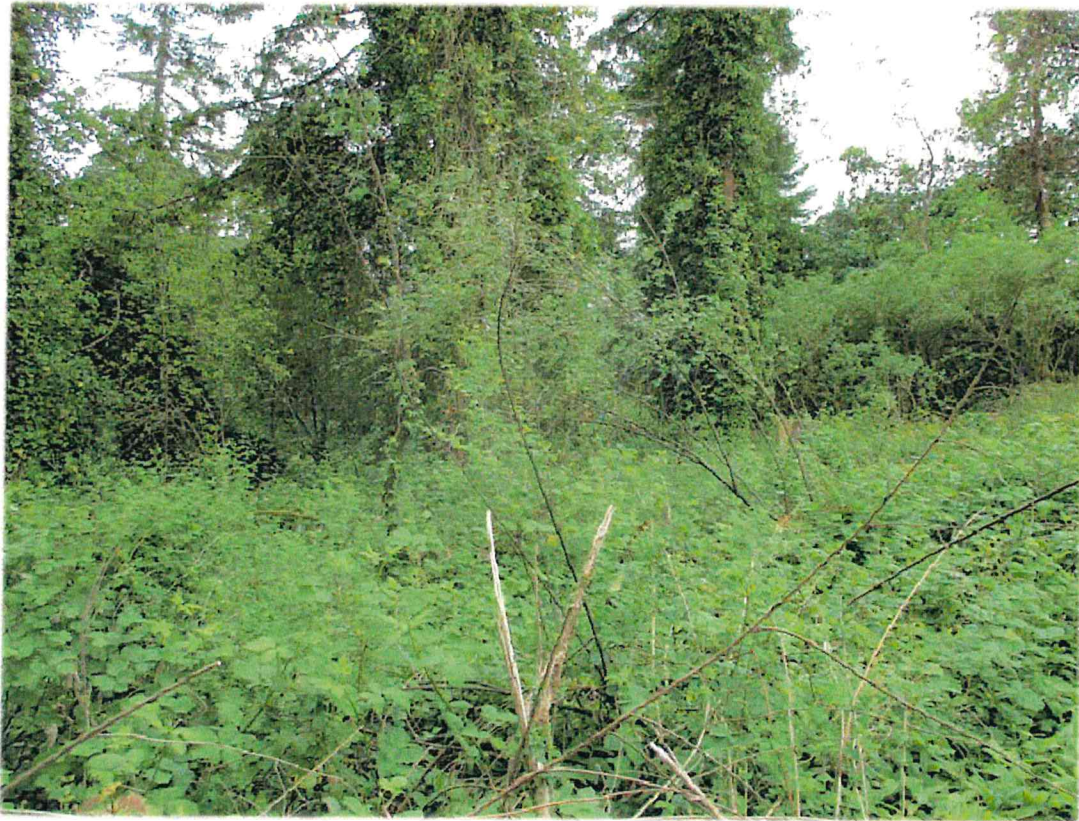
Photo Point 1. From boundary of the southwest portion of the protection zone of Pond 1 looking south at mixed coniferous-deciduous forest of intact protection zone.

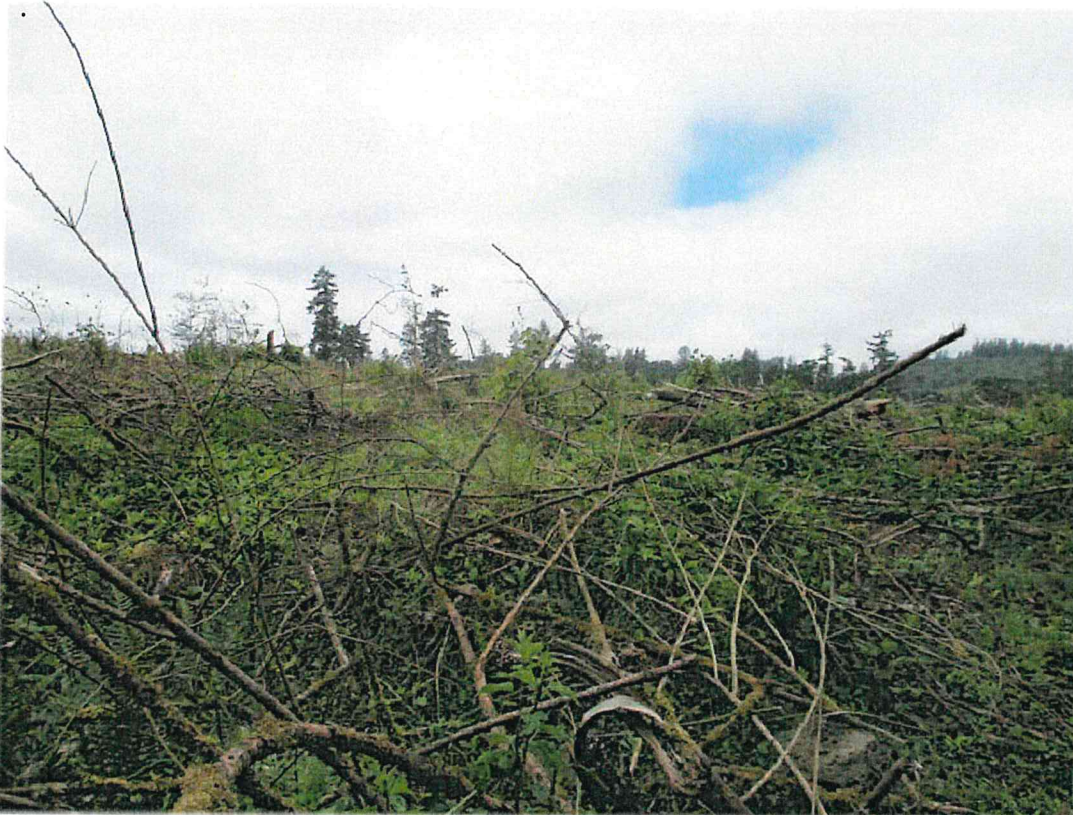
Photo Point 1. From boundary of the southwest portion of the protection zone of Pond 1 looking northwest at logged area beyond protection zone.

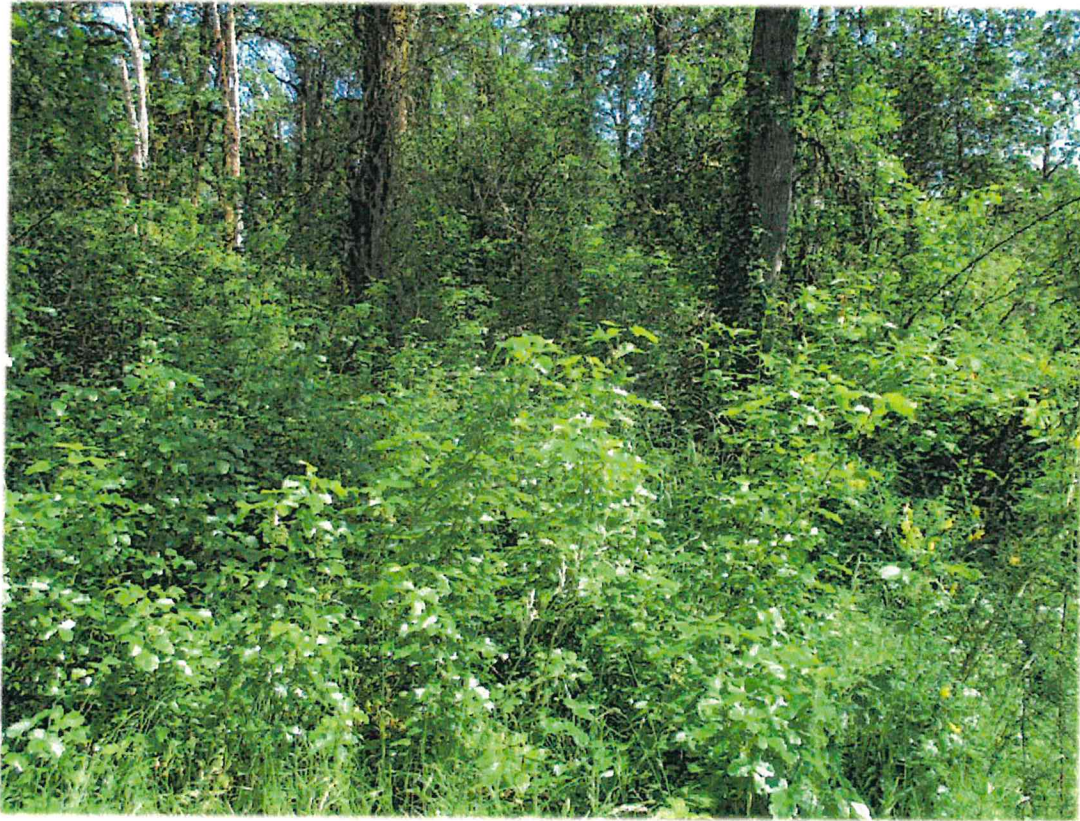
Photo Point 2. From boundary of the west-central portion of the protection zone of Pond 1 looking northeast at mixed coniferous-deciduous forest of intact protection zone.

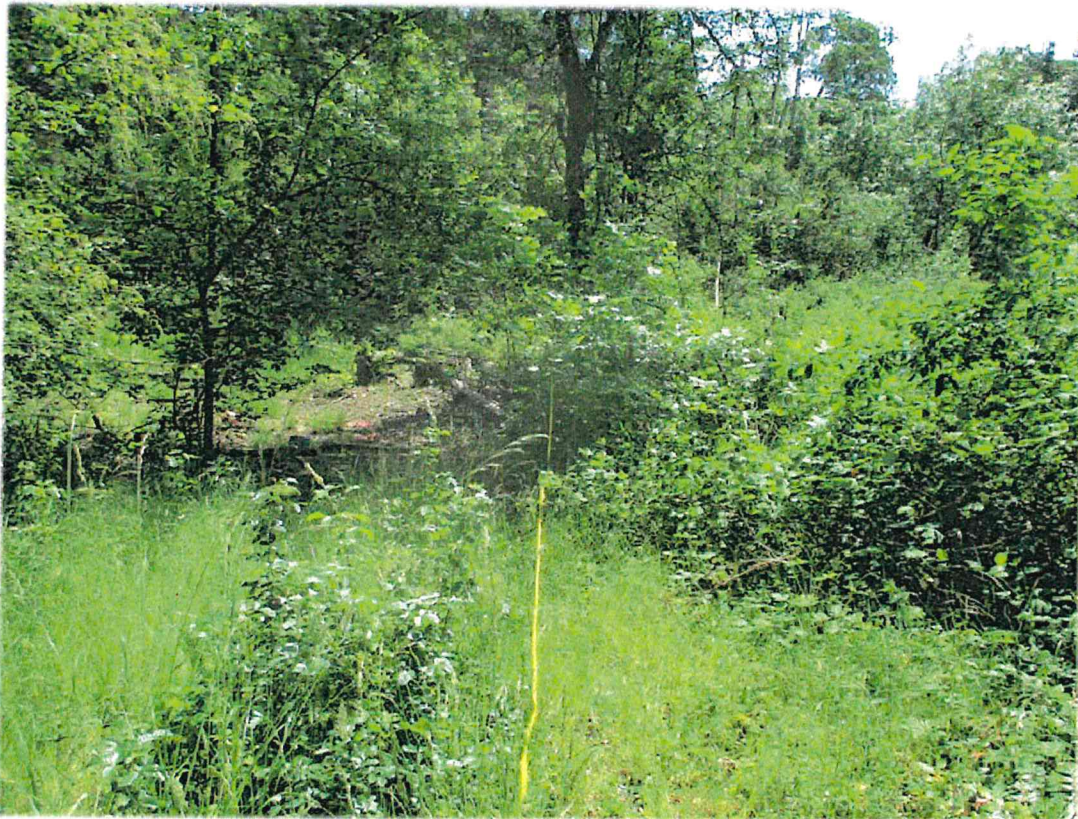
Photo Point 2. From boundary of the west-central portion of the protection zone of Pond 1 looking southeast at mixed coniferous-deciduous forest of intact protection zone.

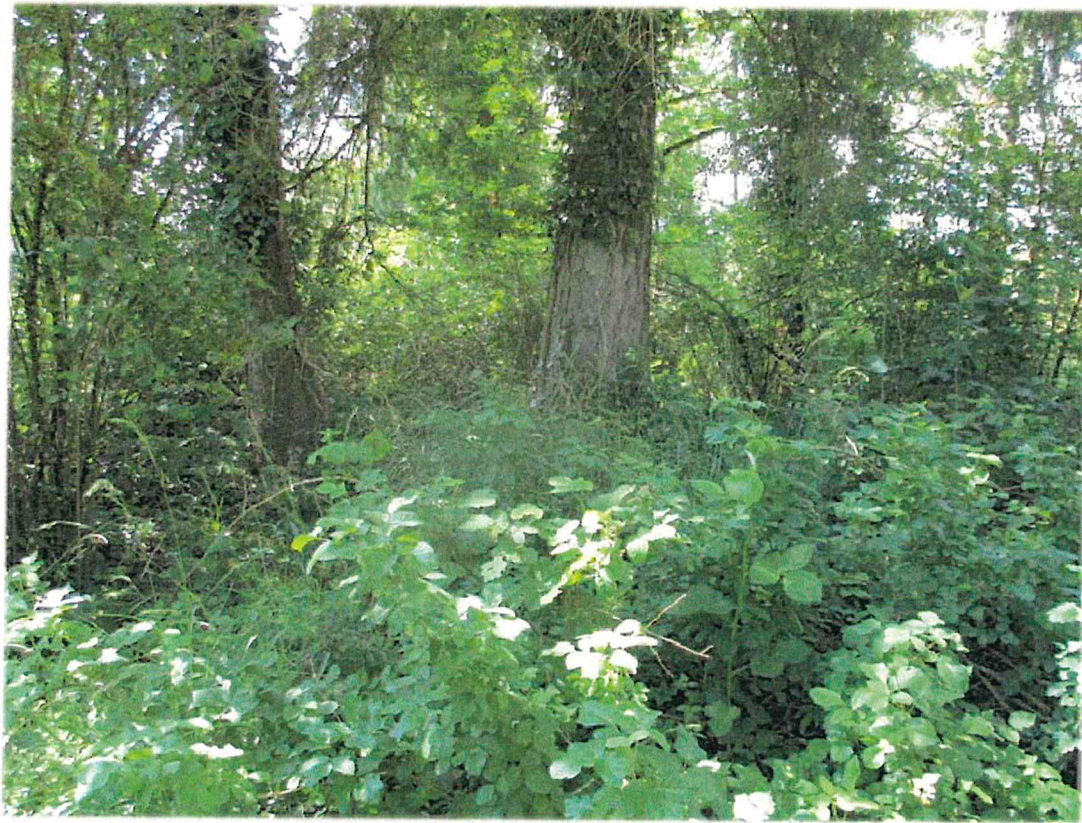
Photo Point 2. From boundary of the west-central portion of the protection zone of Pond 1 looking south at mixed coniferous-deciduous forest of intact protection zone.

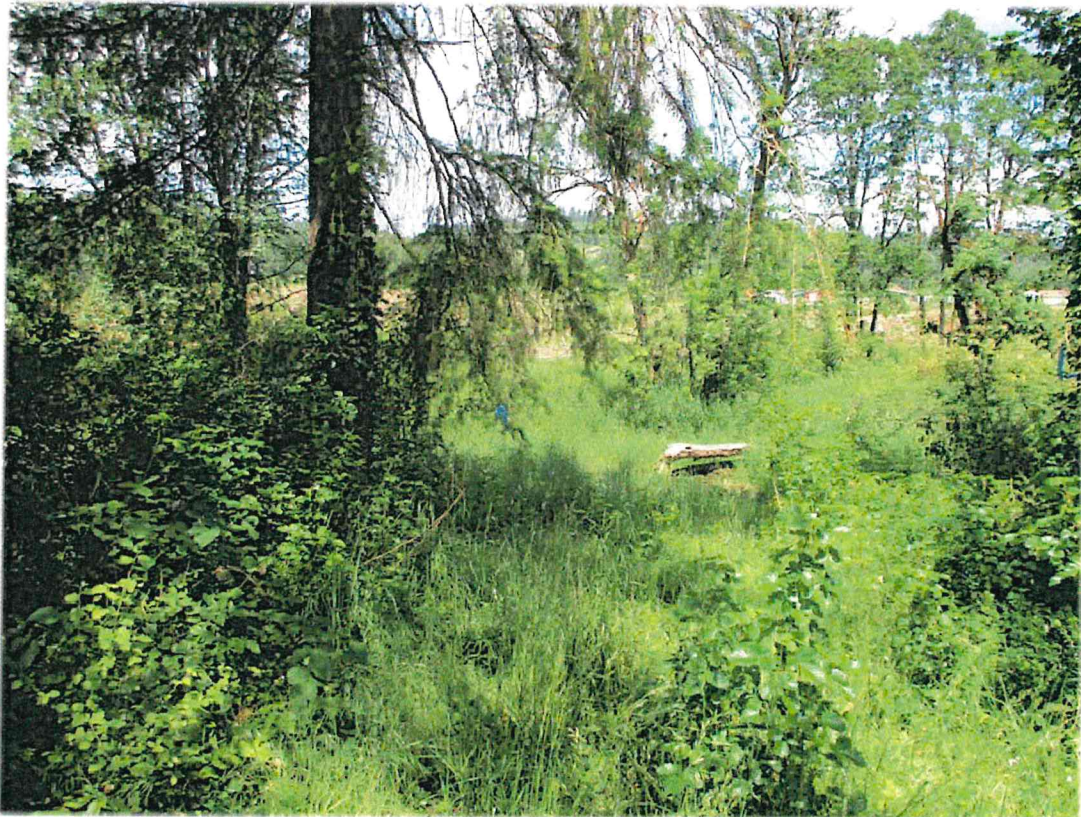
Photo Point 2. From boundary of the west-central portion of the protection zone of Pond 1 looking northwest beyond the protection zone.

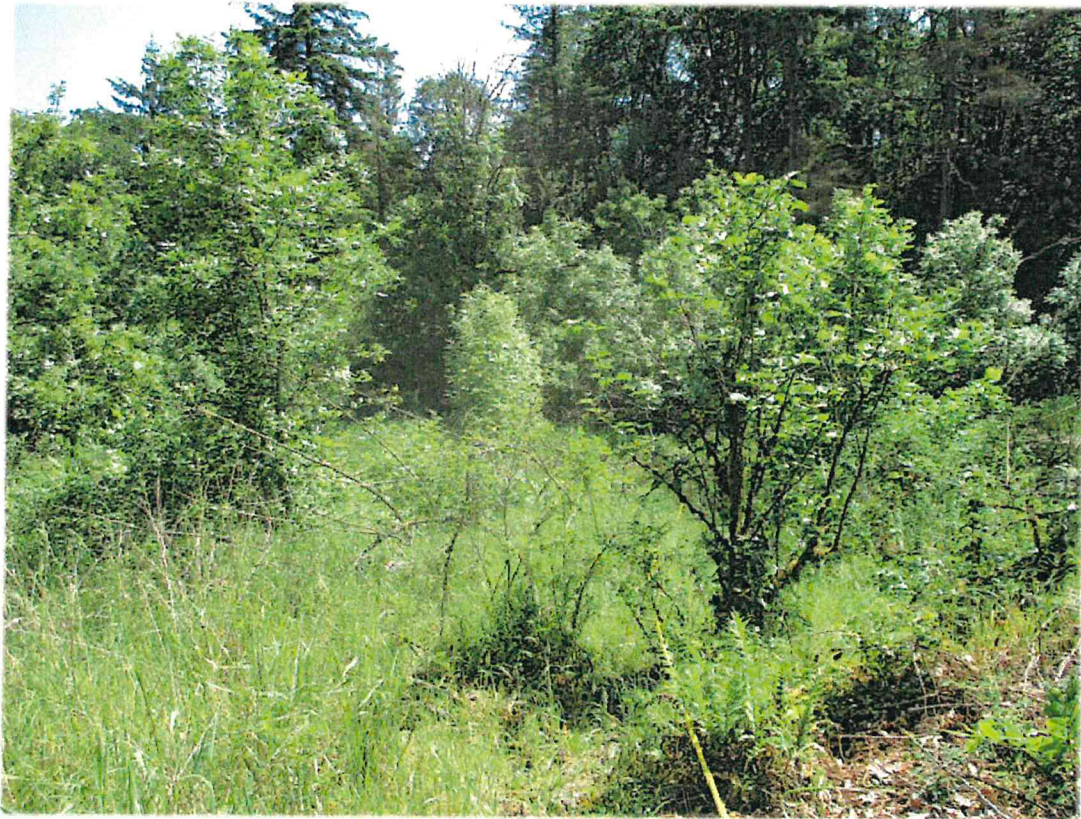
Photo Point 3. From the Oregon oak forest community of the protection zone of Pond 1 looking east.

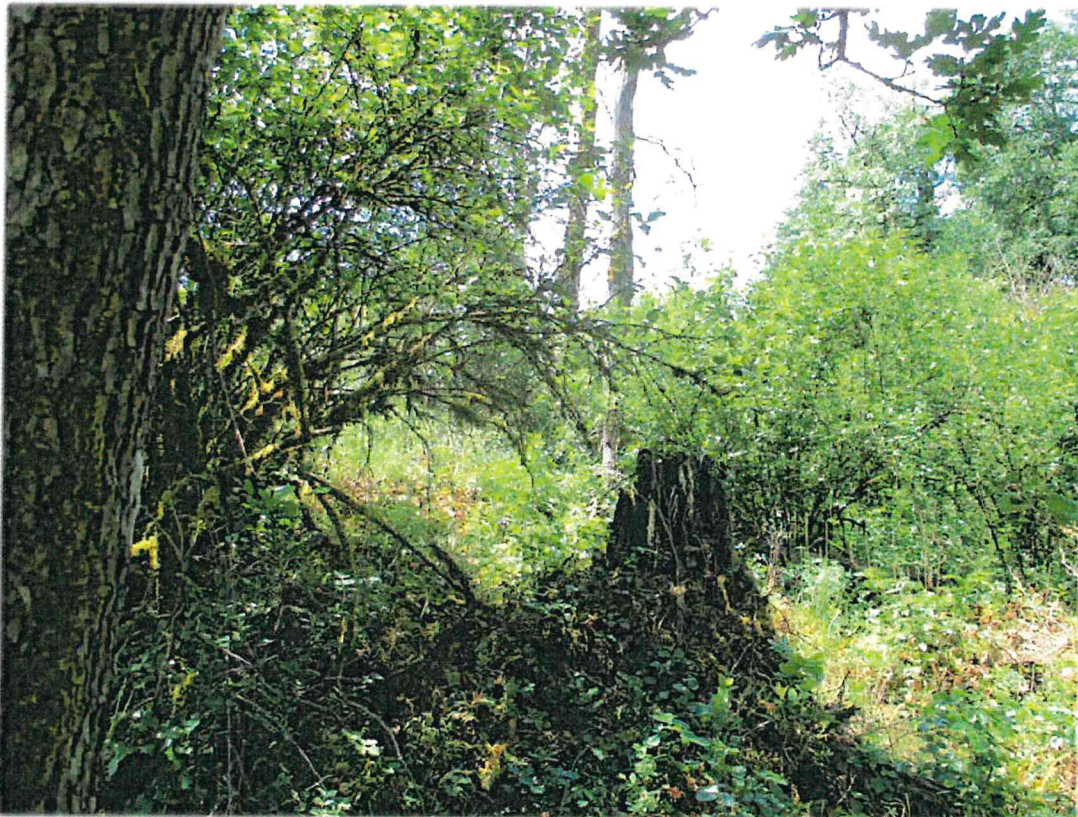
Photo Point 3. From the Oregon oak forest community of the protection zone of Pond 1 looking south

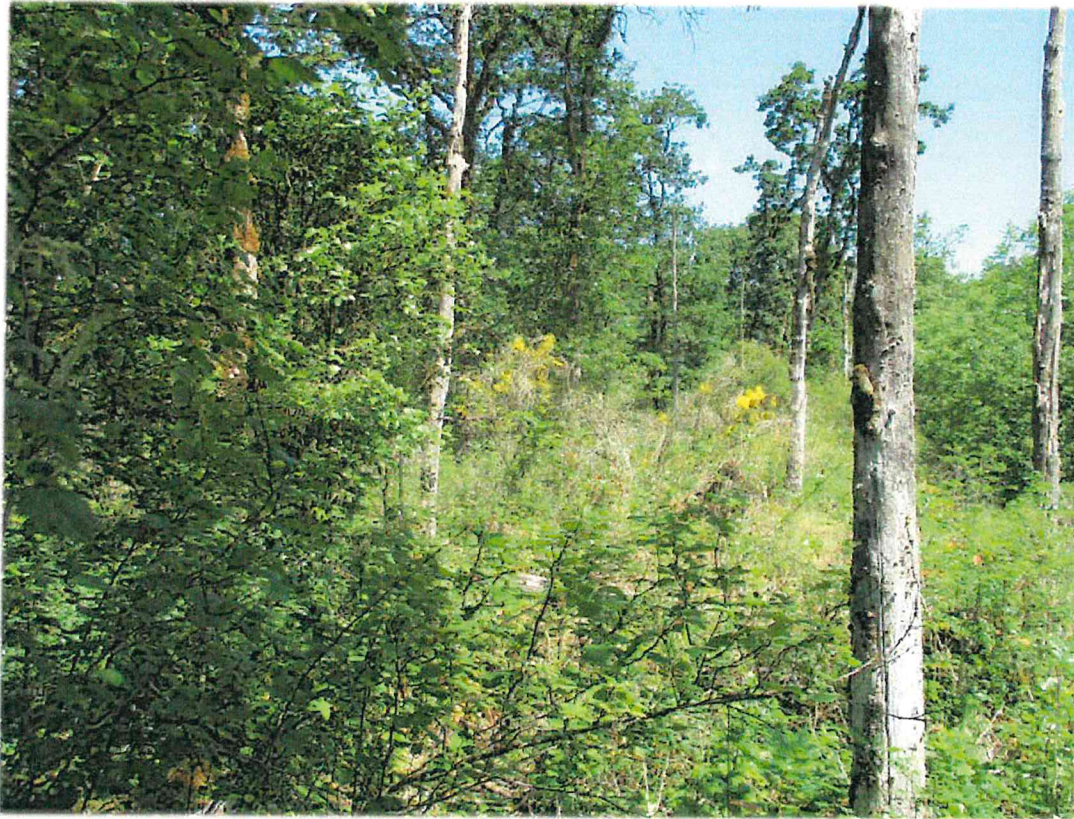
Photo Point 3. From the Oregon oak forest community of the protection zone of Pond 1 looking north.

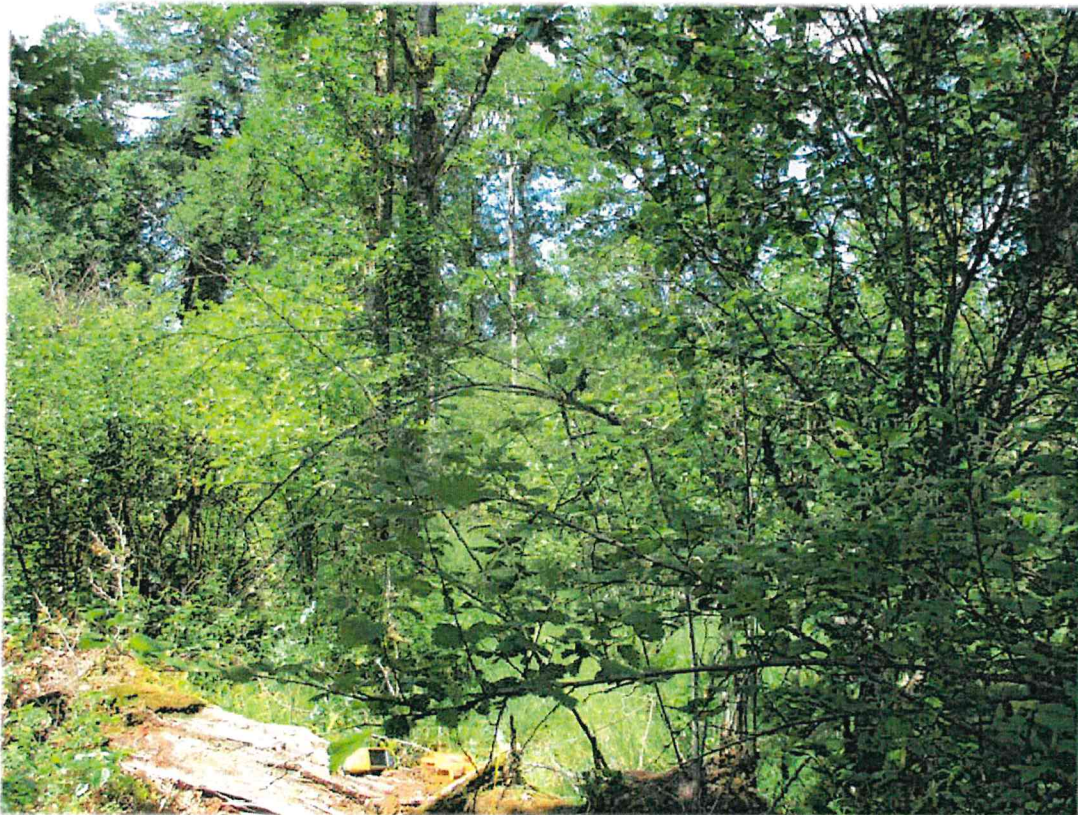
Photo Point 3. From the Oregon oak forest community of the protection zone of Pond 1 looking west

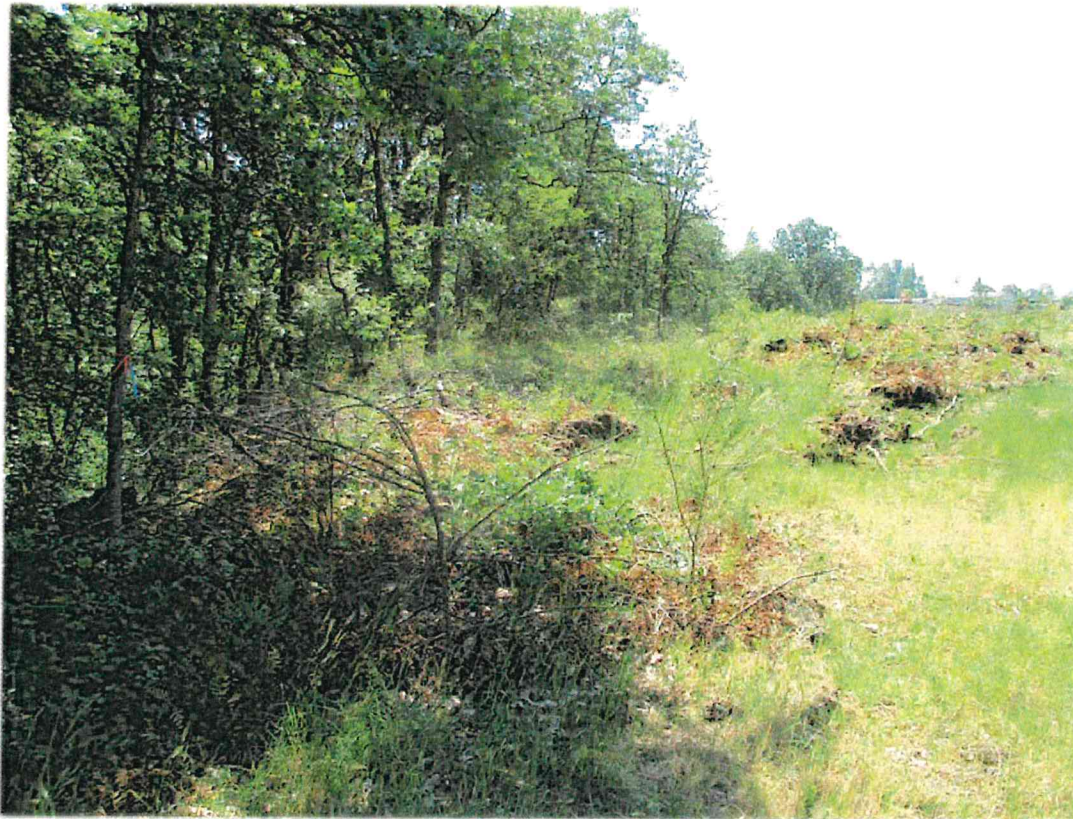
Photo Point 4. From the boundary of the western portion of the protection zone of Wetland 2 looking south along boundary and encroachment area.

Minor encroachments from site logging were noted along the southwest margin of the protection zone of Wetland 2, including the removal of one tree 6" or greater in dbh (listed in Table 1 below) along with some shrub removal. Figure 2 shows the tree removal locations and Appendix A, photo point 4 shows the encroachment area.

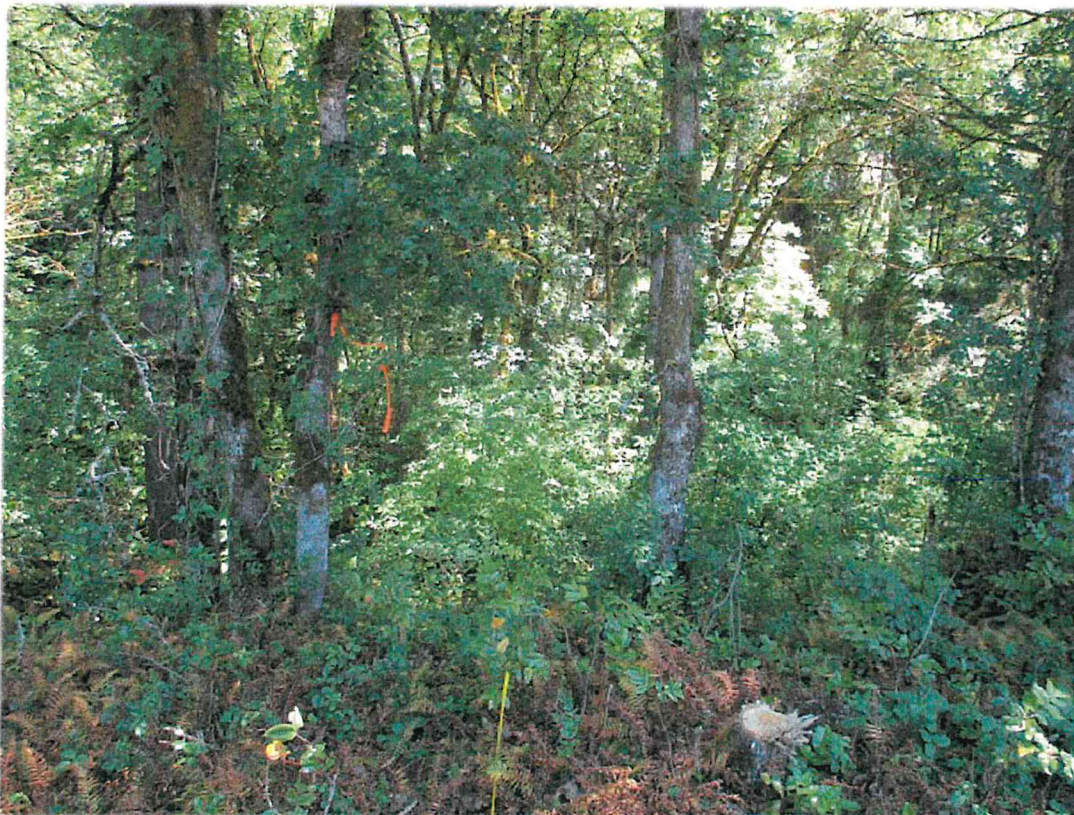
Photo Point 4. From the boundary of the western portion of the protection zone of Wetland 2 looking east at mixed Oregon oak forest of the intact protection zone.

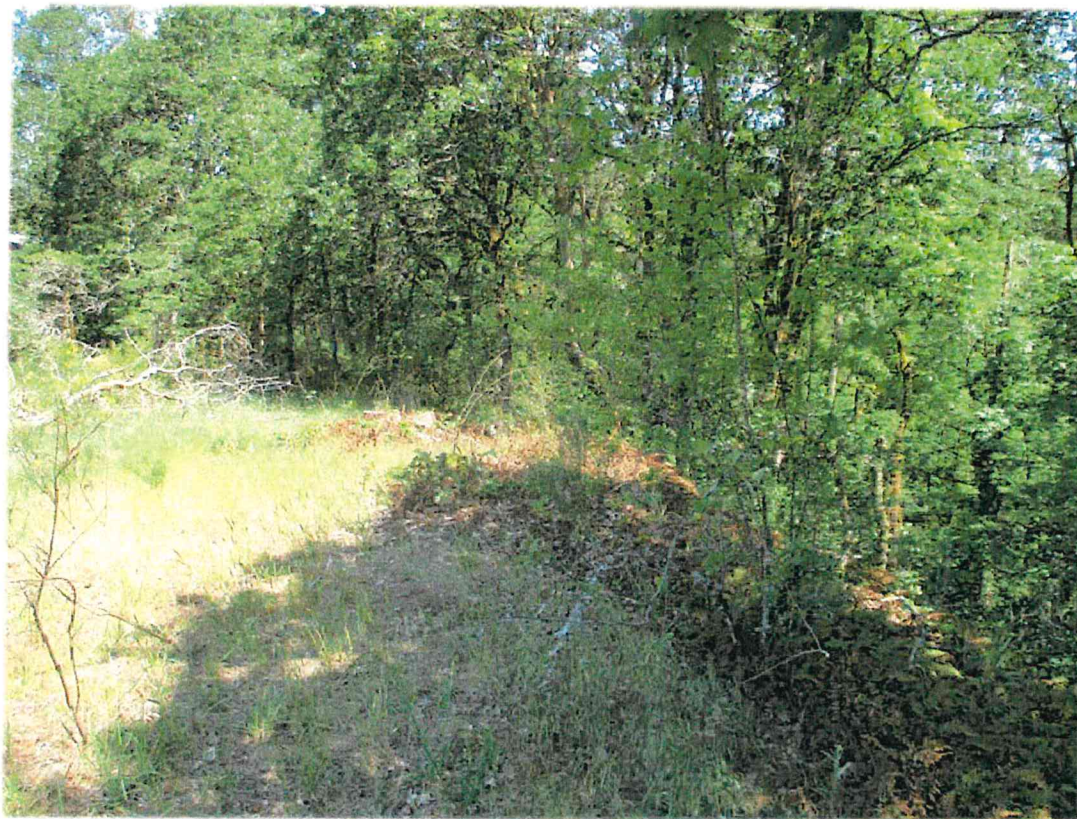
Photo Point 4. From the boundary of the western portion of the protection zone of Wetland 2 looking north along boundary and encroachment area.

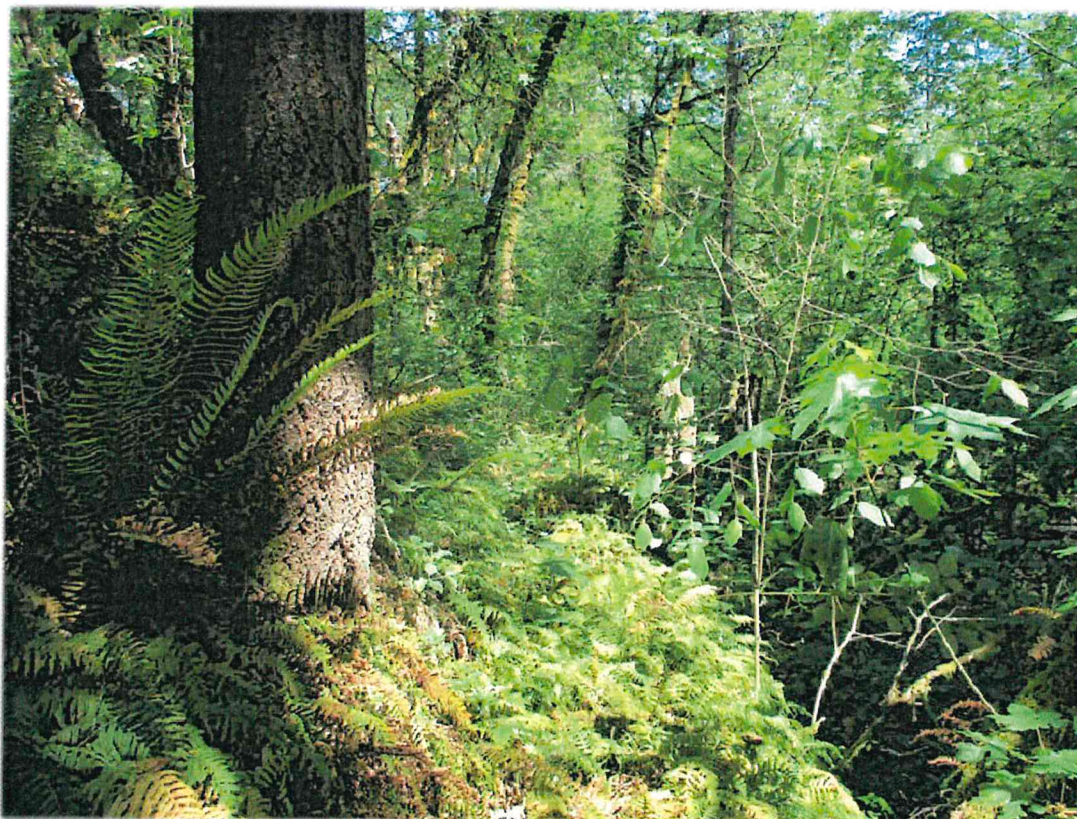
Photo Point 5. From the boundary of the western portion of the protection zone of Wetland 2 looking north at mixed Oregon oak forest of intact protection zone.

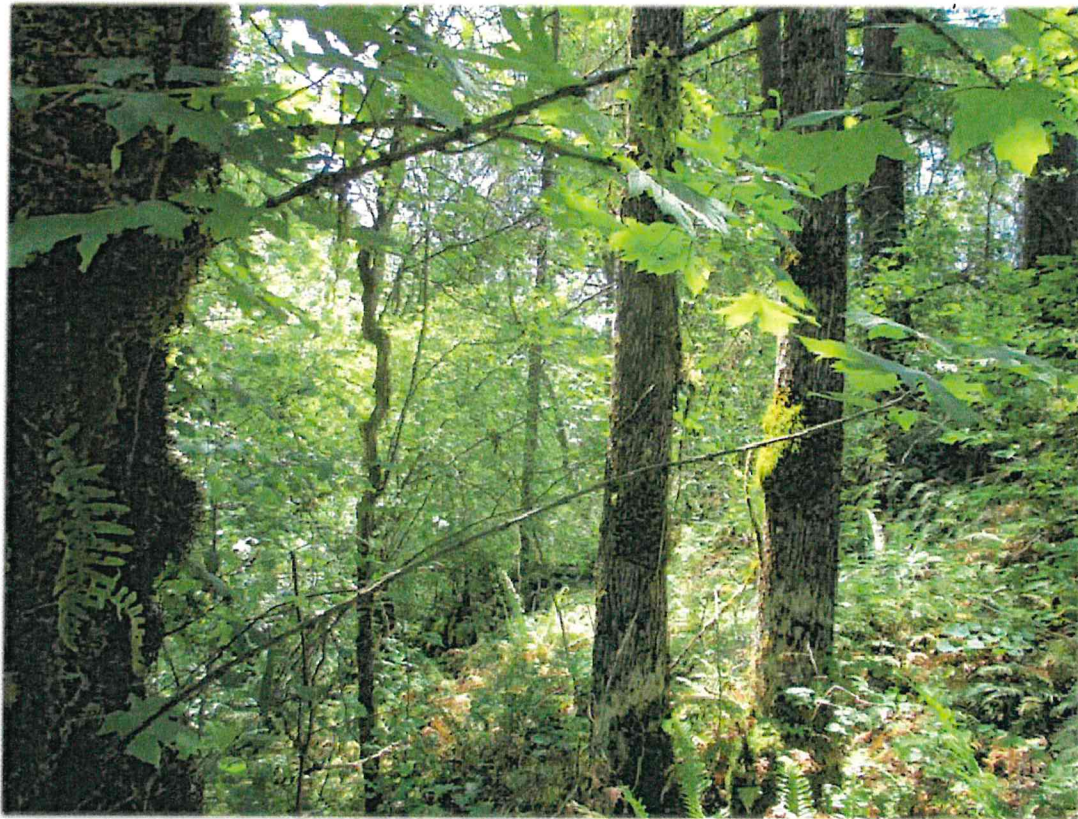
Photo Point 5. From the boundary of the western portion of the protection zone of Wetland 2 looking south at mixed Oregon oak forest of intact protection zone.

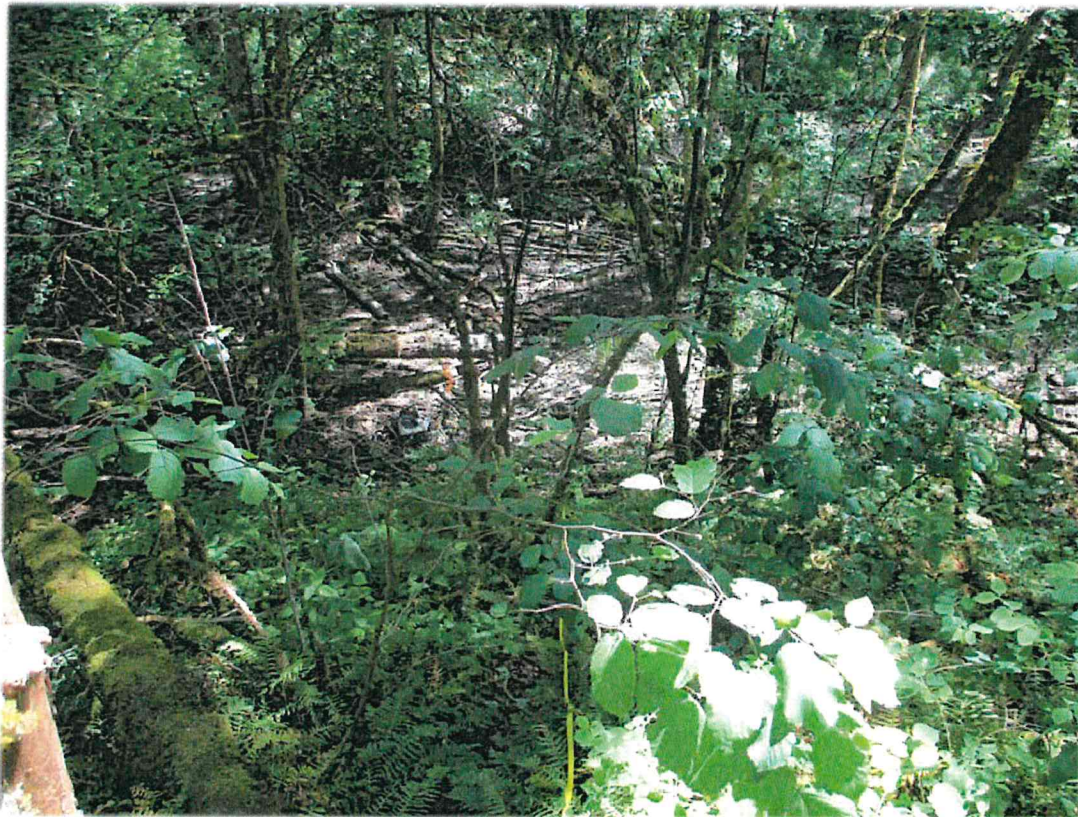
Photo Point 5. From the boundary of the western portion of the protection zone of Wetland 2 looking east at Oregon ash forest of intact protection zone and Wetland 2.

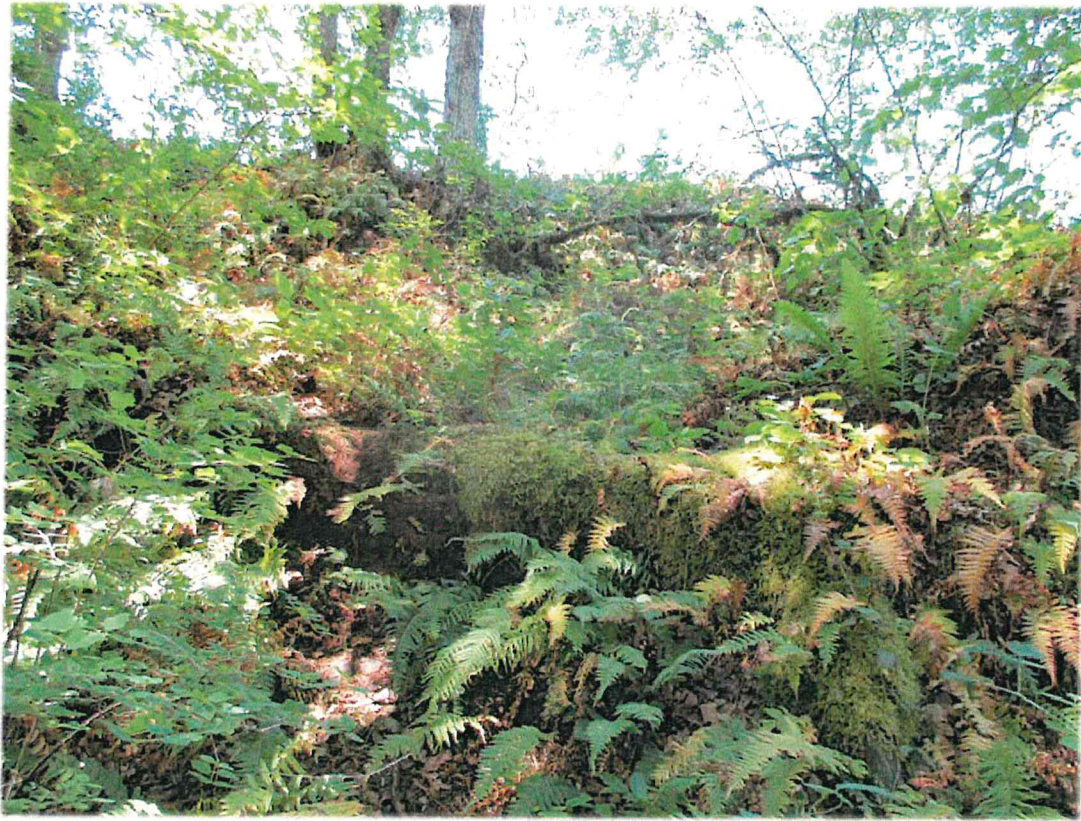
Photo Point 5. From the boundary of the western portion of the protection zone of Wetland 2 looking west at mixed Oregon oak forest beyond protection zone.
