Roof Asset Management Program

Parks & Rec Building

Report Date: 10/18/2023

Title: Wall Waterproofing

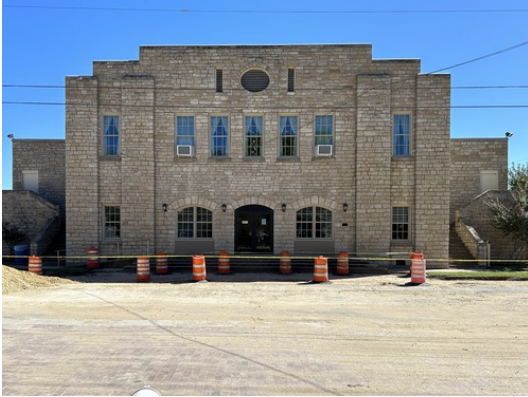
Photo 1

Issue Identified: Water Intrusion through Stone Walls Causing Mildew Smells in the Building, and causing damage to interior of the structure.

Summary: During the inspection, significant water intrusion was observed through the stone walls of the building. This infiltration has resulted in the development of mildew smells throughout the interior spaces. To mitigate this issue and prevent further water damage, it is imperative to implement a waterproofing solution. The recommended approach is the application of Seal-a-por, a product from the Garland company, to seal the stone effectively and prevent water from permeating through.

Conclusion: Implementing the Seal-a-por waterproofing solution from Garland is vital to prevent further water intrusion through the stone walls and eliminate damages and smells within the building. This comprehensive approach will not only address the current issue but also provide long-term protection against water damage, ensuring a dry and odor-free environment for the occupants. Some tuck-pointing may be necessary and minor sealing to the windows between stone and window casings.

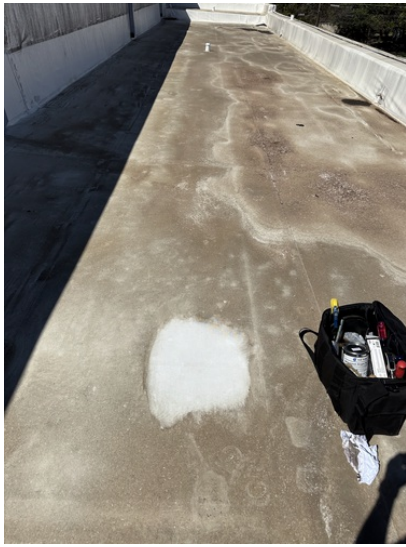
Photo 1

1. **Fasteners Backing Out:** Several spots on the roof were identified where fasteners were observed backing out. This issue needs immediate attention to prevent potential leaks and damage to TPO roofing system.
2. **Old Sealant:** Some areas showed signs of deteriorating sealant. Weathered sealant can compromise the roof's waterproofing capabilities and should be replaced promptly to maintain the roof's integrity.
3. **Debris on Roof:** Accumulated debris on the roof was noted. Regular cleaning is recommended to prevent drainage issues and to prolong the life of the roofing system.
4. **Poor Flashing Details:** Certain flashing details were found to be poorly executed. Proper flashing is crucial for preventing water infiltration, and these areas should be repaired to avoid future leaks. Pipes coming up through the parapet walls are not recommended and should be moved if/when possible.

Issue Identified: TPO Roofing Membrane Loss of Mil Thickness and Brittleness due to Sun Degradation.

Observations: During the inspection, it was observed that the TPO (Thermoplastic Polyolefin) roofing membrane has undergone **sun degradation**. This degradation has led to the gradual loss of mil thickness and brittleness of the material. Exposure to harsh sunlight and UV rays causes the TPO membrane to deteriorate over time, resulting in the following issues:

1. **Fastener Replacement:** Secure all loose or backing out fasteners to ensure the TPO membrane remains tightly in place and membrane does not become damaged.
2. **Sealant Replacement:** Remove old and deteriorated sealant and reapply a high-quality, weather-resistant sealant to maintain waterproofing.
3. **Roof Cleaning:** Schedule a professional cleaning to remove debris from the roof surface and gutters, ensuring proper drainage.
4. **Flashing Repairs:** Address poor flashing details by resealing or replacing flashing materials where necessary to prevent water ingress.
5. **Regular Maintenance:** Implement a routine maintenance plan to inspect the roof periodically, addressing minor issues before they escalate.

1. **Water Test:** roofing areas that are suspected of water intrusion to insure that roofing system is functioning as intended.
 2. **Regular Inspections:** For existing TPO roofs, implement a rigorous inspection schedule. Regular inspections allow for the early detection of issues, enabling timely repairs and maintenance to mitigate further damage.
 3. **Cool Roof Coatings:** If replacing the roof is not immediately feasible, consider applying cool roof coatings. These coatings can provide some level of protection against UV rays and slow down the degradation process, although they are not a permanent solution.
-
