## ST. TAMMANY PARISH

Re: Abita Ridge Subdivision, Phase 1  
Extended Warranty Obligation - \$57,900.00 - LOC # 643

In accordance with the St. Tammany Parish Government Code of Ordinances, Part II "Land Development Code," Chapter 125 "Subdivision Regulations," Section 125-210 "Warranty and Performance Obligations," the Department of Engineering made an inspection of the site on April 15, 2024.

Attachment: Representative photos from site inspection performed on April 15, 2024

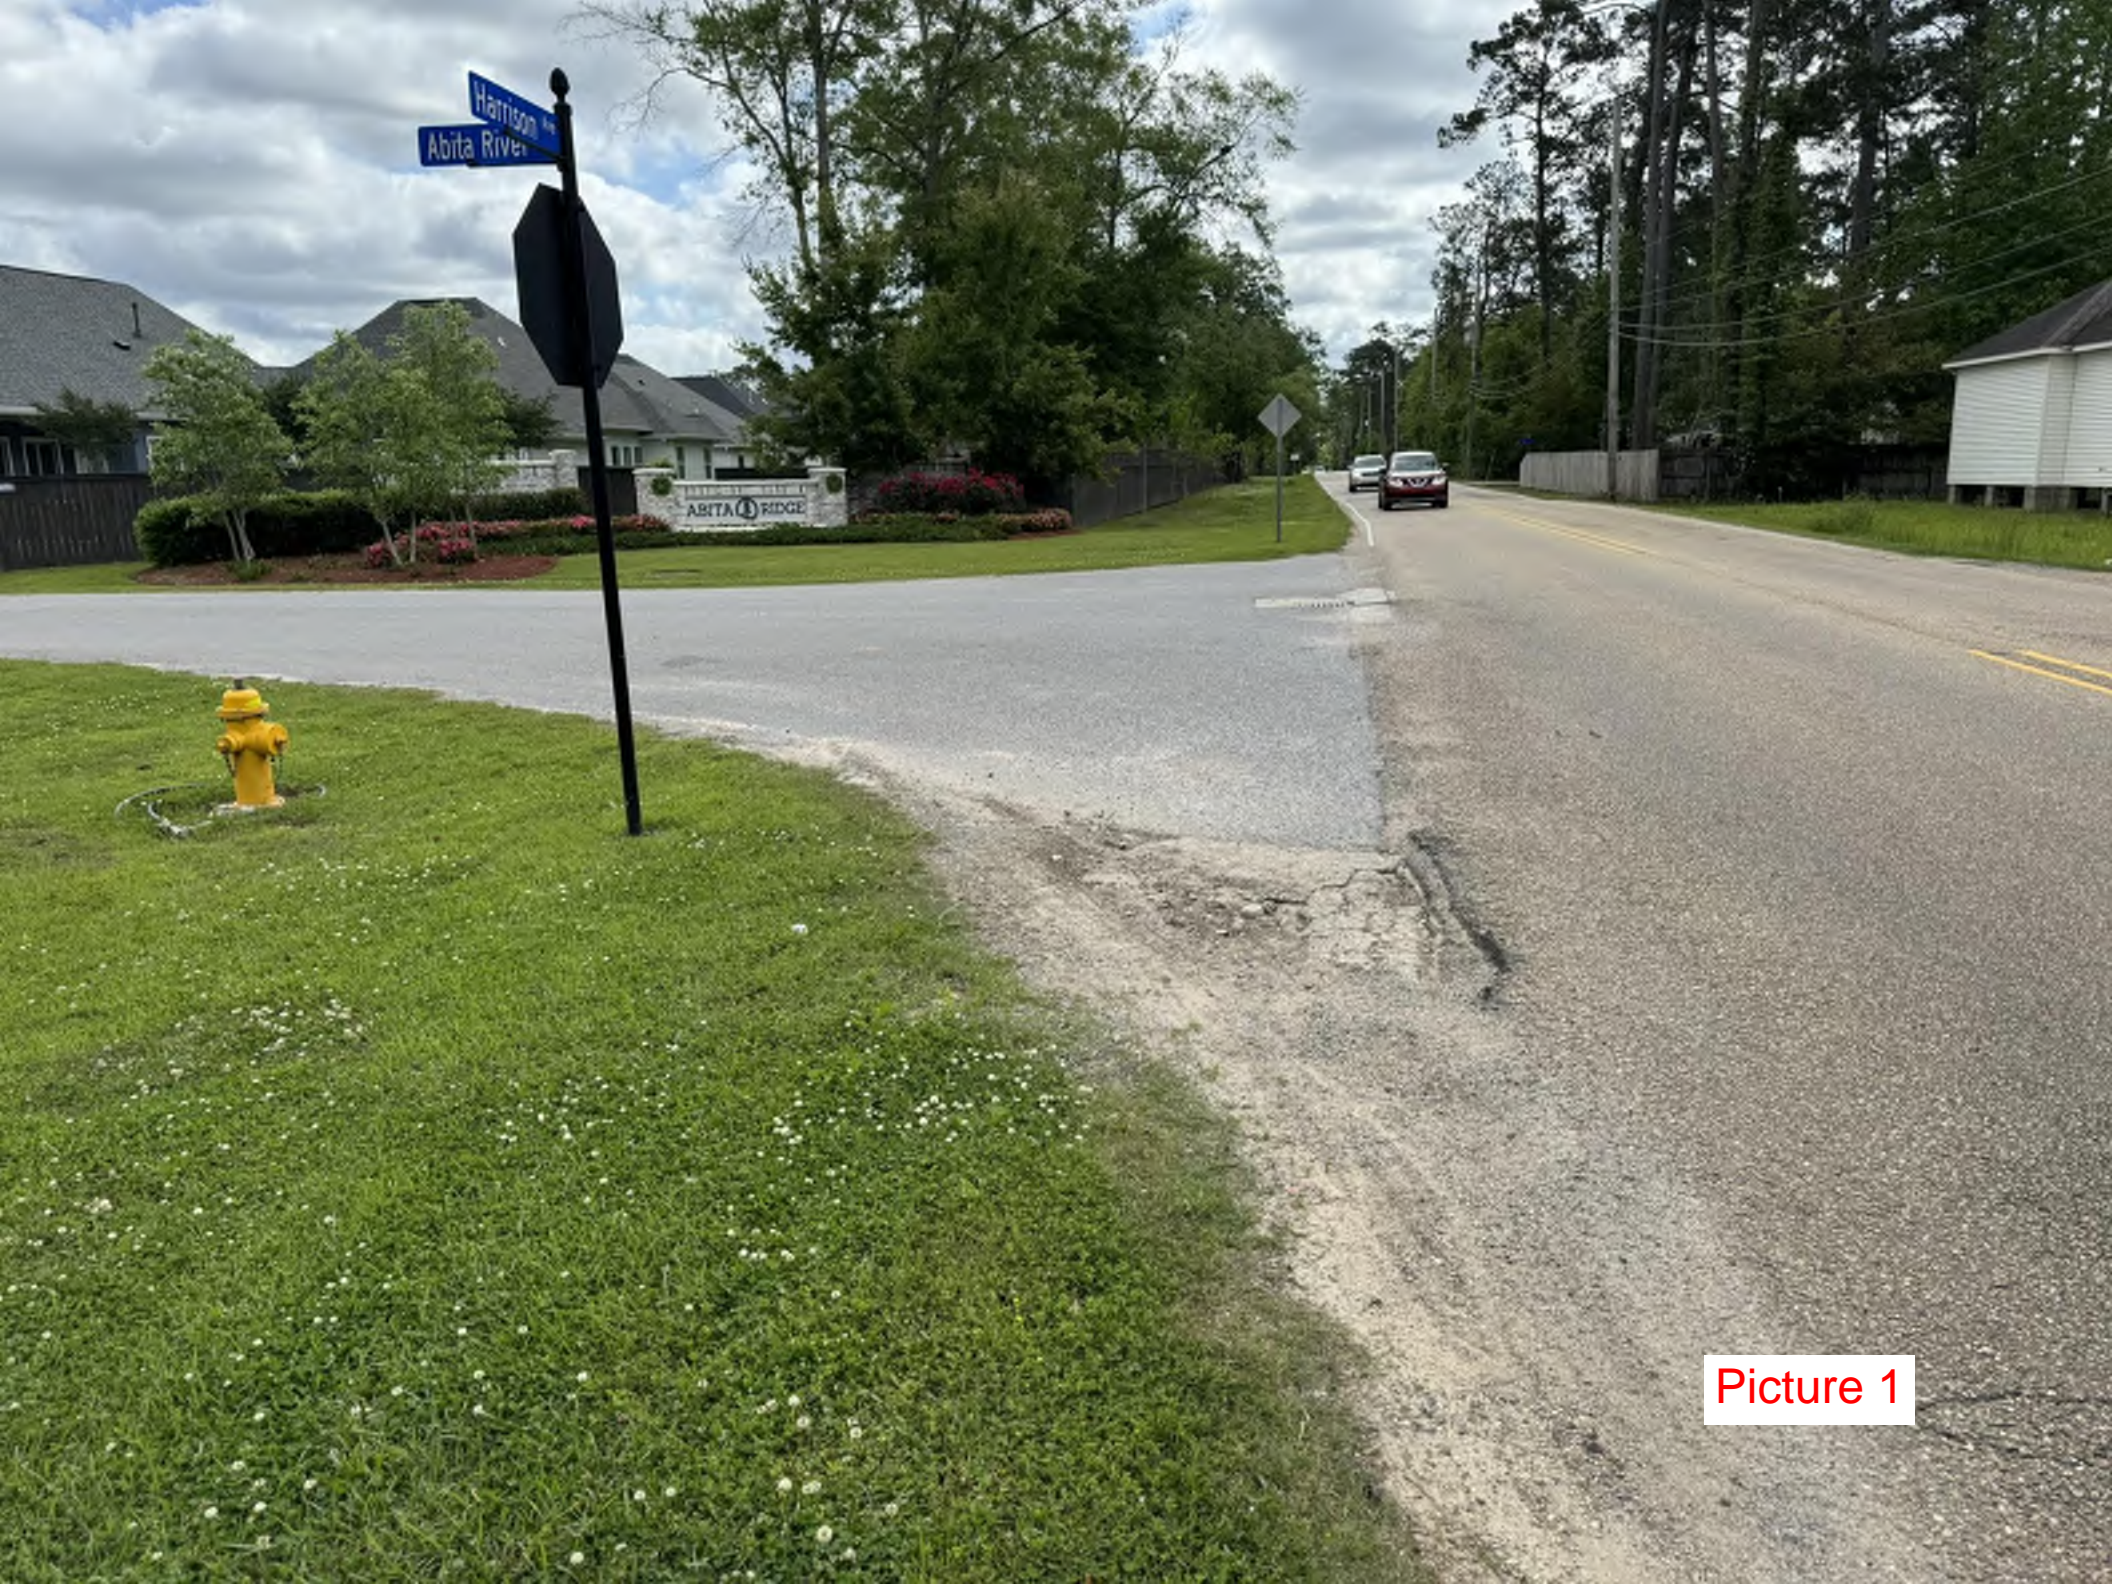
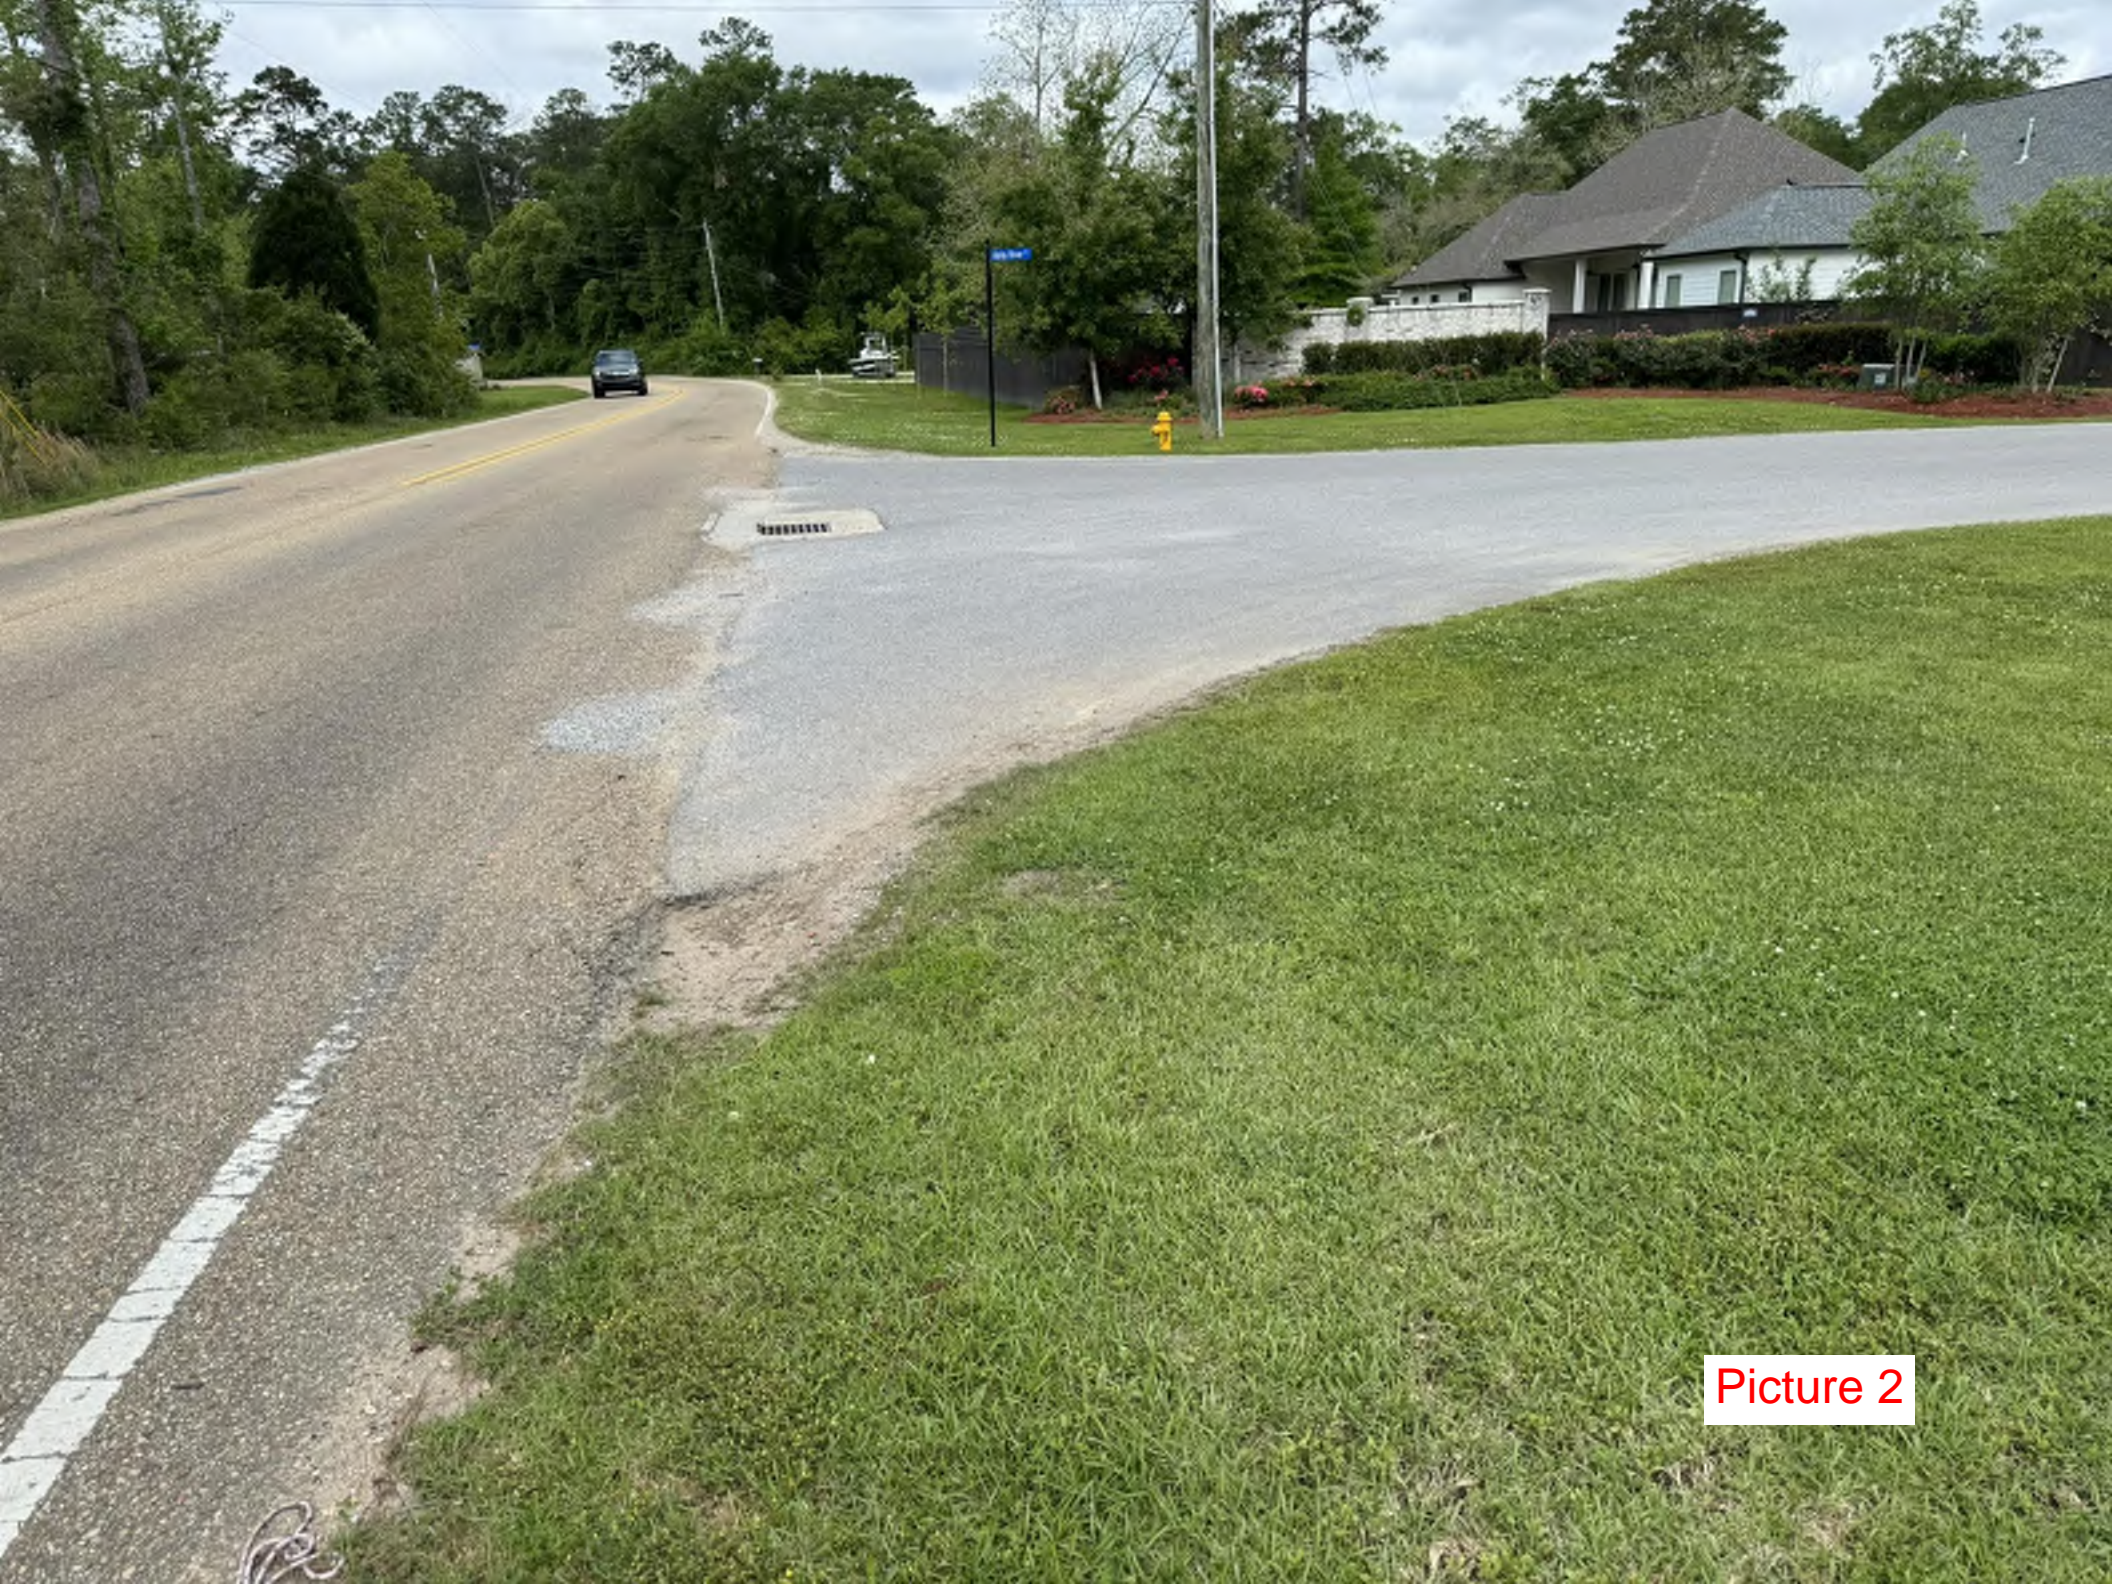
1. The ingress and egress turnout radius located in the main entrance of the Abita Ridge Subdivision, Phase 1 needs to be re-established (See pictures #1 & #2);

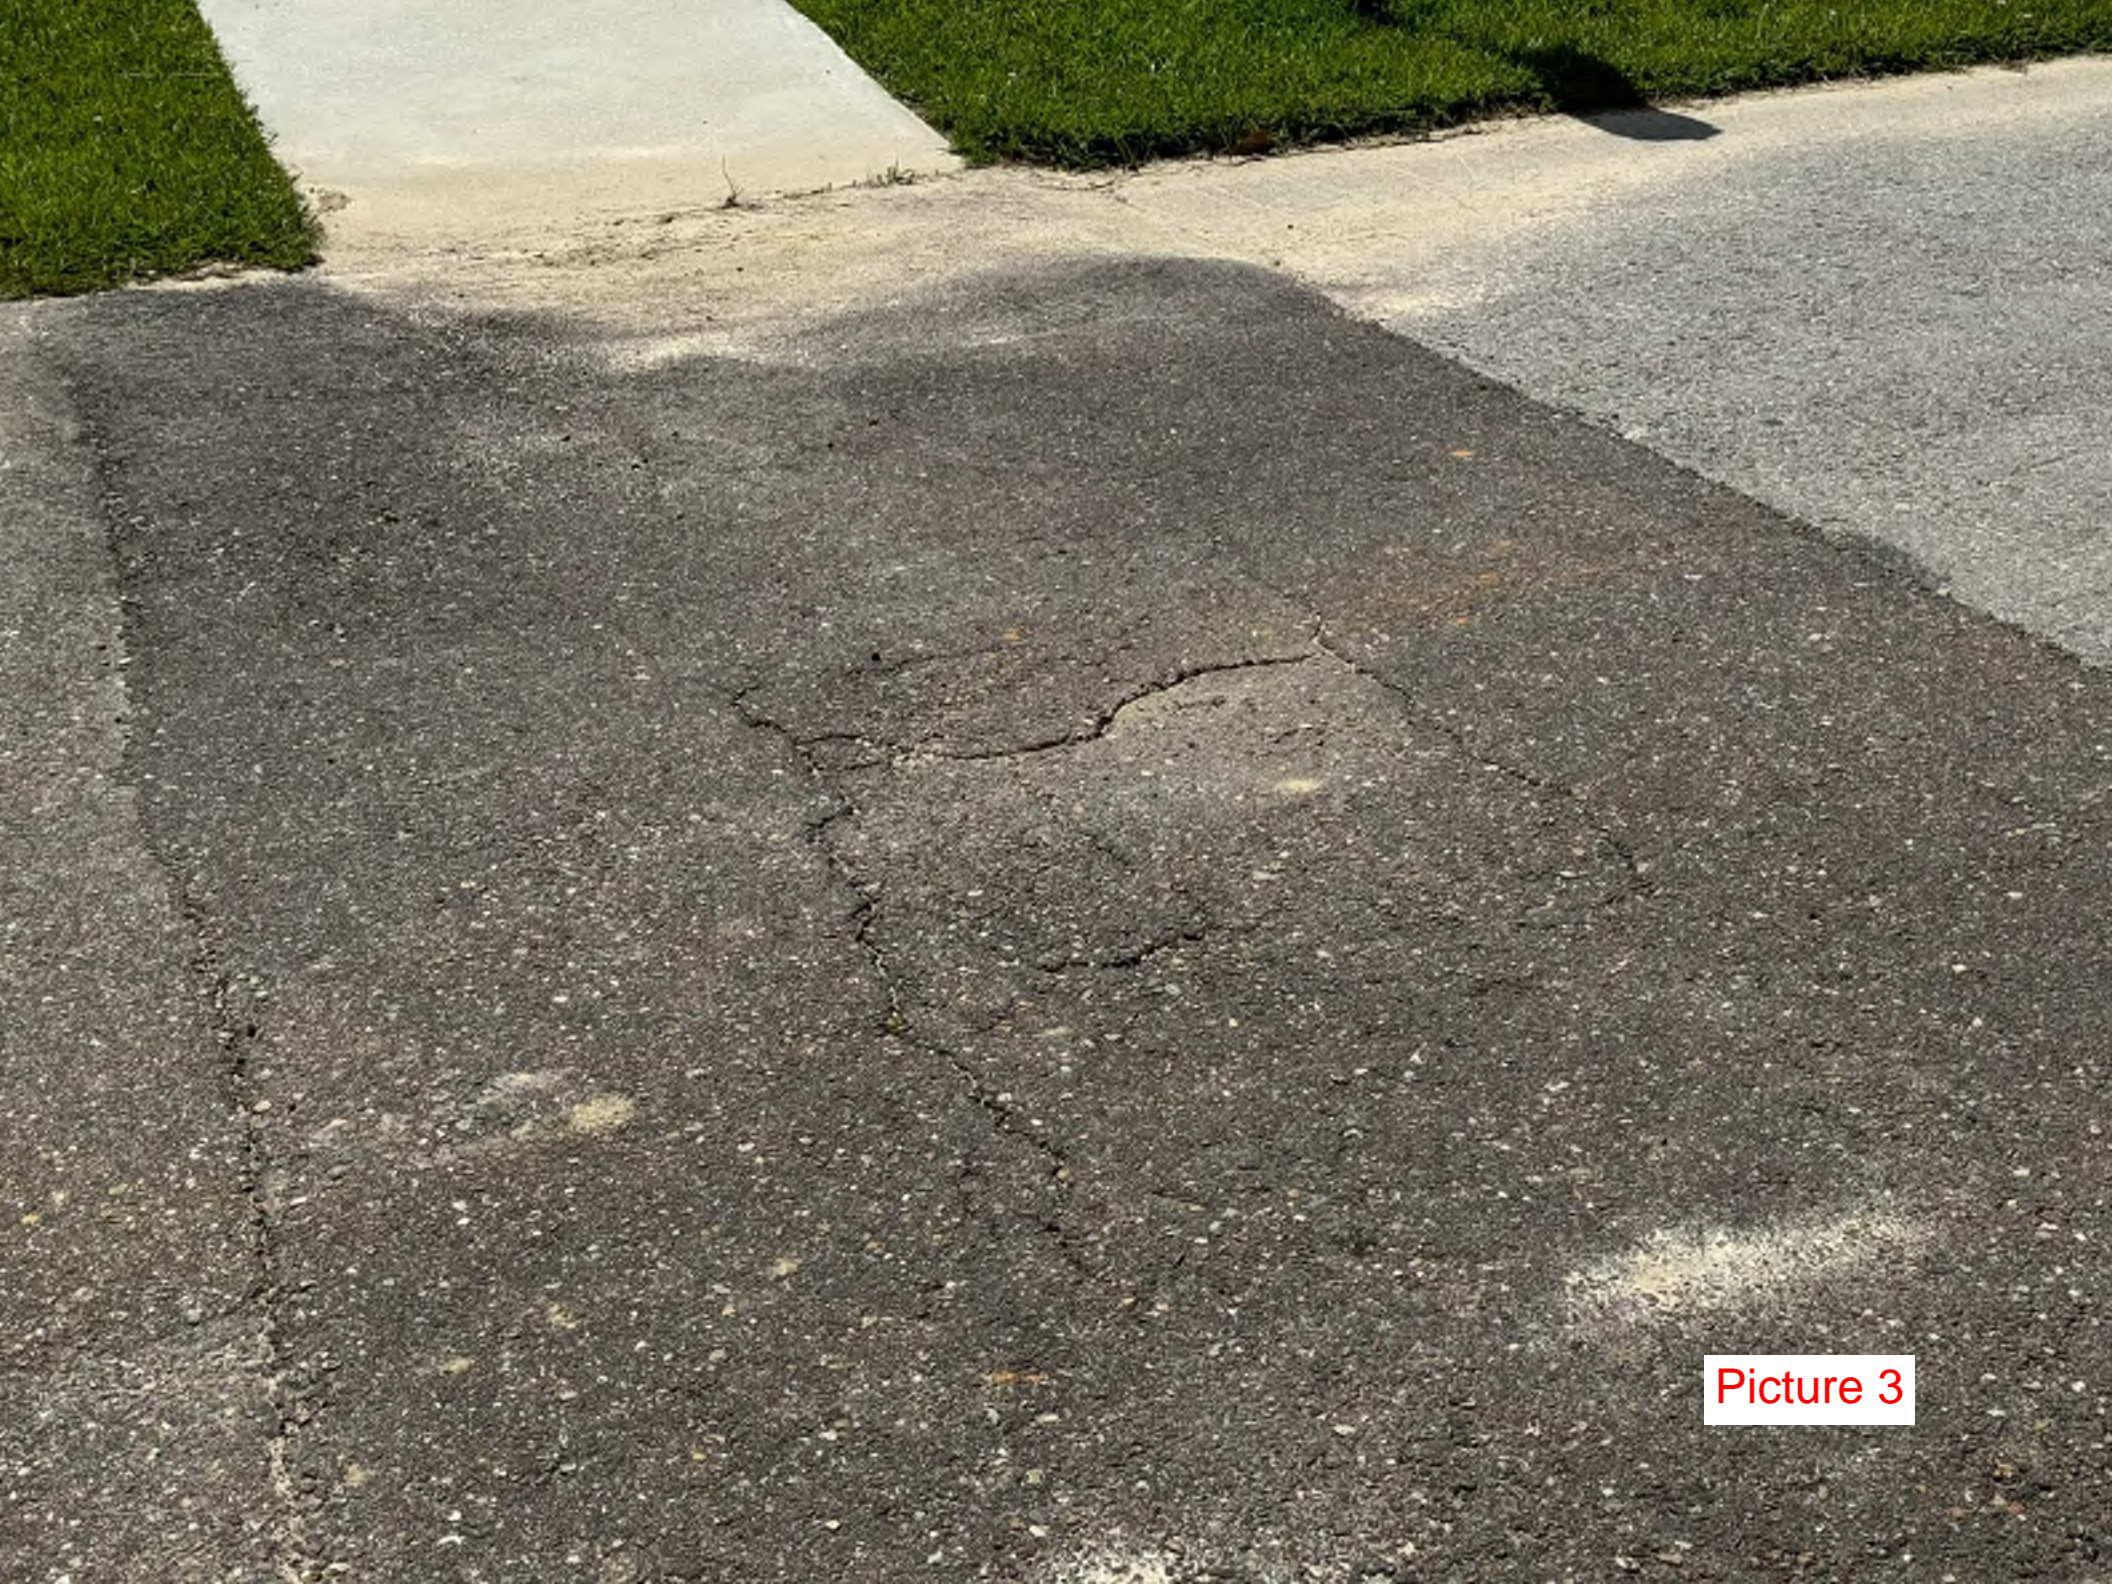
Picture 3

2. The settlement of the asphalt pavement located in the vicinity of Lot #104 needs to be repaired (See picture #3);
3. Shoulders within this phase of Abita Ridge need to be re-established and vegetated (See pictures #4 - #9 - Typical Comment);
