## ST. TAMMANY PARISH

Re: Abita Ridge Subdivision, Phase 1  
Extended Warranty Obligation - \$57,900.00 - LOC # 643

In accordance with the St. Tammany Parish Government Code of Ordinances, Part II "Land Development Code," Chapter 125 "Subdivision Regulations," Section 125-210 "Warranty and Performance Obligations," the Department of Engineering made an inspection of the site on April 15, 2024.

Attachment: Representative photos from site inspection performed on April 15, 2024

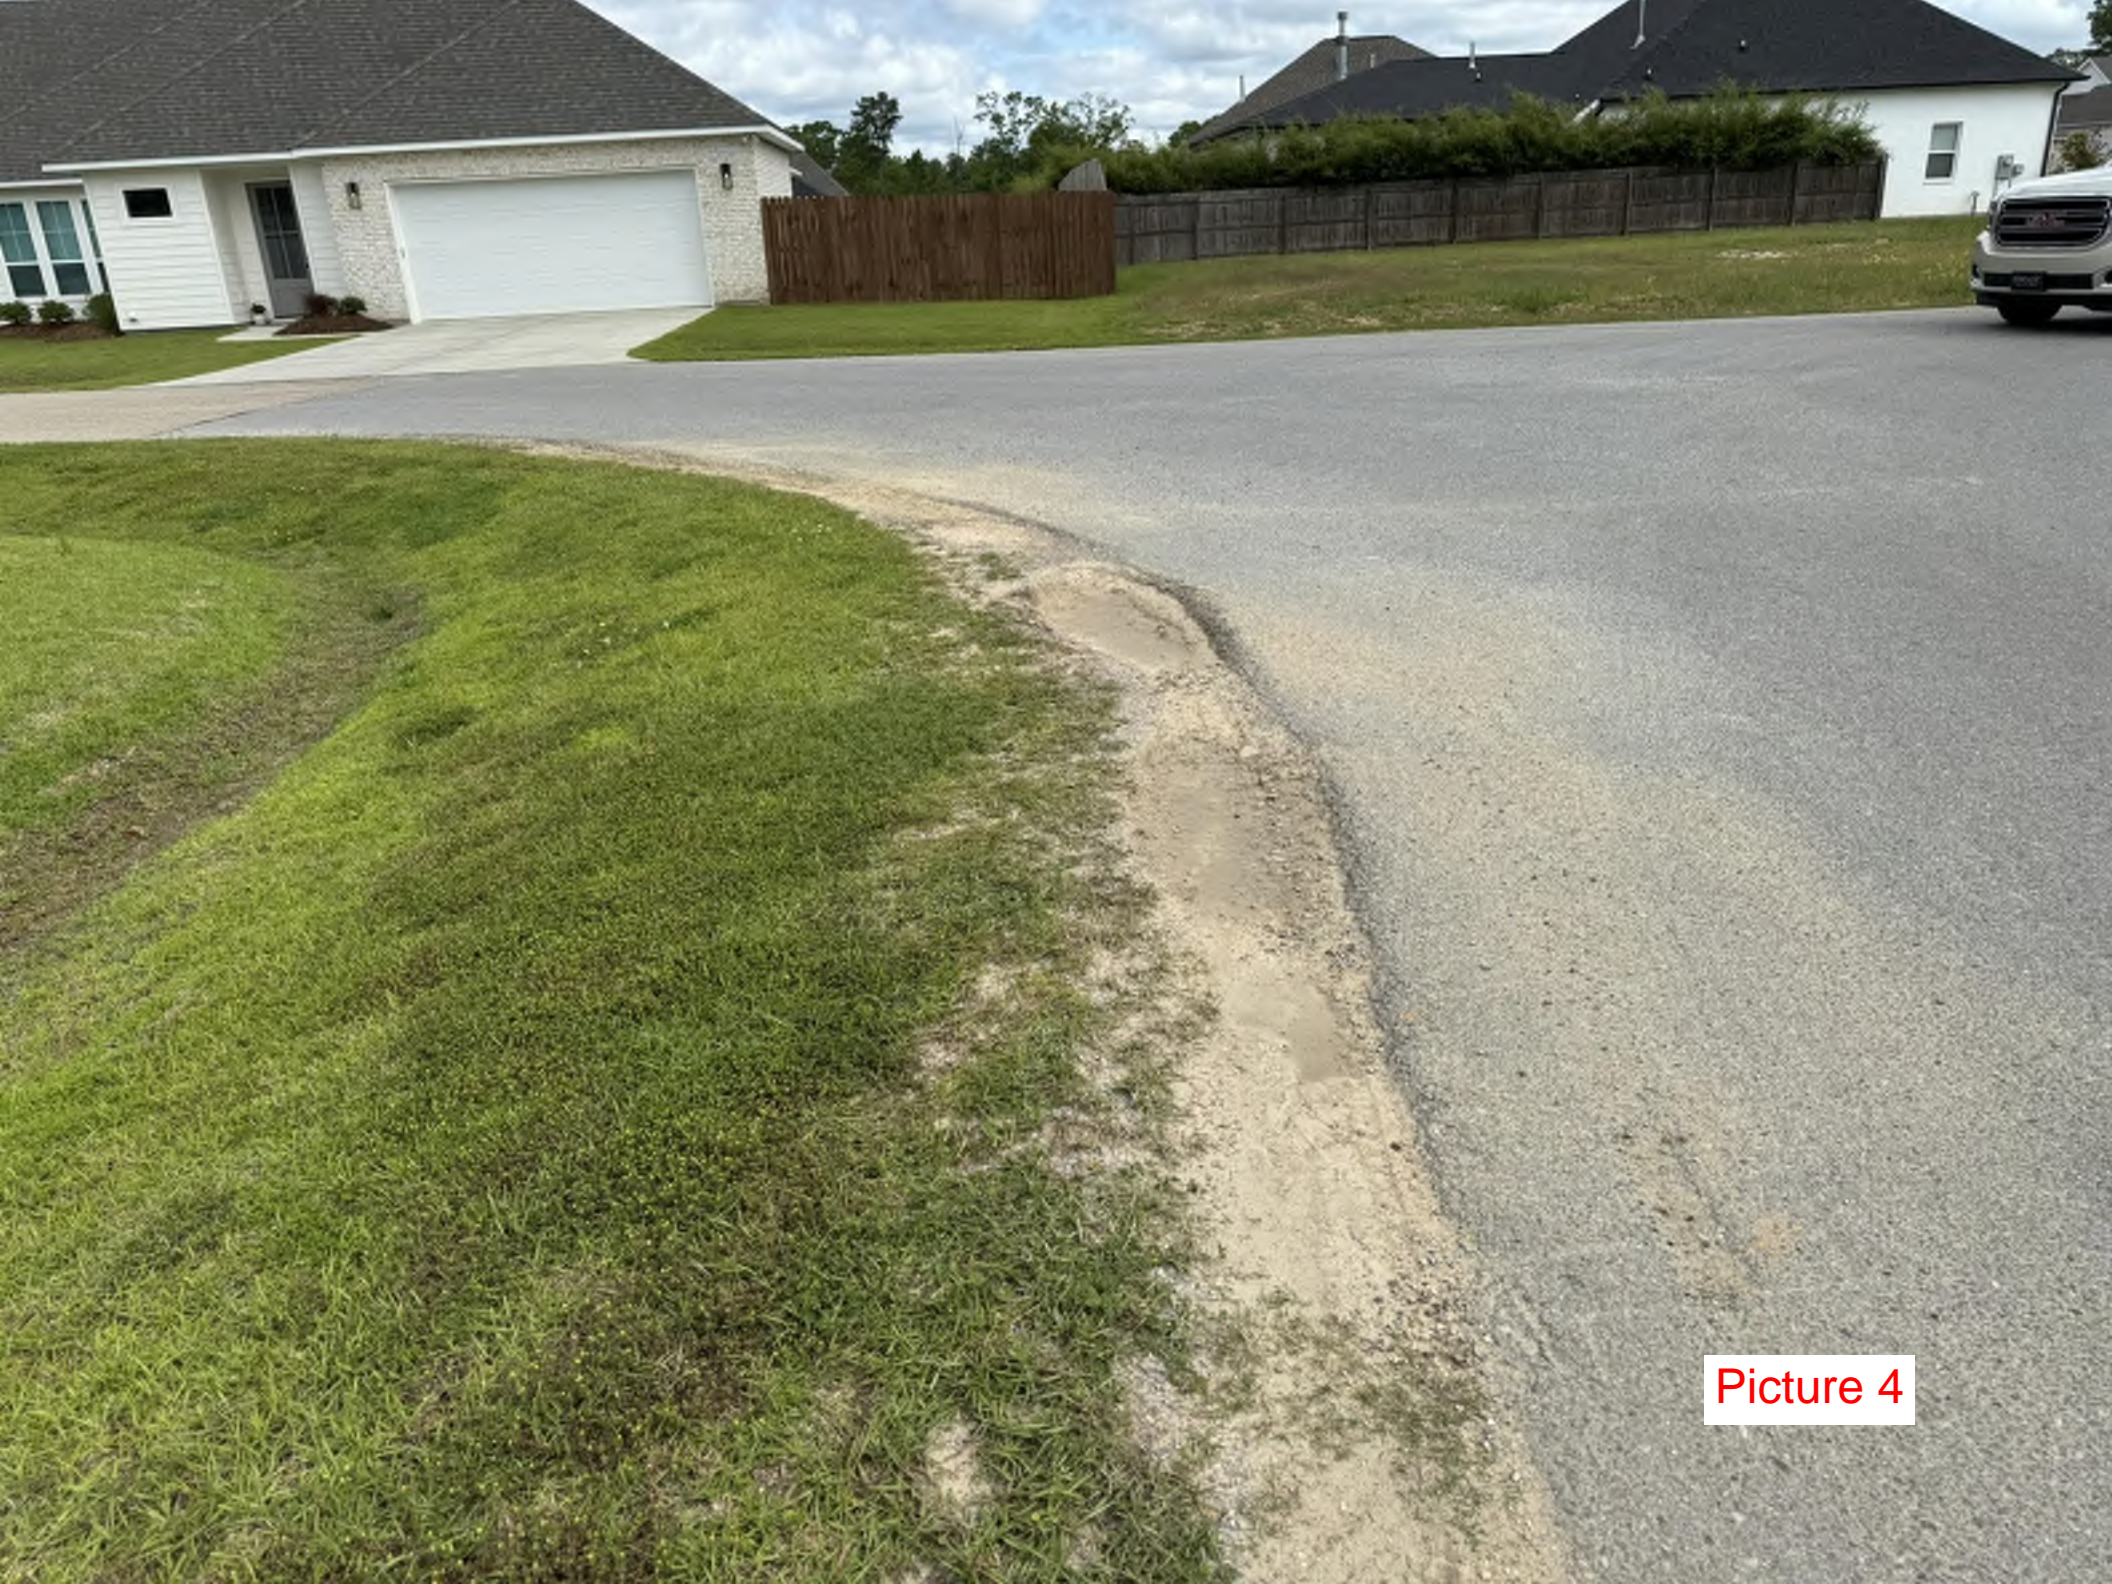
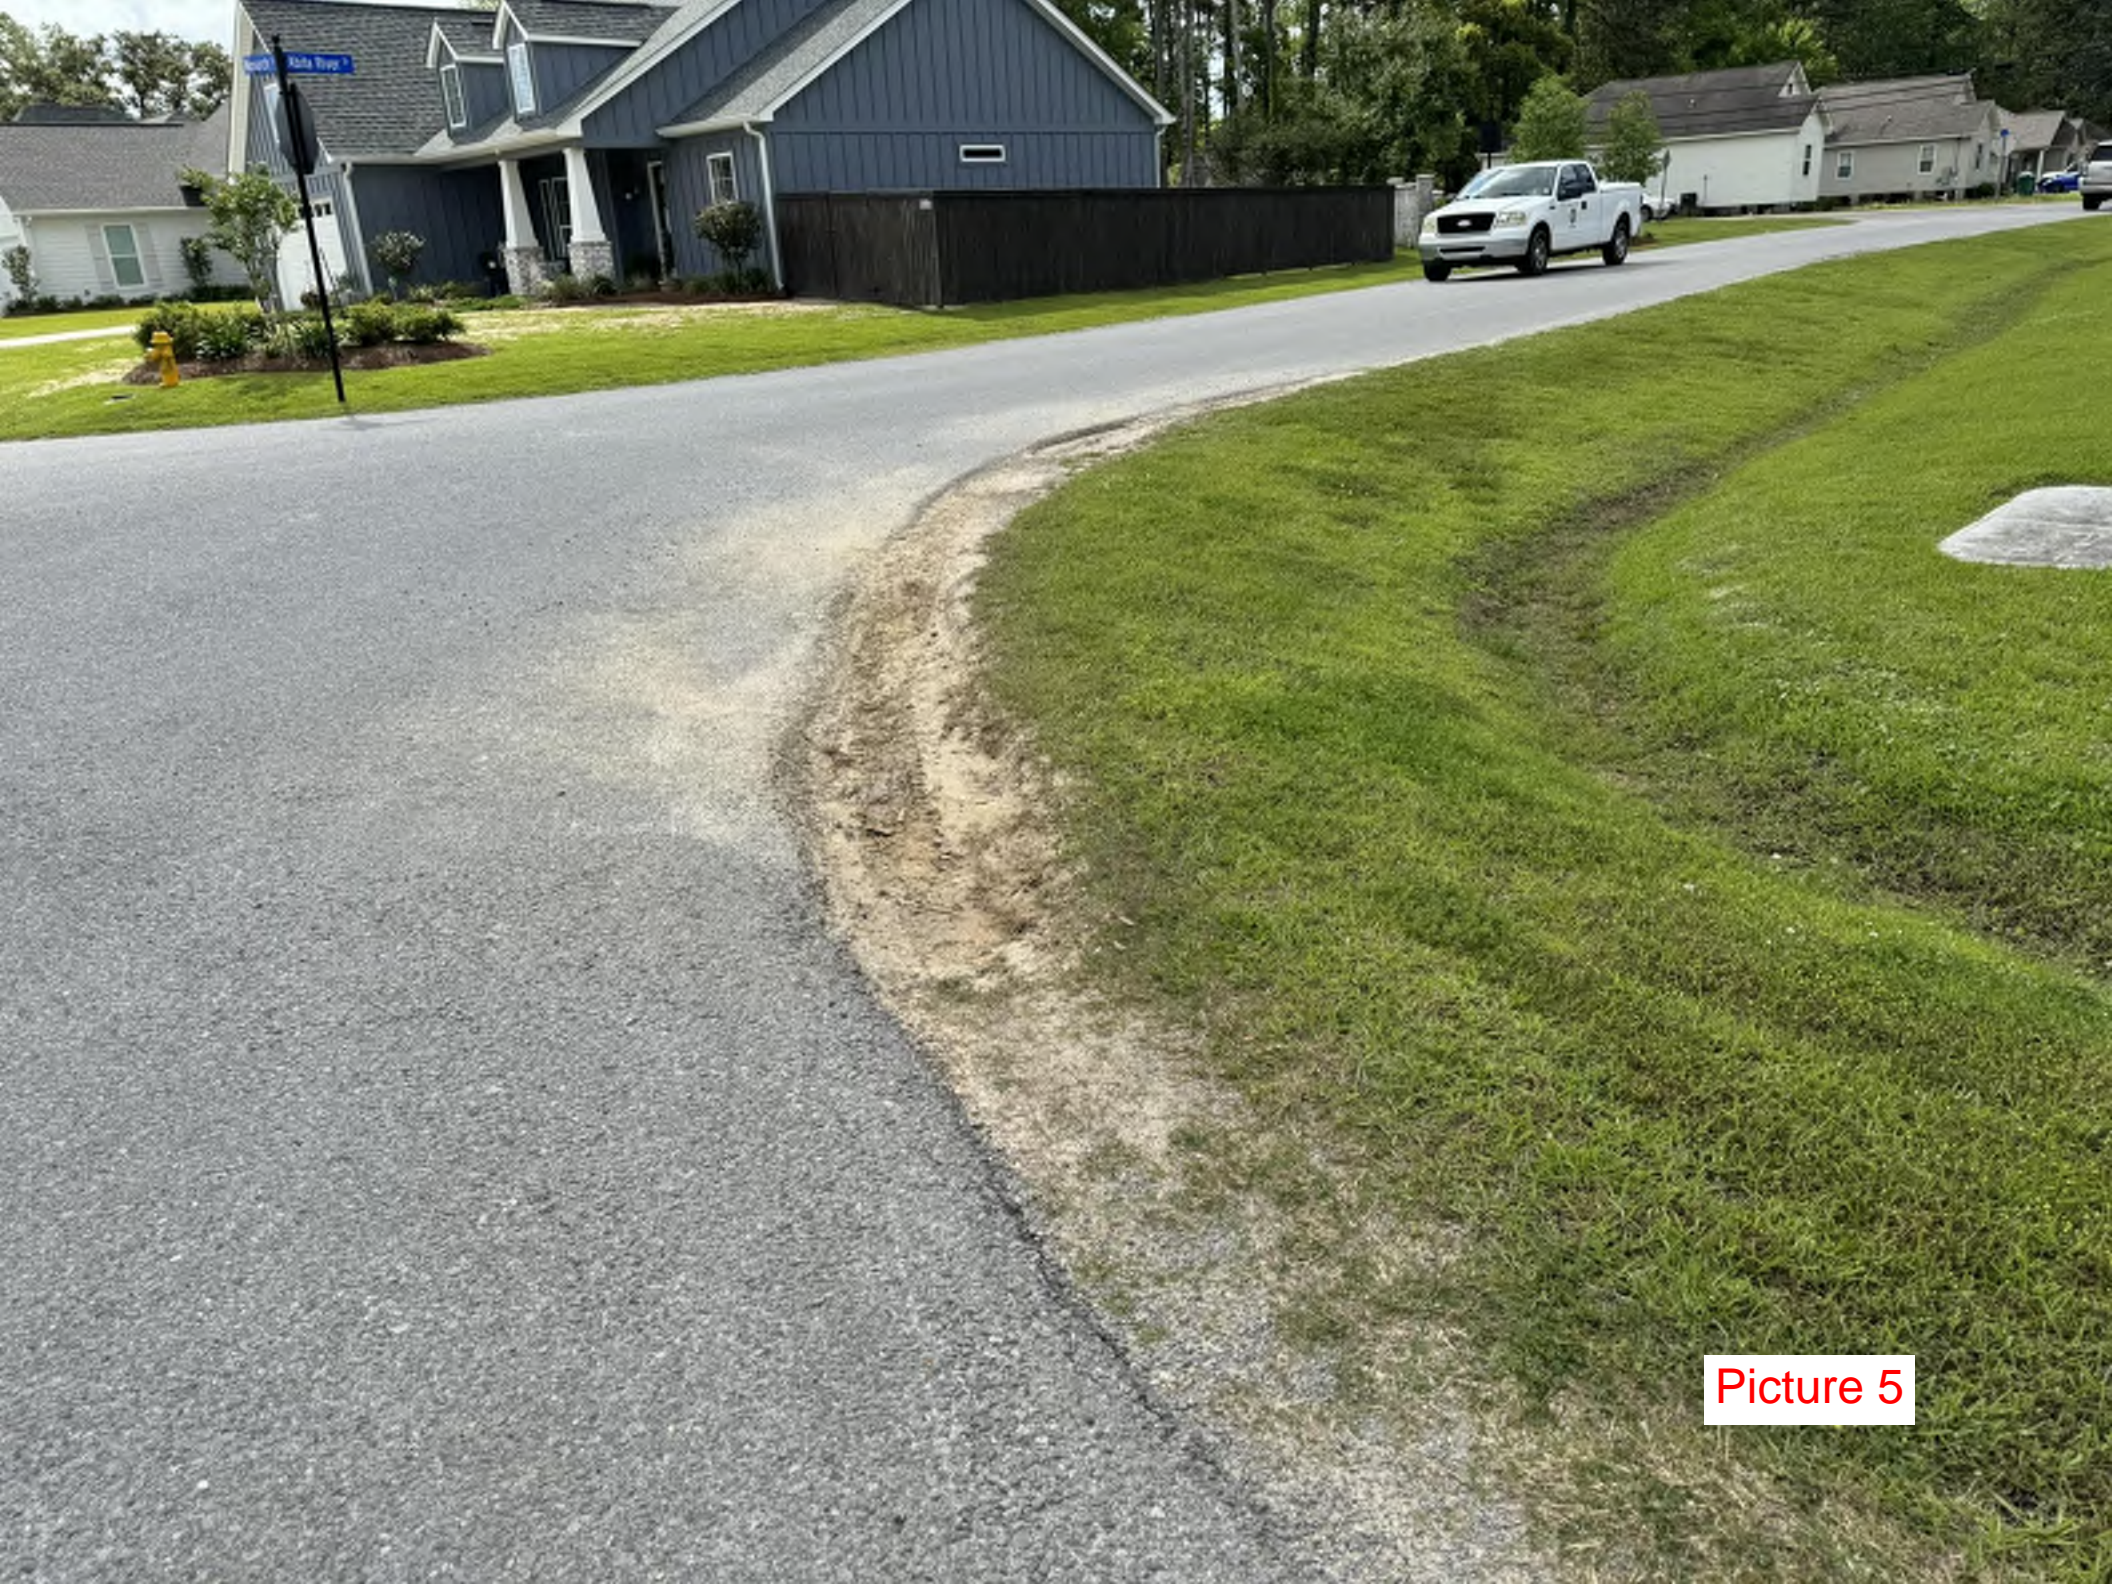
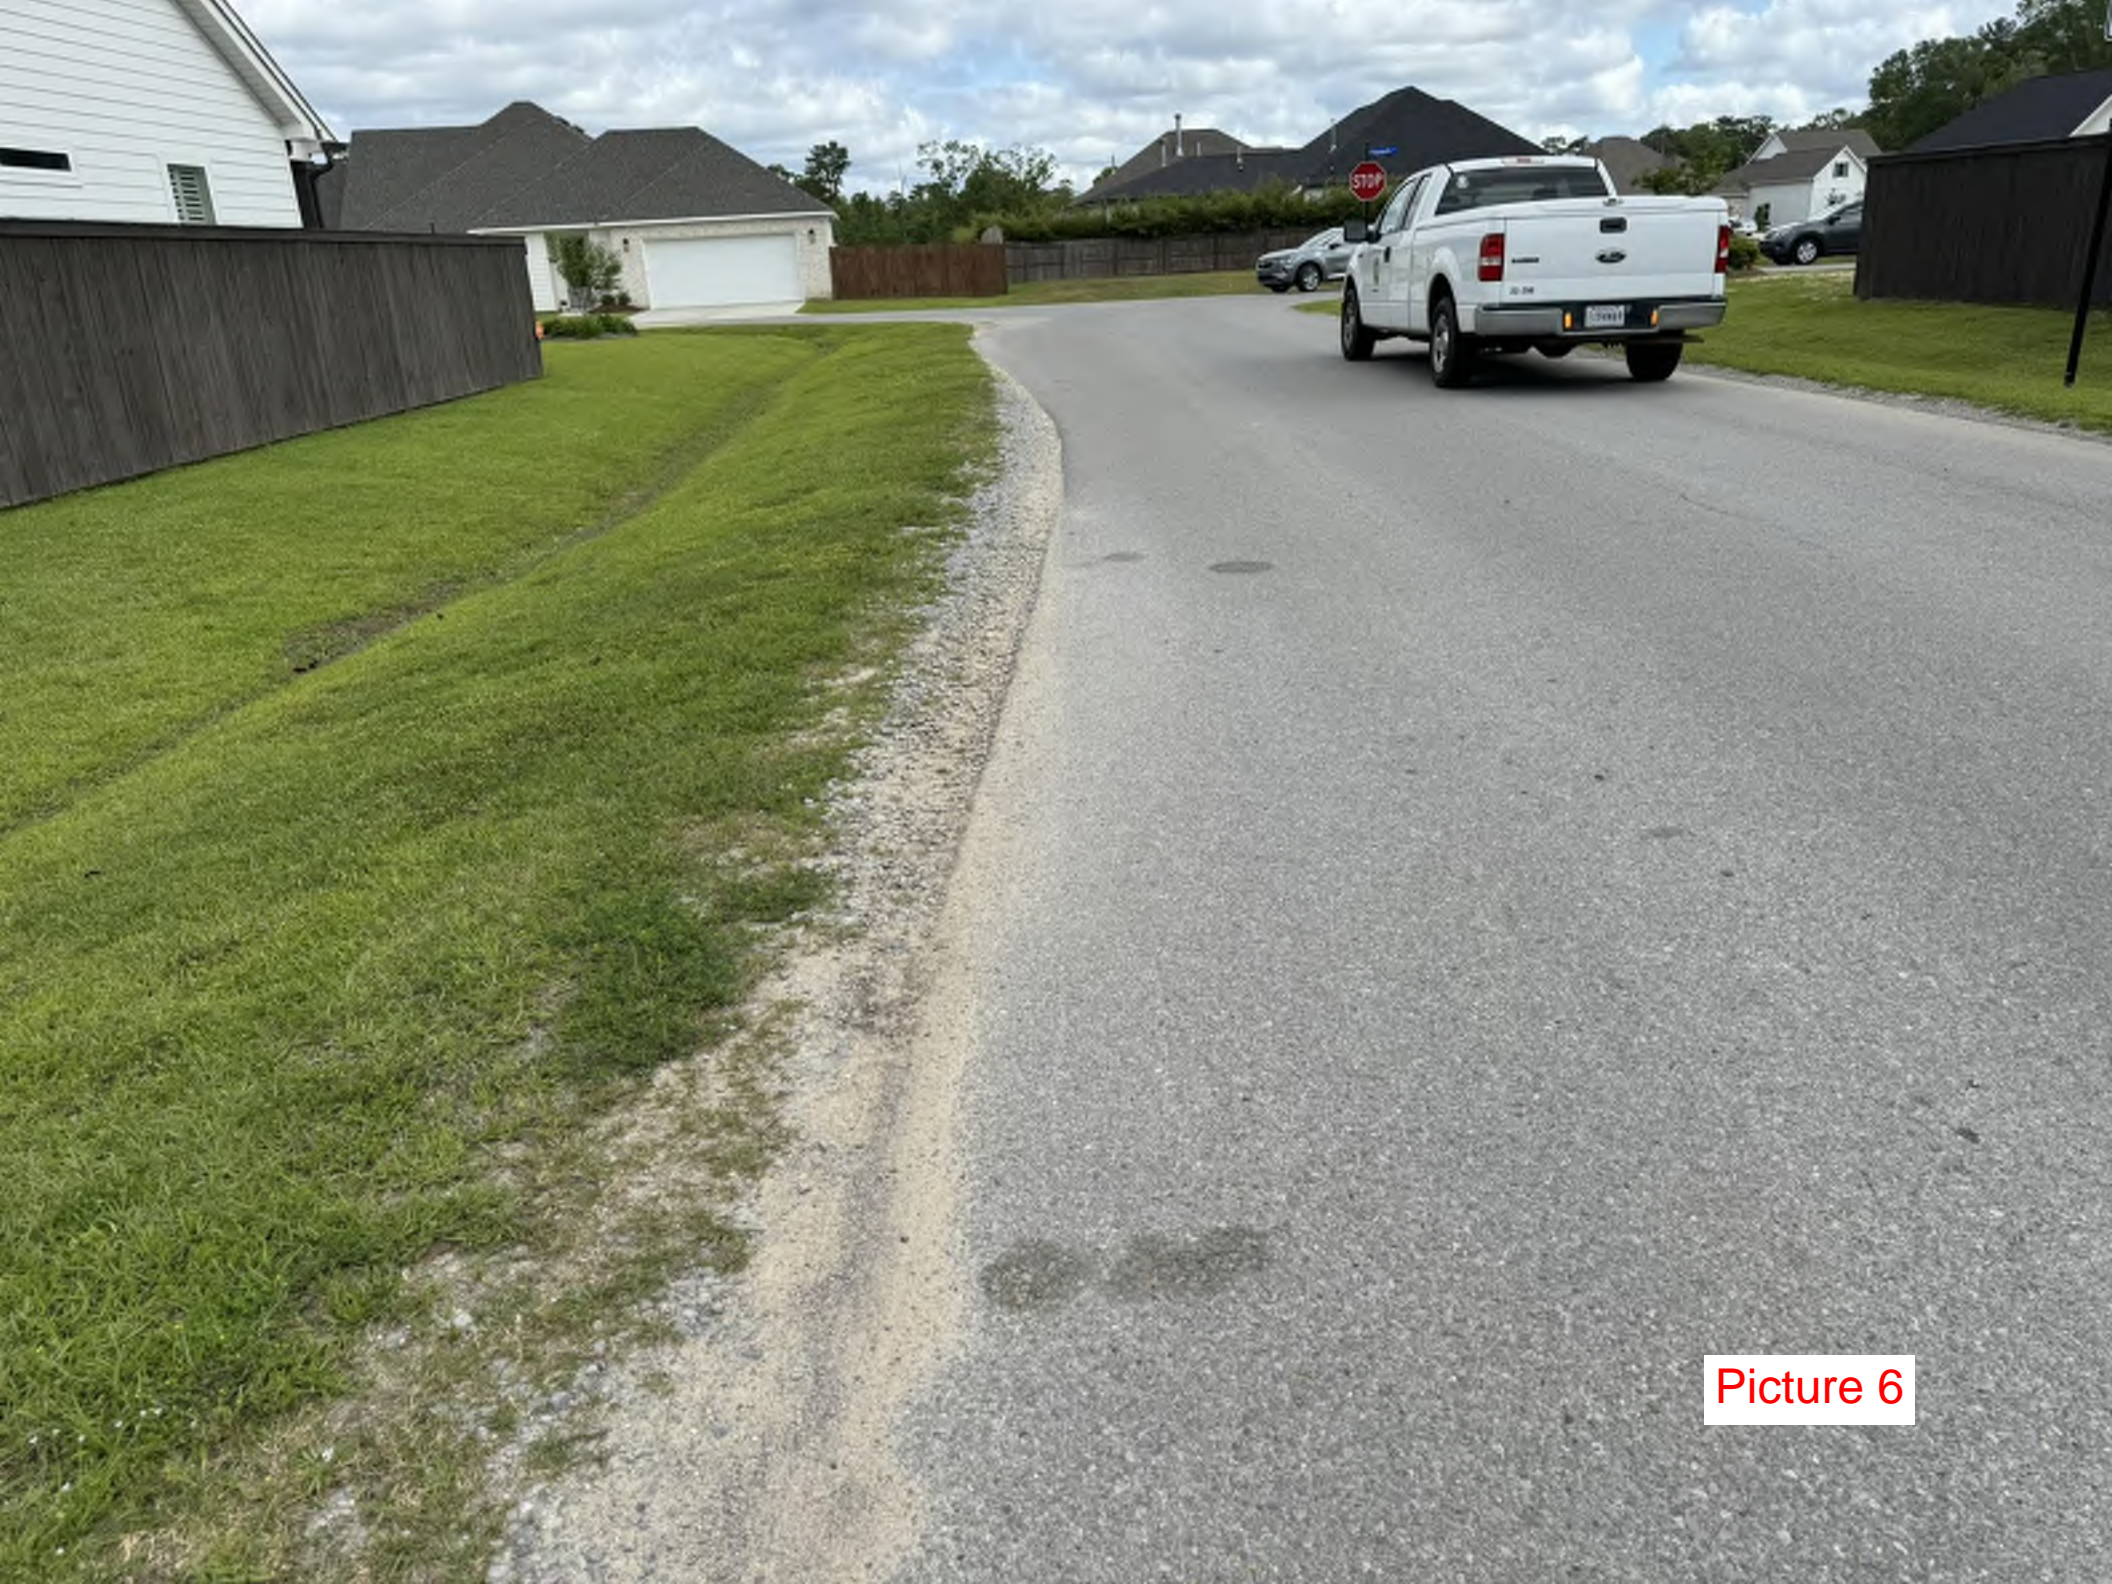
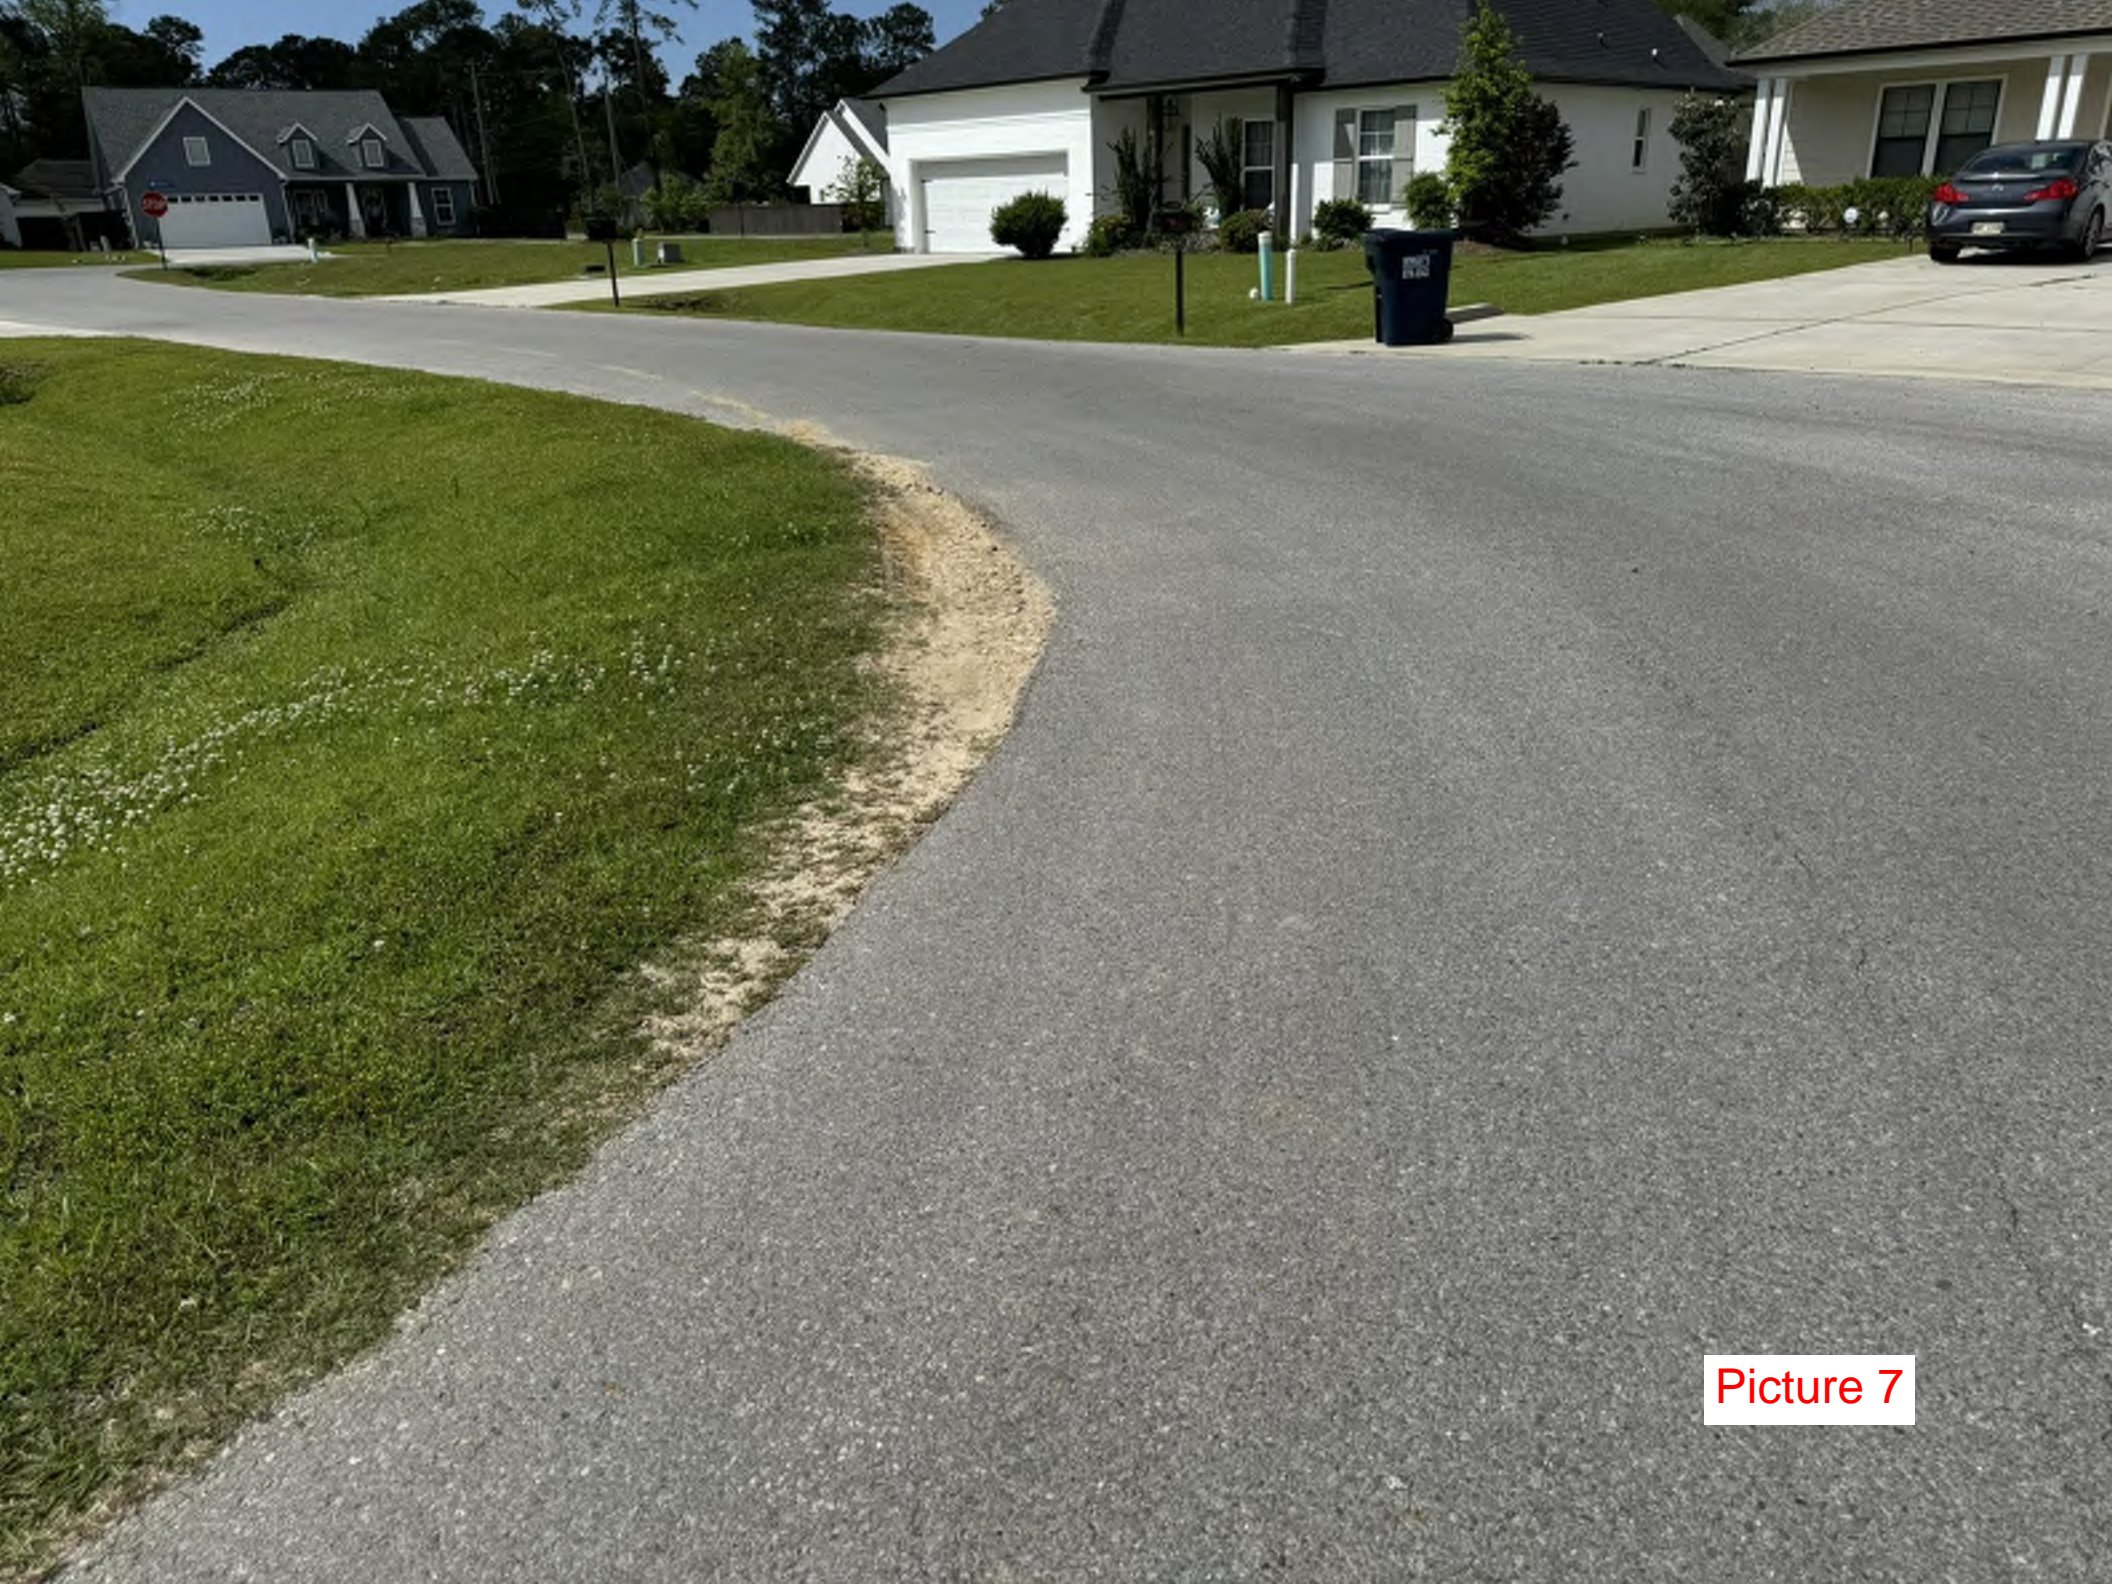
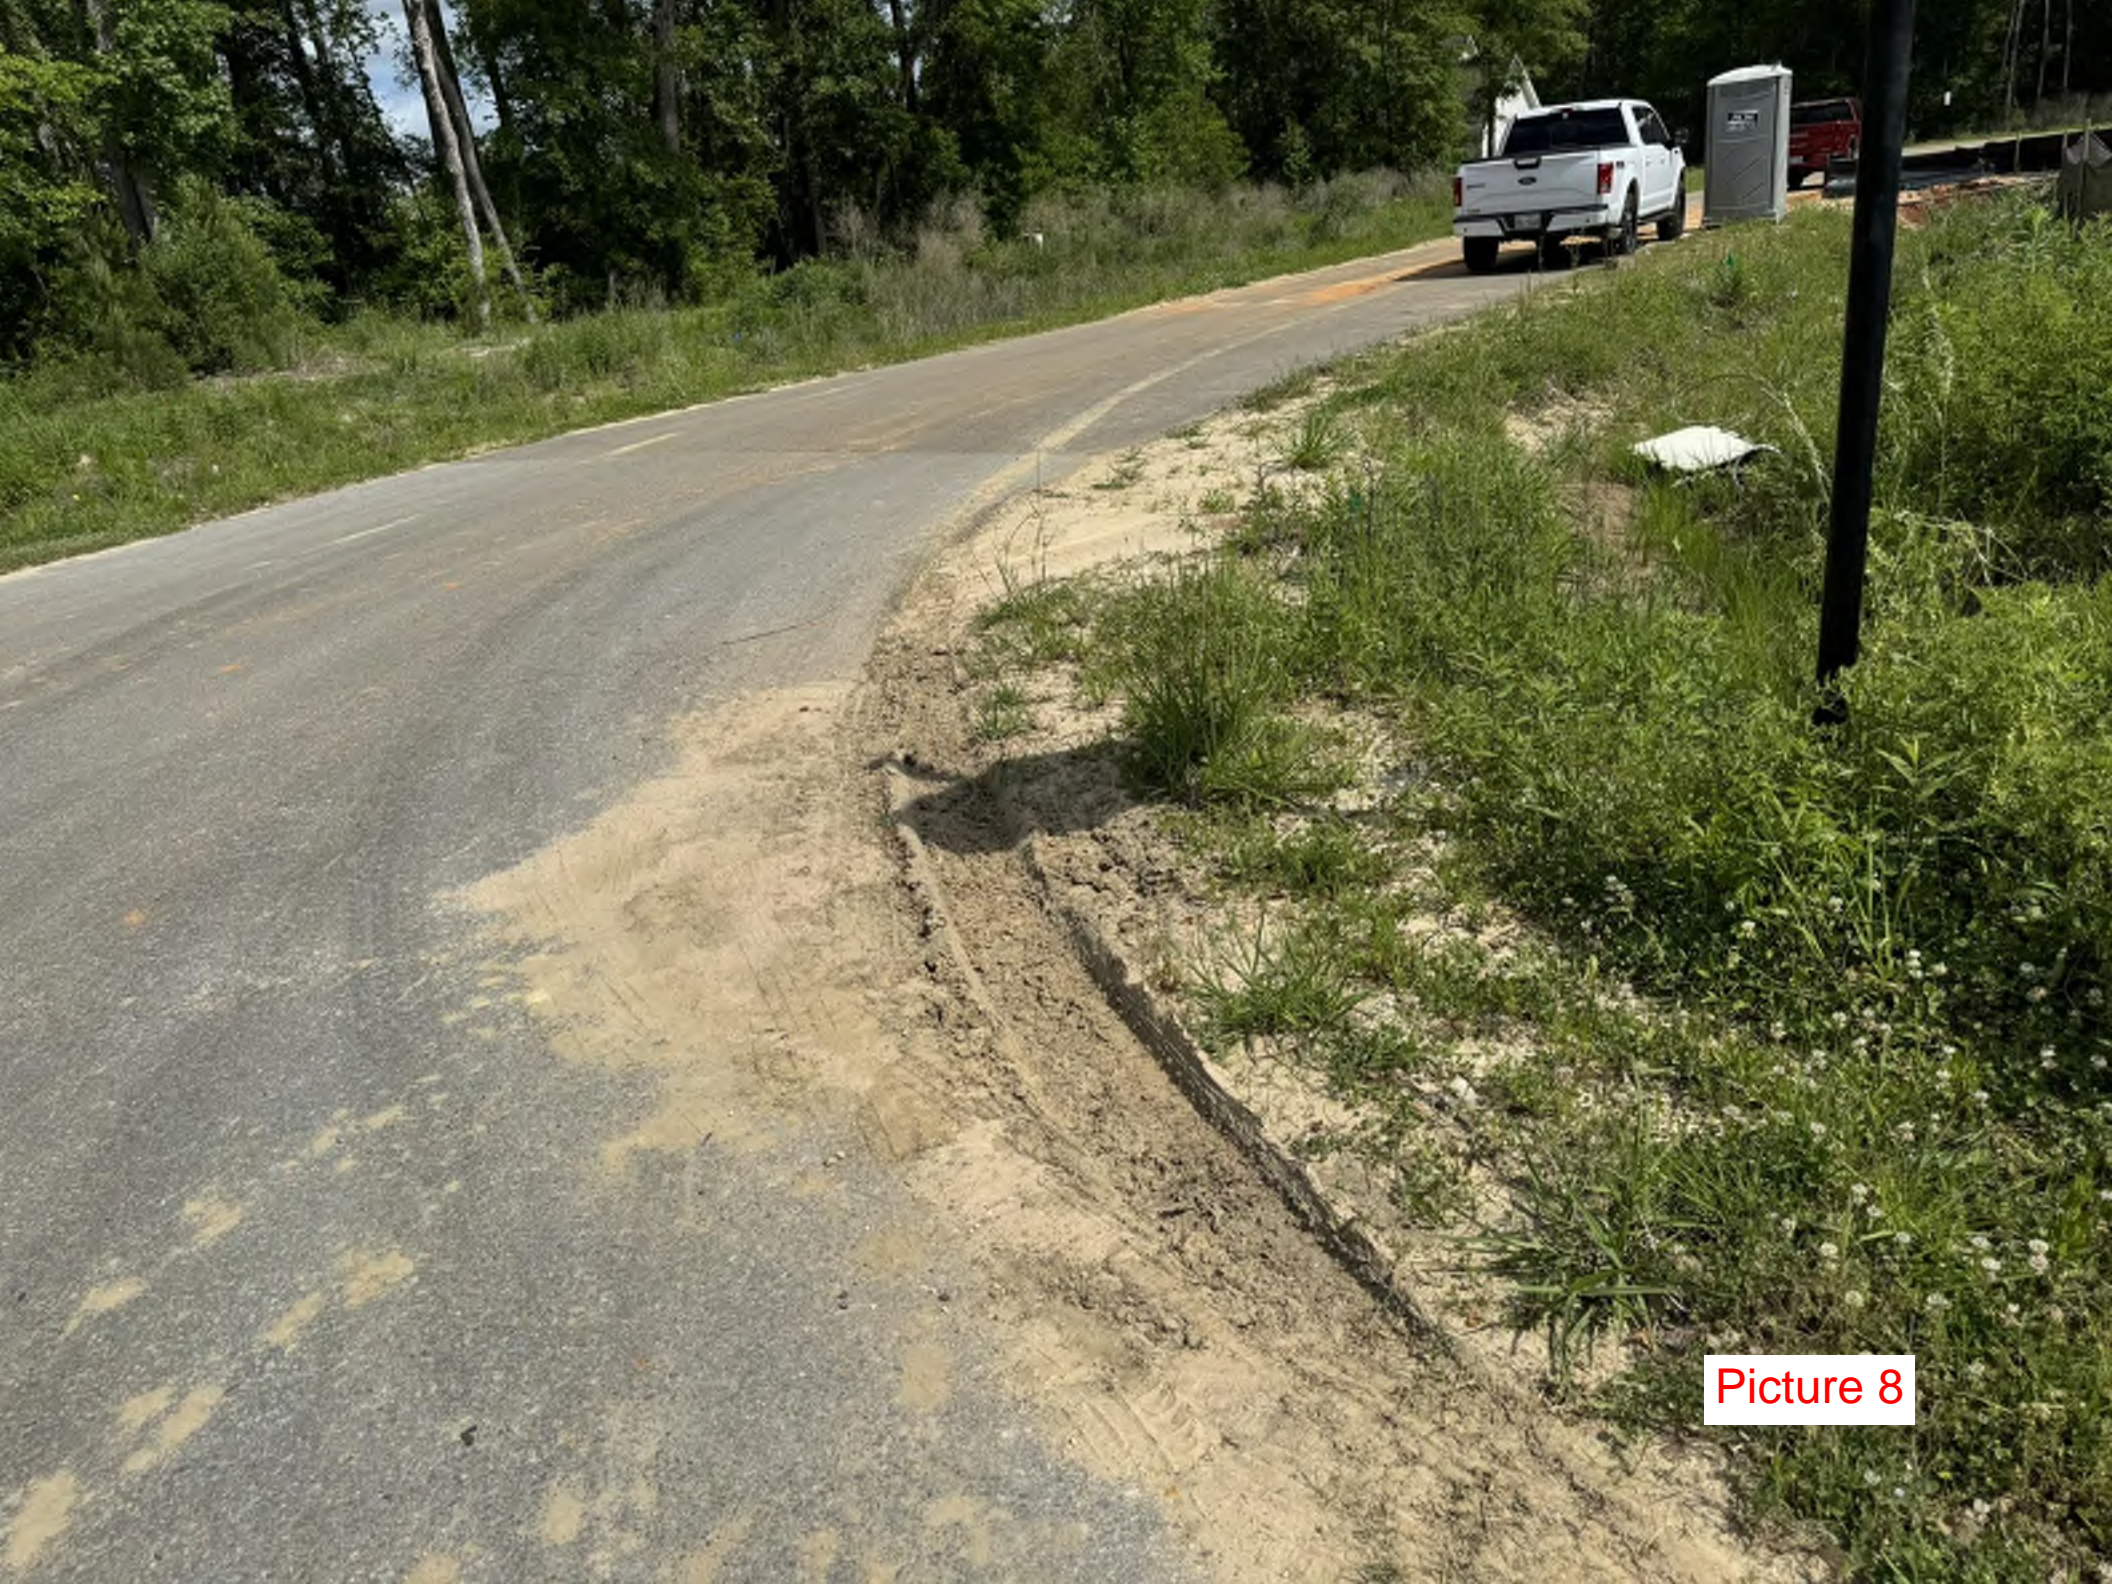
2. The settlement of the asphalt pavement located in the vicinity of Lot #104 needs to be repaired (See picture #3);
3. Shoulders within this phase of Abita Ridge need to be re-established and vegetated (See pictures #4 - #9 - Typical Comment);
