## ST. TAMMANY PARISH

Re: Abita Ridge Subdivision, Phase 1  
Extended Warranty Obligation - \$57,900.00 - LOC # 643

In accordance with the St. Tammany Parish Government Code of Ordinances, Part II "Land Development Code," Chapter 125 "Subdivision Regulations," Section 125-210 "Warranty and Performance Obligations," the Department of Engineering made an inspection of the site on April 15, 2024.

Attachment: Representative photos from site inspection performed on April 15, 2024

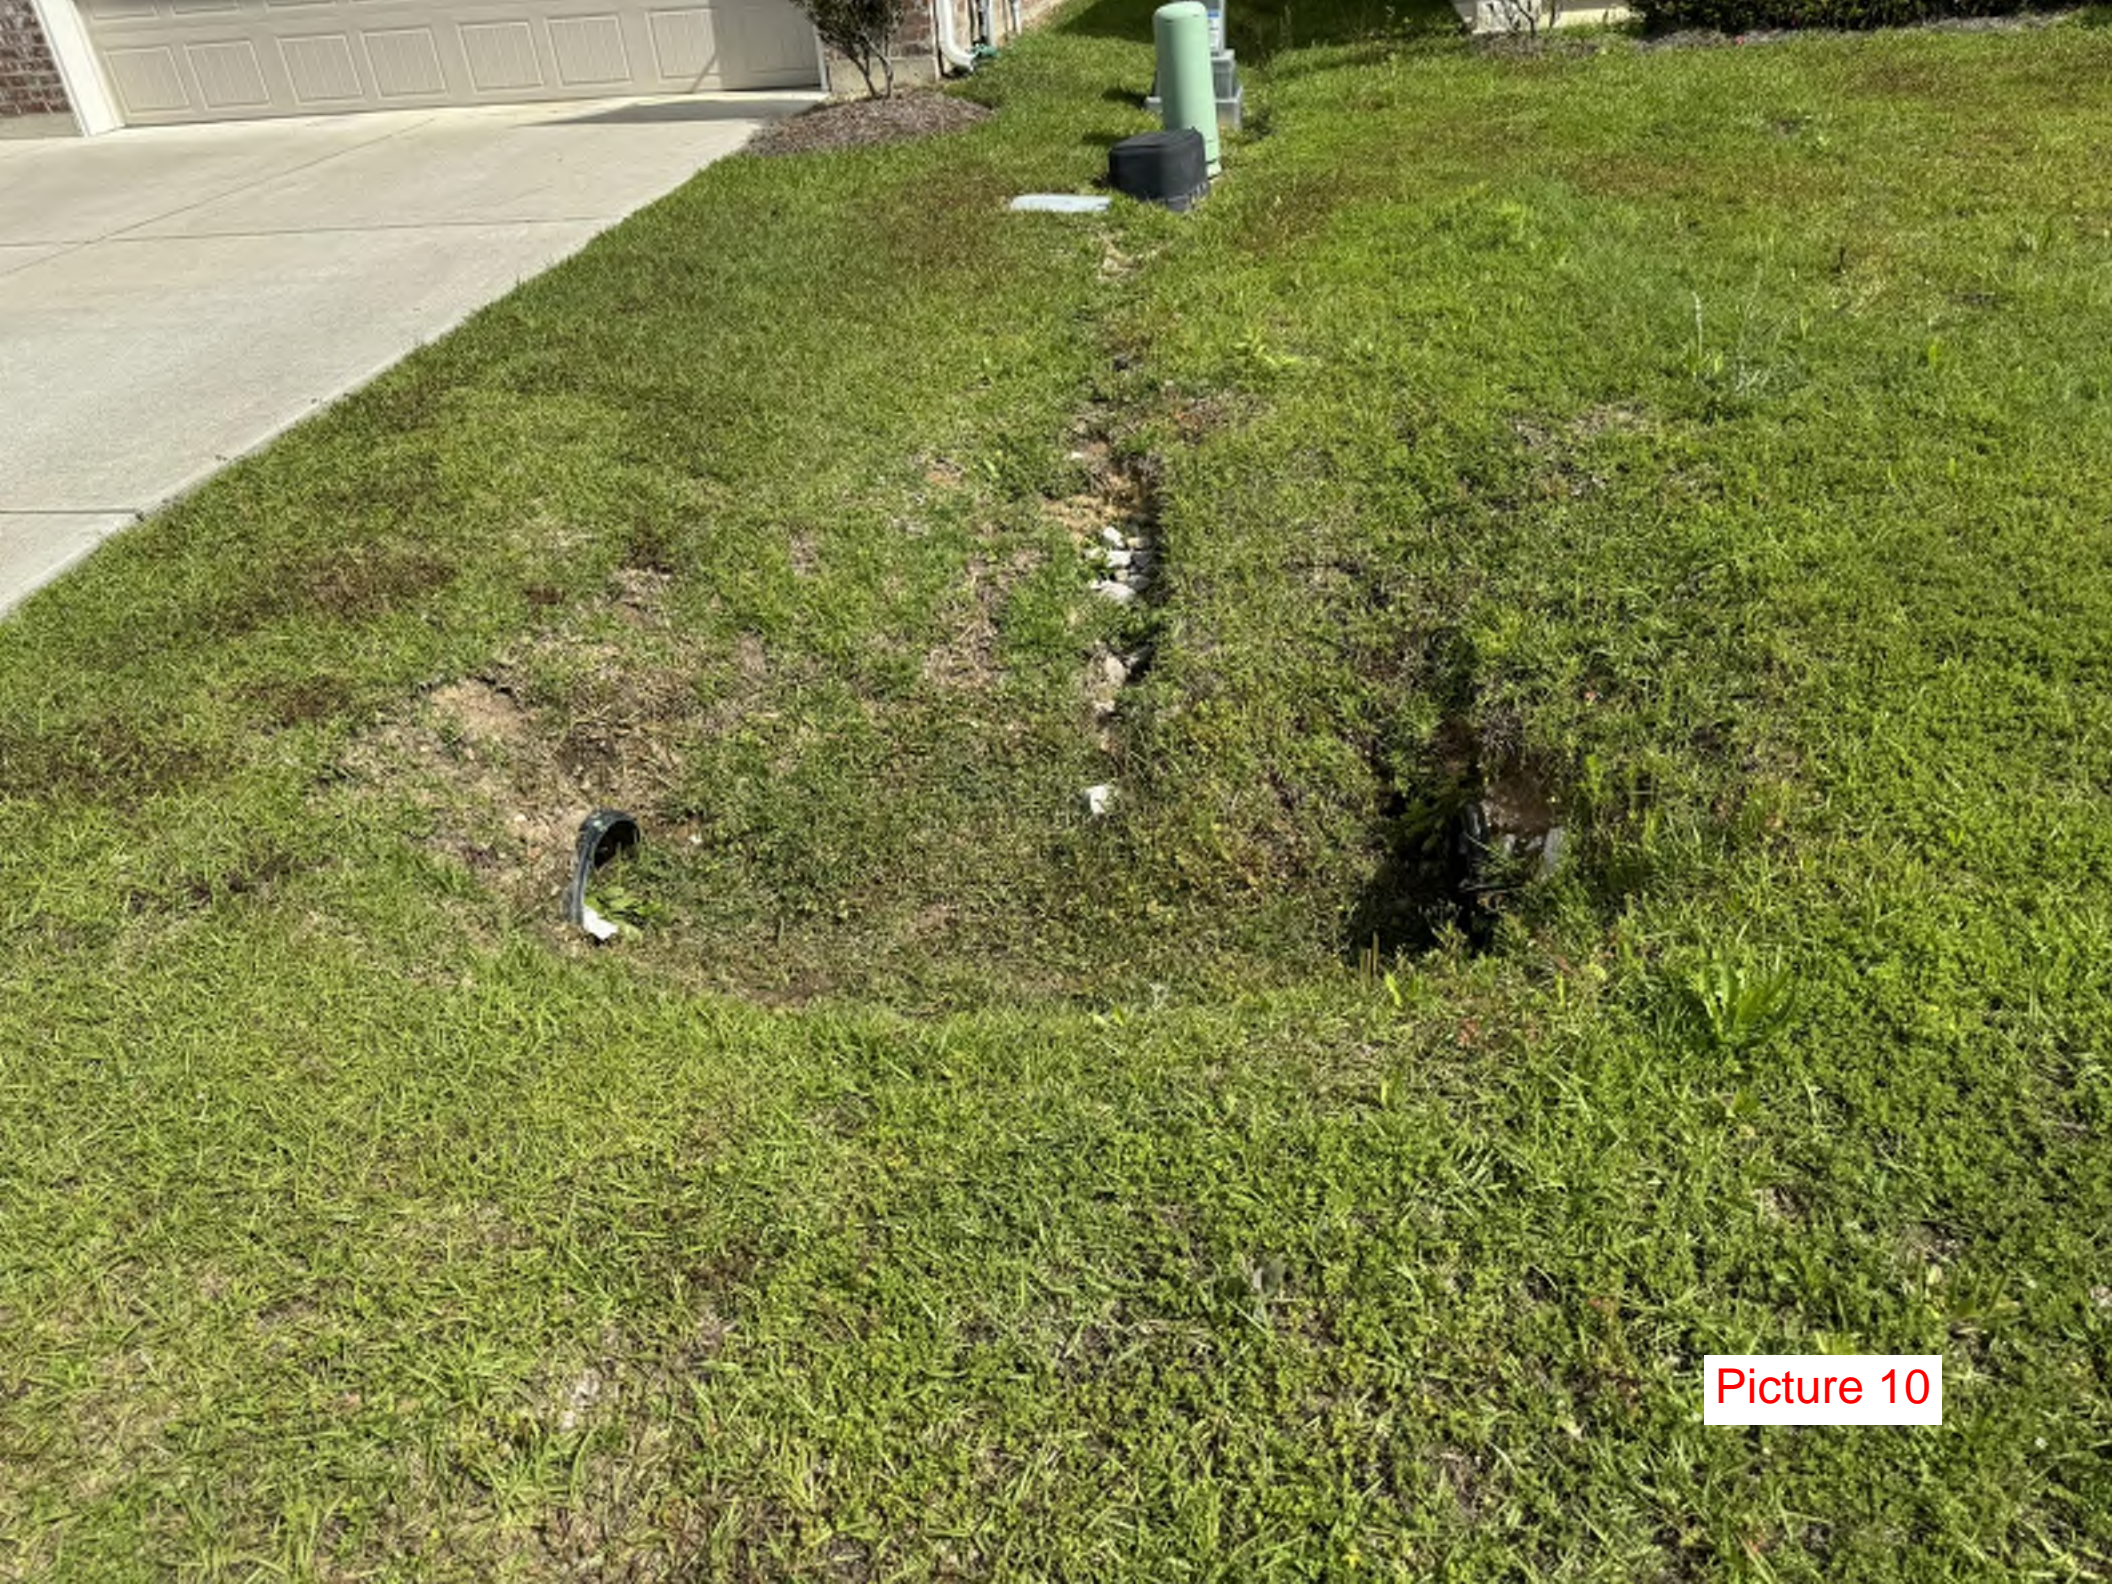
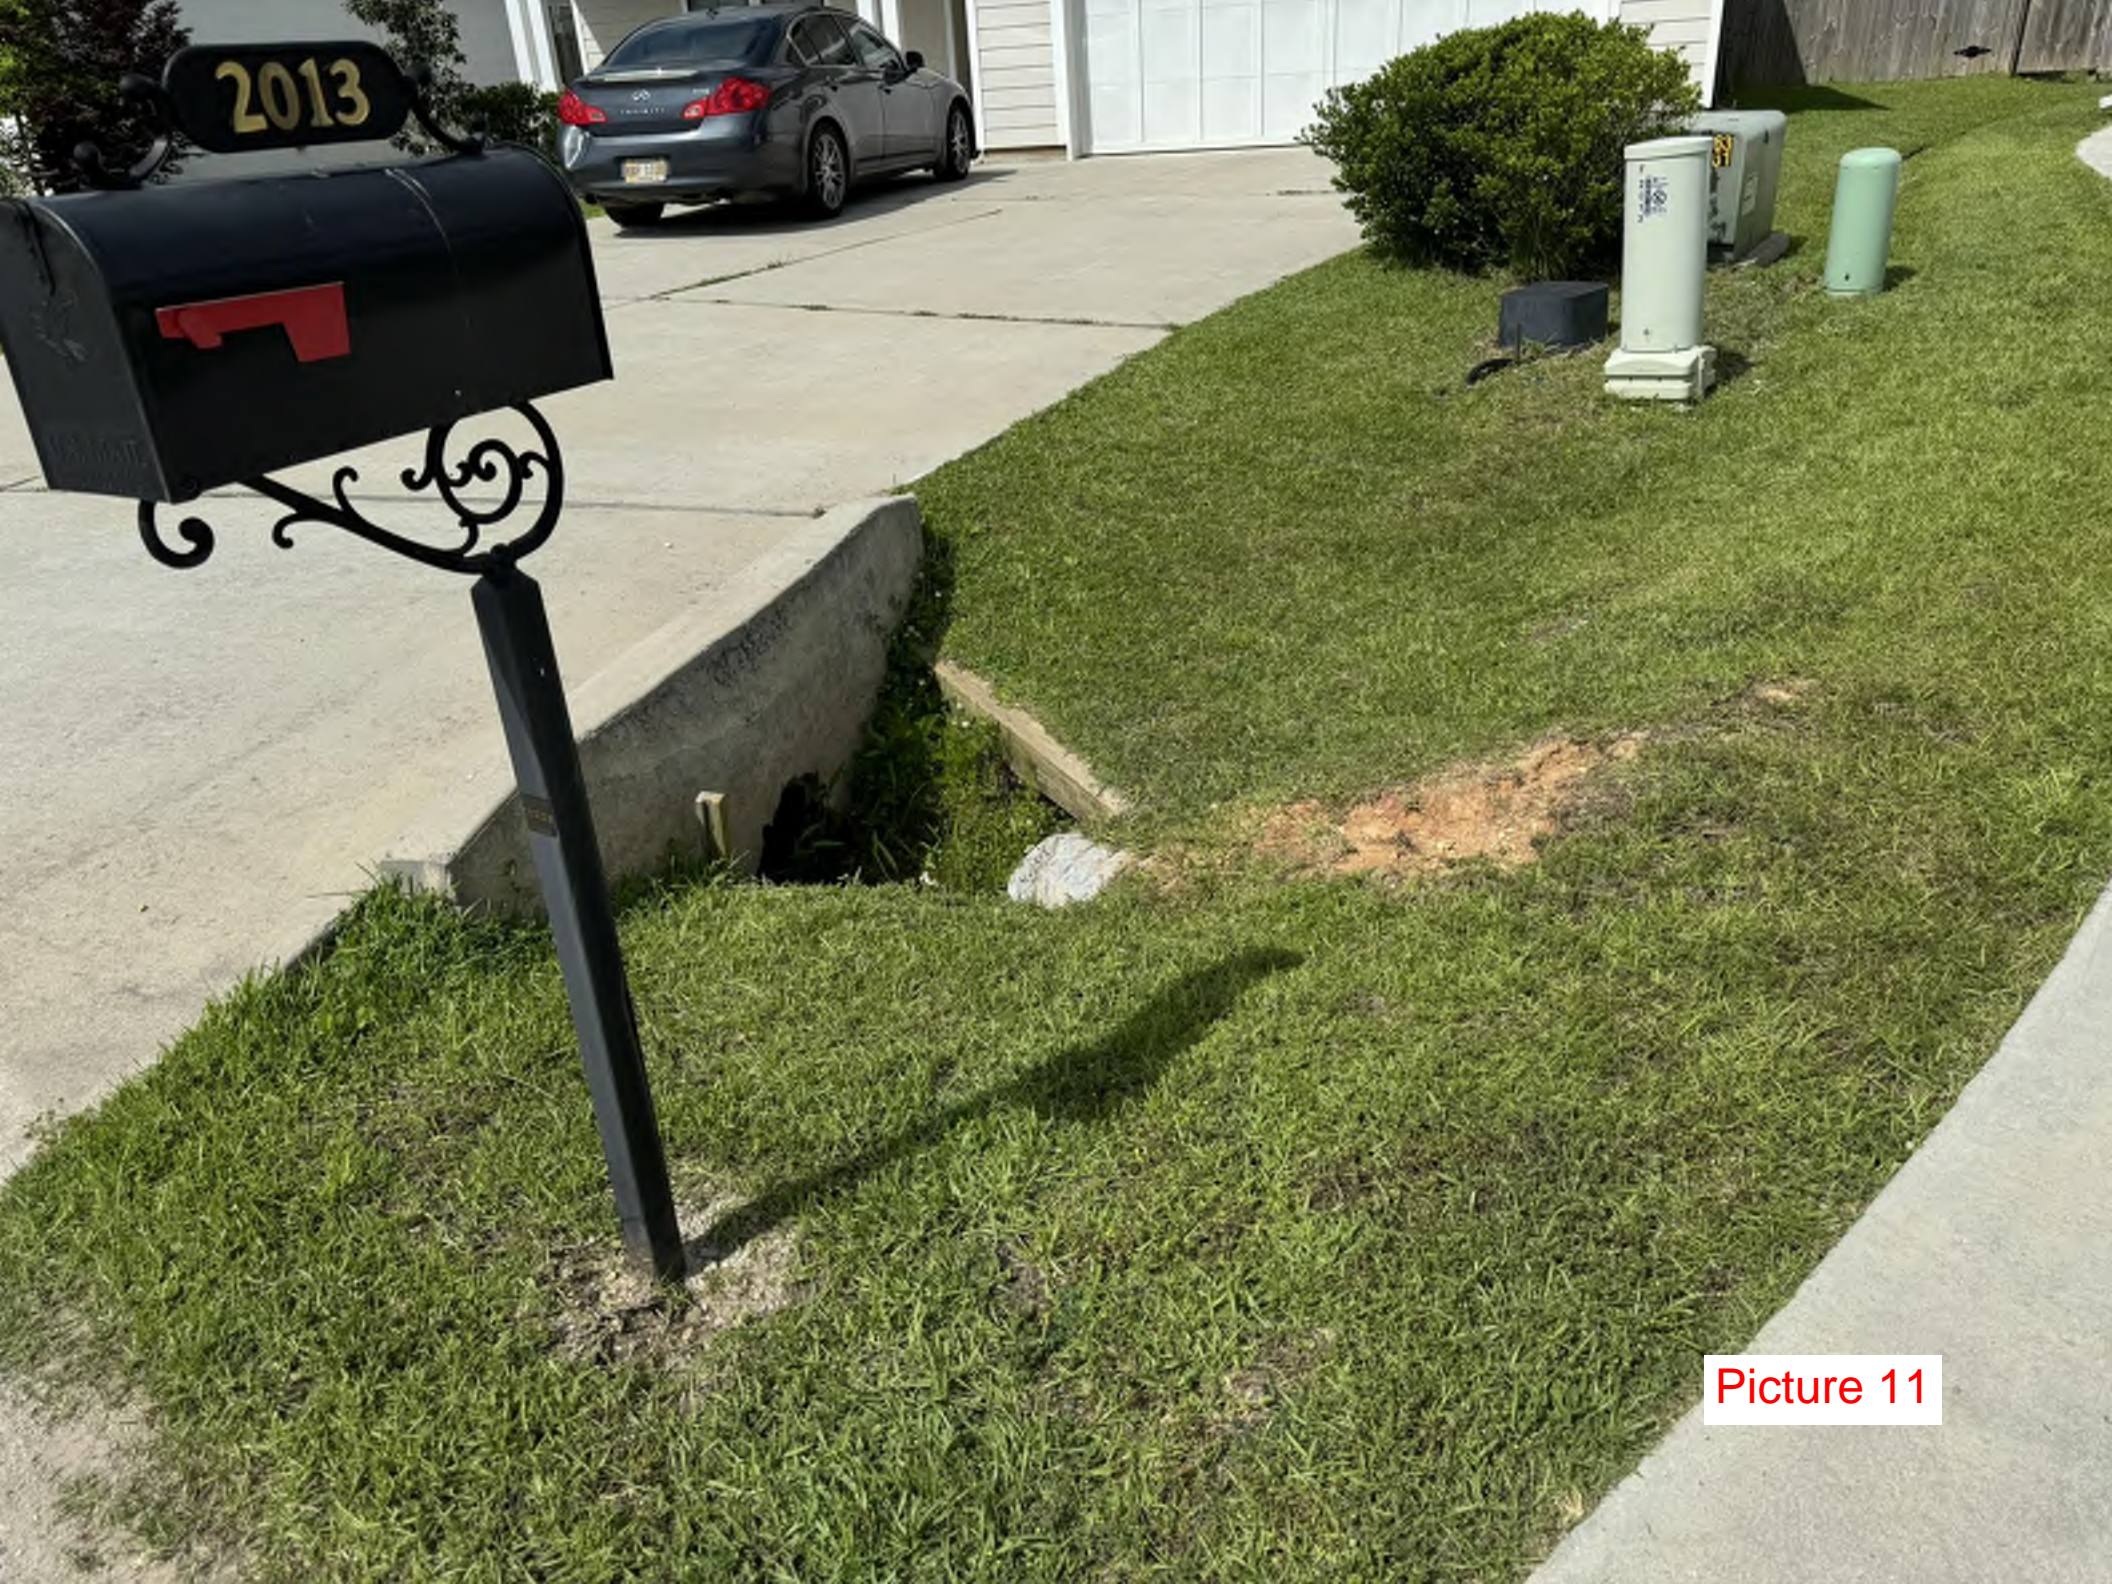
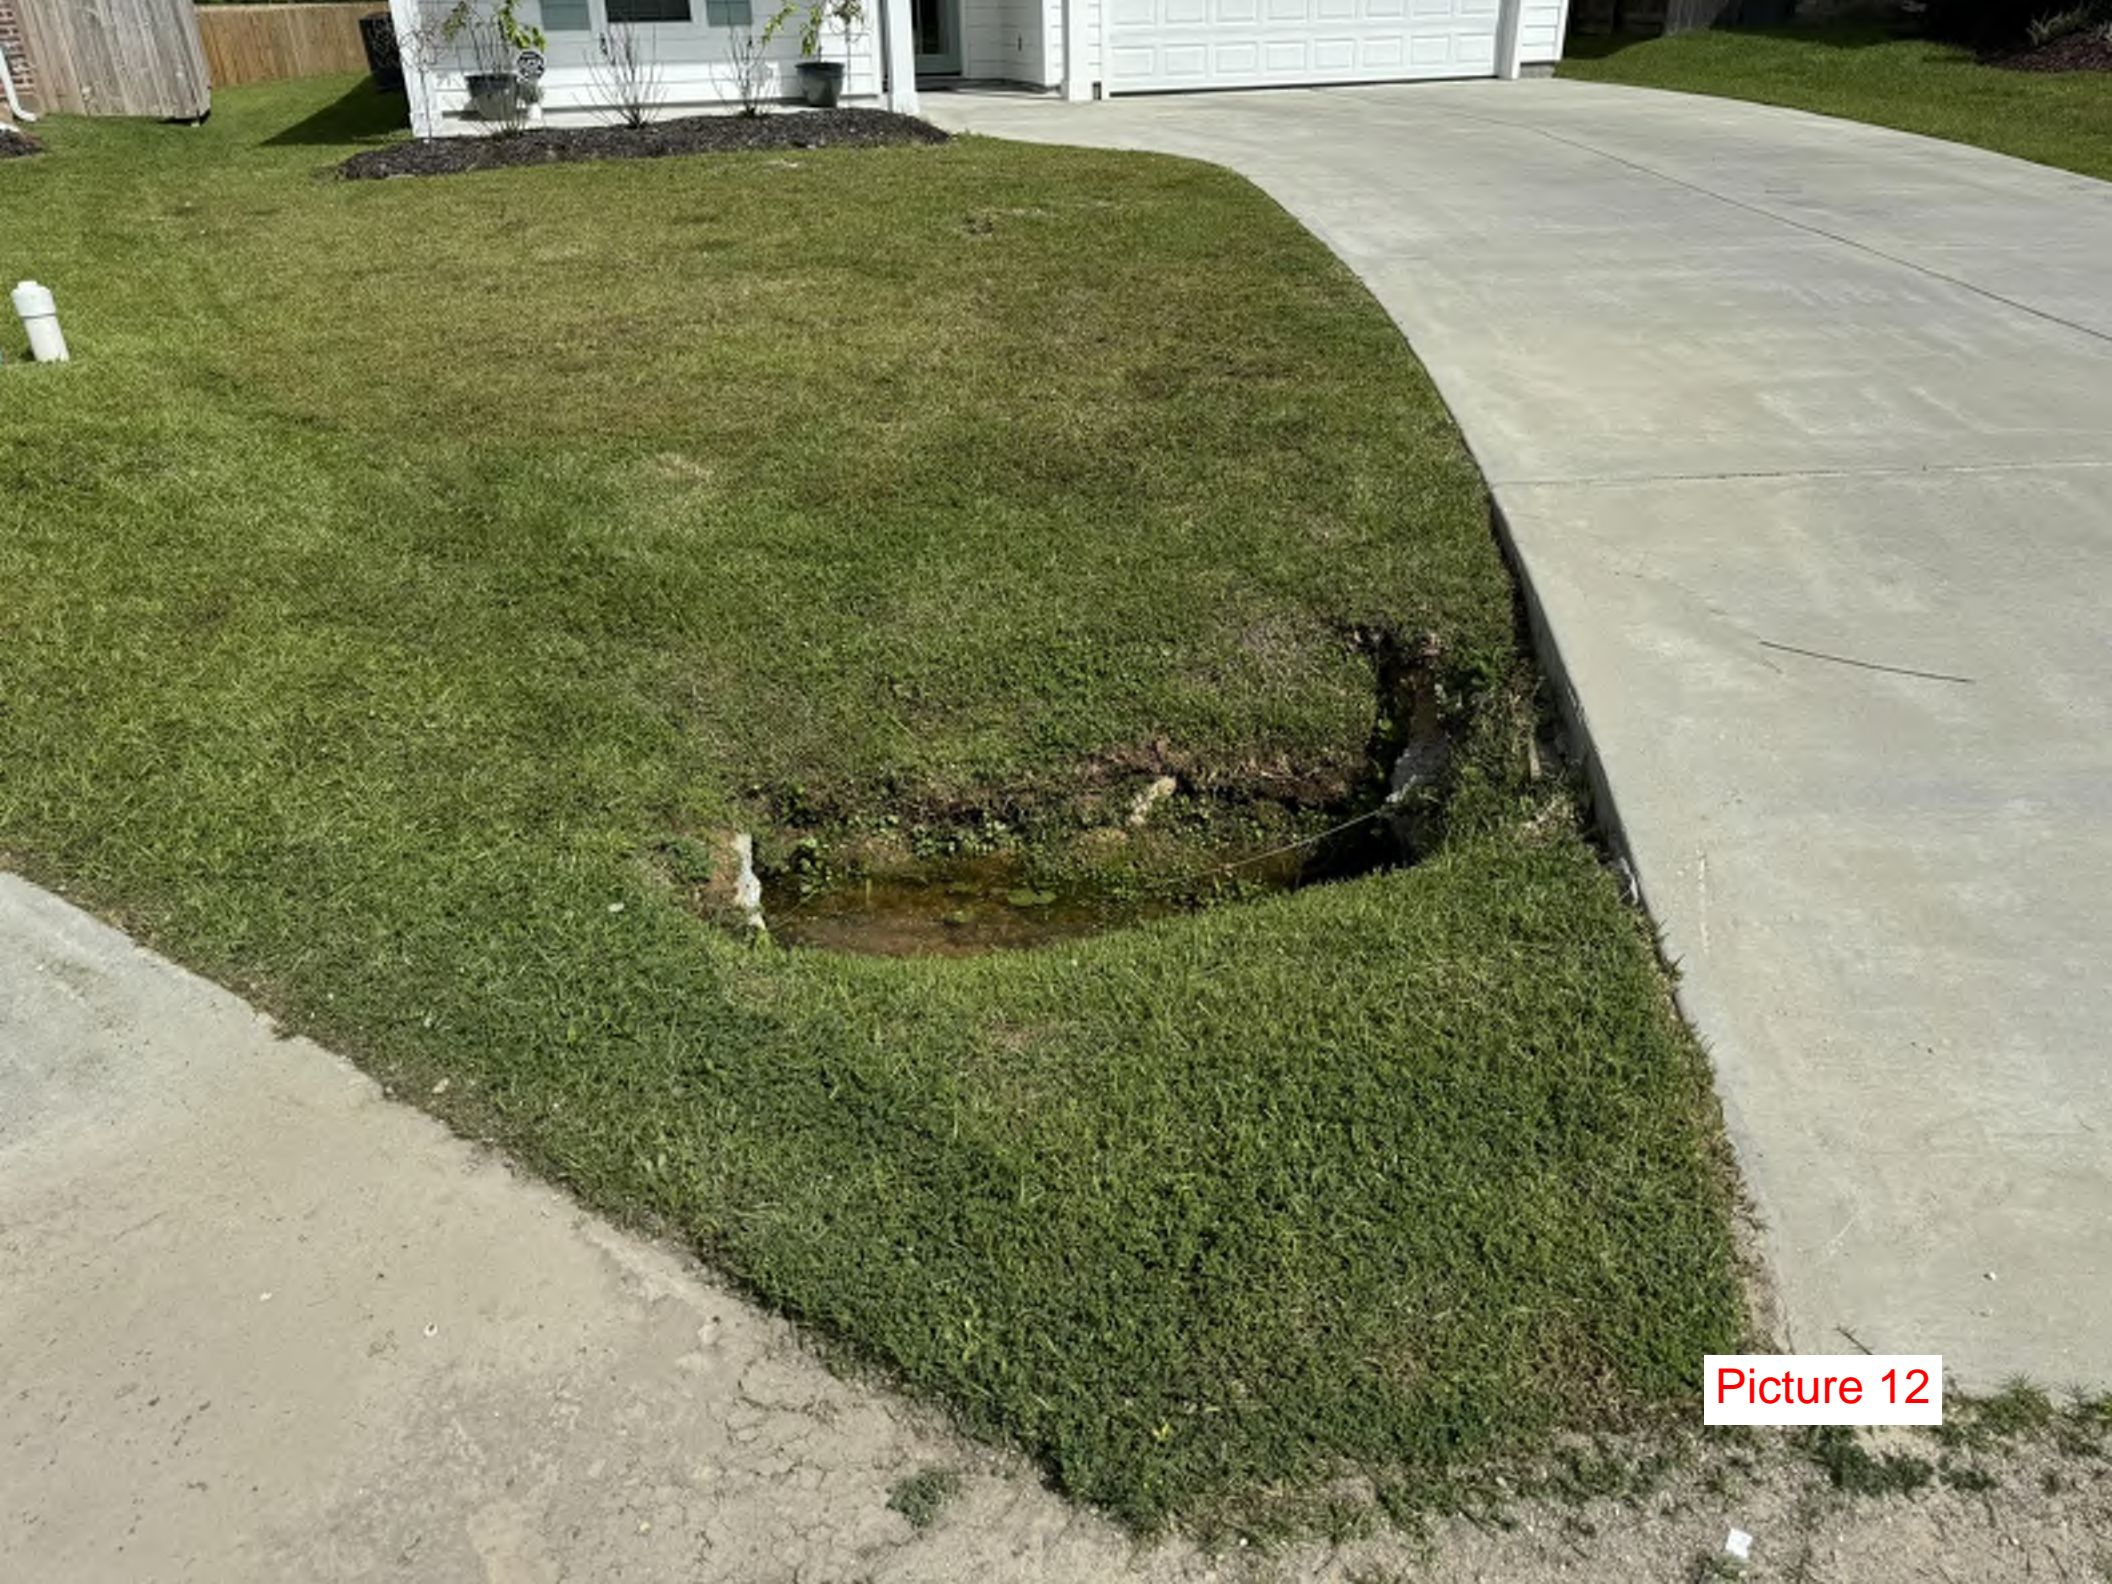
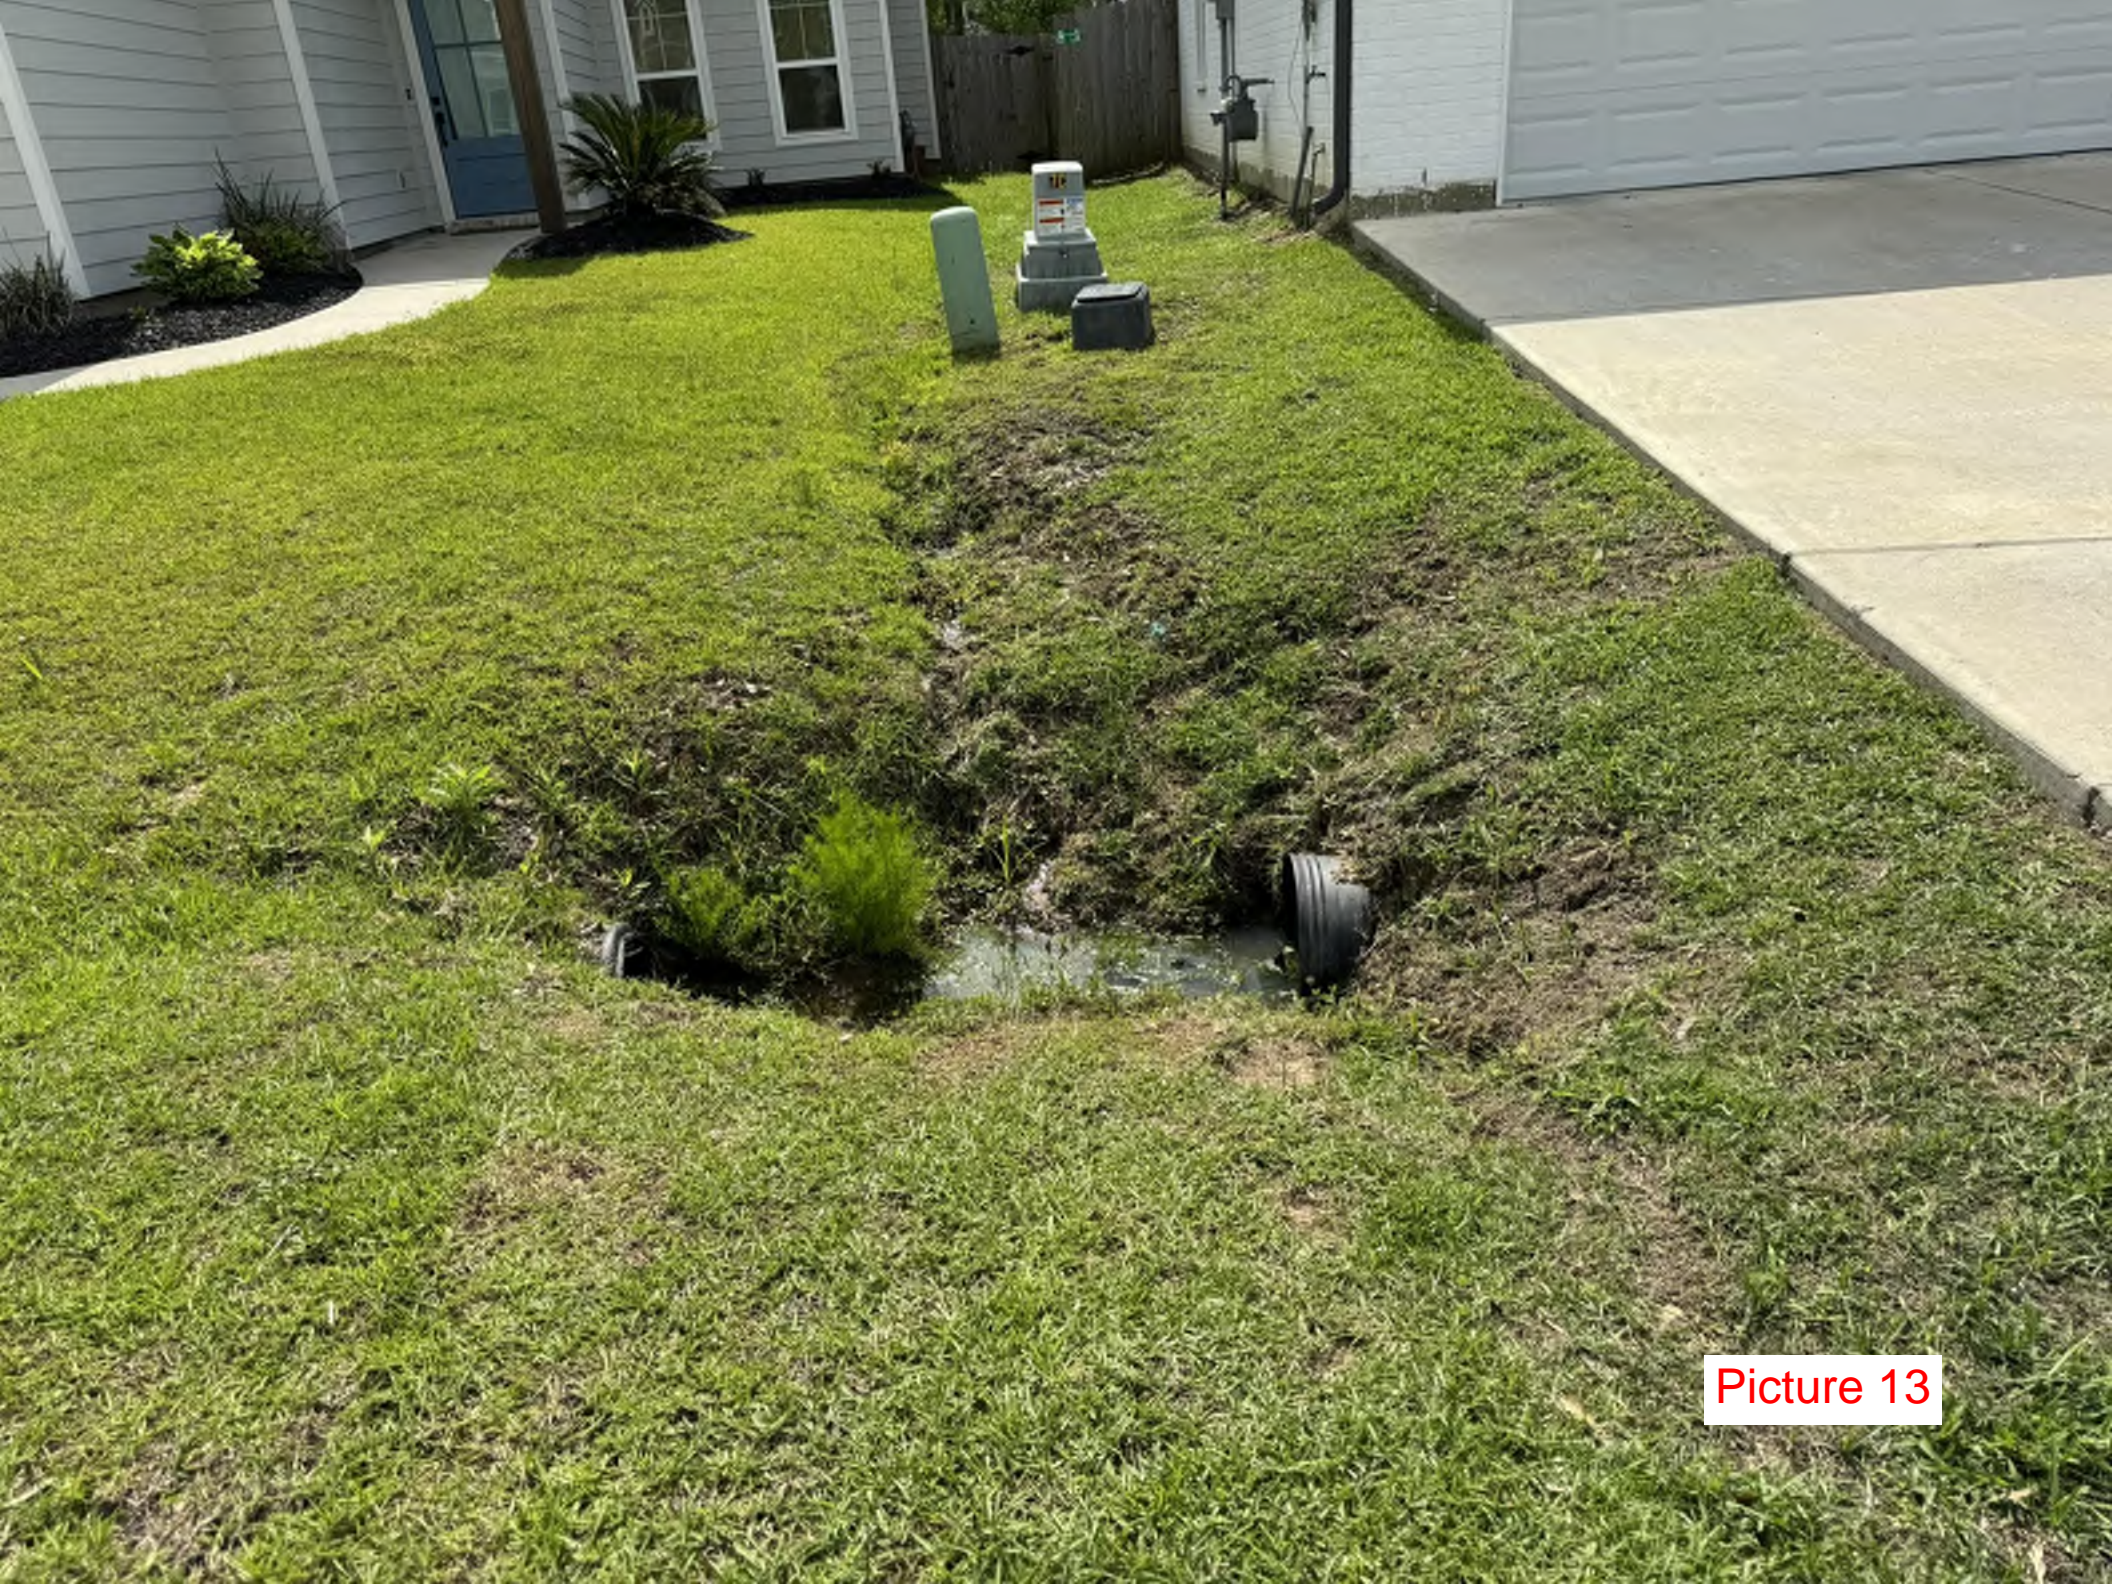
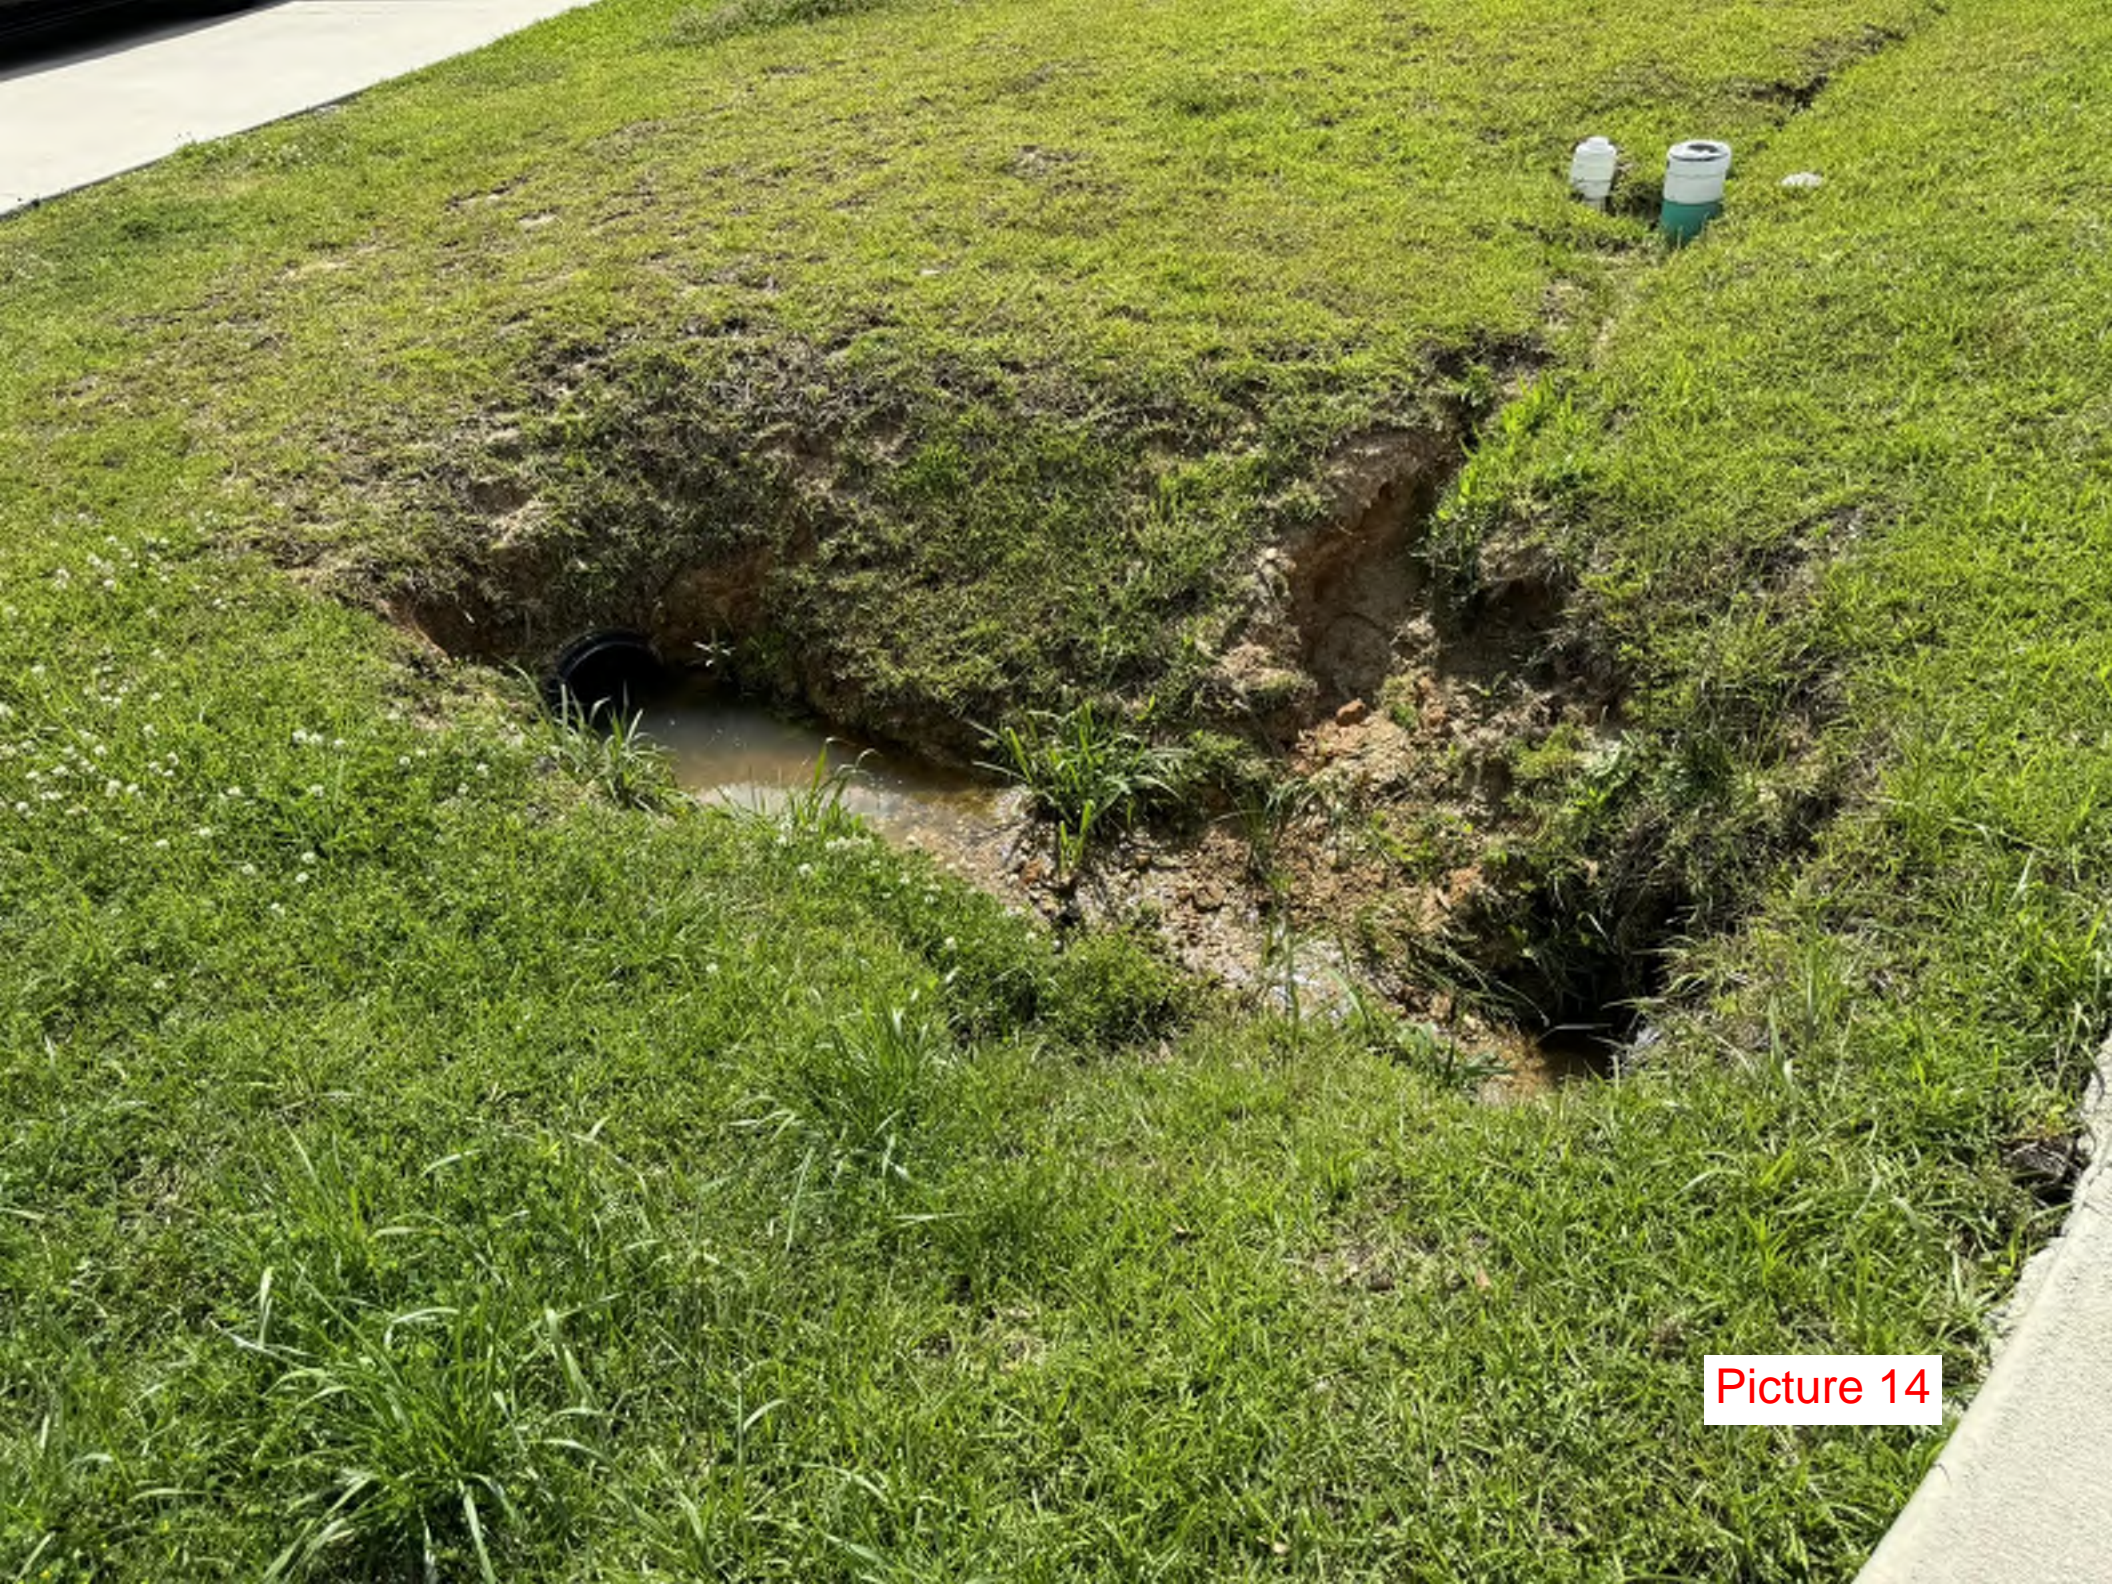
4. The distance between the driveway culverts for Lots #82 through #85, Lots #116 through #120, Lots #126 through #132, and between Lots #50 and #51 are too close in proximity for Public Works to maintain, as such this section of ditch will either need to be subsurfaced and closed in (following STP subsurface procedure by adding catch basins every 50'), or the driveways adjusted to provide the required space for maintenance. The minimum distance allowed between pipe ends is 10 feet (See pictures #10 - #14);
