## ST. TAMMANY PARISH

Re: Abita Ridge Subdivision, Phase 1  
Extended Warranty Obligation - \$57,900.00 - LOC # 643

In accordance with the St. Tammany Parish Government Code of Ordinances, Part II "Land Development Code," Chapter 125 "Subdivision Regulations," Section 125-210 "Warranty and Performance Obligations," the Department of Engineering made an inspection of the site on April 15, 2024.

Attachment: Representative photos from site inspection performed on April 15, 2024

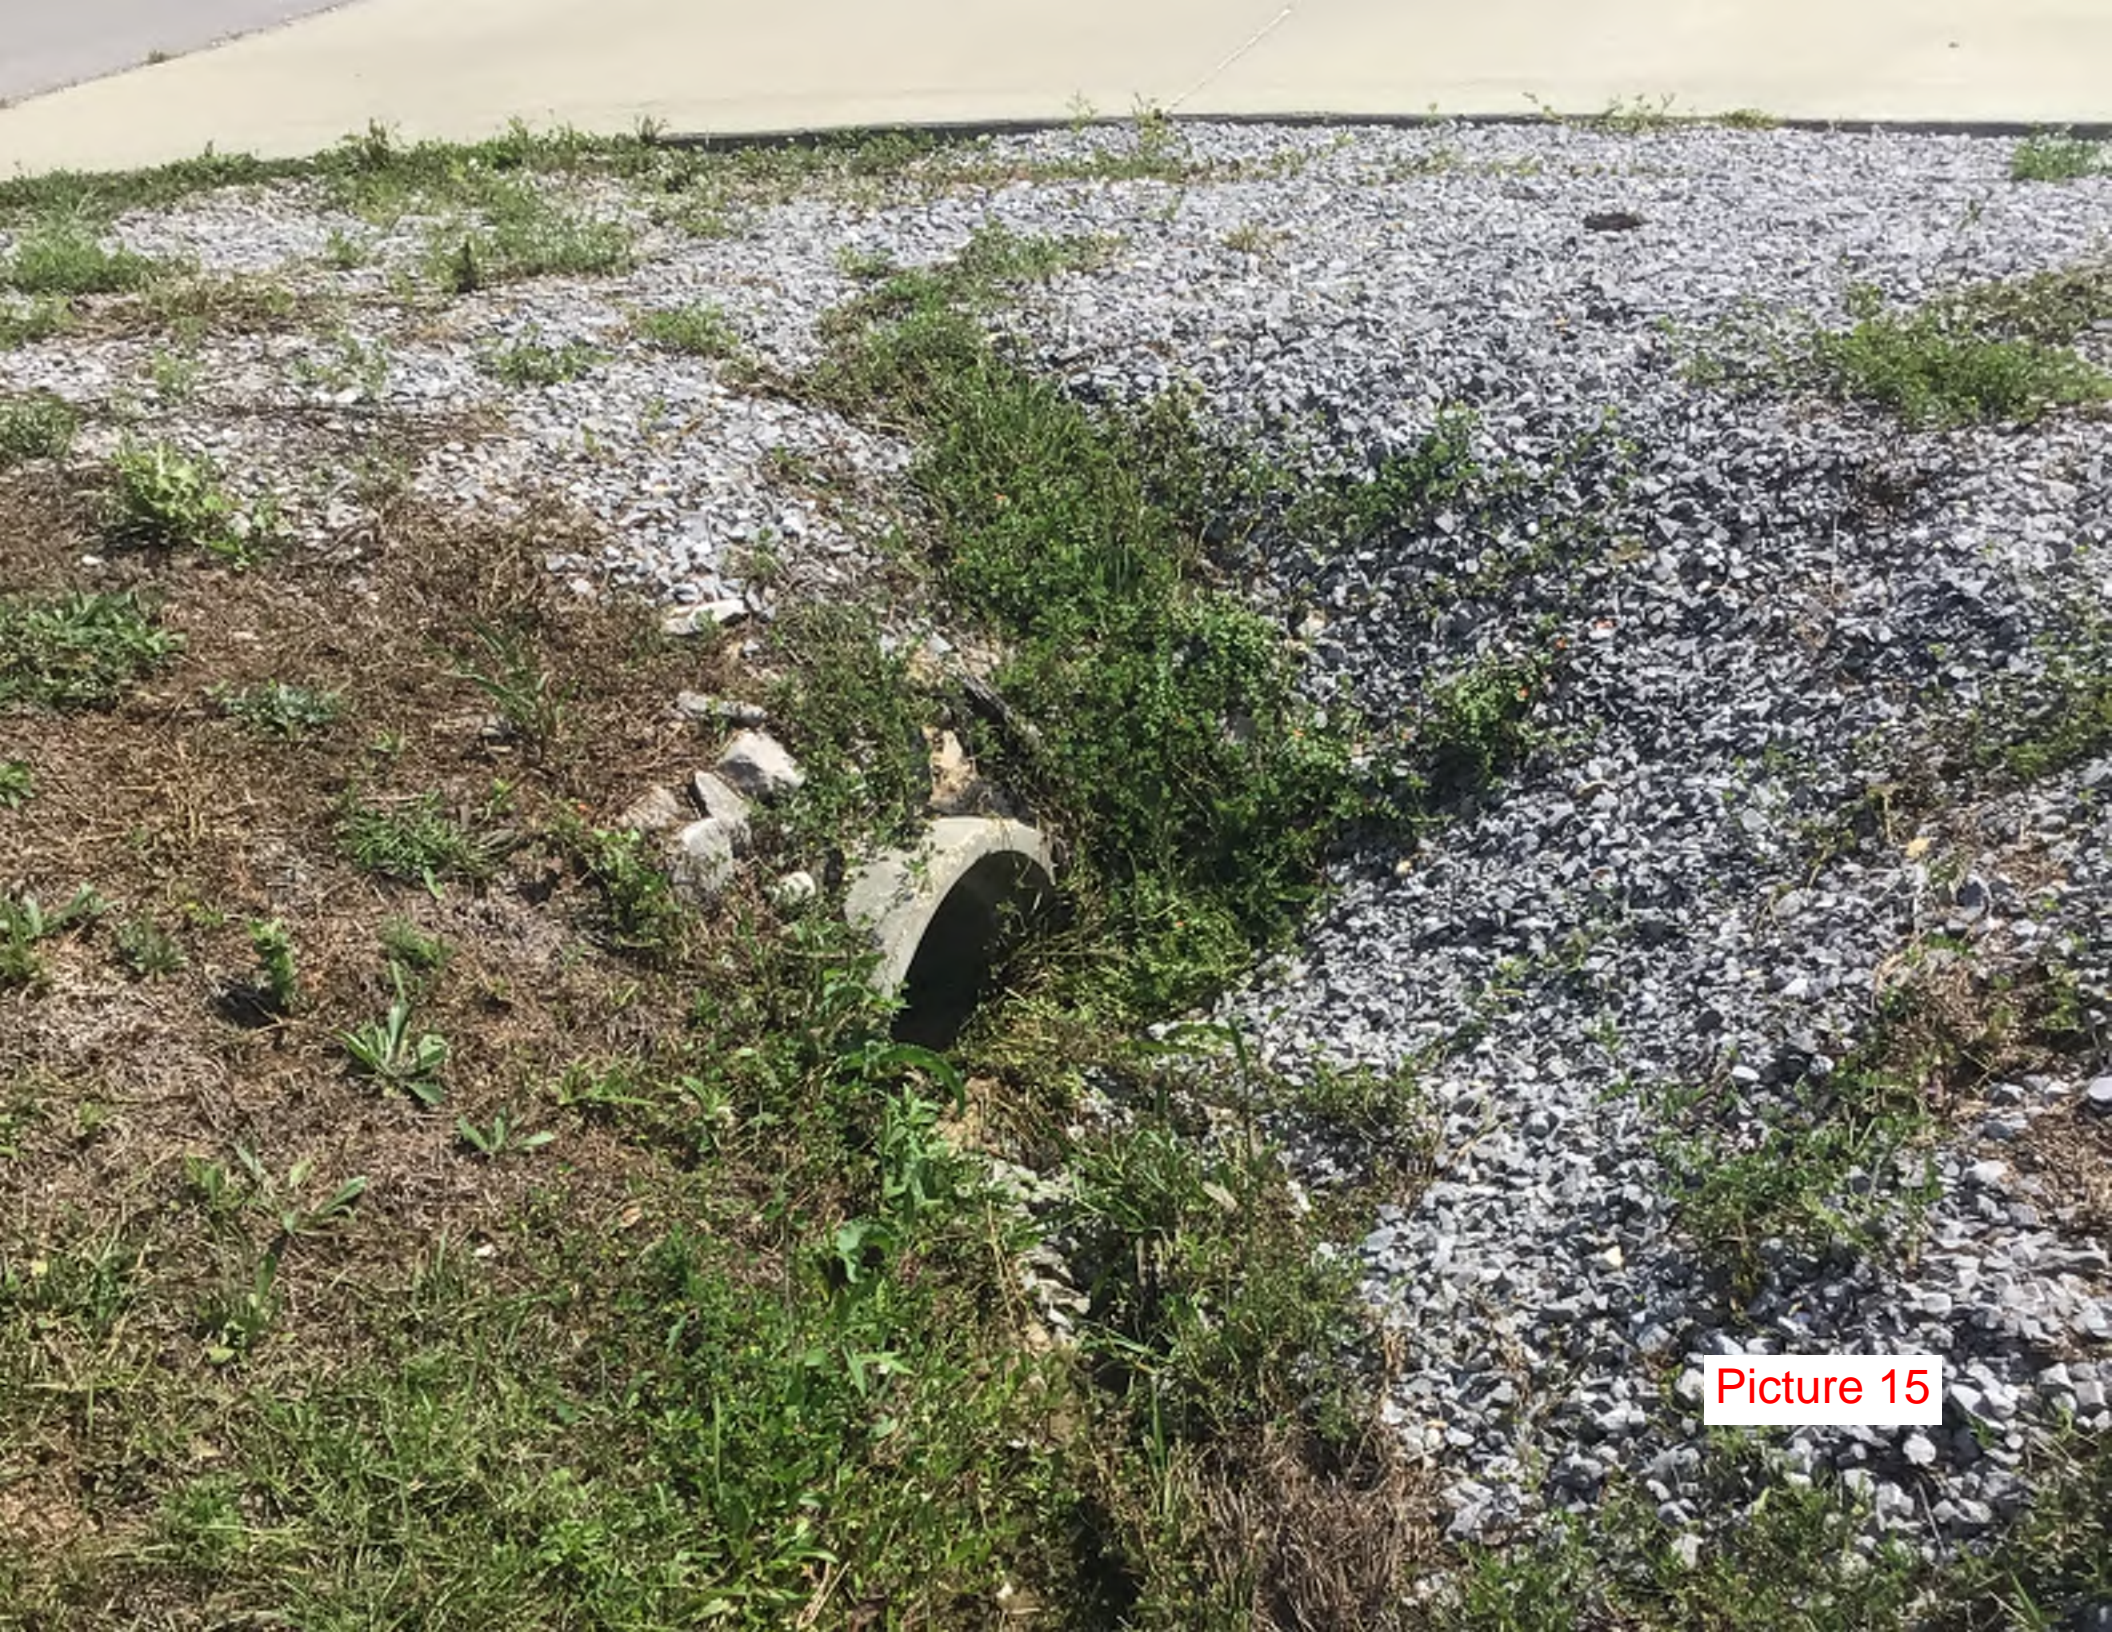
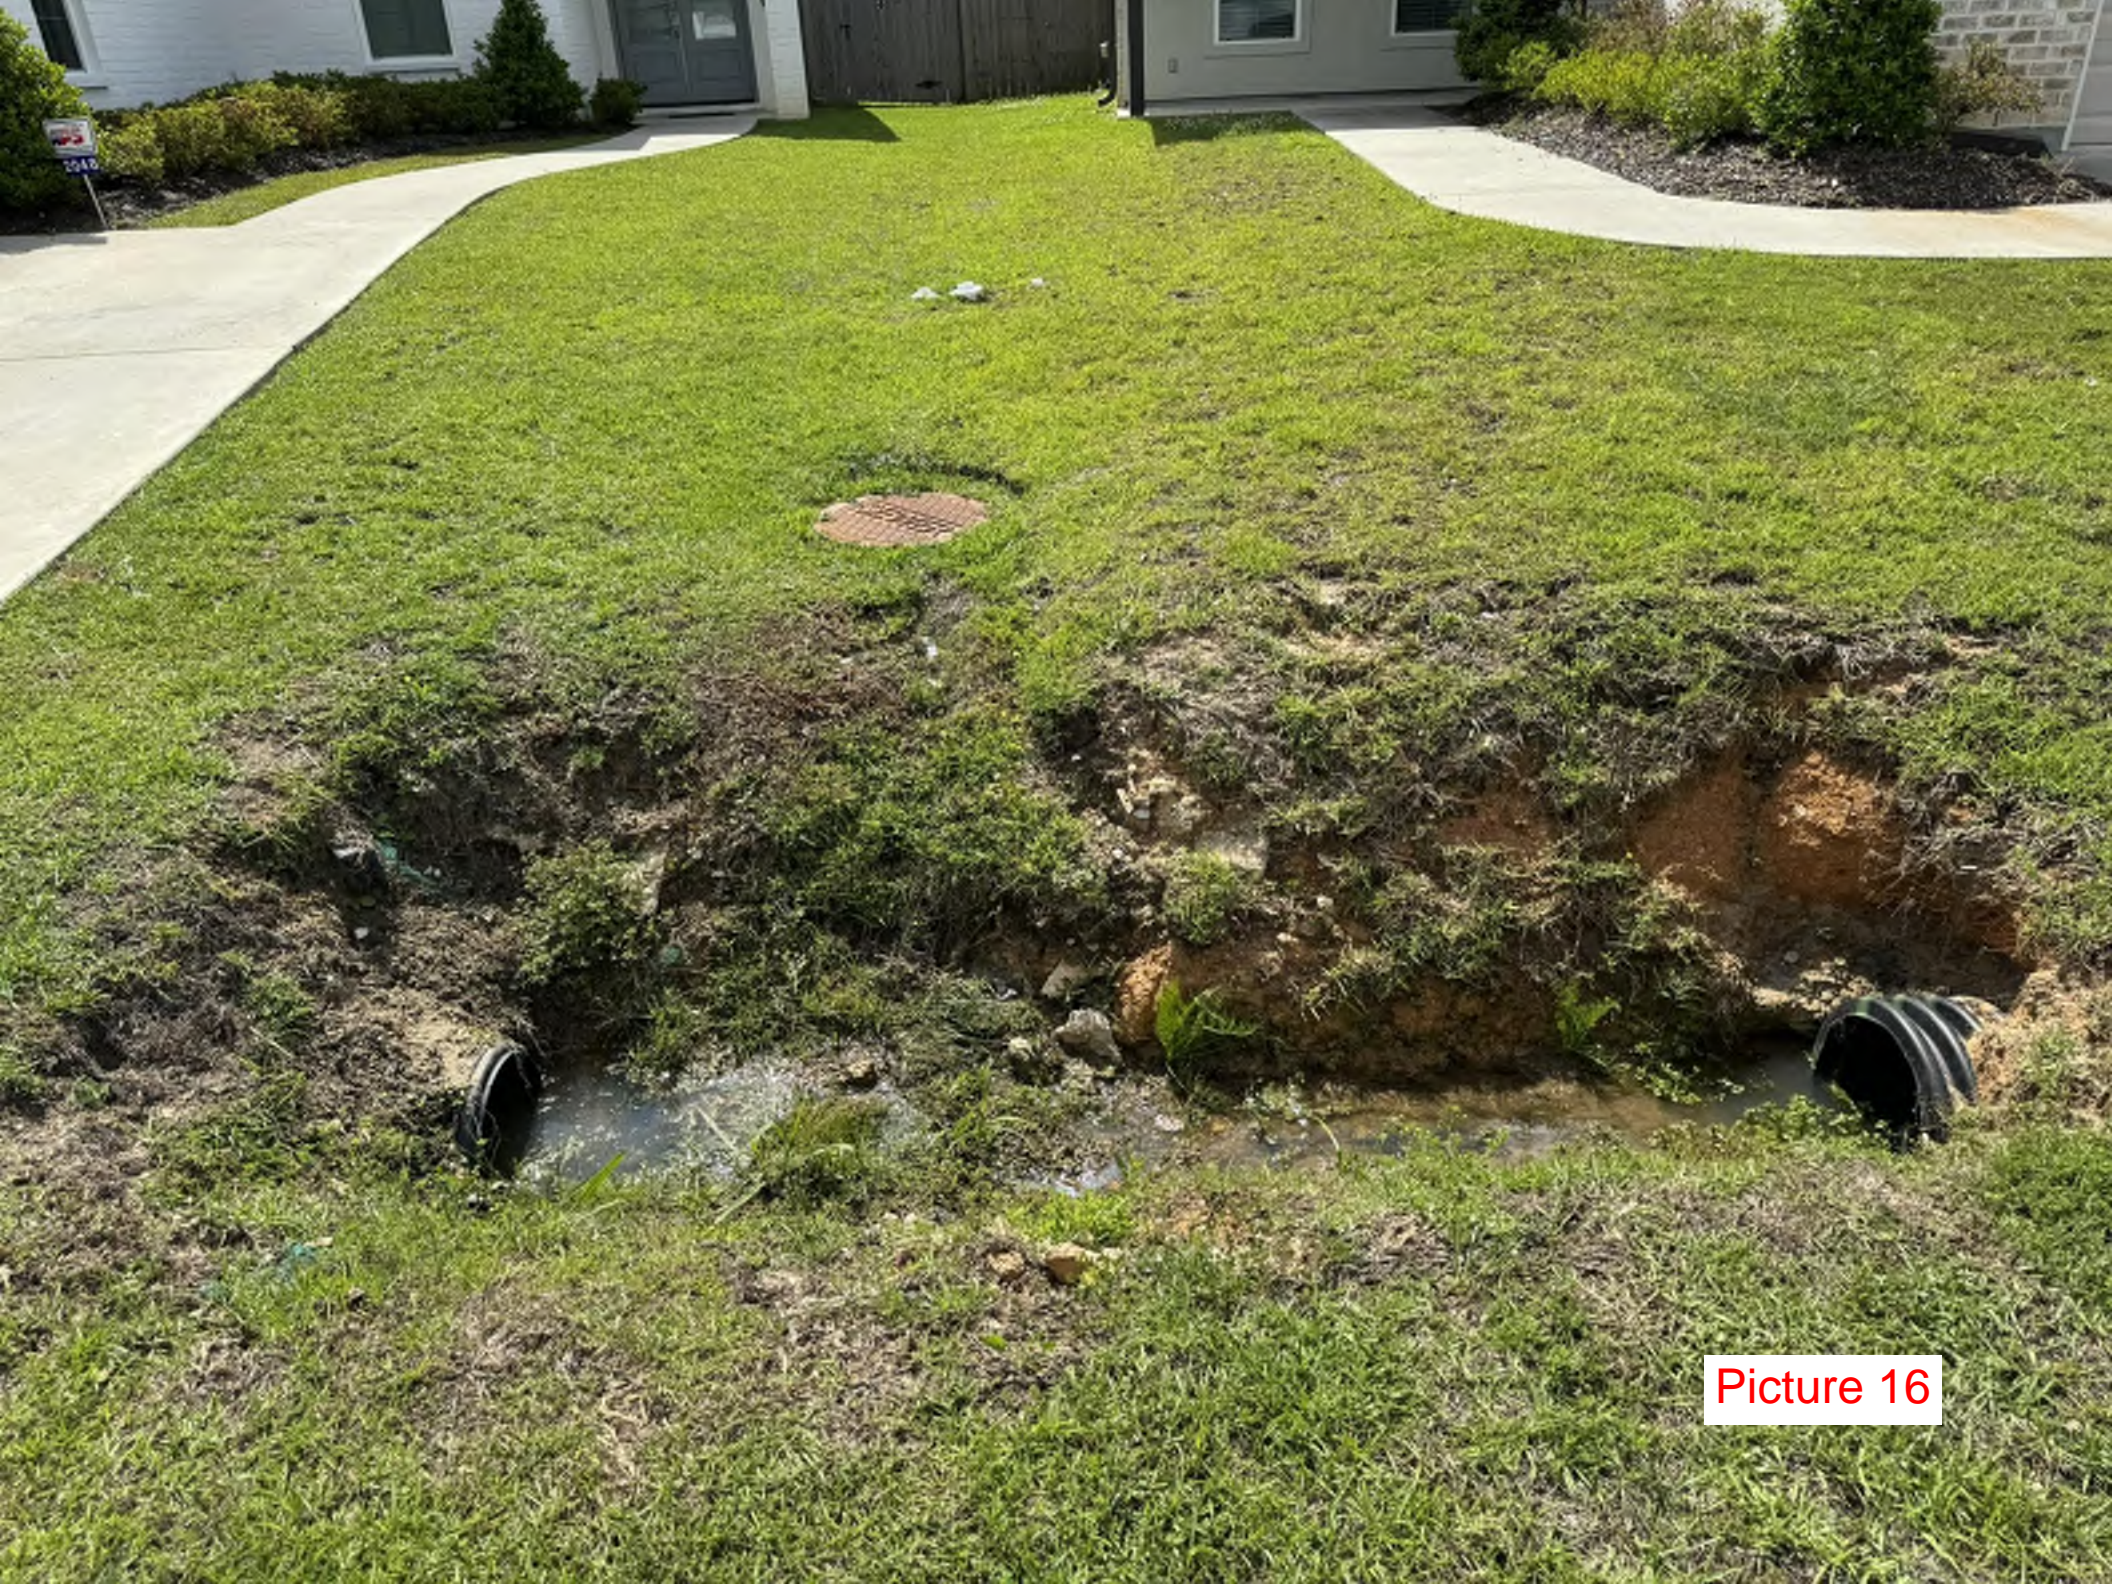
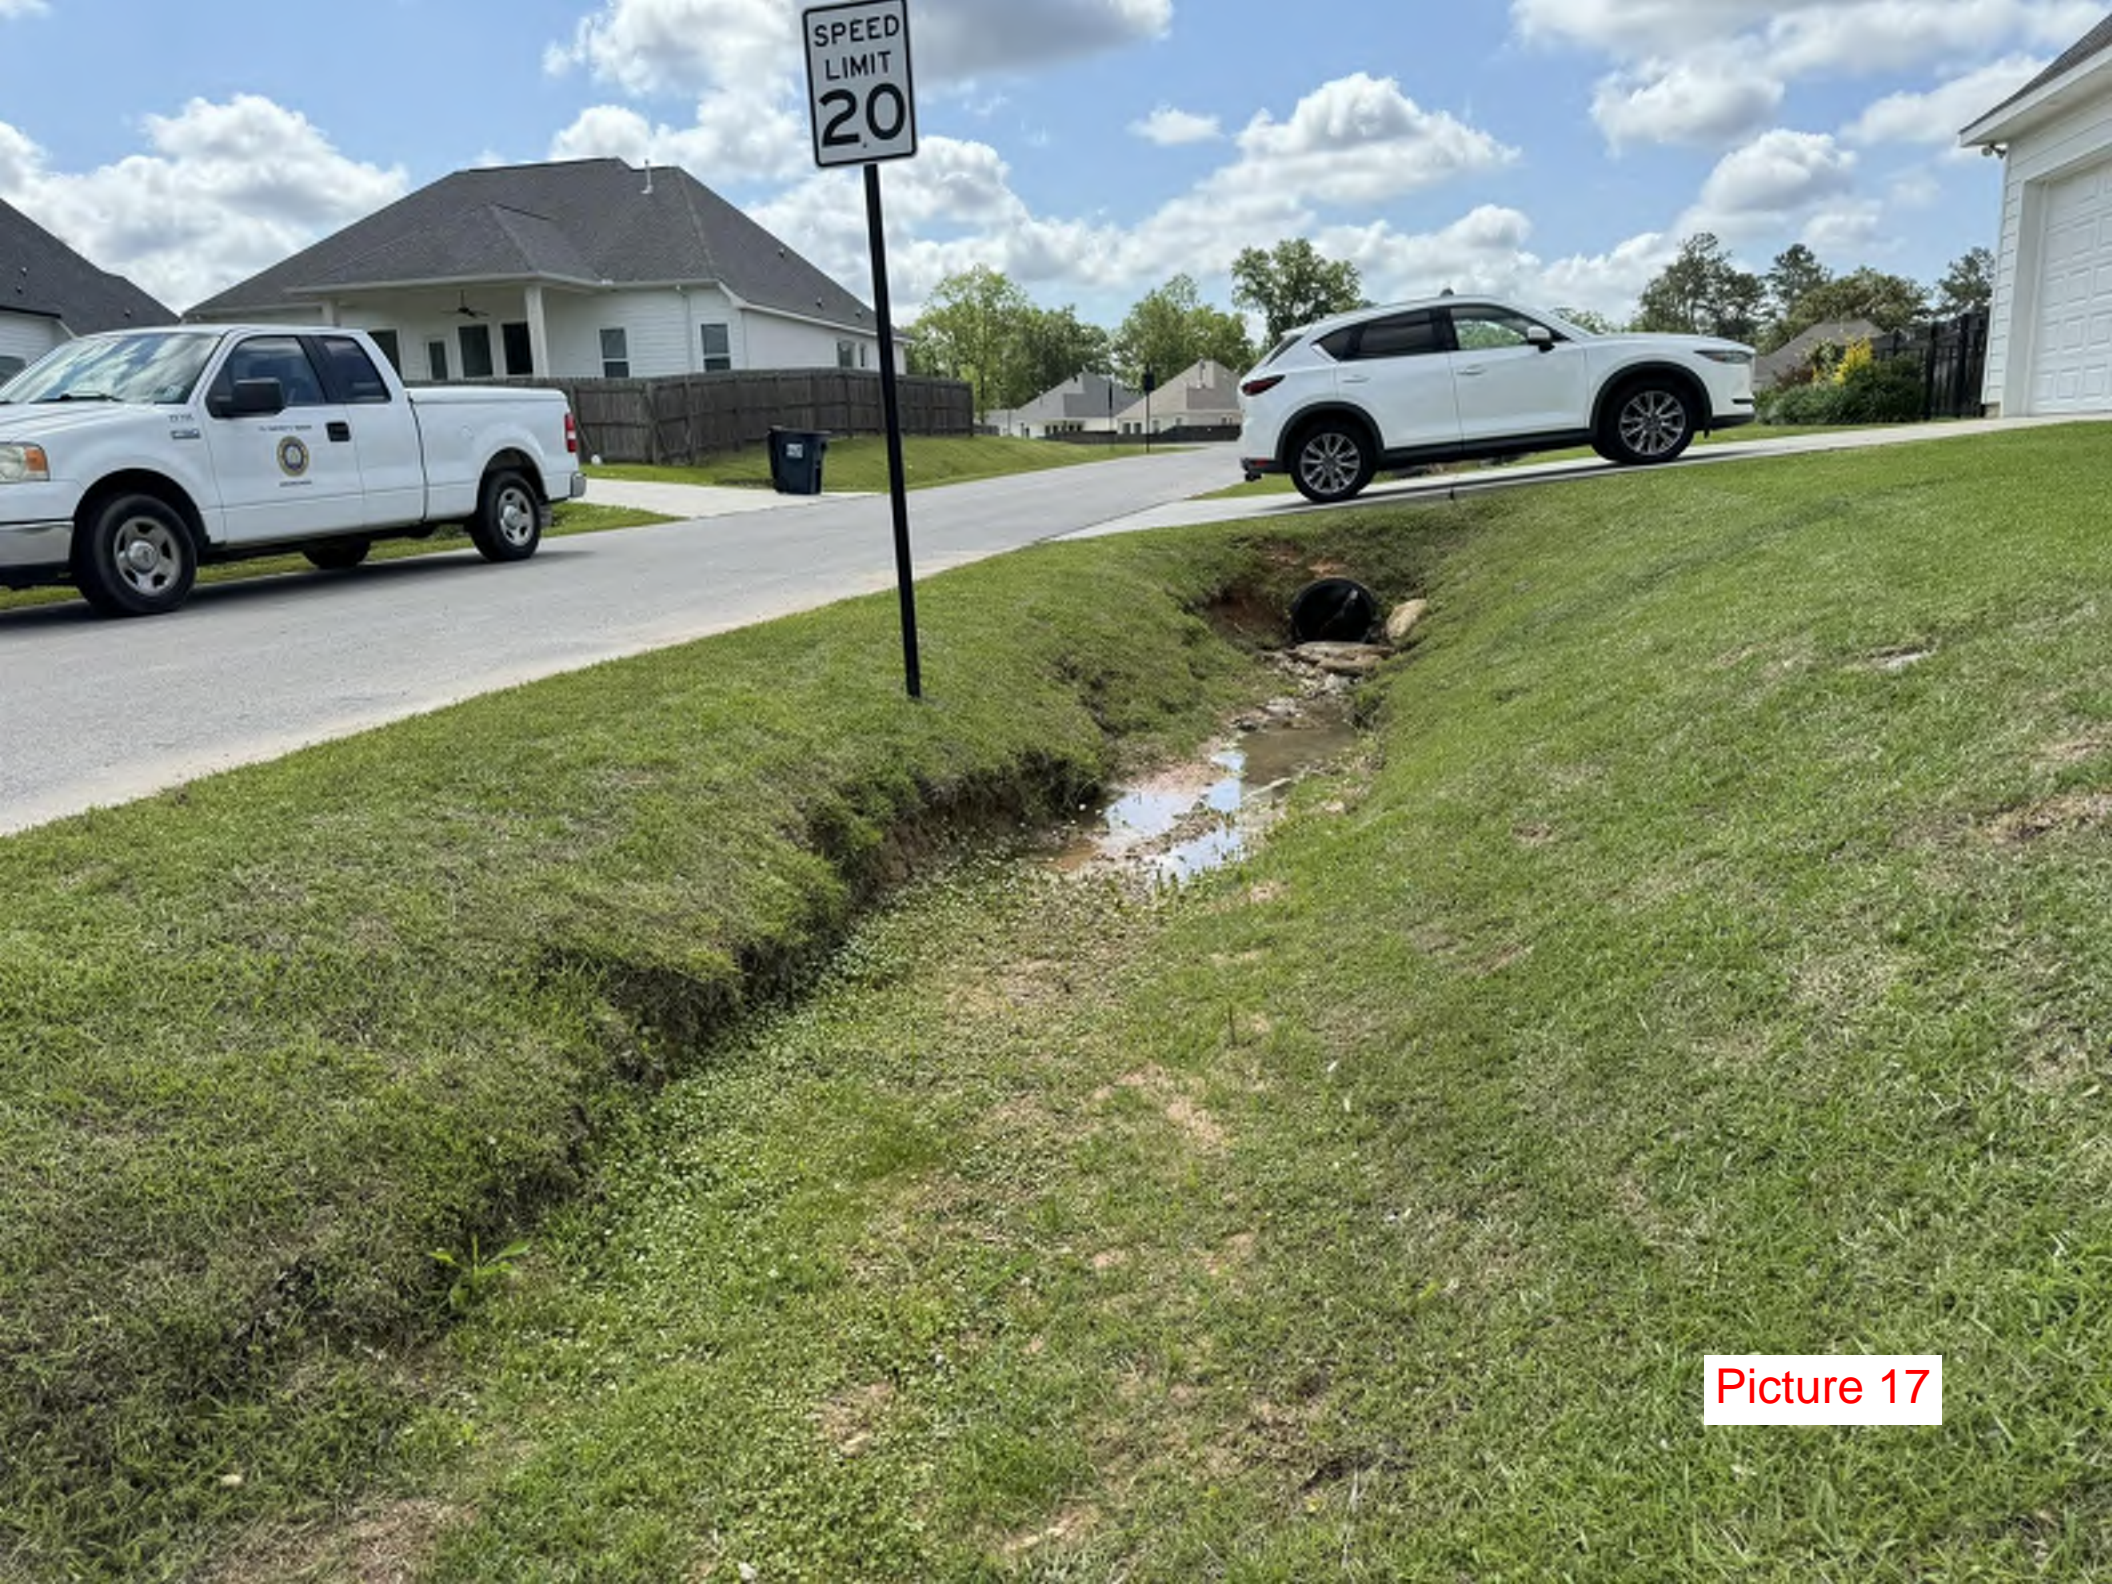
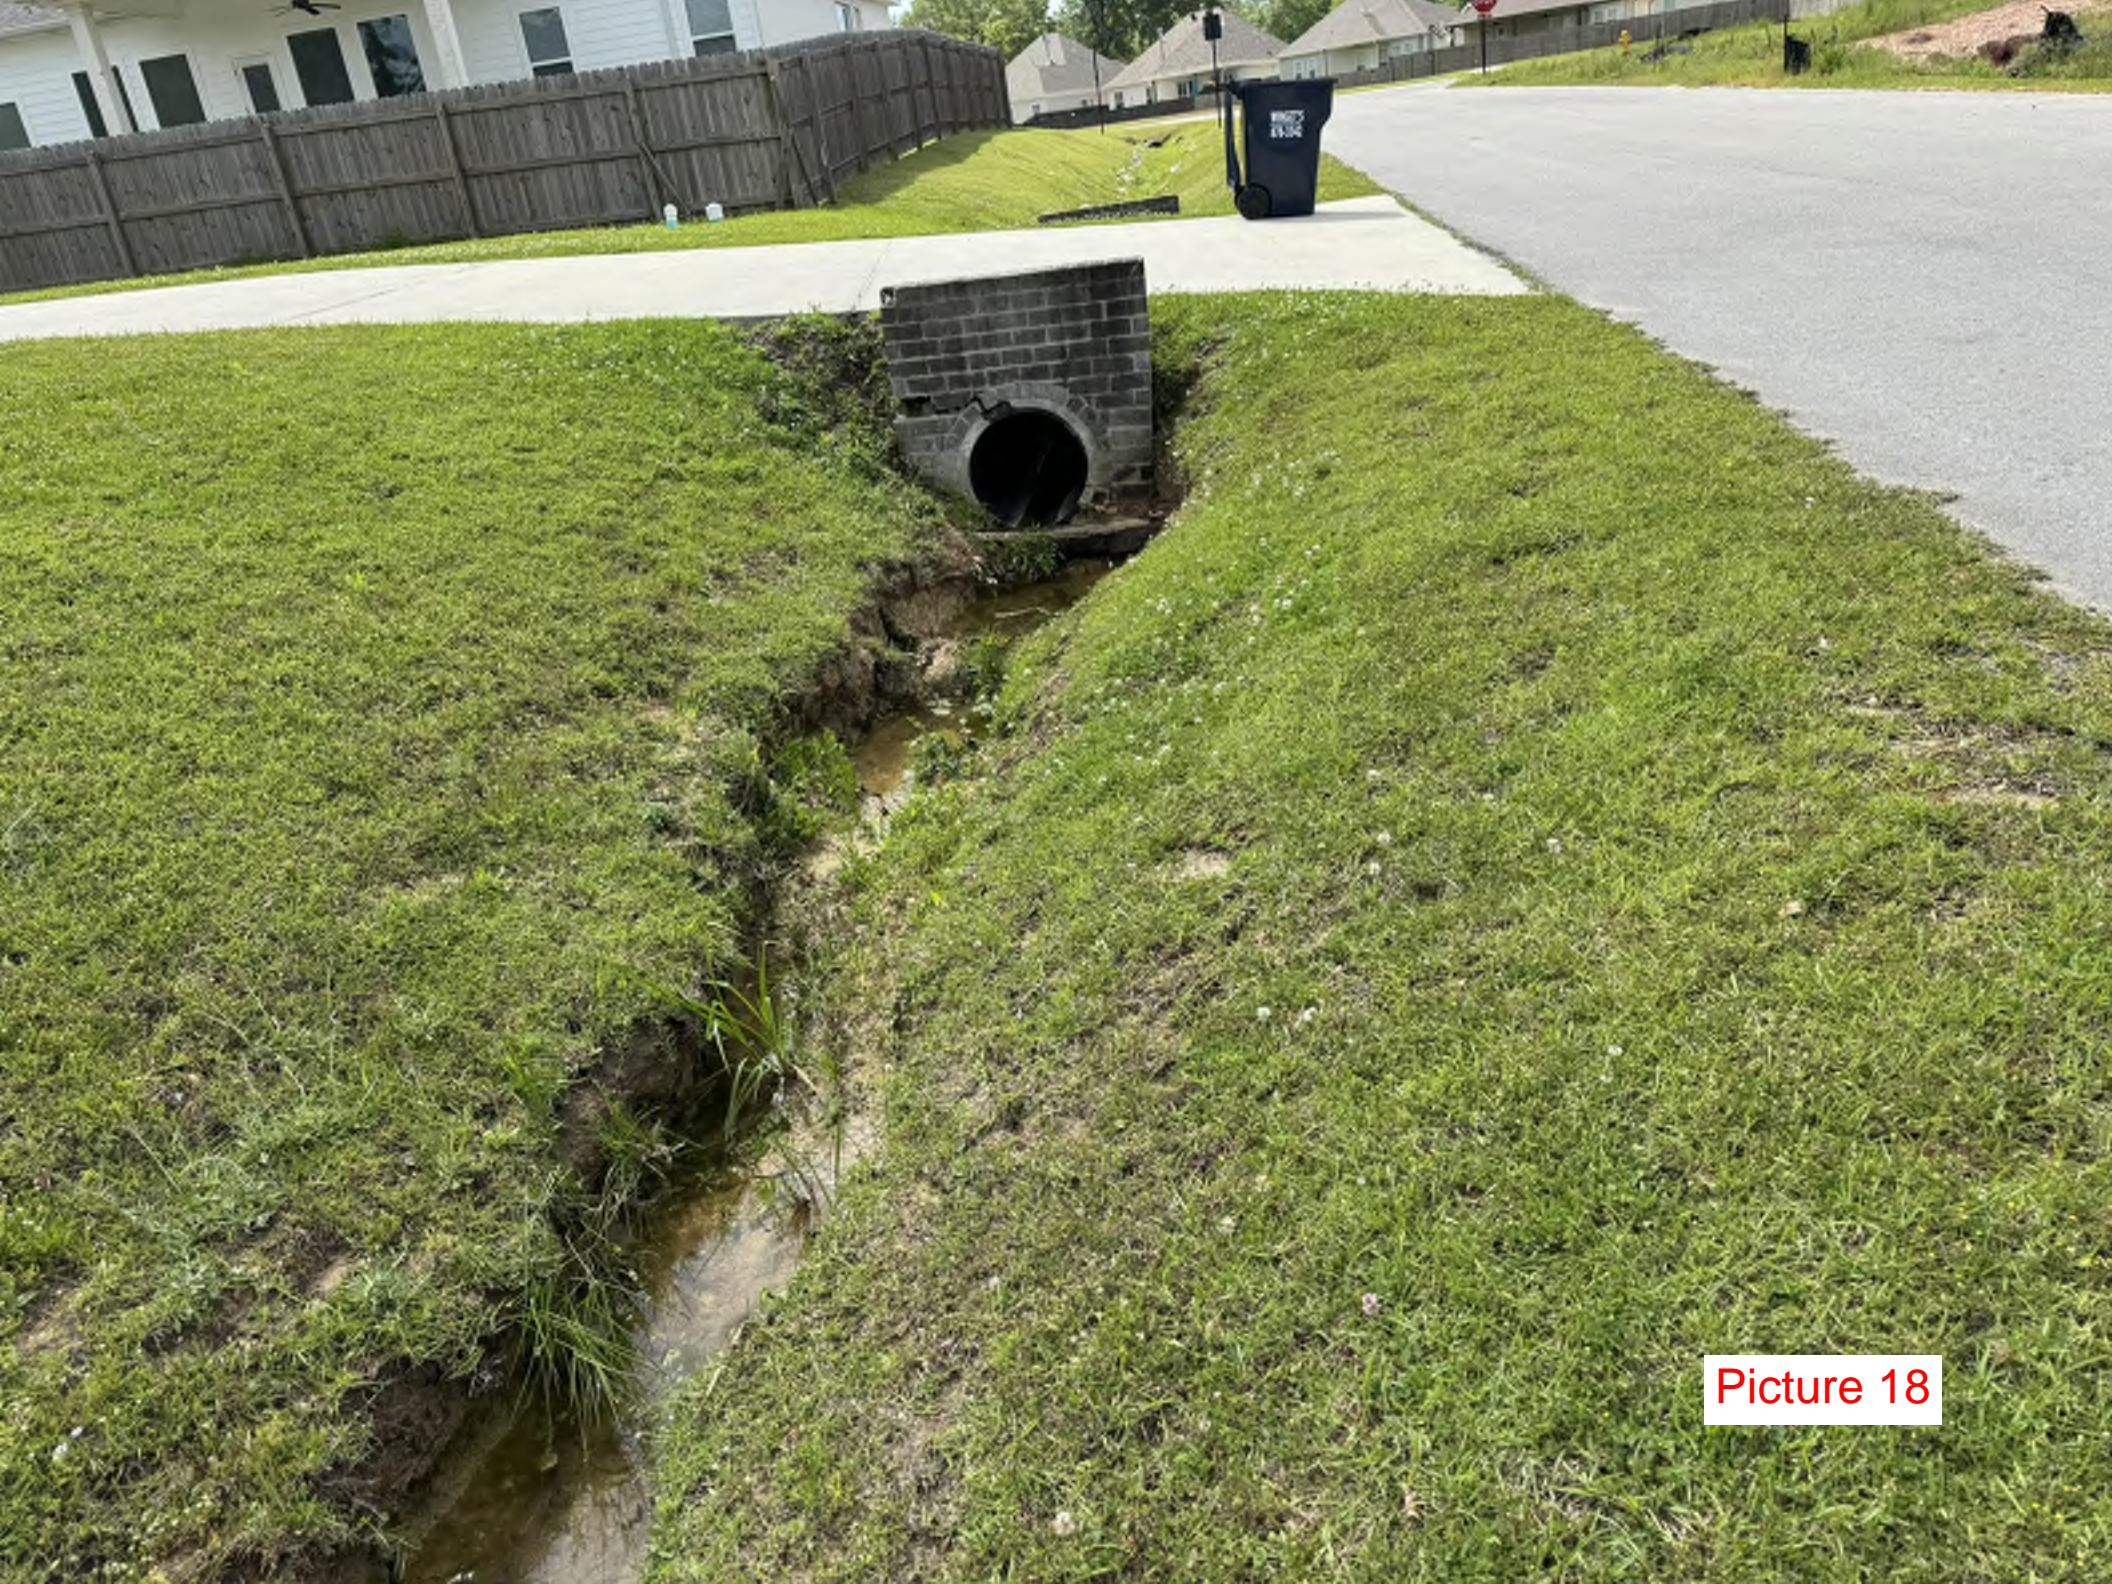
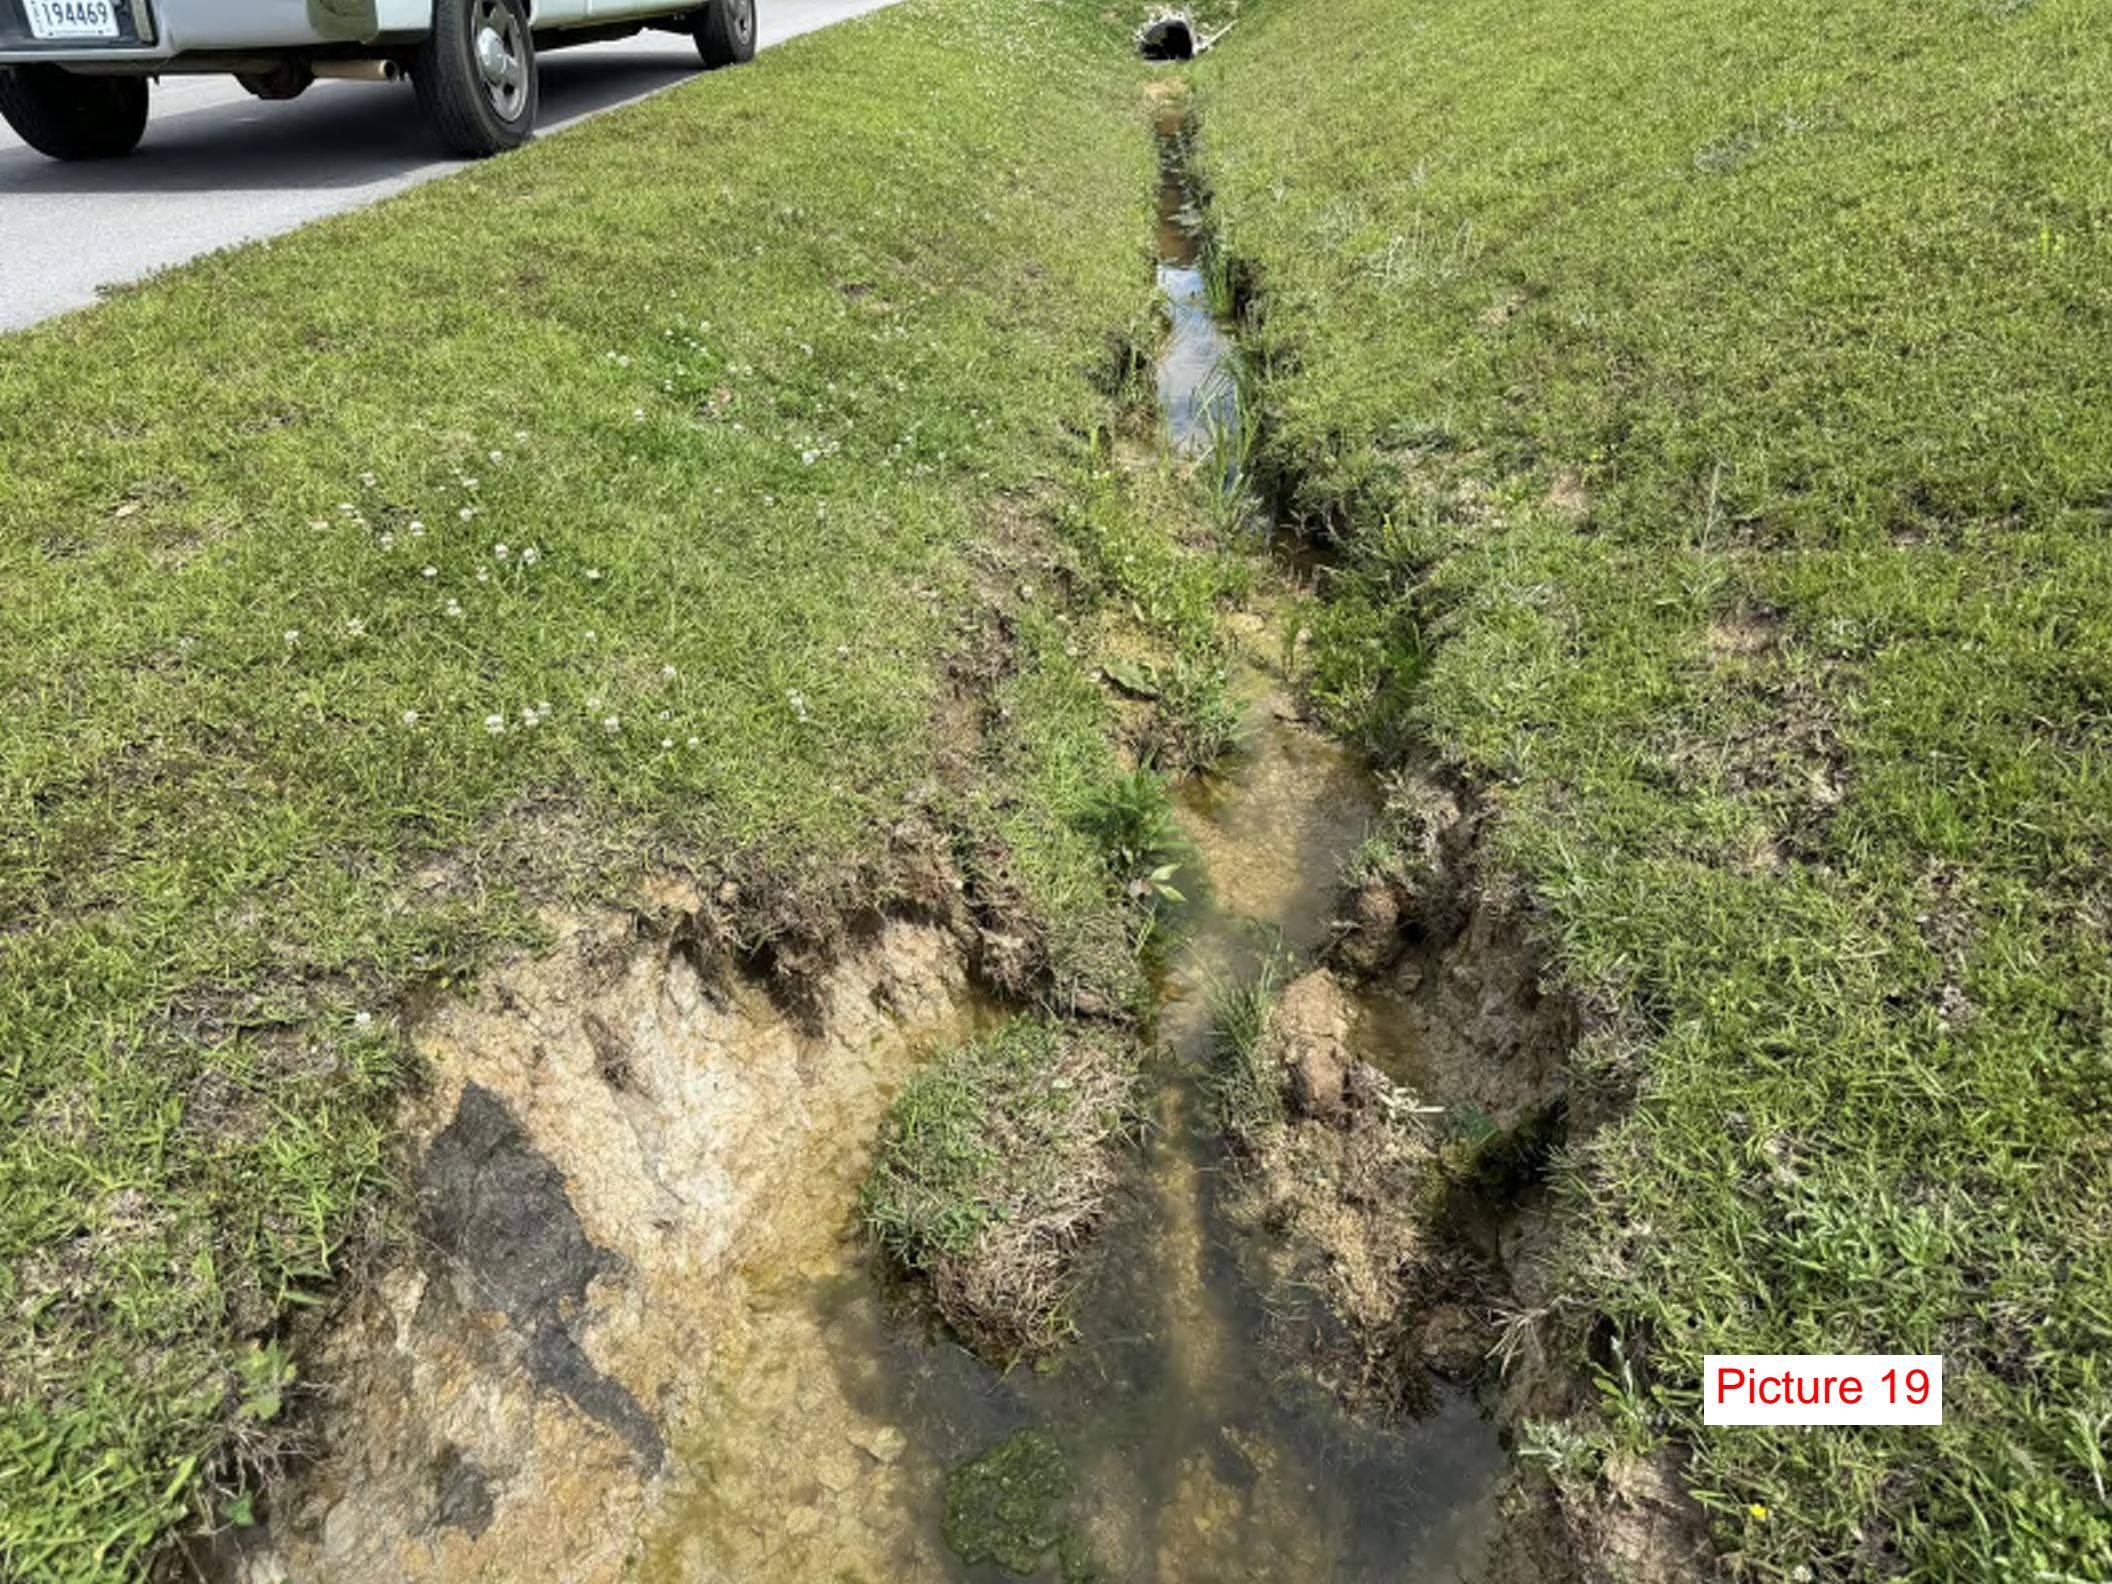
5. The roadside ditches' side slopes throughout this phase of Abita Ridge and the side slopes in the vicinity of the culverts' pipe ends are eroding and need to be repaired. Due to the severity of the erosion observed, staff is requesting an onsite meeting with the developer and the engineer of record to discuss the means and methods prior to performing the repairs (See pictures #15 - #26 - Typical Comment);

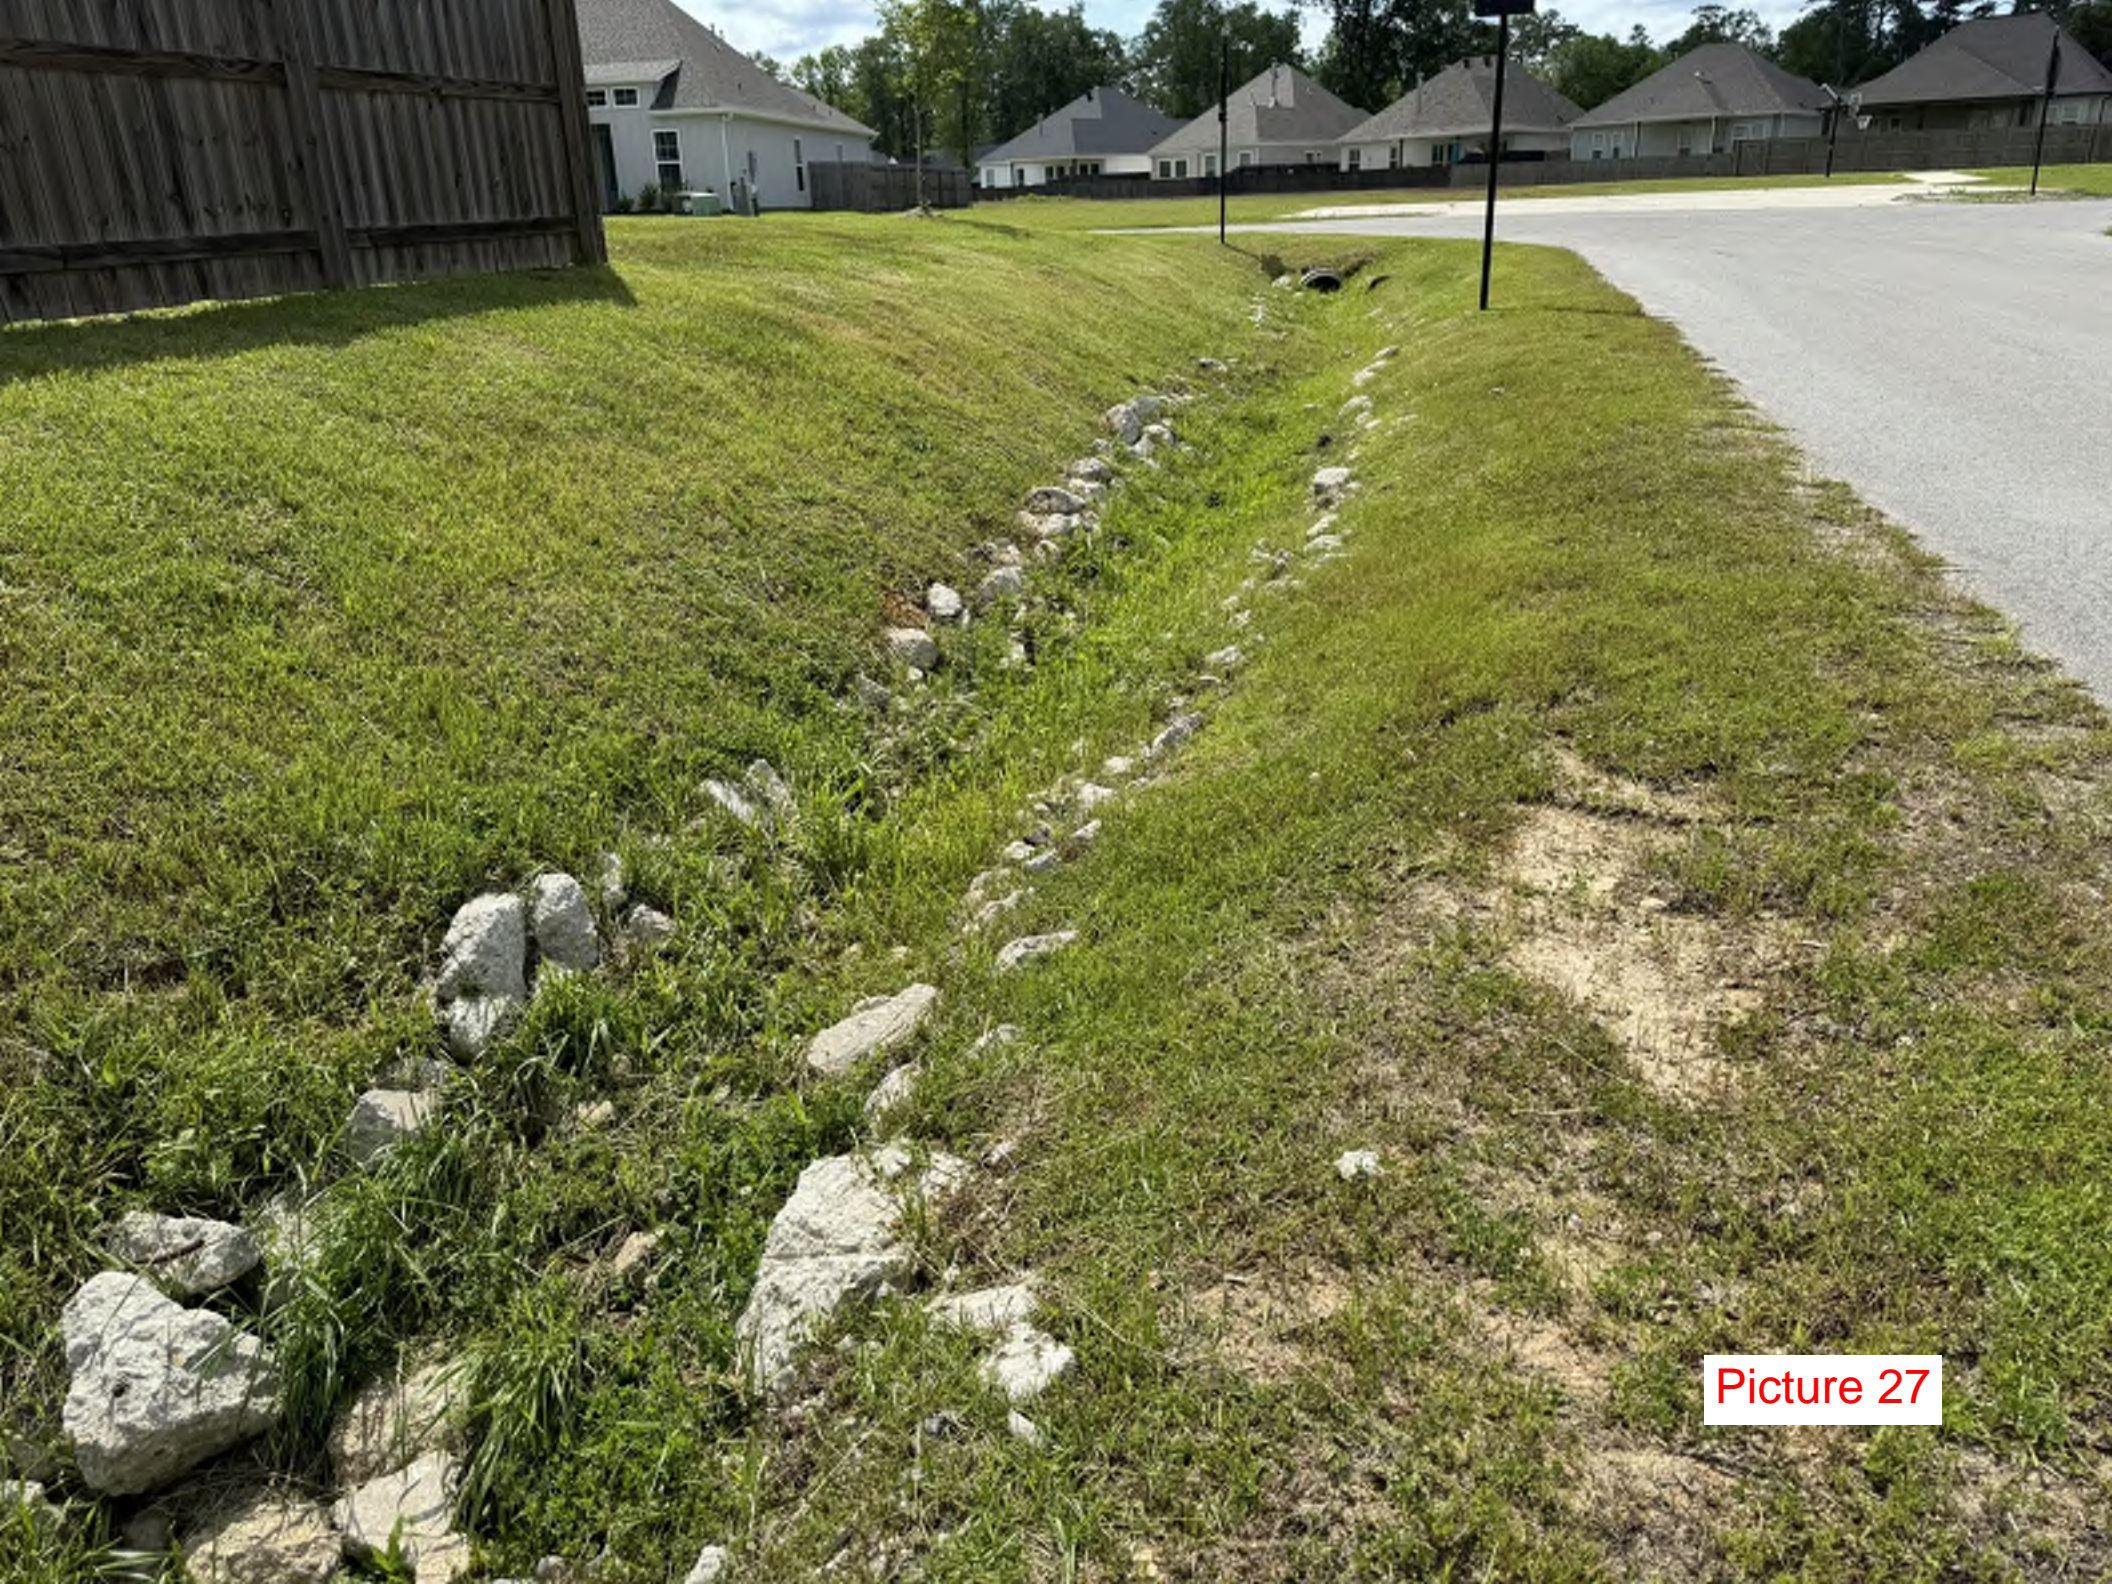
Picture 27

6. Remove stones and boulders placed on the roadside ditches throughout this phase of Abita Ridge and once removed, regrade to provide positive flow and vegetate once regraded. Public Works will be responsible for maintaining the roadside ditches once the Warranty Obligation is released and this will impede the future maintenance (See picture #27 - Typical Comment);
