## ST. TAMMANY PARISH

Re: Abita Ridge Subdivision, Phase 1  
Extended Warranty Obligation - \$57,900.00 - LOC # 643

In accordance with the St. Tammany Parish Government Code of Ordinances, Part II "Land Development Code," Chapter 125 "Subdivision Regulations," Section 125-210 "Warranty and Performance Obligations," the Department of Engineering made an inspection of the site on April 15, 2024.

Attachment: Representative photos from site inspection performed on April 15, 2024

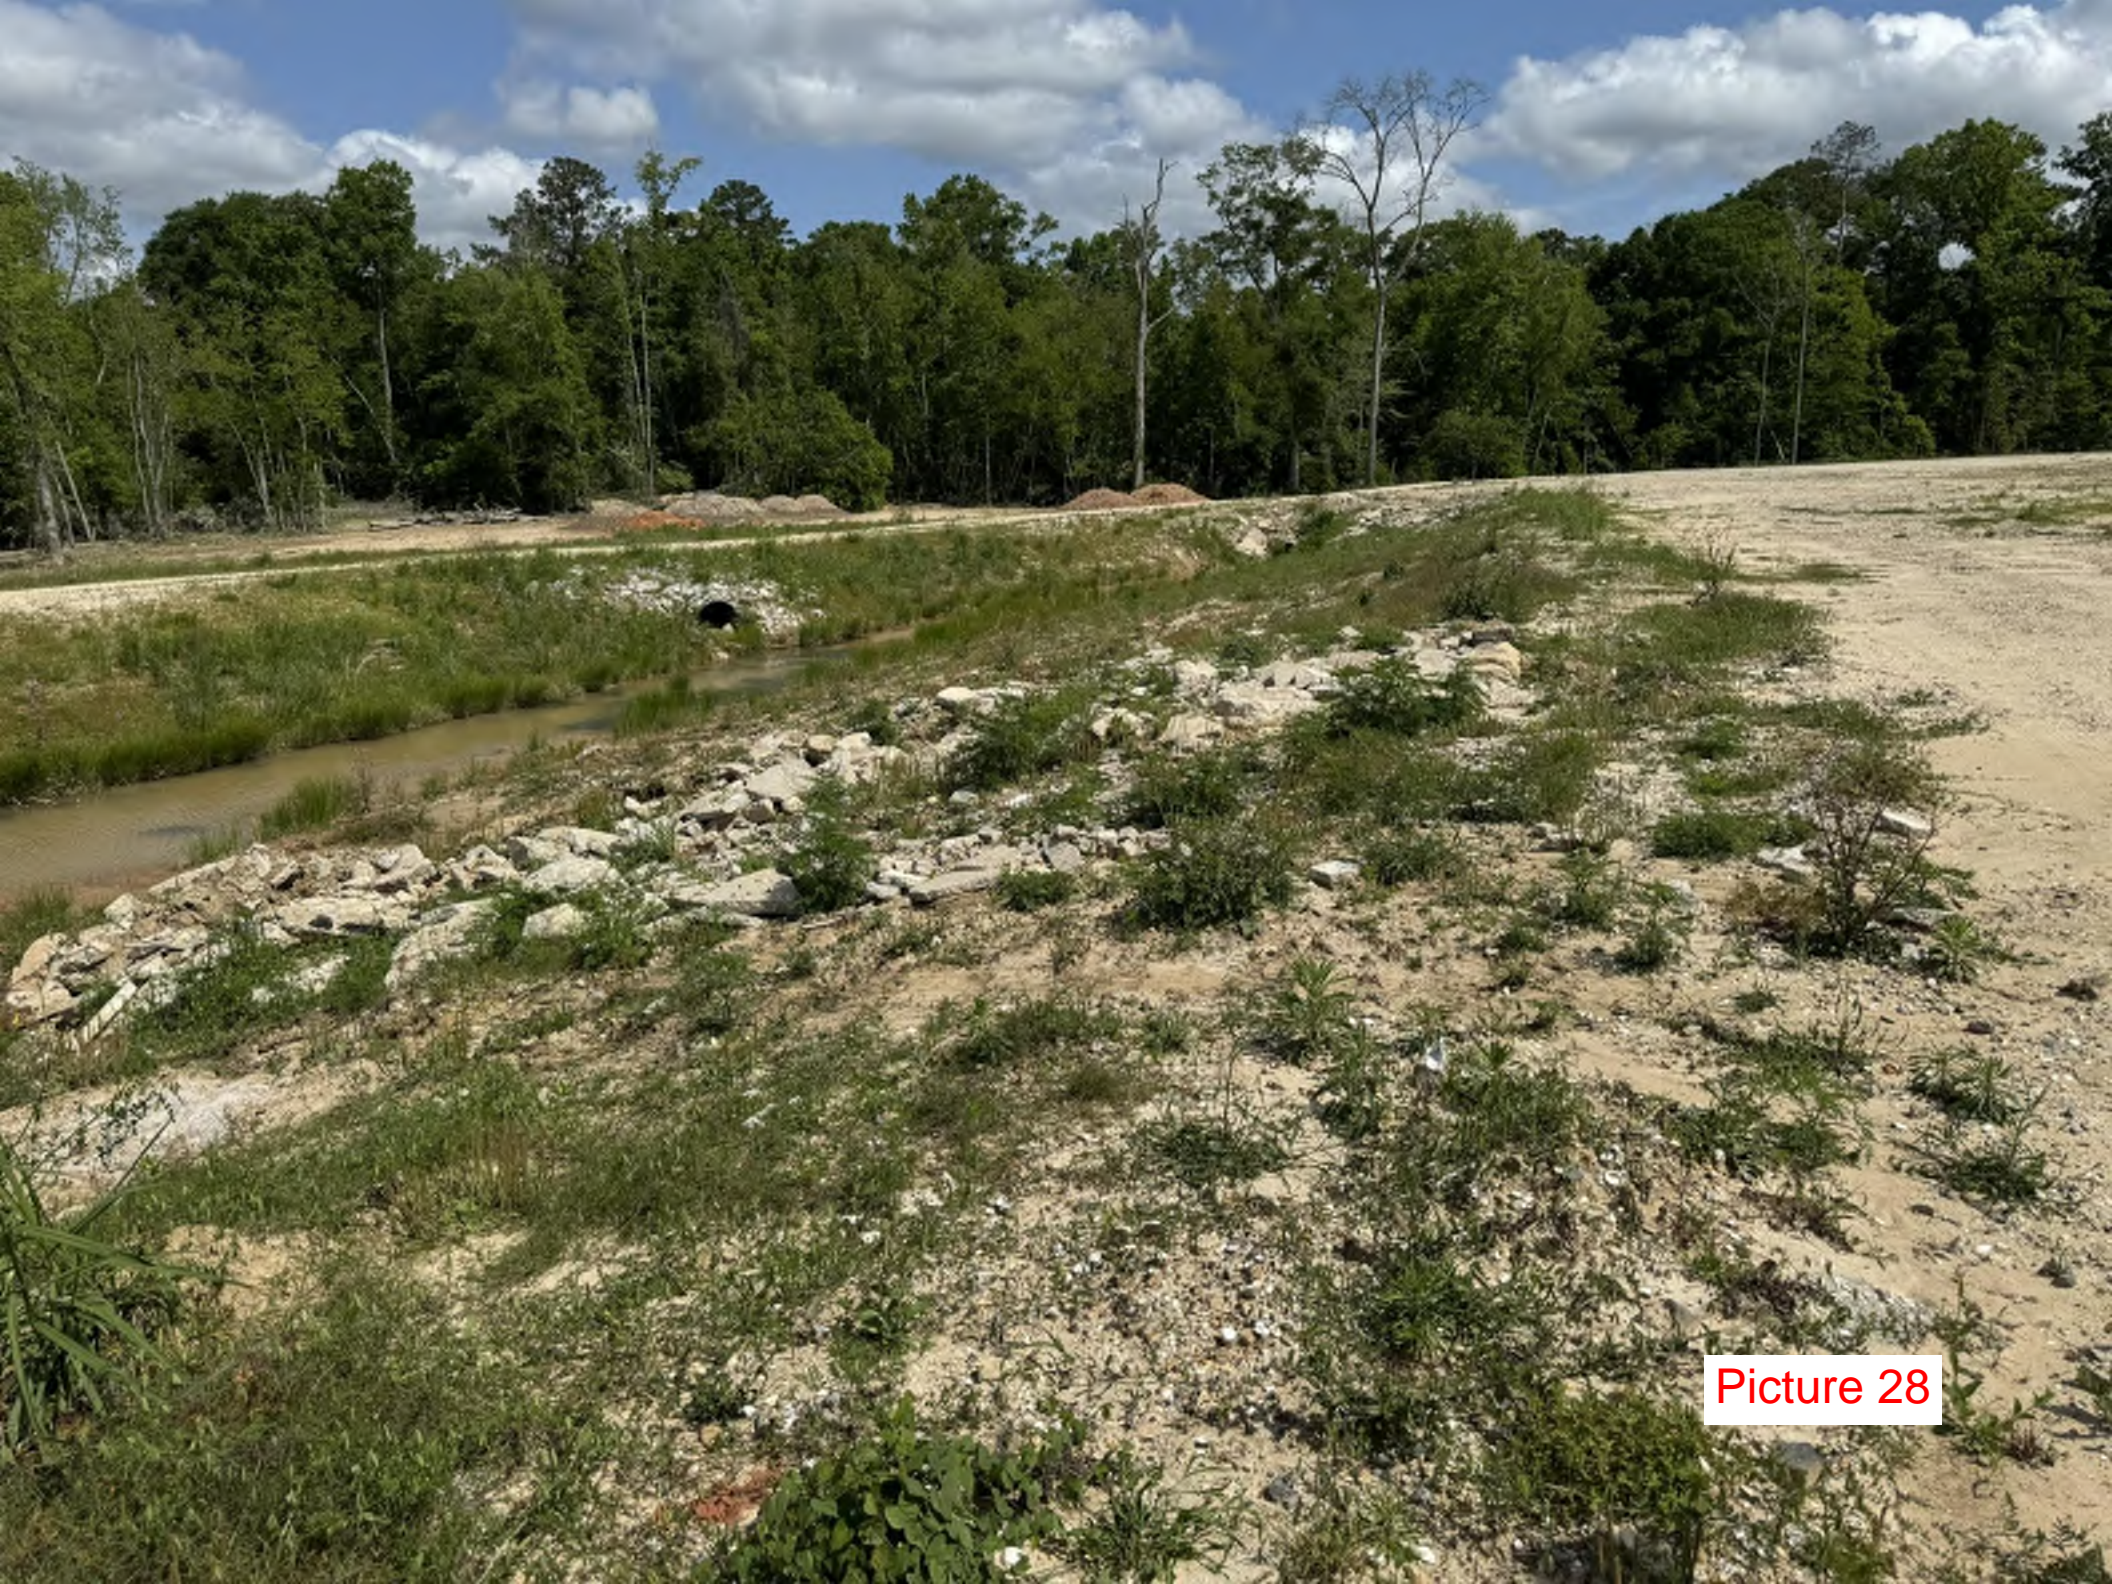
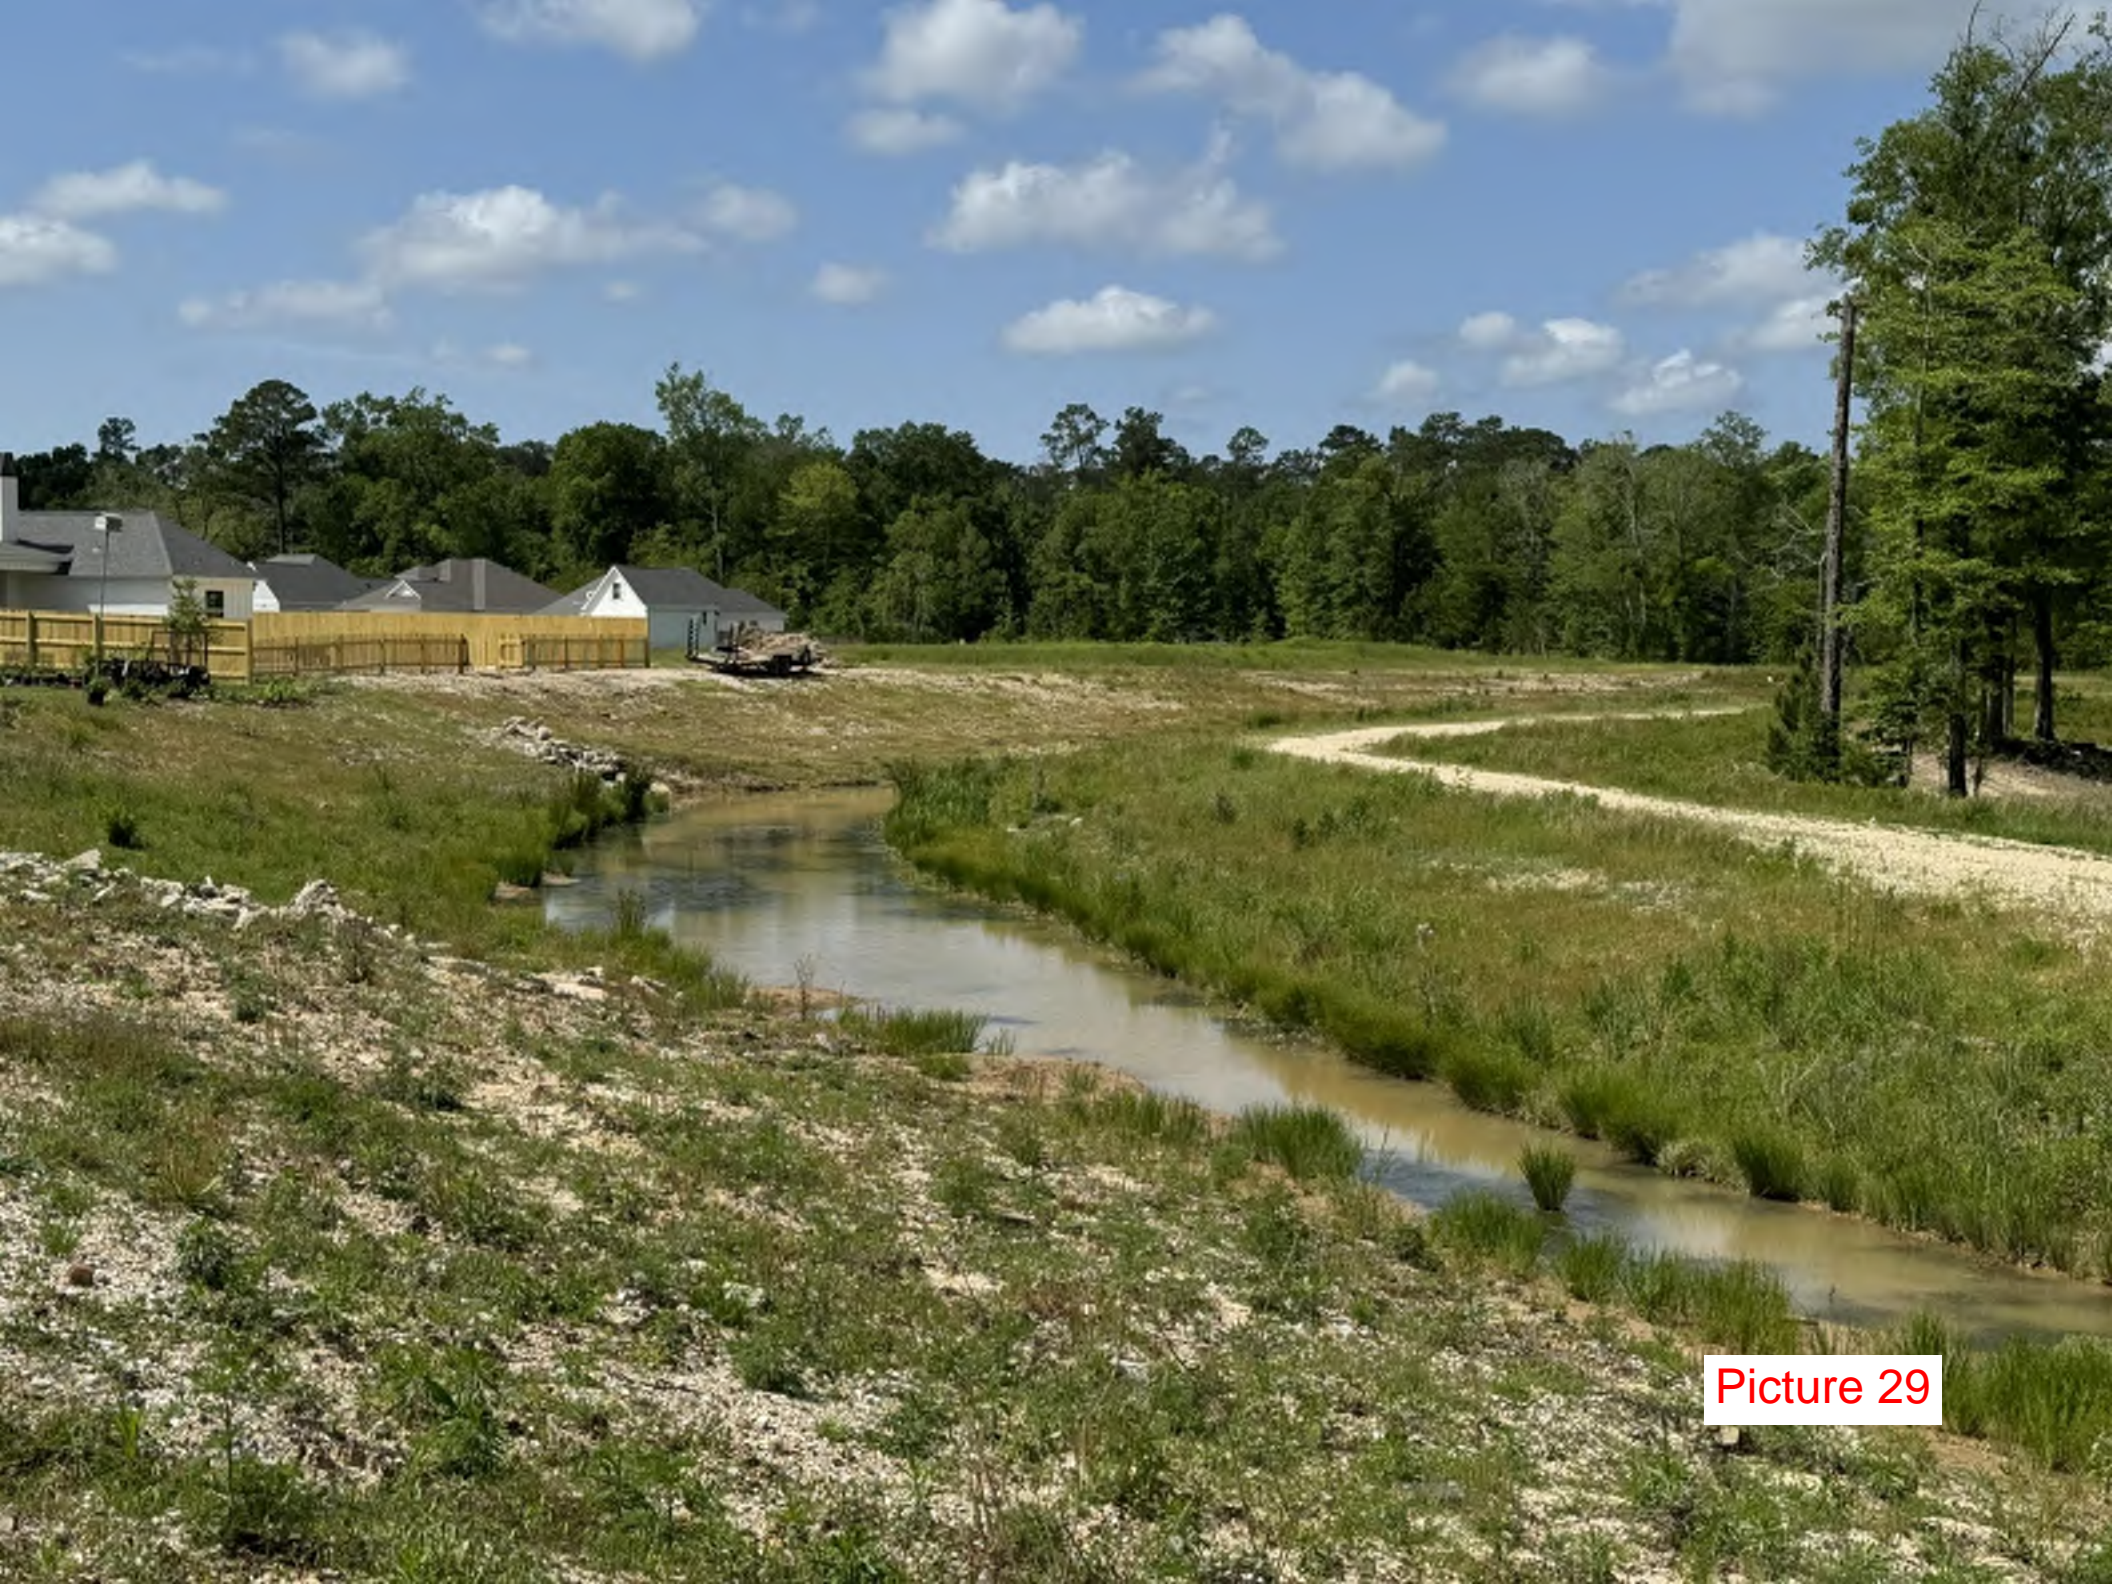
7. Detention pond has construction debris along the side slopes. Pond side slopes need to be reestablished and the pond re-dug to provide bottom elevation of 3.0' and to provide the wet pond required minimum 5.0' depth to the normal water surface elevation set at 8.0'. All side slopes and top of bank of the detention ponds should be properly vegetated and proper erosion control measures installed and maintained until vegetation is established (See pictures #28 & #29);

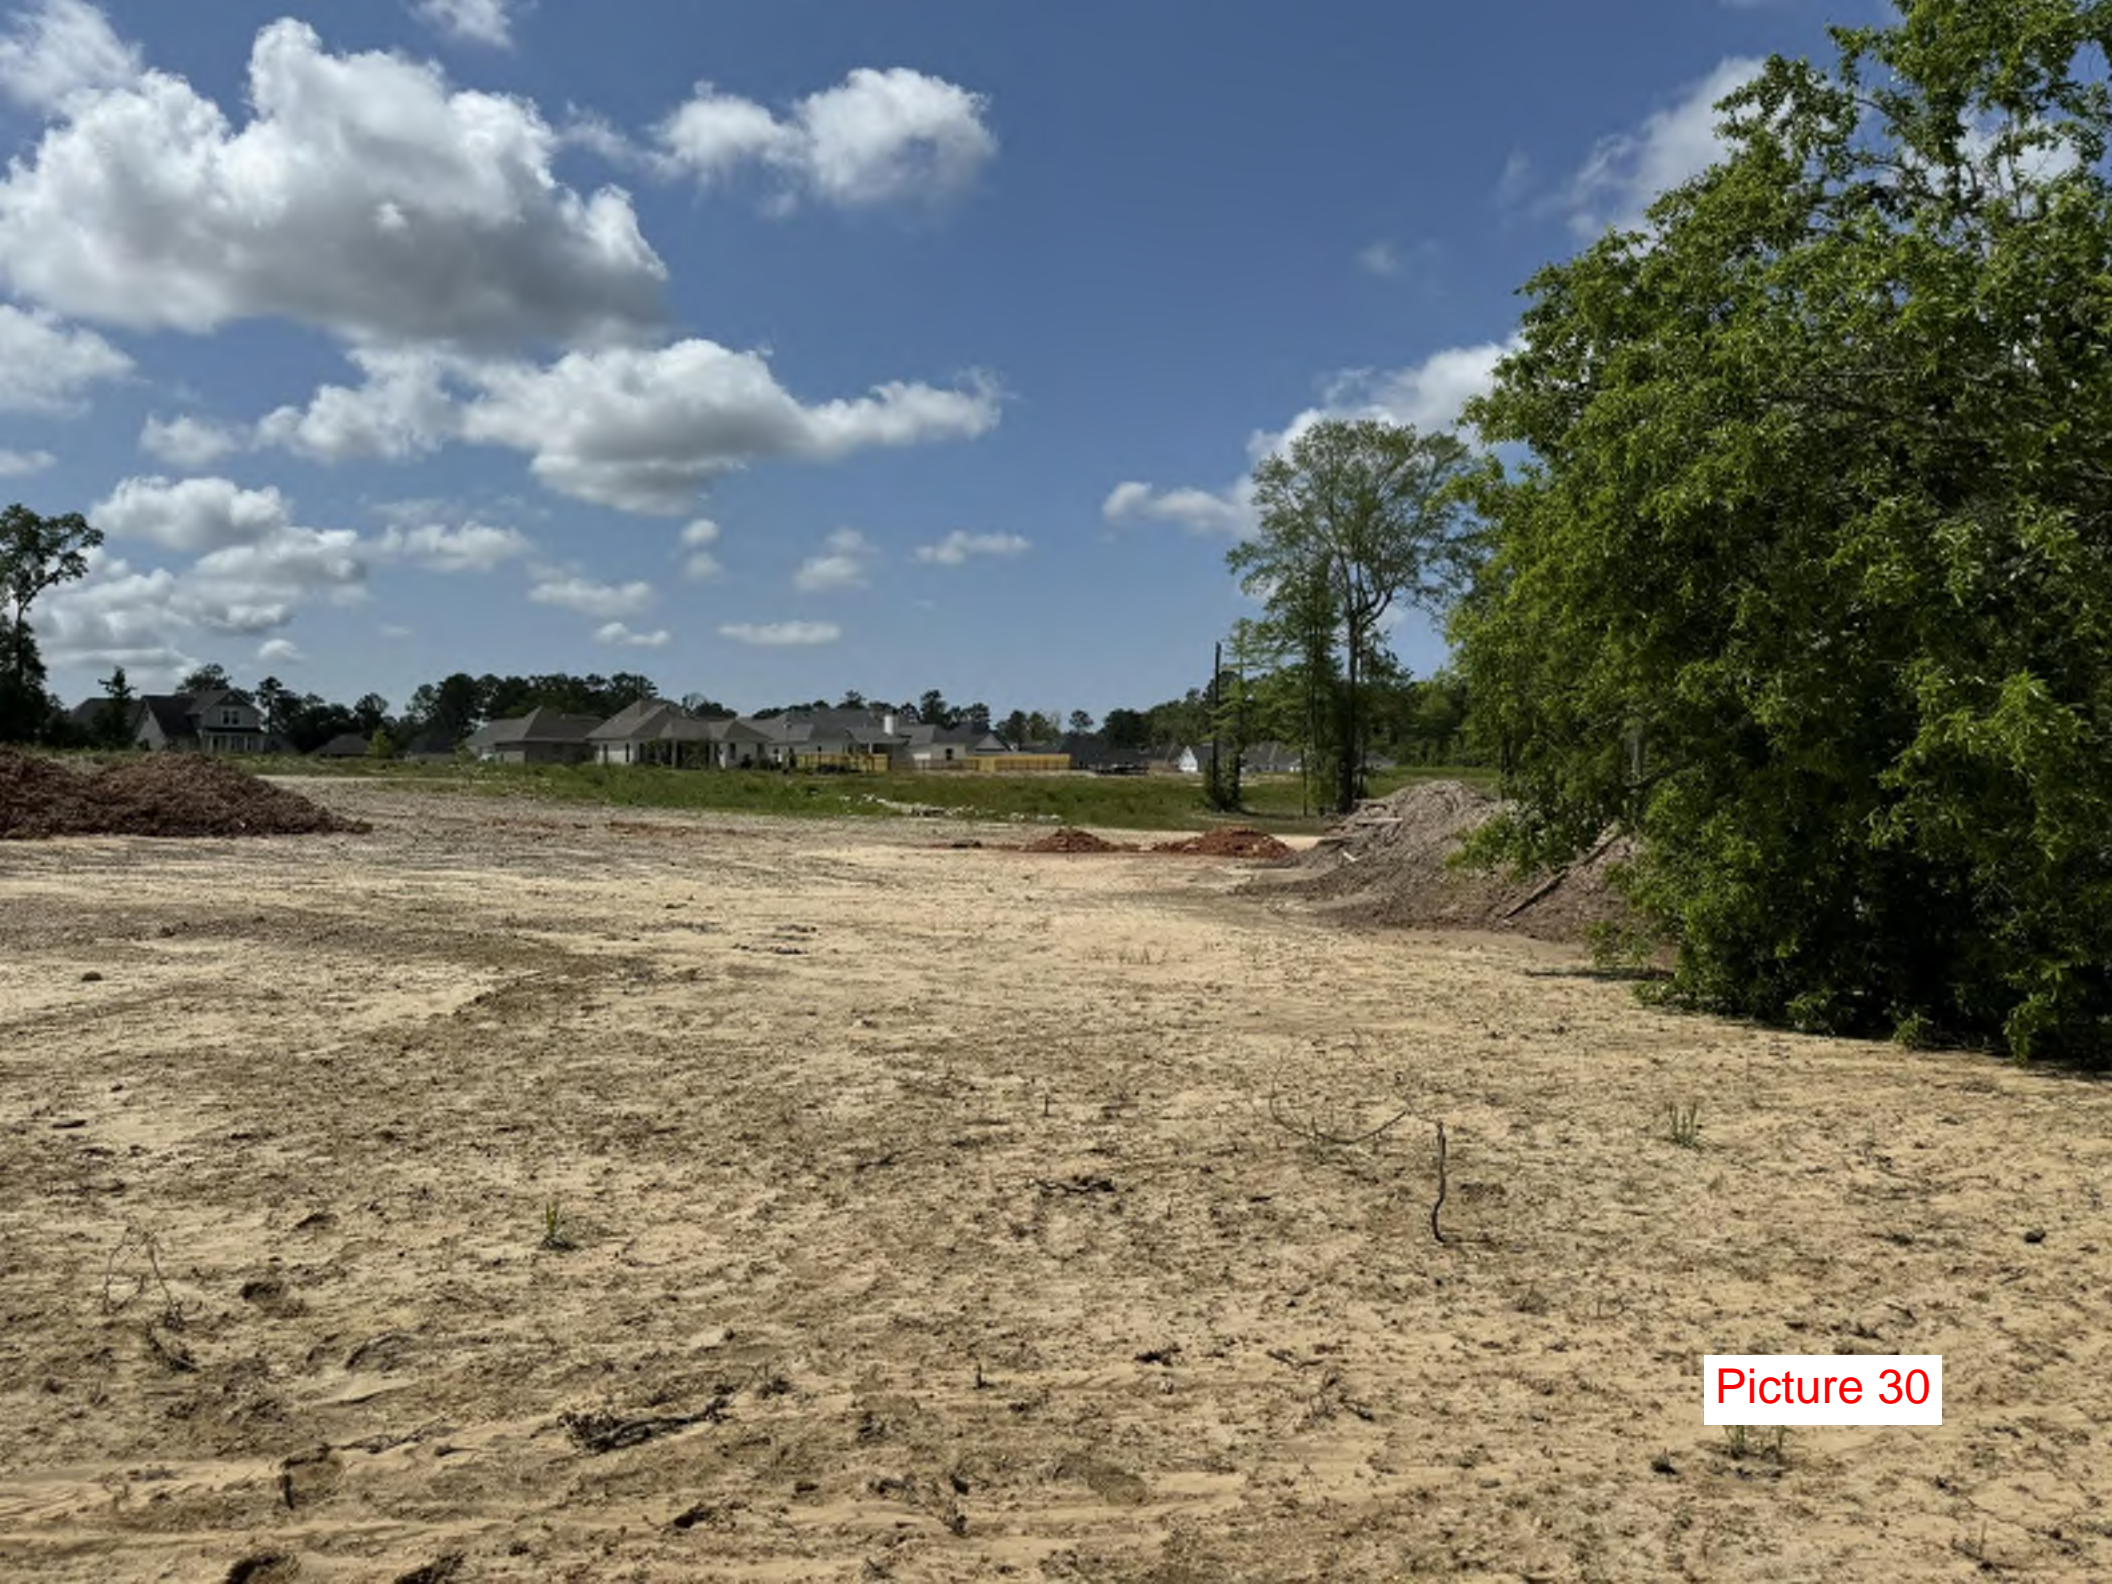
Picture 30

8. All areas surrounding the pond including, but not limited to, the pond levee and the side slopes, cut and fill areas and all disturbed areas needs to be properly graded and vegetated. (See picture #30);

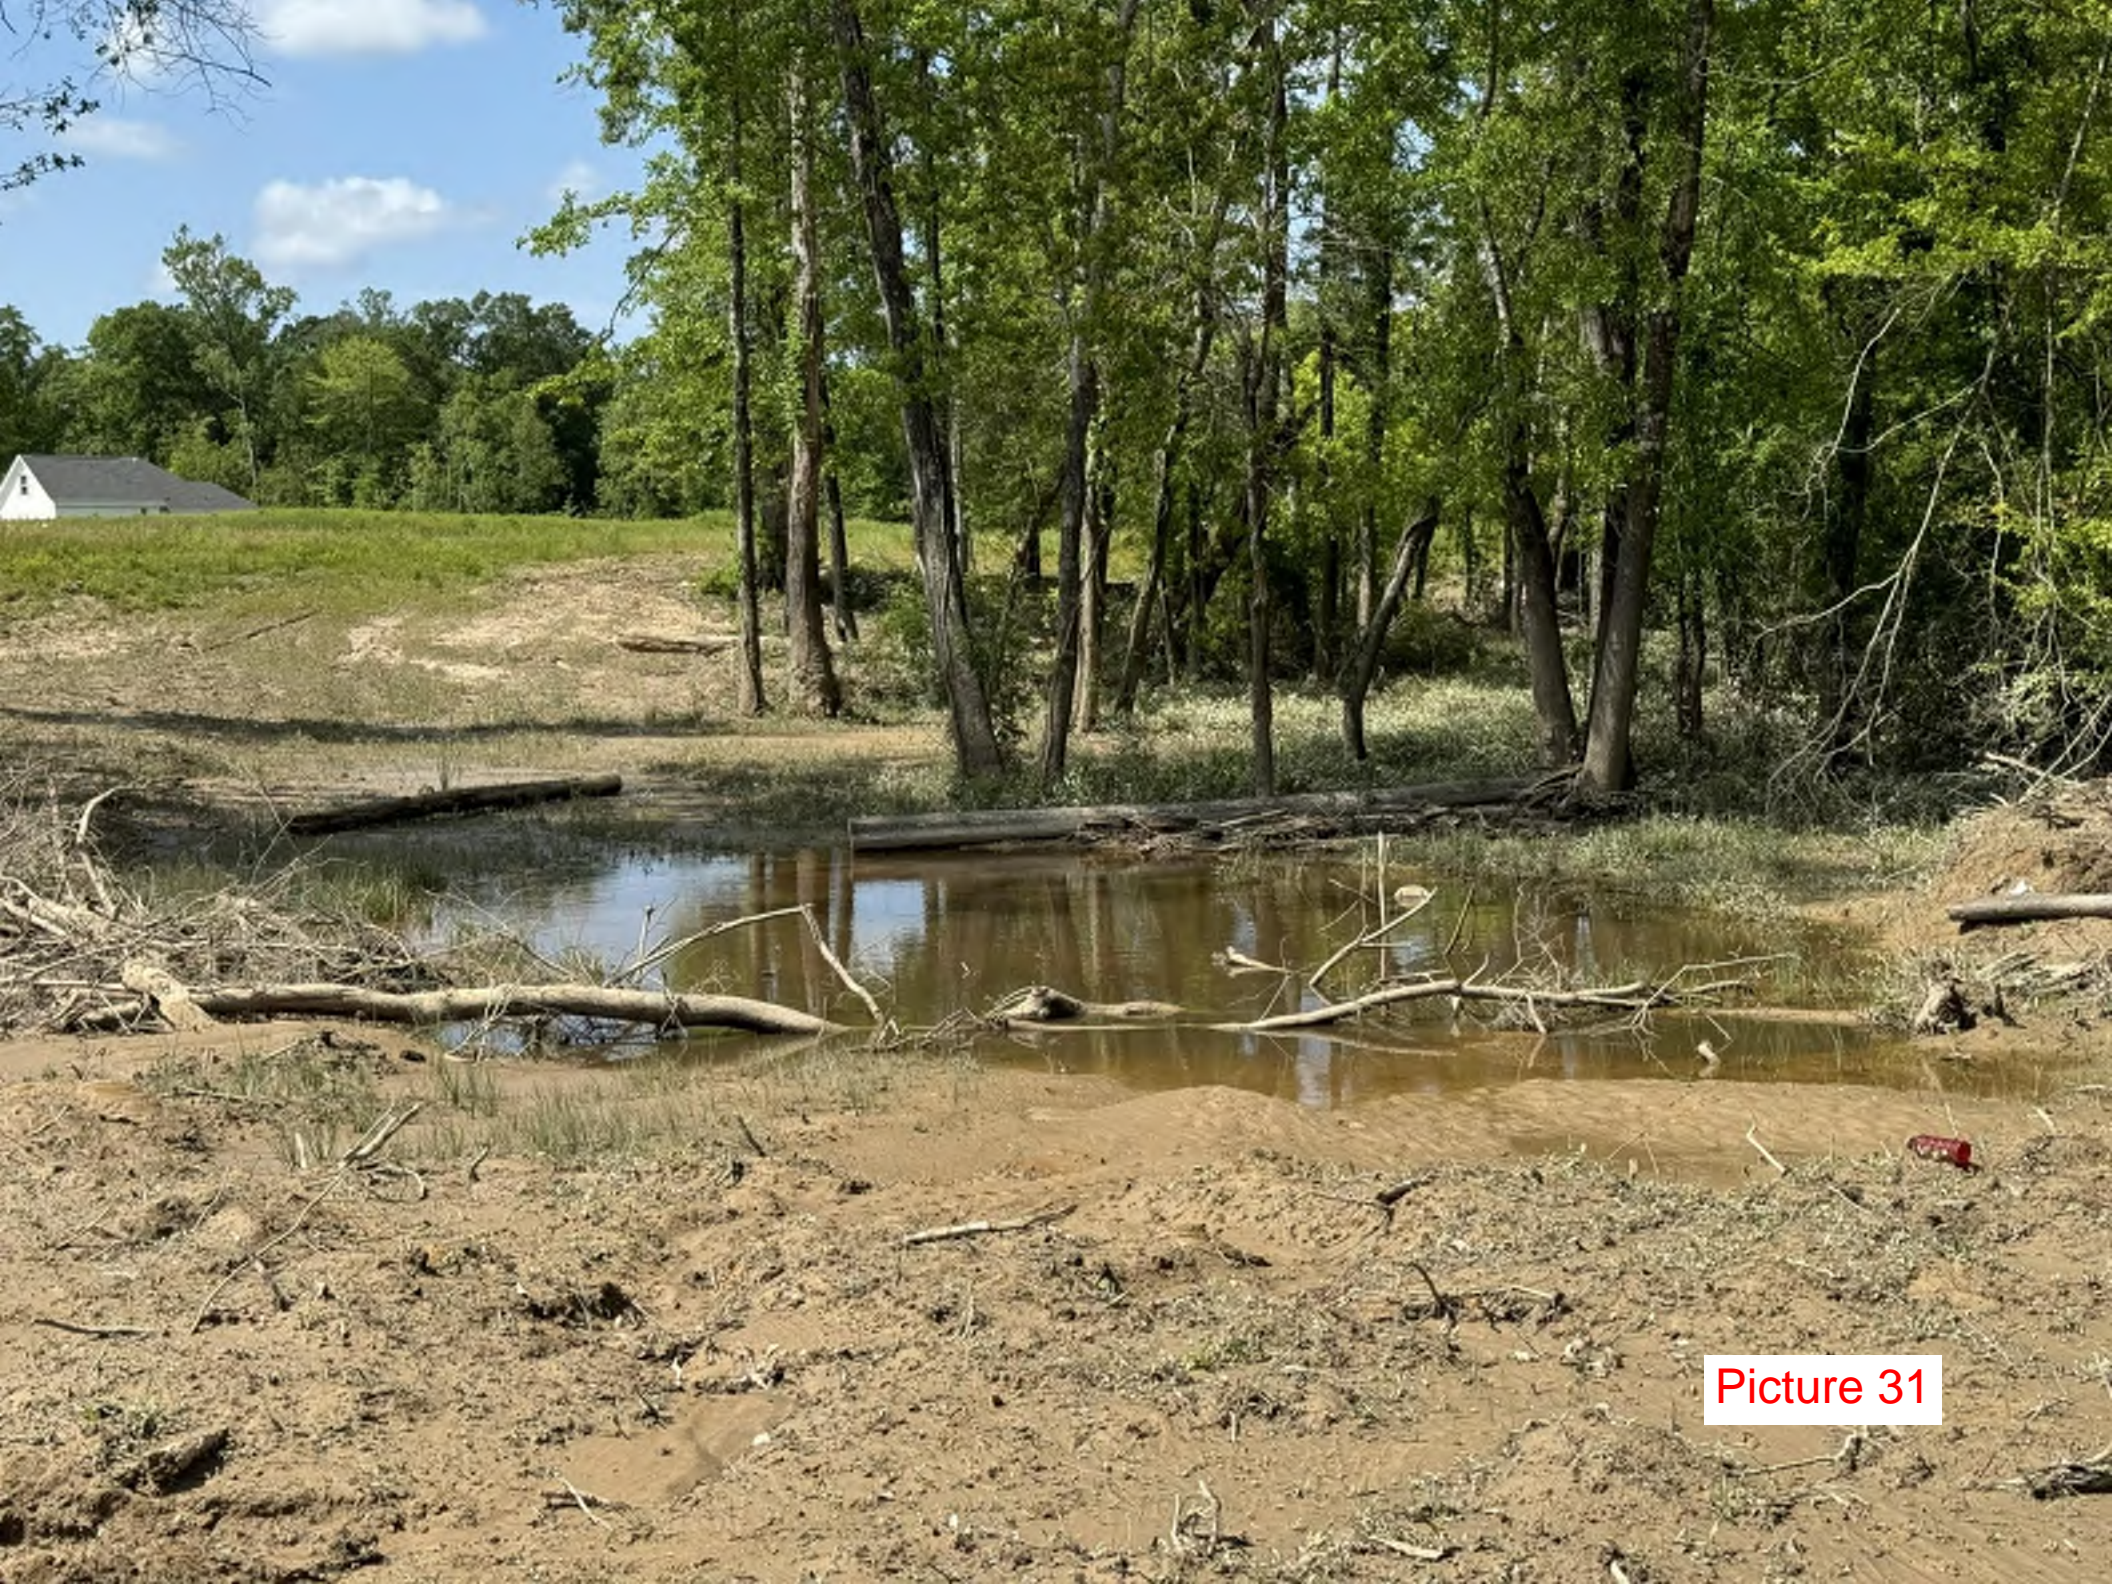
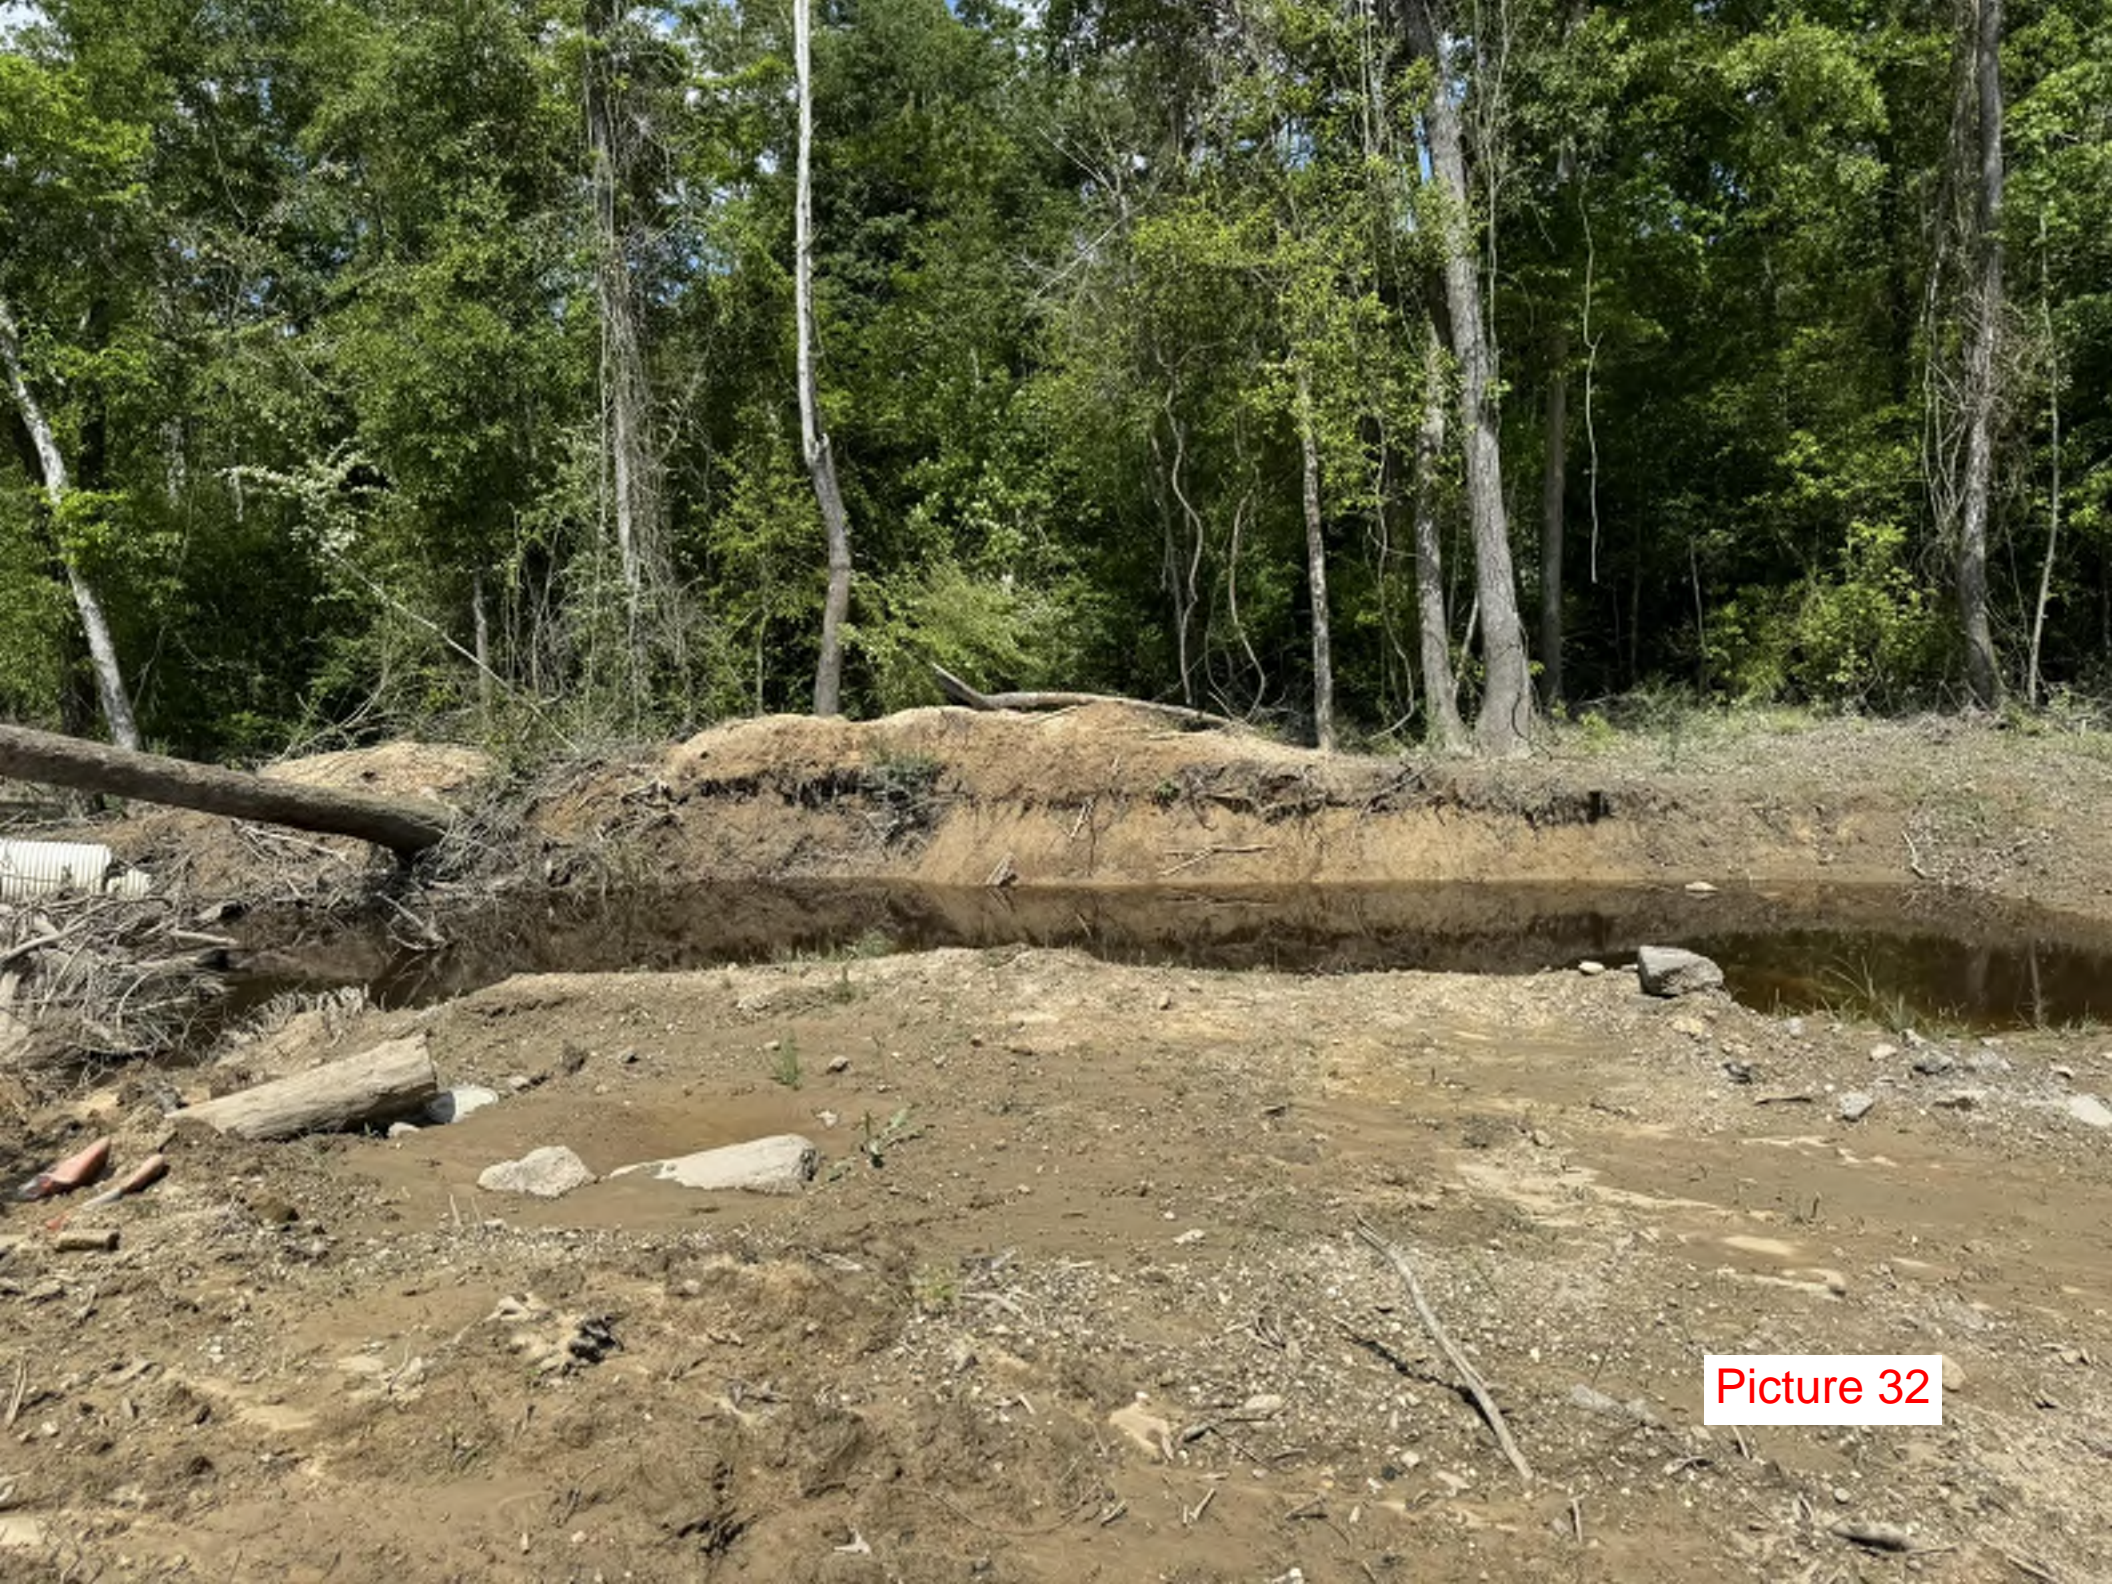
9. Two excavation pits were observed during the site inspection located to the northeast of the detention pond. These excavation pits need to be filled, regraded and vegetated once regraded (See pictures #31 & #32);

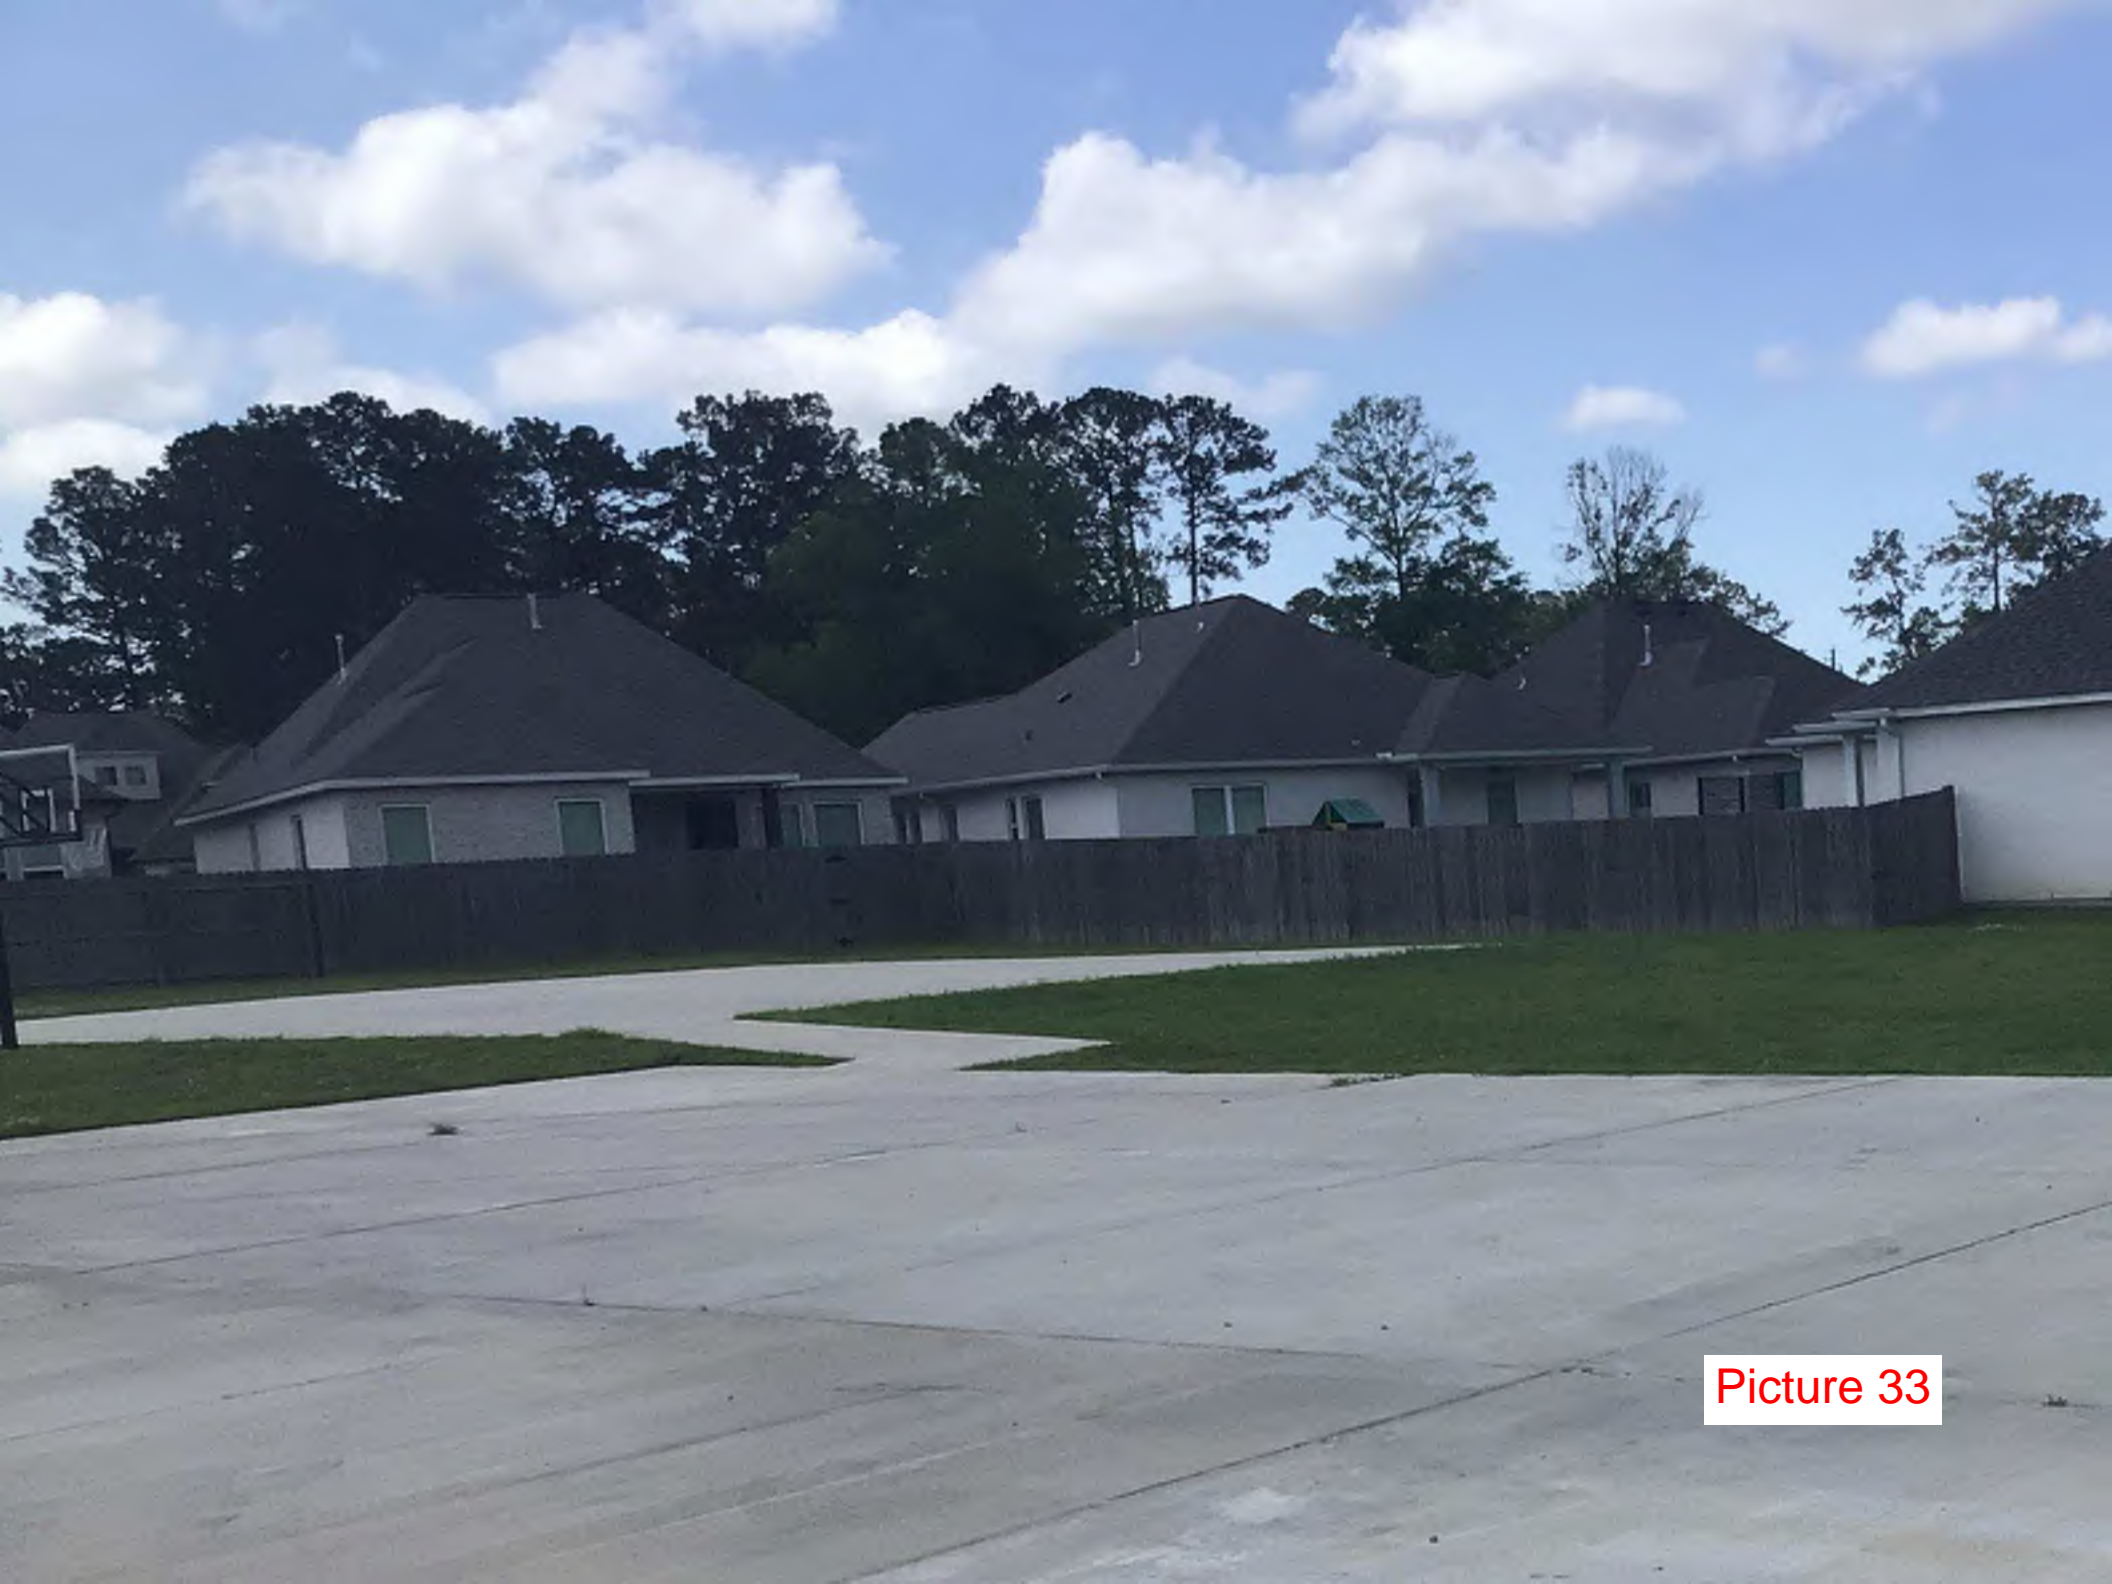
Picture 33

10. Blue reflectors need to be re-installed in the proximity of all fire hydrants (Typical Comment);
11. The parking lot of the Active Recreation Area in this phase of Abita Ridge needs wheel stops and striping. (See picture #33);
