## ST. TAMMANY PARISH

Re: Abita Ridge Subdivision, Phase 1  
Extended Warranty Obligation - \$57,900.00 - LOC # 643

In accordance with the St. Tammany Parish Government Code of Ordinances, Part II "Land Development Code," Chapter 125 "Subdivision Regulations," Section 125-210 "Warranty and Performance Obligations," the Department of Engineering made an inspection of the site on April 15, 2024.

Attachment: Representative photos from site inspection performed on April 15, 2024

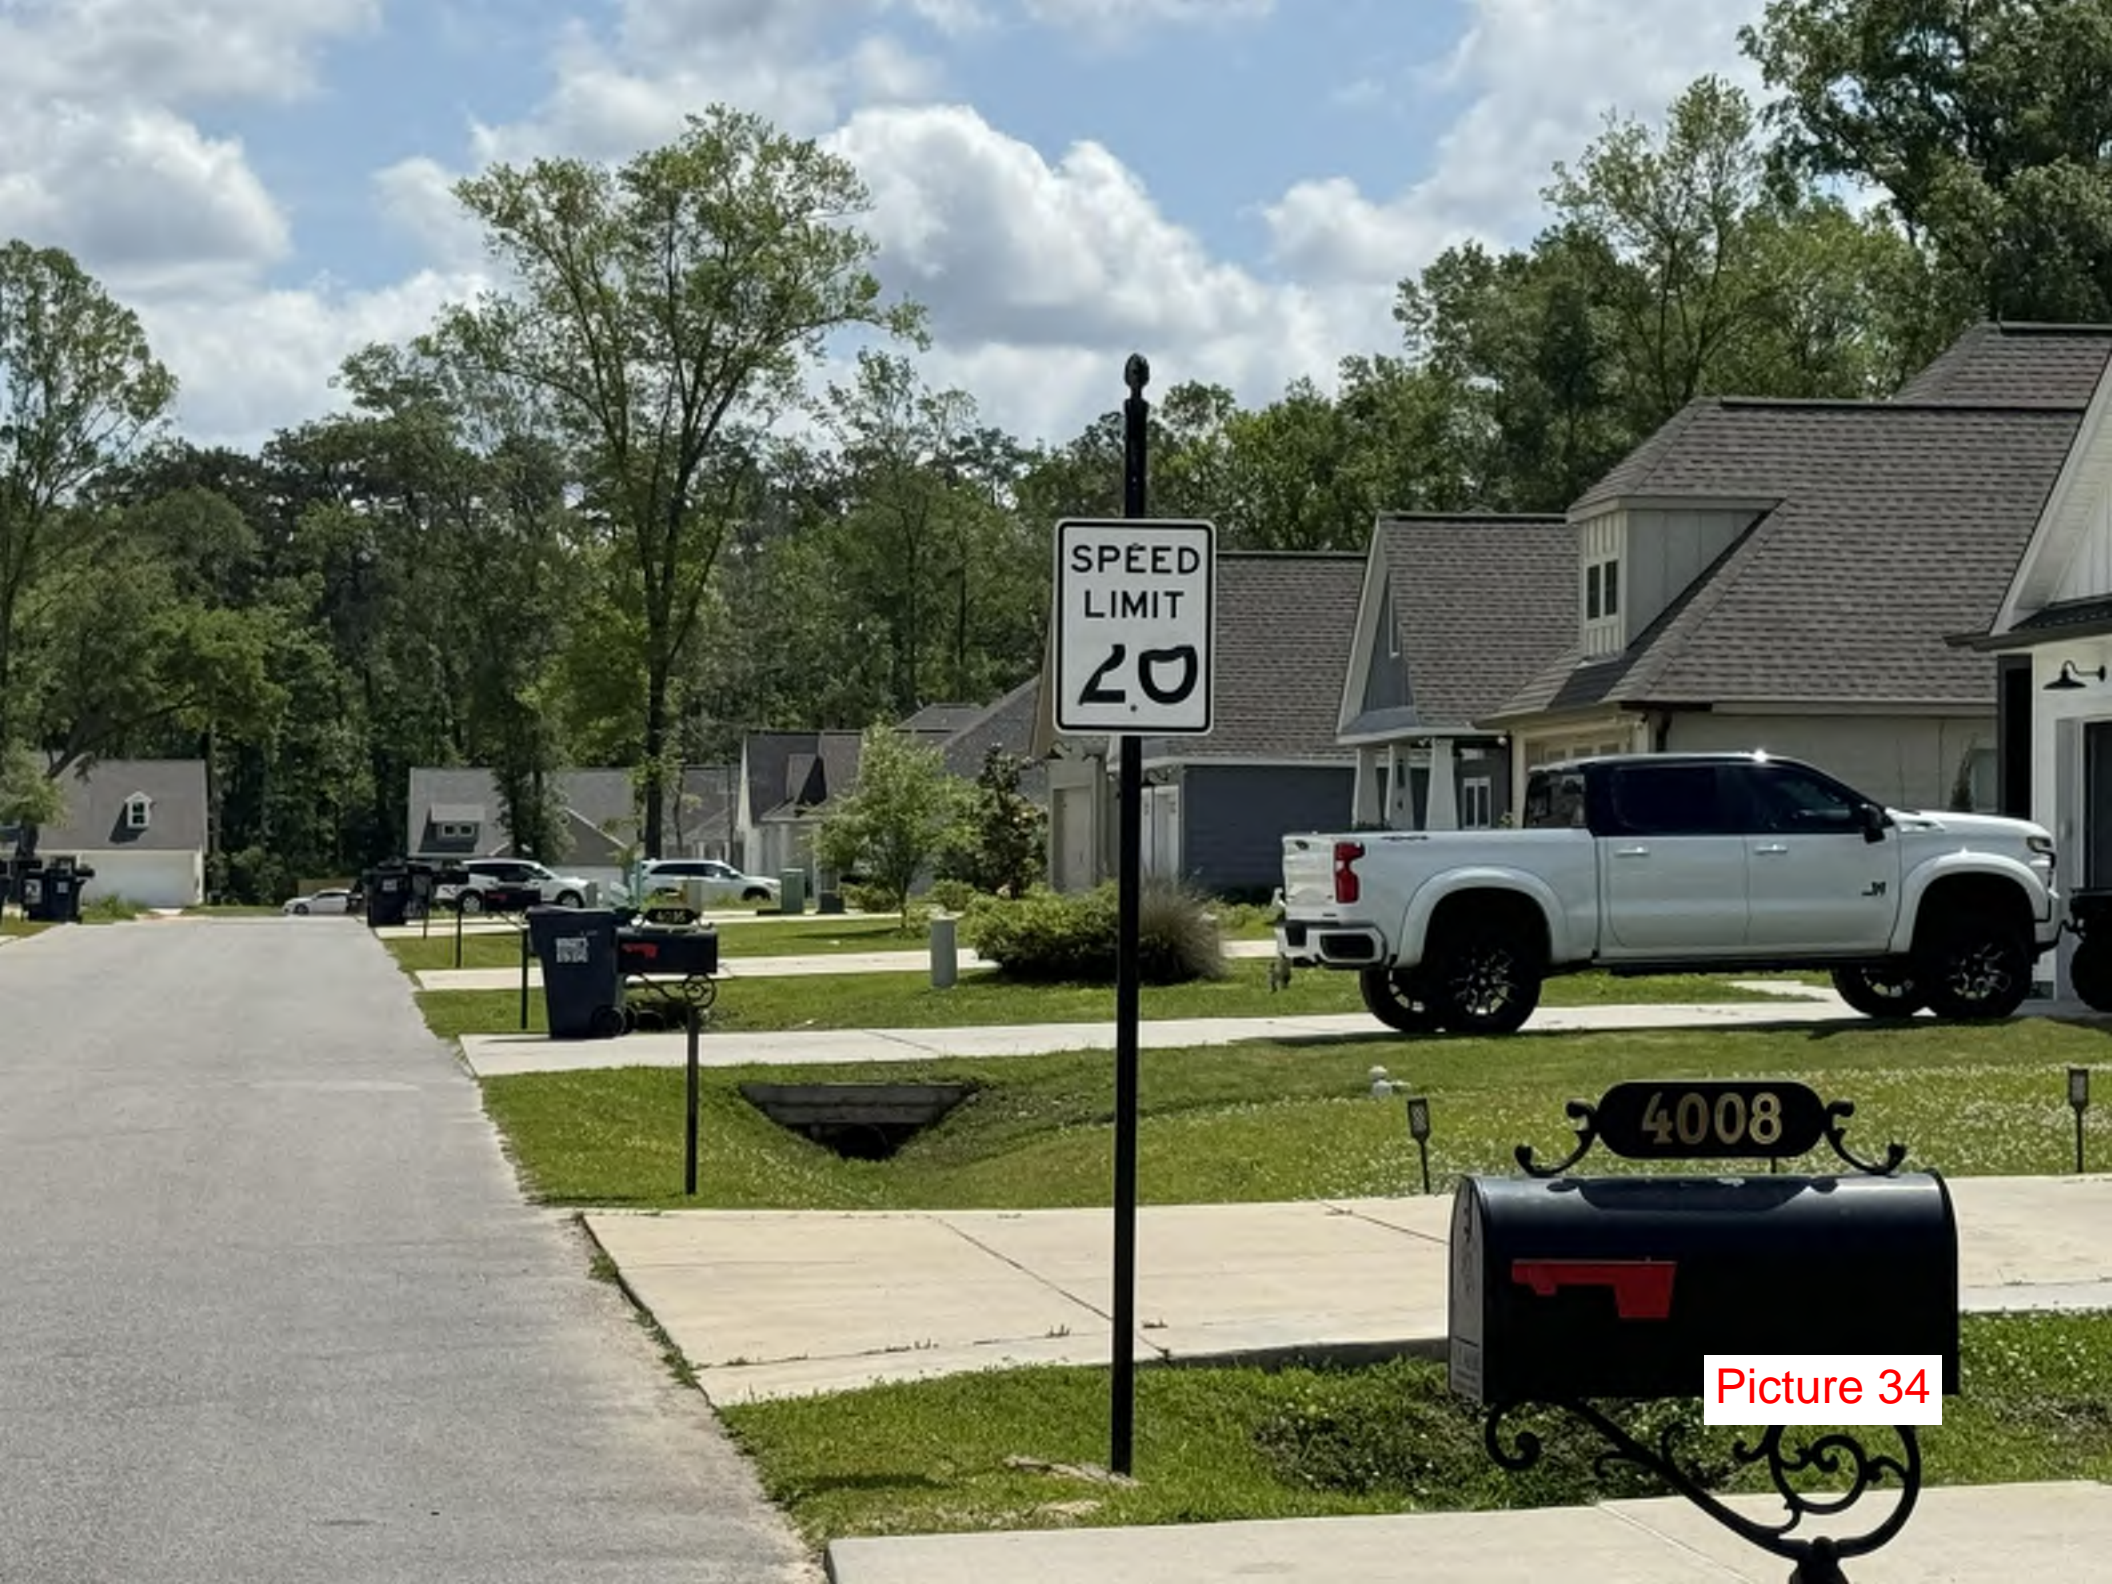
Picture 34

12. Replace/Repair all damaged and/or leaning speed signages located throughout this phase of Abita Ridge (See picture #34 - Typical Comment).
