2021
STATE OF
DONNER LAKE
MARCH 2022

DIPS
DONNER LAKE
INTERAGENCY
PARTNERSHIP FOR
STEWARDSHIP

2021 Assessment of Donner Lake's Ecological Condition

**Prepared for the Donner Lake Interagency Partnership for Stewardship
March 23, 2022**

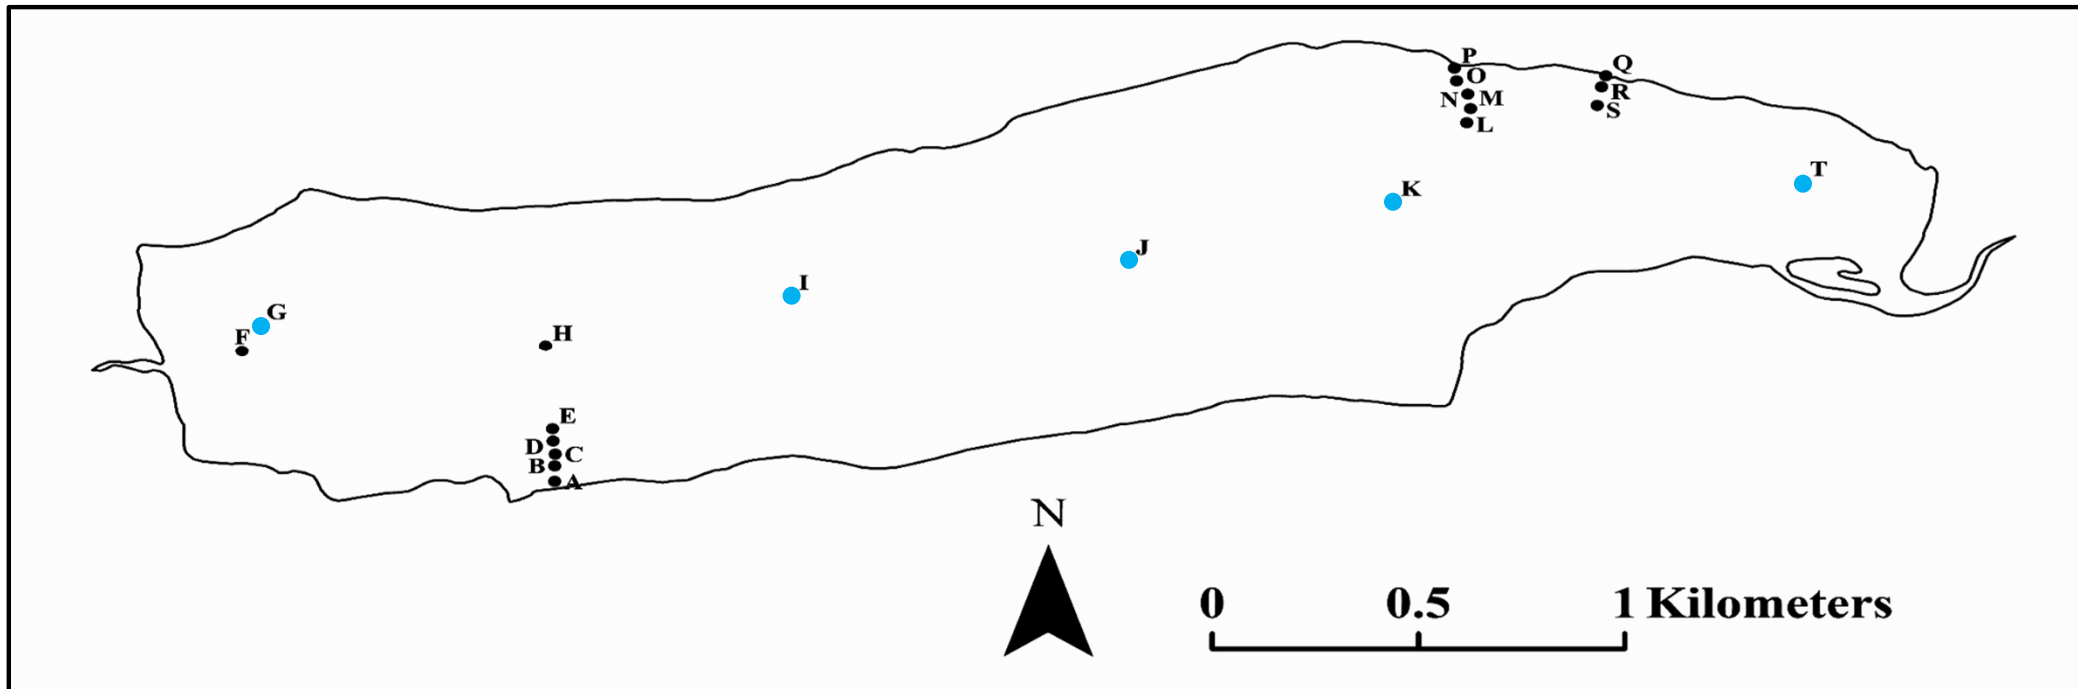
Sampling Sites

Lake Area: 3.4 km²

Shoreline Length: 12.5 kilometers

Max Depth: 71 meters (July 2021)

- 2021 sampling sites
- 2021 & historic sampling sites

Site	Sampling Activities
A	Nearshore temperature, nearshore oxygen, benthic invertebrates (3 meters depths)
B	Benthic invertebrates (10 meters depth)
C	Benthic invertebrates (20 meters depth)
D	Benthic invertebrates (30 meters depth)
E	Benthic invertebrates (40 meters depth)
F	Gill nets (~20 meters depth)
G	Gill nets, mysid collections in 1978-1980 and 2021 (~40 meters depth)
H	Light profile, secchi depth, nutrient profile, temperature profile, dissolved oxygen profile, chlorophyll <i>a</i> profile (~70 meters depth)
I	Mysid collections in 1978-1980 and 2021 (~60 meters depth)
J	Mysid collections in 1978-1980 and 2021 (~40 meters depth)
K	Mysid collections in 1978-1980 and 2021 (~50 meters depth)
L	Gill nets, crayfish sampling (30 meters depth)
M	Crayfish sampling (20 meters depth)
N	Crayfish sampling (15 meters depth)
O	Crayfish sampling (10 meters depth)
P	Crayfish sampling (3 meters depth)
Q	Air particulate concentration (PM _{2.5}), surface radiation

R	Nearshore temperature, nearshore oxygen (~3 meters depth)
S	Gill nets (~20 meters depth)
T	Mysid collections in 1978-1980 and 2021 (~15 meters depth)

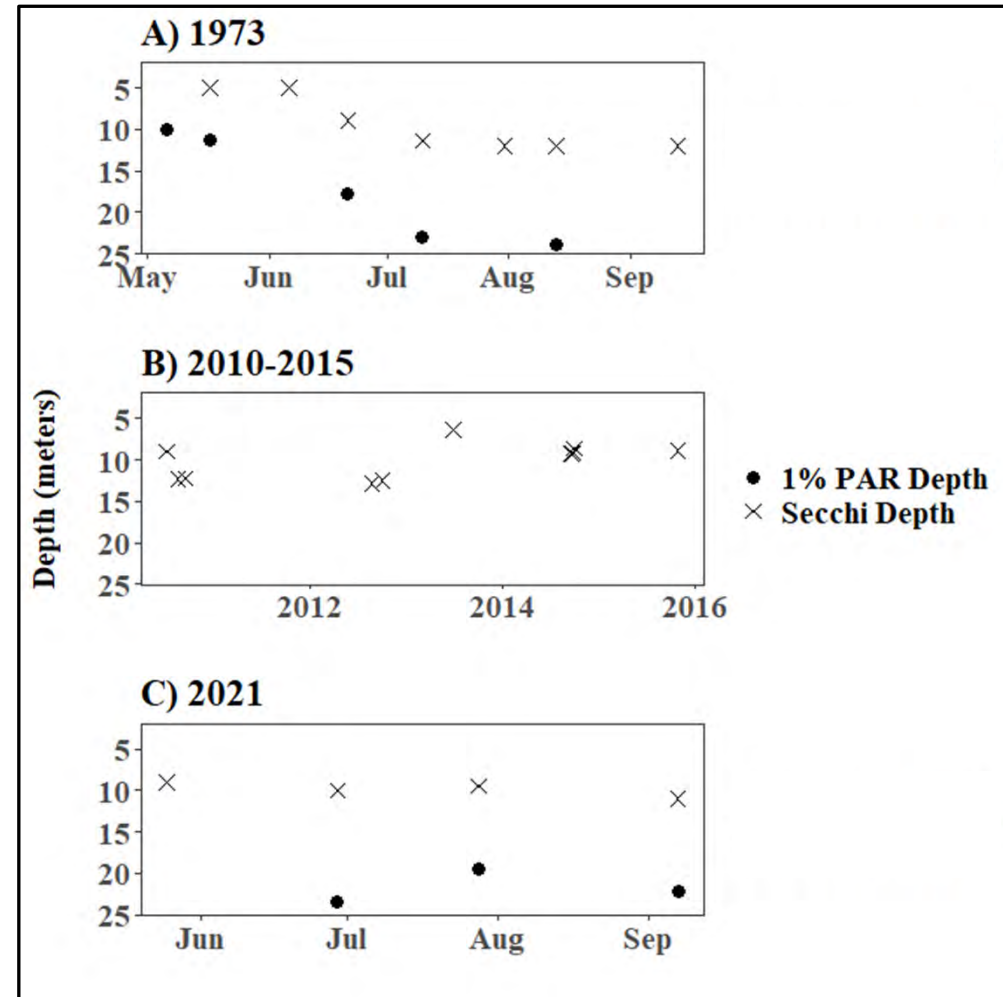
Light Conditions have been stable since 1980s

- **Summer 2021**
 - 1% Photosynthetically Active Radiation (PAR) Light Depth: Secchi Depth Ratio for Donner Lake ~ 2.0
 - Generally 1.8 - 2.5 for inland waters
 - Secchi depths (depth at which a disk lowered into the water can no longer be seen from the surface) ranged from 9 to 11 meters in summer 2021
 - 1% PAR depths (maximum depth at which algae may grow) ranged from 19 to 22 meters in summer 2021
- **Early 1973 show degraded condition**

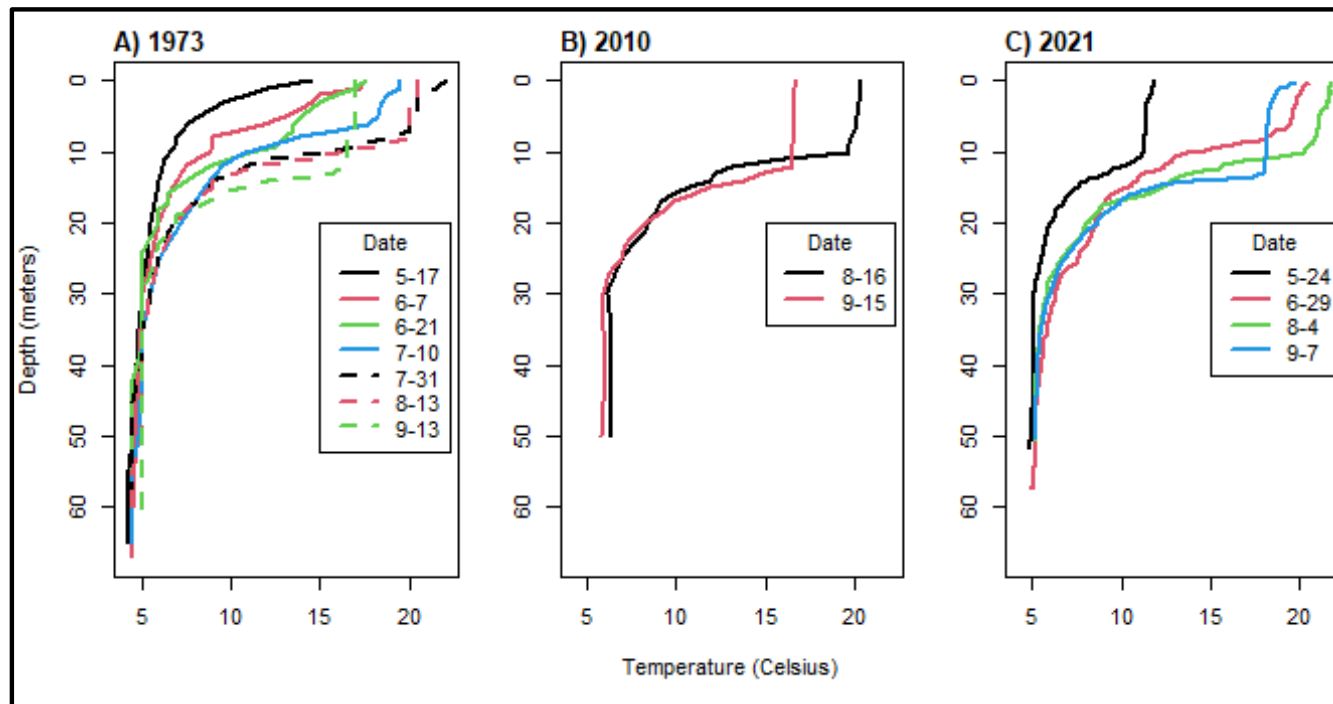
Water temperature conditions – as expected

- Little interannual variation in summertime water temperatures between historical (1973, 2010) measurements and today (2021)
- Upper water column temperatures reach a high in late July/early August
- Bottom water column temperatures are consistently $\sim 5^{\circ}\text{C}$

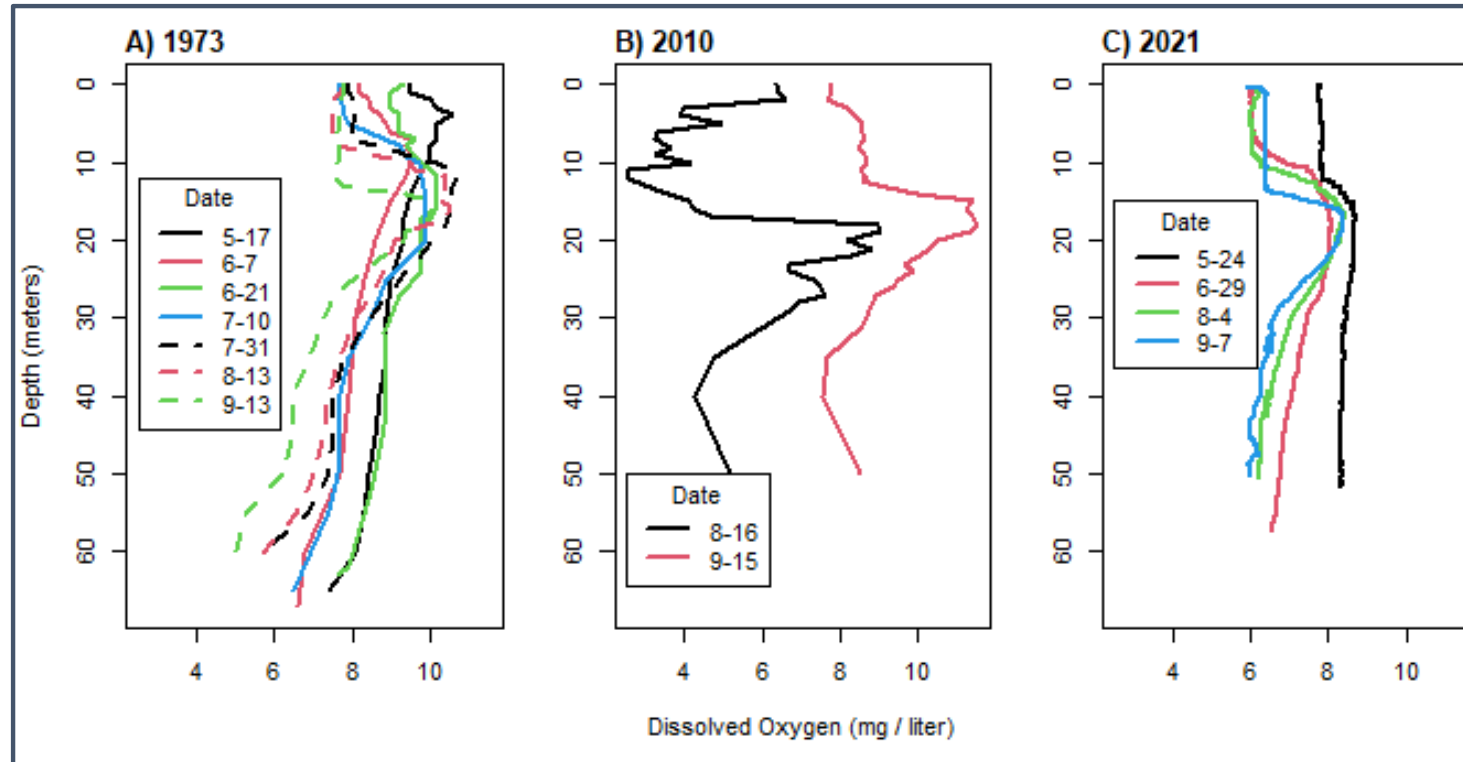
Oxygen conditions – as expected

- Dissolved oxygen profiles indicated the lake is well oxygenated towards the lake bottom
- Highest concentrations near the thermocline (where water temperatures change rapidly and algal growth is likely dominating)

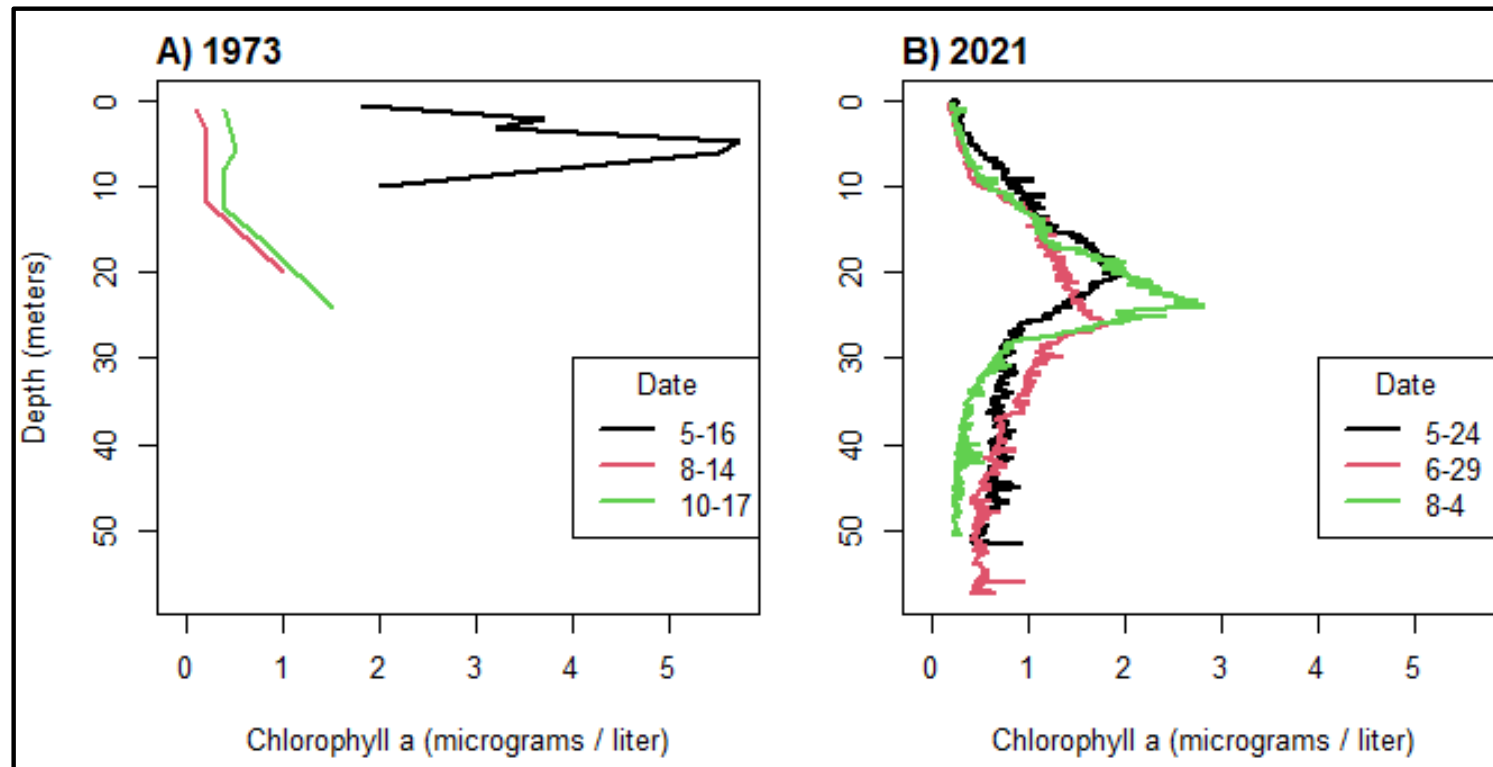
Phytoplankton Biomass (Algae) – as expected in 2021

- Deep chlorophyll maxima occur at 20-25 meters depth
- The deep chlorophyll maxima in summer 2021 ranged from ~2 to 3 micrograms/liter and occurred below the thermocline, as is typical for mountain lakes

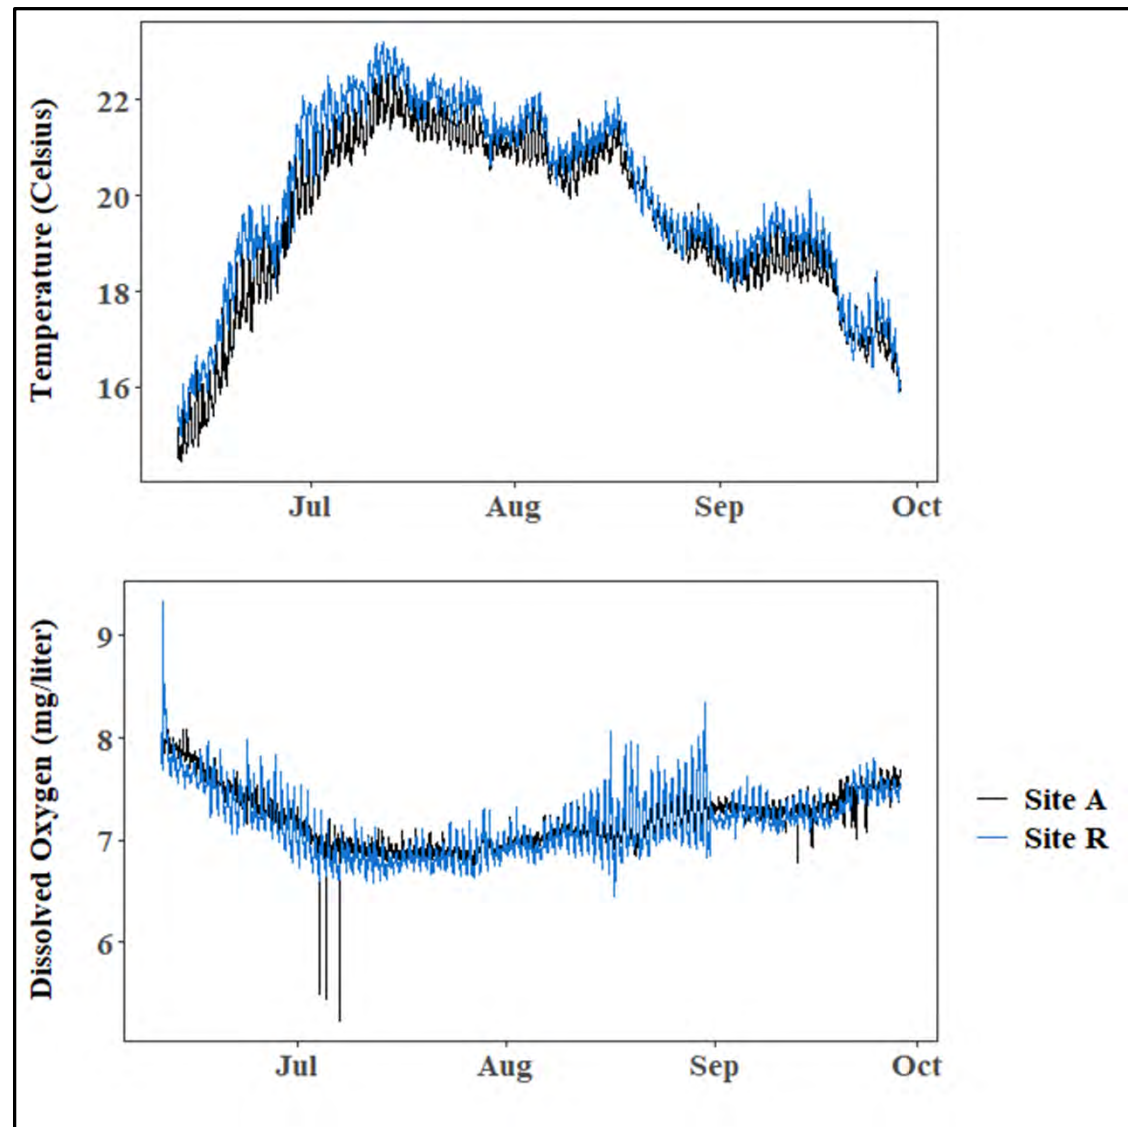
Nearshore Oxygen and Temperature – as expected

- Nearshore temperatures reached a high of 22.5 °C on July 12th at site A and a high of 23.2 °C at site R
- Maximum nearshore water temperatures and maximum air temperatures were both recorded on July 12th
- Nearshore dissolved oxygen concentrations mirror temperatures, reaching a low in the second week of July
- Site A = SW side of lake
- Site R = NE side of lake

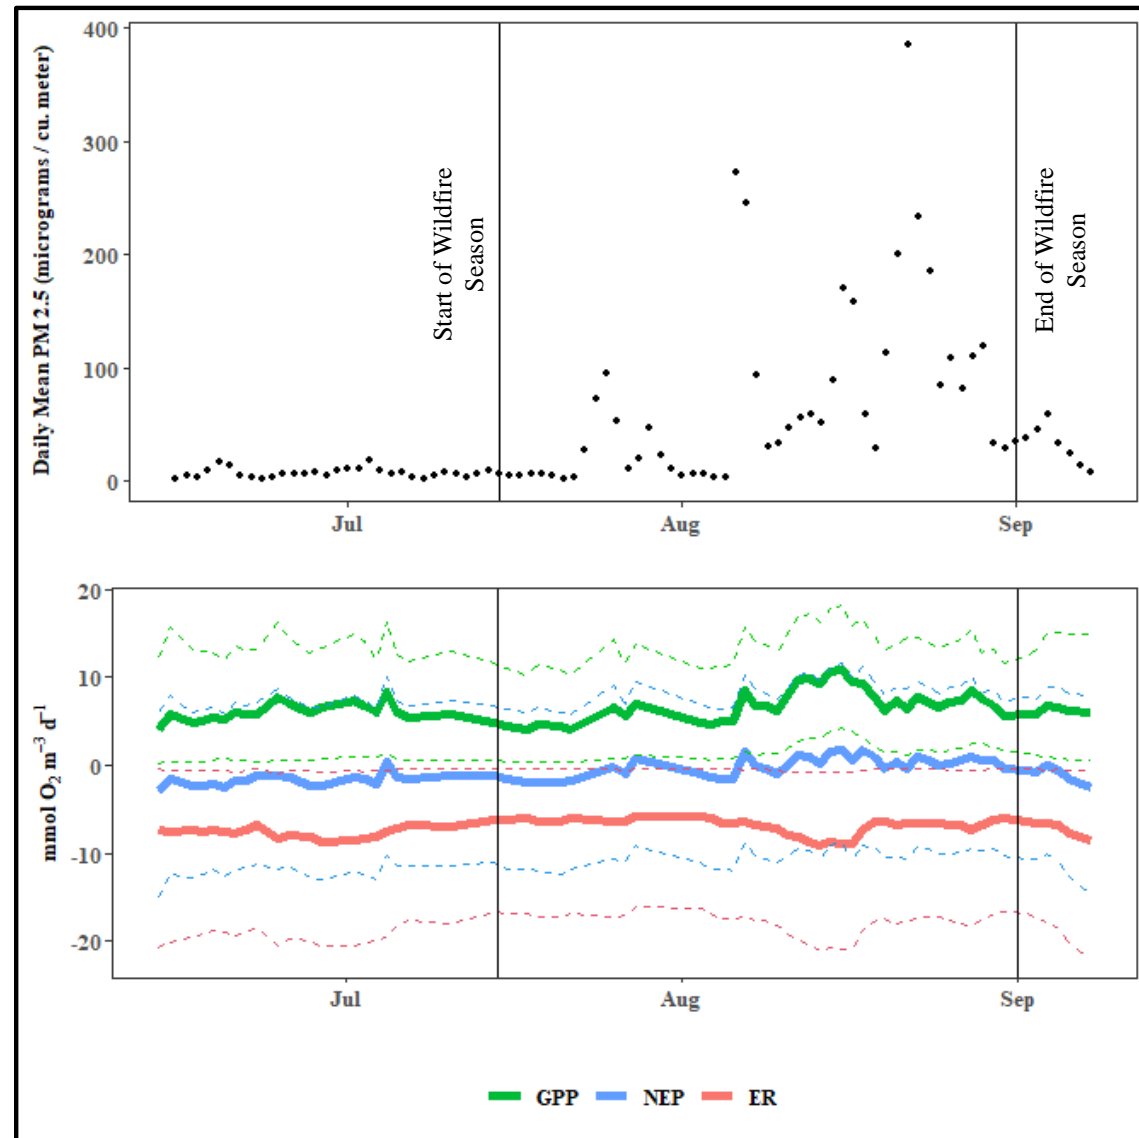
Wildfire season impacts Nearshore Productivity in 2021

- Increases in nearshore Gross Primary Productivity (GPP) and decreases in Ecosystem Respiration (ER) correspond with increases in smoke during wildfire season

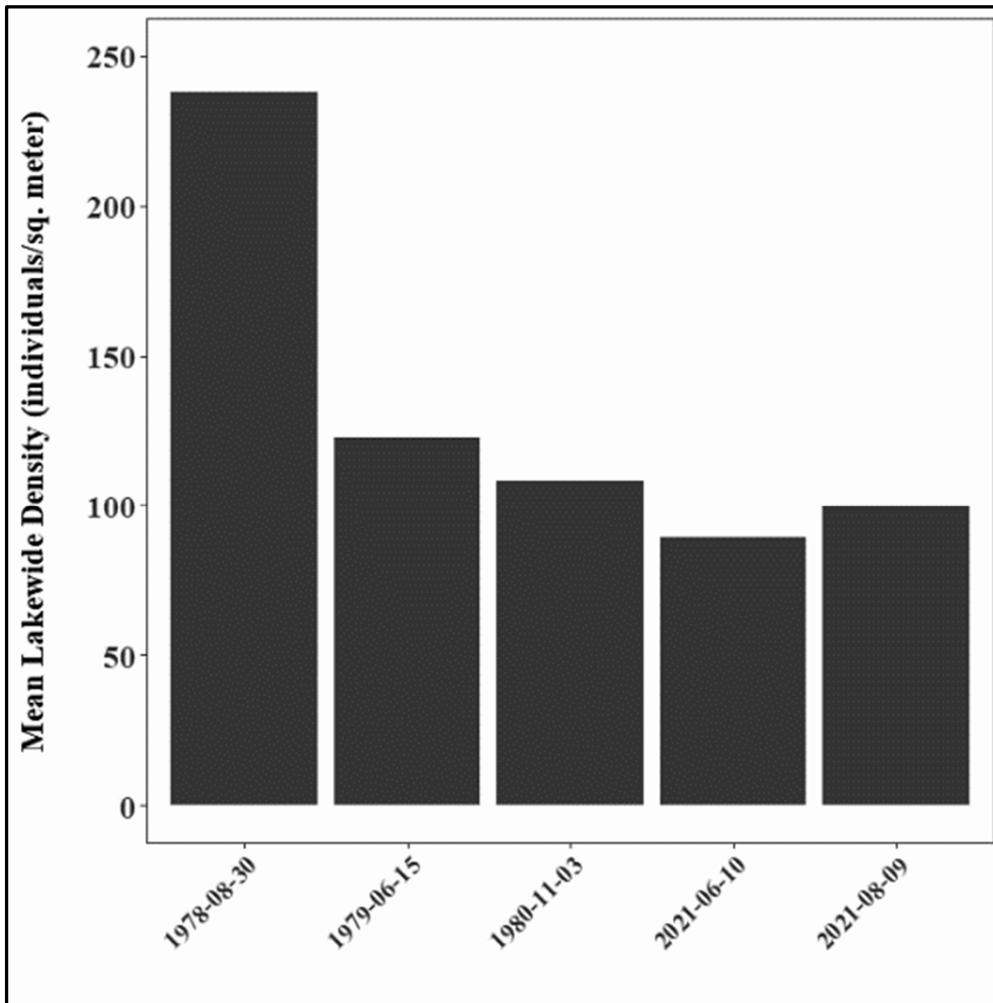
Invasive mysid shrimp density consistent since 1979

- Mysids were sampled at 5 sites in 1978, 1979, 1980, and 2021.
 - Sampled at Sites G, I, J, K, & T
- The densities observed in summer 2021 agree with the densities seen in June 1979 and November 1980 but are significantly less than what was seen in August 1978

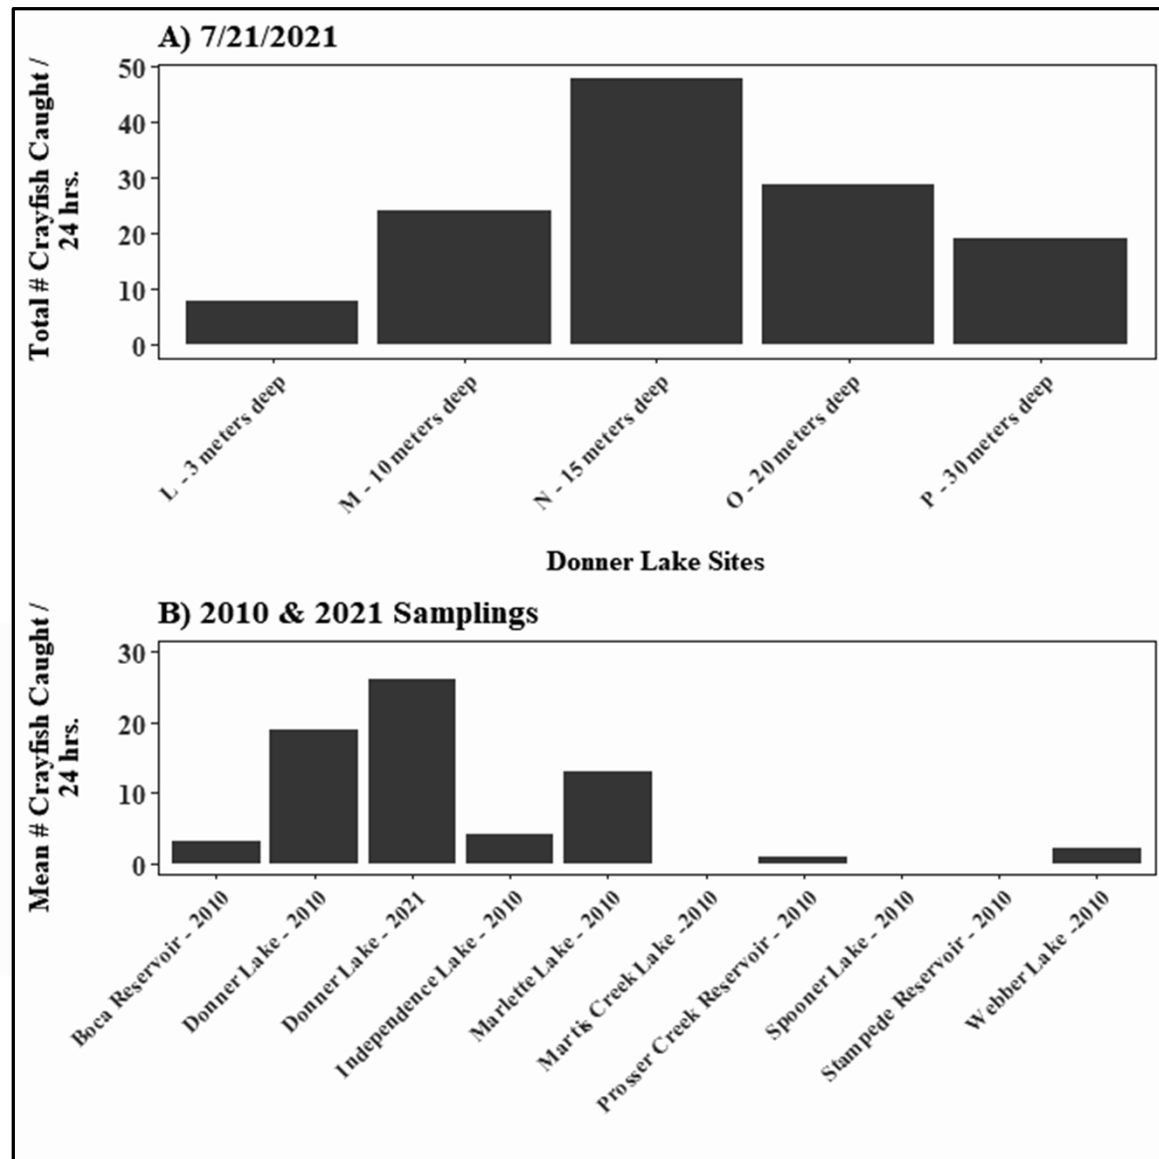
Donner Lake has more Invasive Crayfish than neighboring lakes

- Crayfish reach their highest densities at 15 meters
- Densities in summer 2021 were higher than in summer 2010 and other lakes in the region

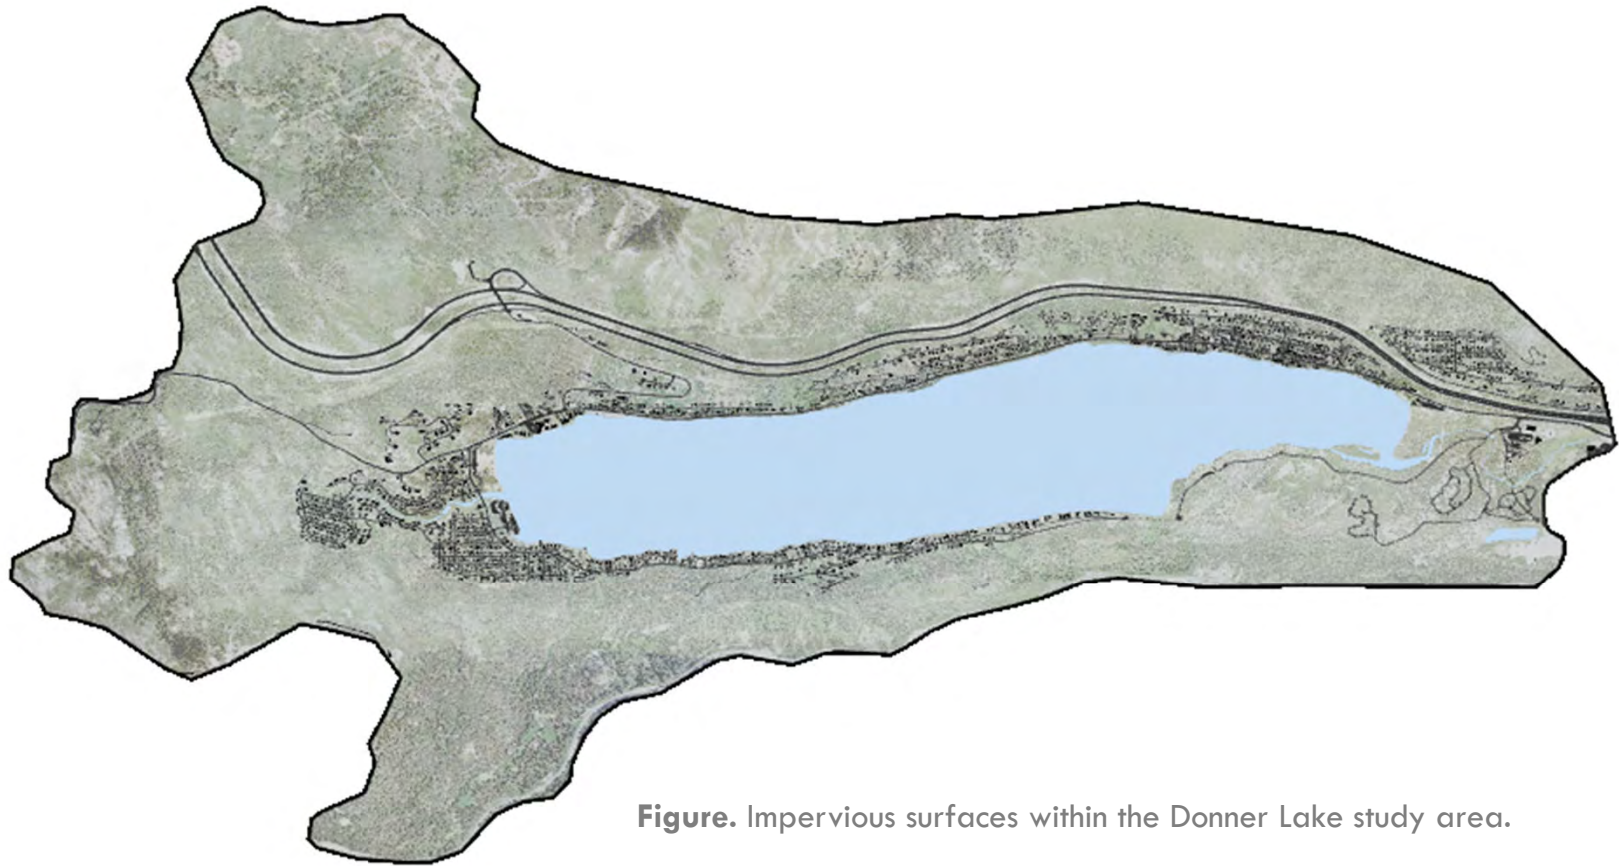
Facilities and Infrastructure: Impervious Surfaces

Figure. Impervious surfaces within the Donner Lake study area.
