State of California - The Resources Agency
 DEPARTMENT OF PARKS AND RECREATION
PRIMARY RECORD

Page 1 of 3 *Resource Name or #: THRI - 149 (1998: KEC-134-MM-12)

*P2. Location: Not for Publication Unrestricted *a. County Nevada
 *b. USGS 7.5' Quad Truckee, CA Date 1992 T 17N; R 16E; NW 1/4 of NE 1/4 of Sec 15; Mt. Diablo B.M.
 c. Address 10115 West River Street City Truckee Zip 96161
 d. UTM: (Give more than one for large and/or linear feature) Zone 10; mE/ mN
 e. Other Locational Data: (e.g., parcel #, legal description, directions to resource, elevation, additional UTM's, etc. as appropriate)
 Parcel No. 19-090-31

BUILDING, STRUCTURE, AND OBJECT RECORD

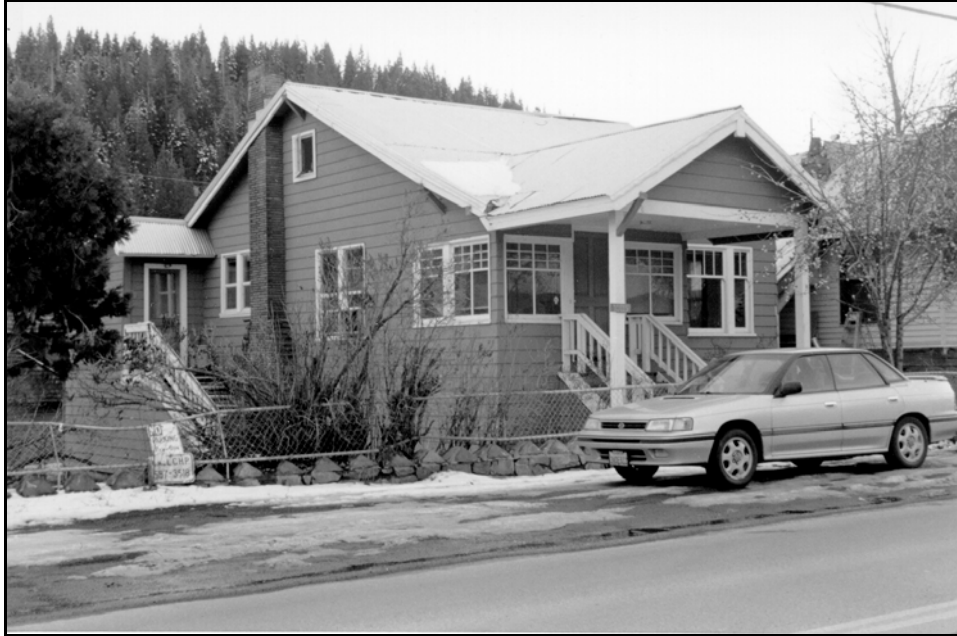
East and north elevations; southwest view; 11/20/98; Acc. #134-14-3.

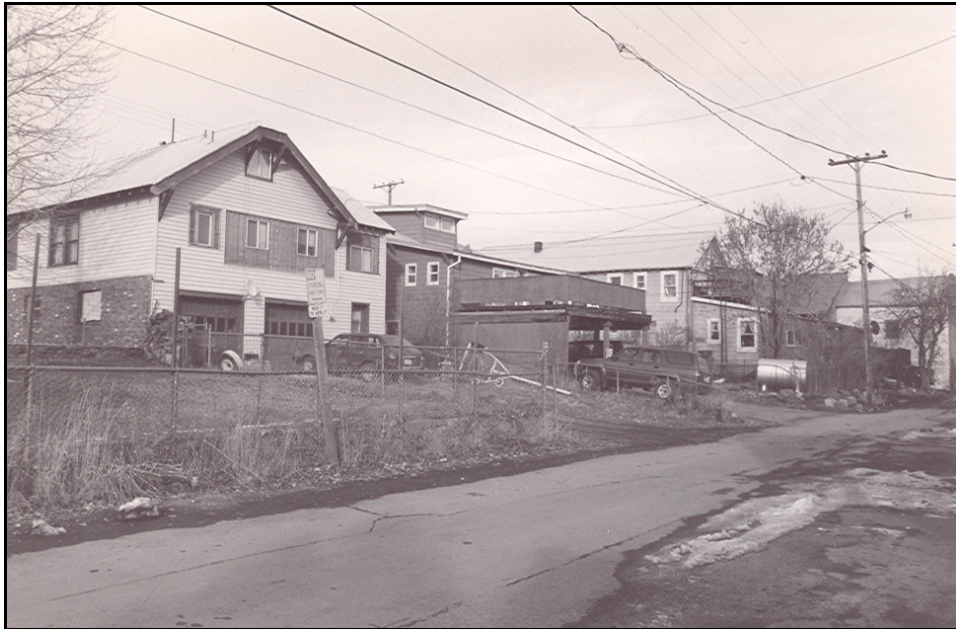
West and south elevations; northeast view from Riverside Drive, 11/20/1998; Acc. #134-15-2.
Resource #149 is the dark building at the center (note balcony and carport).
