Donner Lake:  
A Pearl in Peril

2022-2023 Nevada County Grand Jury

Report Date: May 16, 2023

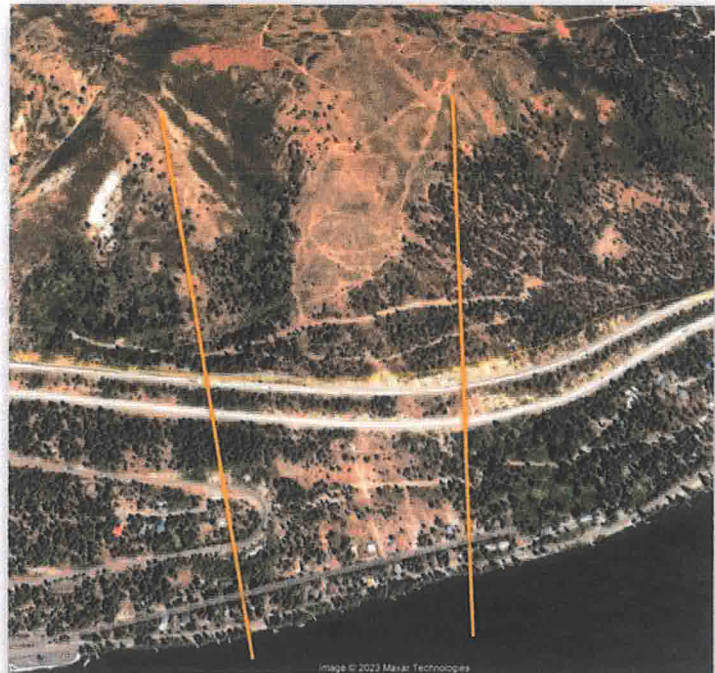
The location specific to this report, 1,500 feet of steep hillside assessed to be at the highest level of risk for erosion and landslides, a location that carries polluted runoff from I-80.

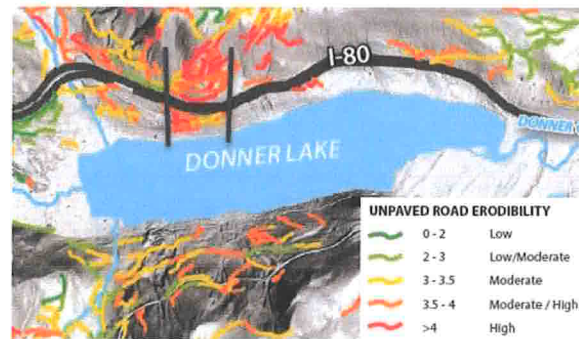
This location has the highest density of backcountry roads. These destabilize hillsides and contribute large amounts of sediment to runoff.

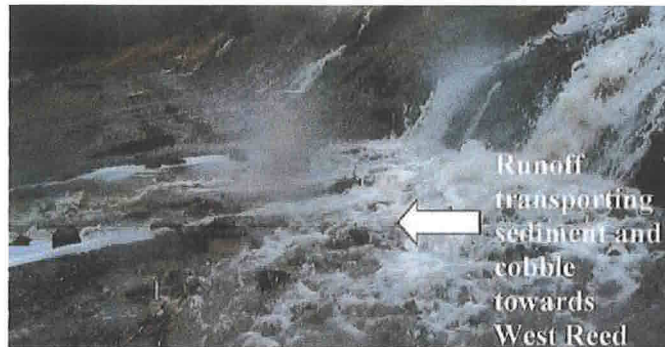
Water and electric utilities buried under unpaved road without drainage mitigation on hillside below I-80, above Reed Avenue West, Donner Pass Road, and Donner Lake.

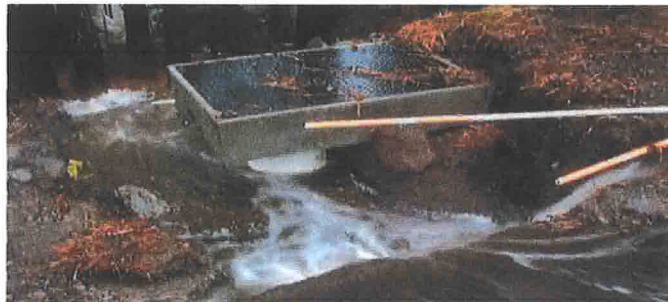
Utilities connecting West Donner to East Donner and located along Reed Avenue West compromised by runoff.

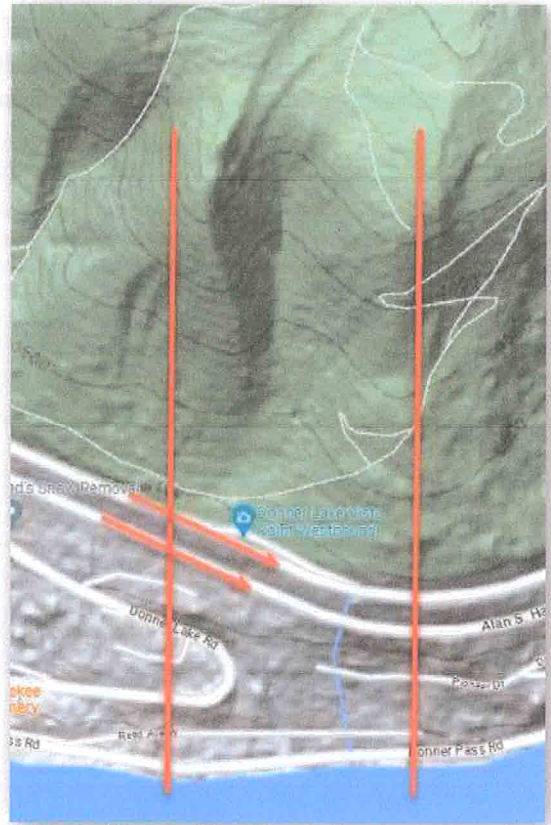
I-80 Drainage Culvert

From 1960-1964, Caltrans built I-80 above Donner Lake using drainage design and technology of the time, which is much different than what would be used today. Sixty years after I-80 was built, Caltrans reports on the changing nature of drainage design in its July 2020 Highway Design Manual:

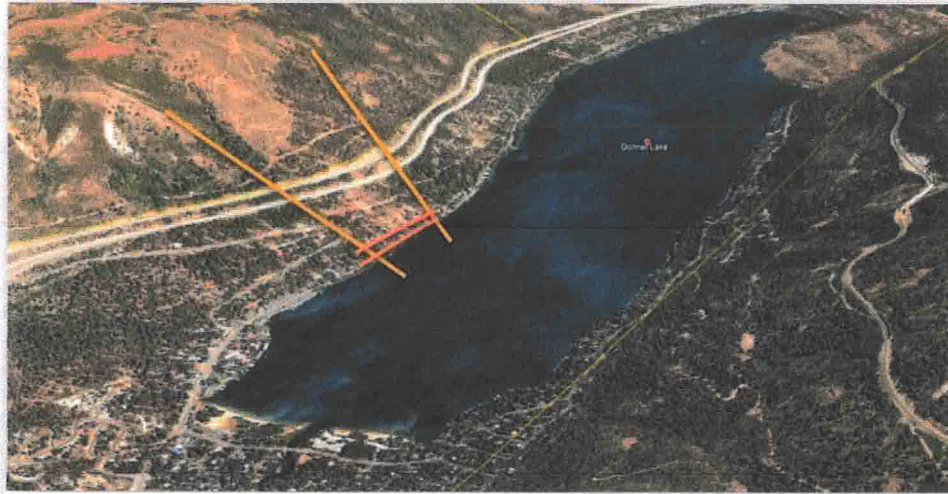
The focus of this report is a hillside and drainage that is unique in the Lake basin due to the extreme lack of vegetation, its length and steepness, its erodability, and the concentration of freeway drainage all funneling stormwater (sediment and pollutants) runoff down to and sometimes into the homes of the residents of Reed Avenue West and Donner Pass Road, shown in orange, and then into Donner Lake.

To address the concentration of runoff and associated erosion problems, small-scale stormwater management or "Best Management Practices" (BMPs) should be installed at the outlets of stormwater culverts. Where space is available, small settling basins or infiltration features should be developed. In other locations where little to no space is available, energy dissipation devices, slope drains, "hydro brakes" and other BMPs could be pursued.

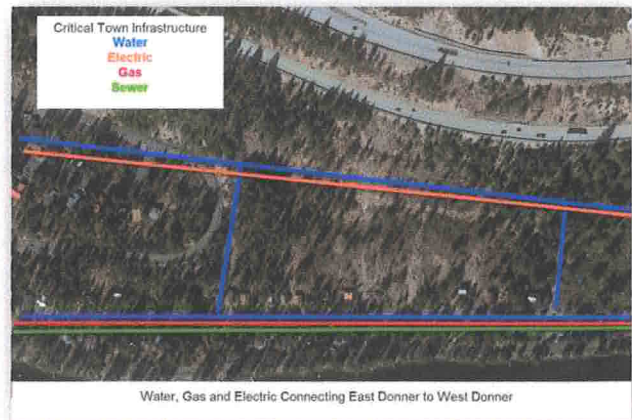
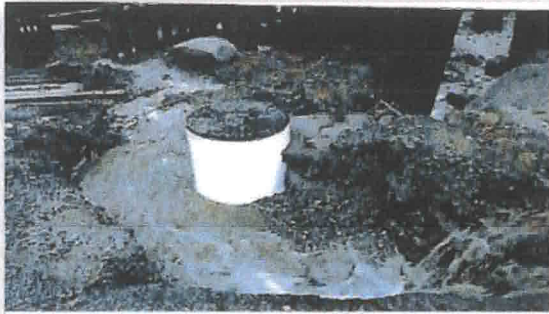
Utility infrastructure on Reed Avenue West

The existing infrastructure for Reed Avenue West will be at risk if the hillside-drainage issues remain unattended. The risk is to the health and safety of Truckee residents and visitors. [[Finding](#)]

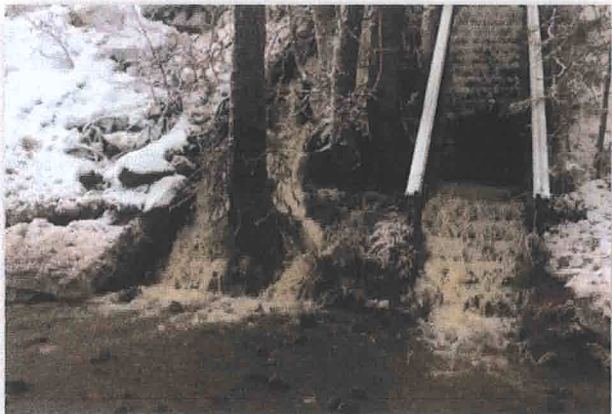
Stormwater from the hillside moving down from Reed Avenue West onto Donner Pass Road and into Donner Lake

The volume and velocity of runoff from the hillside and I-80 seasonally overwhelm Reed Avenue West, which further degrades its surface, adds pollutants to stormwater, and threatens utilities buried under its length. Sometimes, stormwater runs into and through the homes of residents who live on this road.
