**Historic Resource Assessment for 10236 Donner Pass Road, Truckee,  
Nevada County, California**

Prepared by:  
Broadbent & Associates, Inc.

Broadbent Project No.  
23-02-129

December 2024

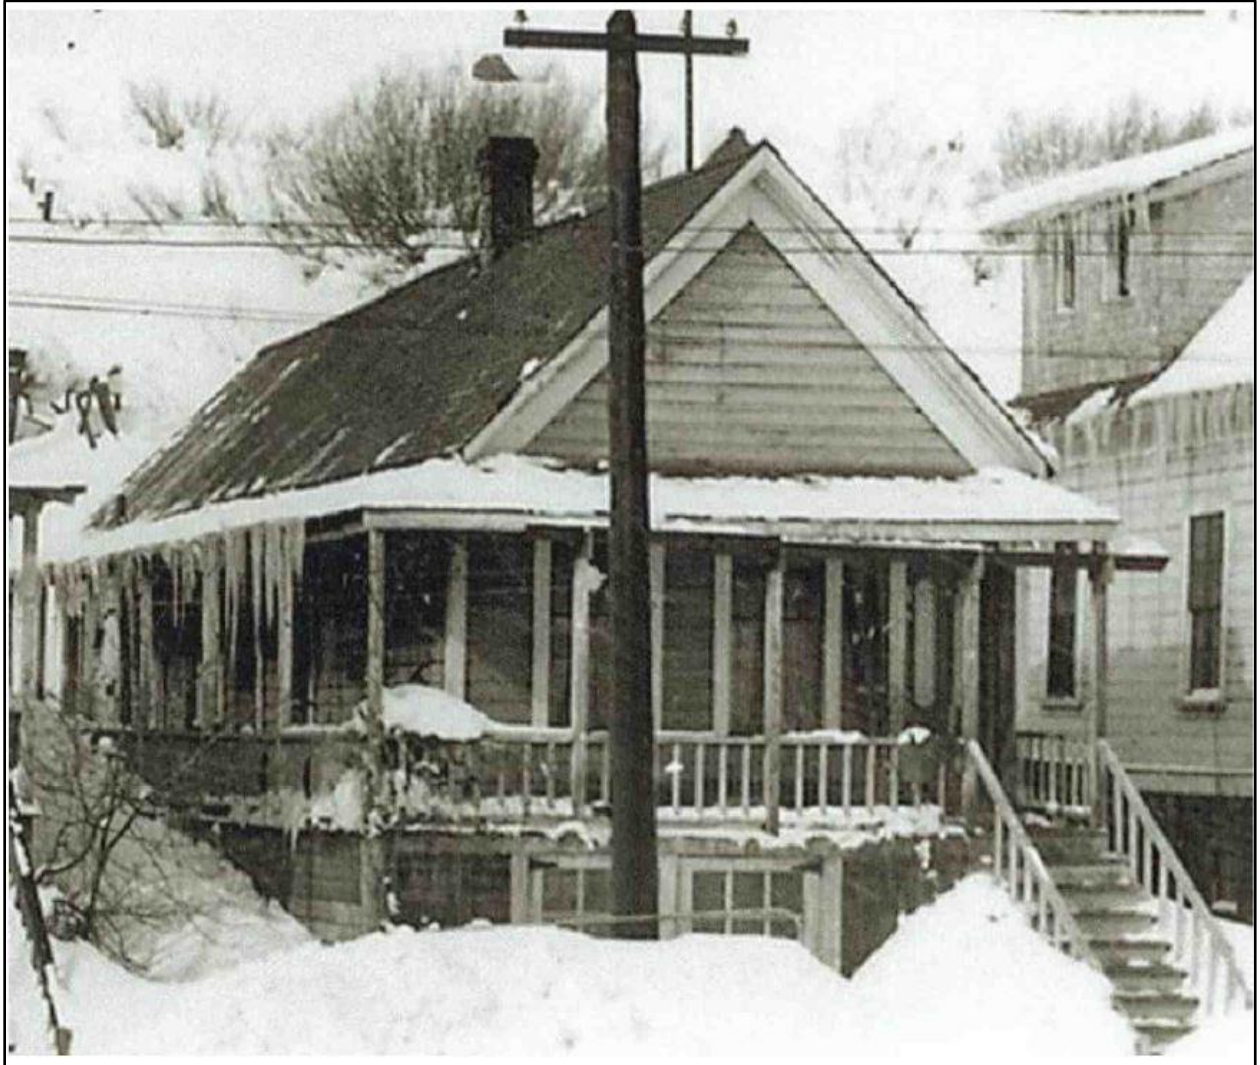
*Photograph 1: South (primary) and west elevations of Subject Property circa 1920s. Photograph from Truckee Donner Historical Society (as shown on HPAC Memo dated 8/9/23).*

style, a vernacular adaptation of the Greek Revival architectural style. It is a long, narrow, rectangular building with a front gable (Photograph 1).

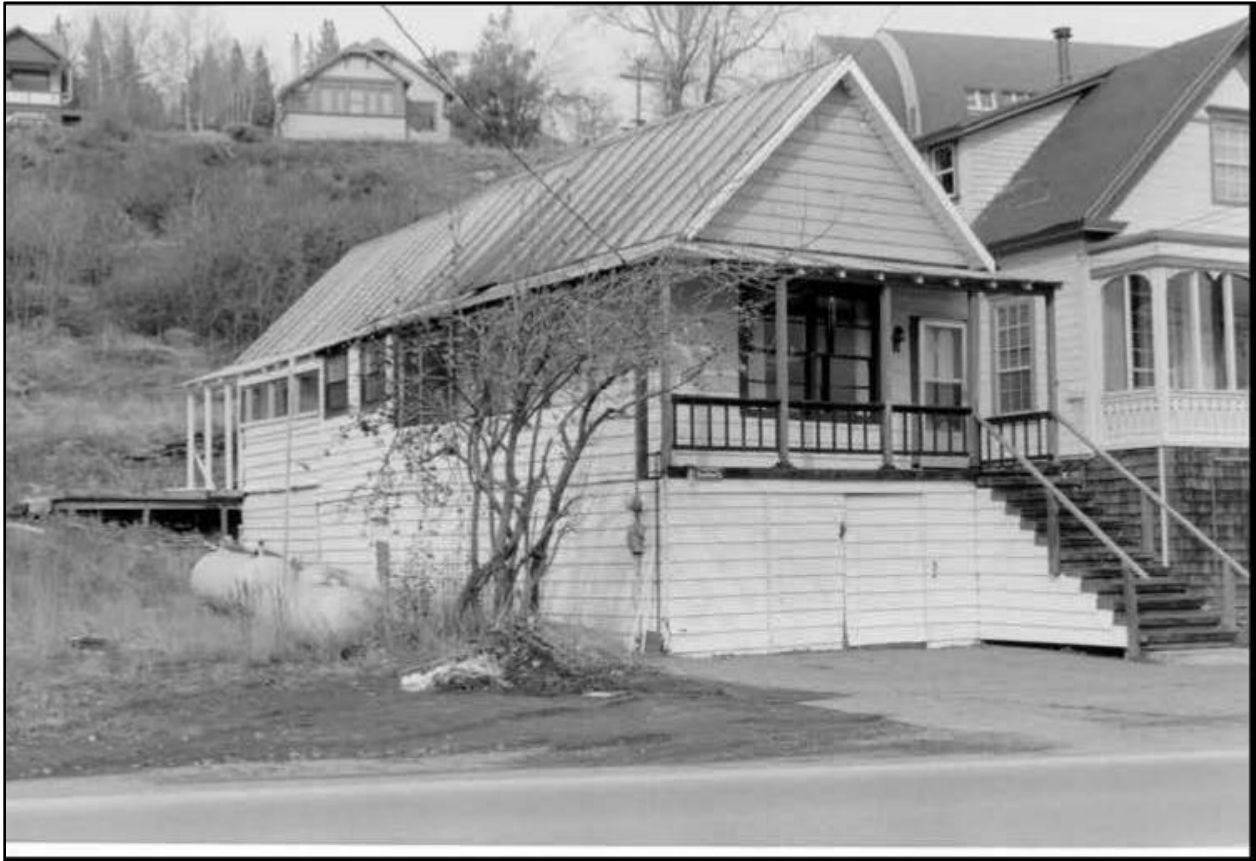
*Photograph 2: South (primary) and west elevations of Subject Property as depicted in 1998 DPR form.*

Alterations were considered minor and included aluminum siding (which presumably covered the original cladding), metal-frame windows, partial enclosure of the porch, and the addition of a porch at the rear. These findings generally reflected the findings of the earlier (1998-2003) townwide inventory that identified the key existing historic features of the building as its Folk Vernacular style; front-gable with rectangular plan; steep-pitched roof with narrow eave; enclosed rafters on gable and porch; full-width, dropped shed, wrap-around porch; stick balustrade; plain wood support posts; offset wooden stairs with plain, square rails; and the building's fenestration pattern. The inventory recommended the following potential restoration opportunities: remove aluminum siding and restore original cladding if present beneath; replace metal-frame windows with appropriate historic restoration forms; remove rear porch; and restore enclosed section of front porch (Kimball 2003). The Subject Property was in the same general condition at the start of the current project as it was when it was documented during the two previous efforts (Photograph 2, Photograph 3, Photograph 4, and Photograph 5).

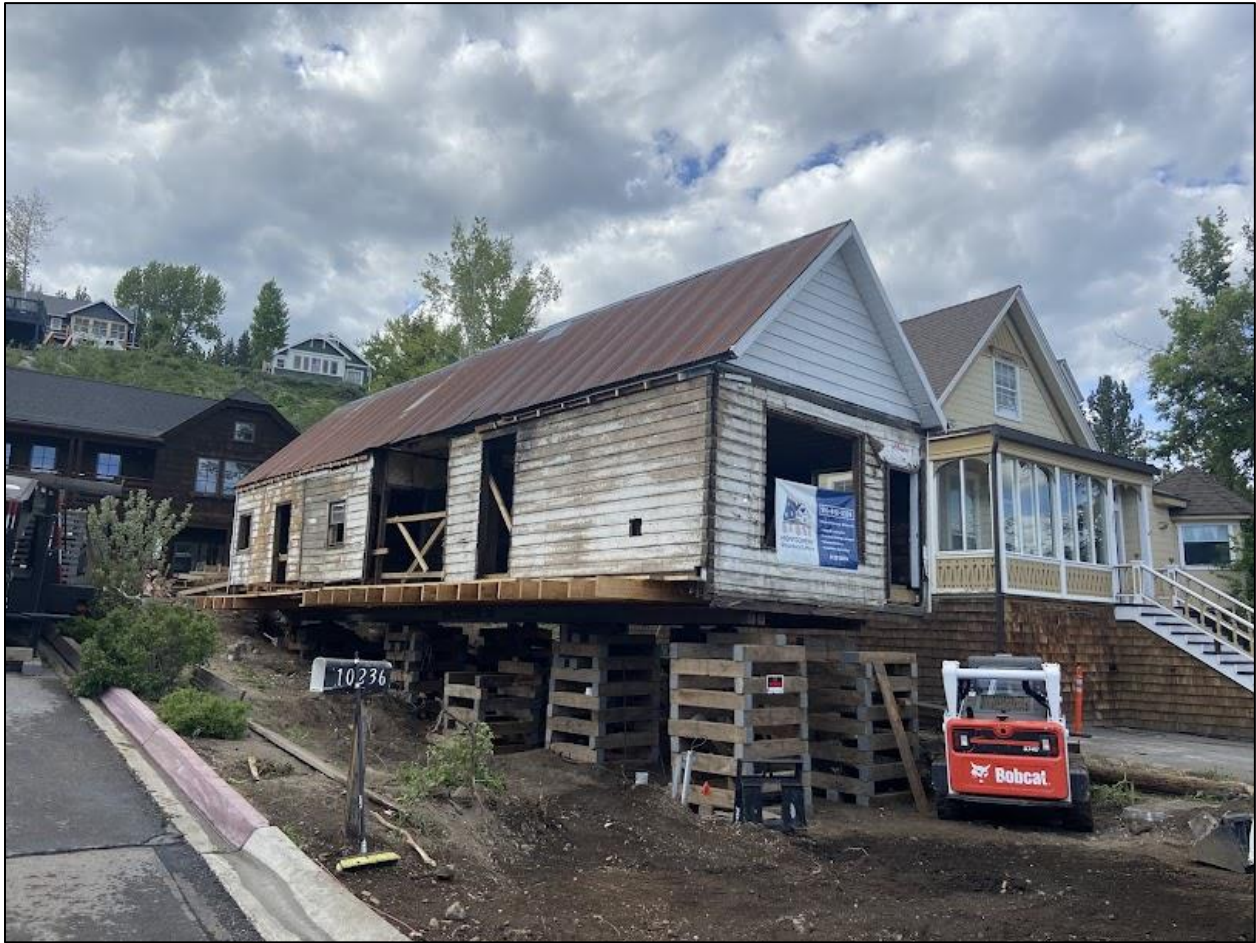
Location is the place where the historic property was constructed or the place where the historic event occurred. The current project involved relocating the Subject Property 11'-6" closer to Donner Pass Road.

As a result, it was moved from its original location but is still on its original site. During the historic period, the façade of the Subject Property was aligned with the other residences that lined the north side of Donner Pass Road. Because it was moved significantly closer to the road, the Subject Property does not retain integrity of location.

*Photograph 6: South (primary) and west elevations of Subject Property during project implementation (showing porch, basement, foundation, front steps, and all windows and doors removed prior to relocation closer to road). Photo taken by applicant team on May 29, 2024.*

The Subject Property no longer retains sufficient integrity to convey its historical significance and should be reclassified as a Category D (Non-essential) resource in Truckee's Historic Resource Inventory.

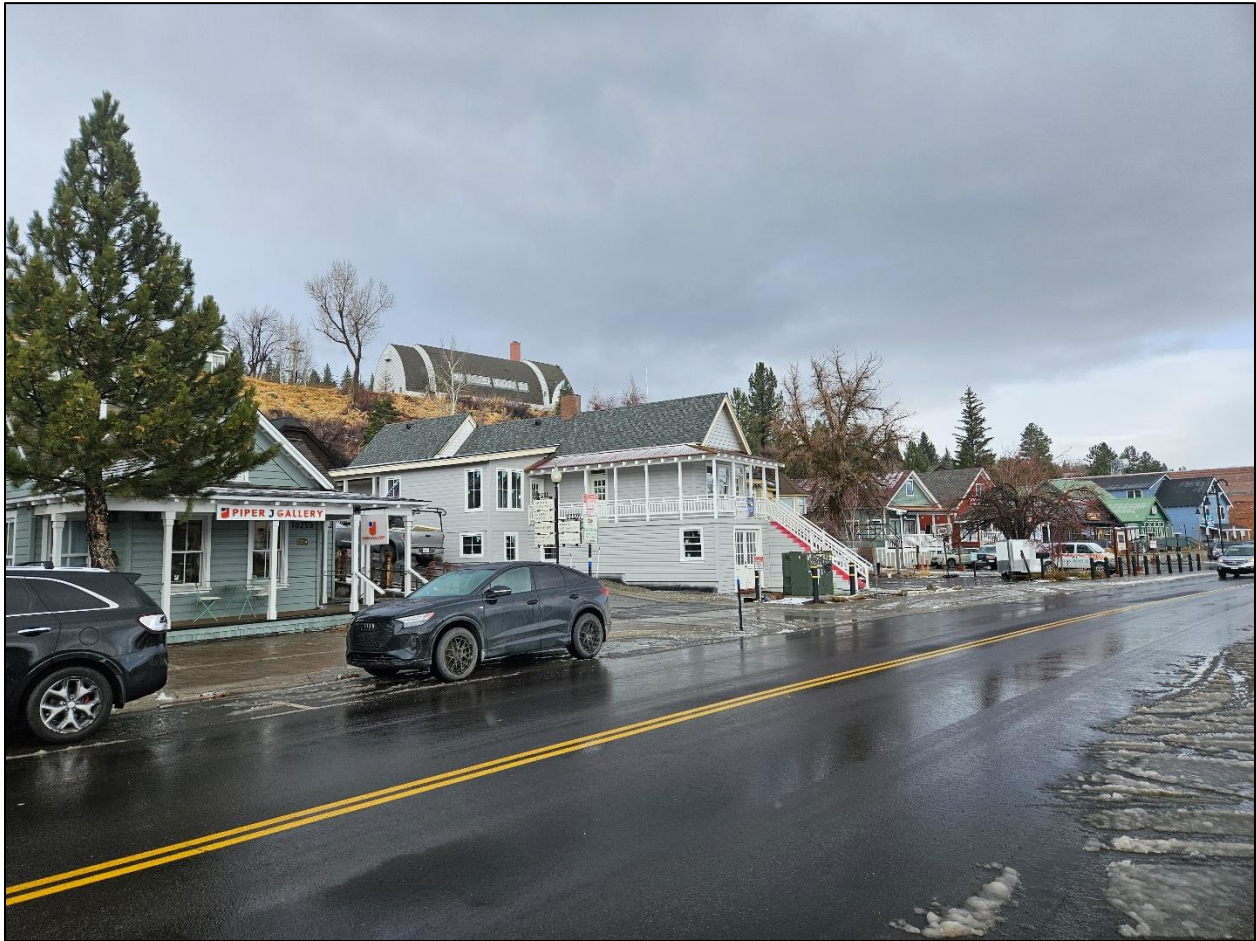
Setting is the physical environment of a historic property and refers to the character of the place in which the property played its historical role. The Subject Property is in the National Register-listed Commercial Row/Brickelltown Historic District. While most buildings in the Commercial Row/Brickelltown Historic District are close to the street, small front yards are important historic features. When the District was listed in 2009, 33 of the 48 properties within it (70 percent) were contributing elements, suggesting a high degree of integrity of setting. The surrounding neighborhood has not changed significantly since 2009; however, the relocation of the Subject Property closer to Donner Pass Road (notably closer than the adjacent Campbell House) has impacted the setting of both the building and the district. As a result of the relocation, the Subject Property does not retain integrity of setting.

*Photograph 9: View east along Donner Pass Road near project completion (showing mass of addition and reduced setback blocking view of Campbell House). Photo taken by Broadbent on November 21, 2024.*

Furthermore, by significantly reducing the setback of the Subject Property, the project has interrupted the street wall defined by the building fronts along Donner Pass Road and has altered this character defining feature of the district. If the NPS Form 10-900 for the Commercial Row/Brickelltown Historic District is updated, the district's integrity of setting should also be reevaluated.

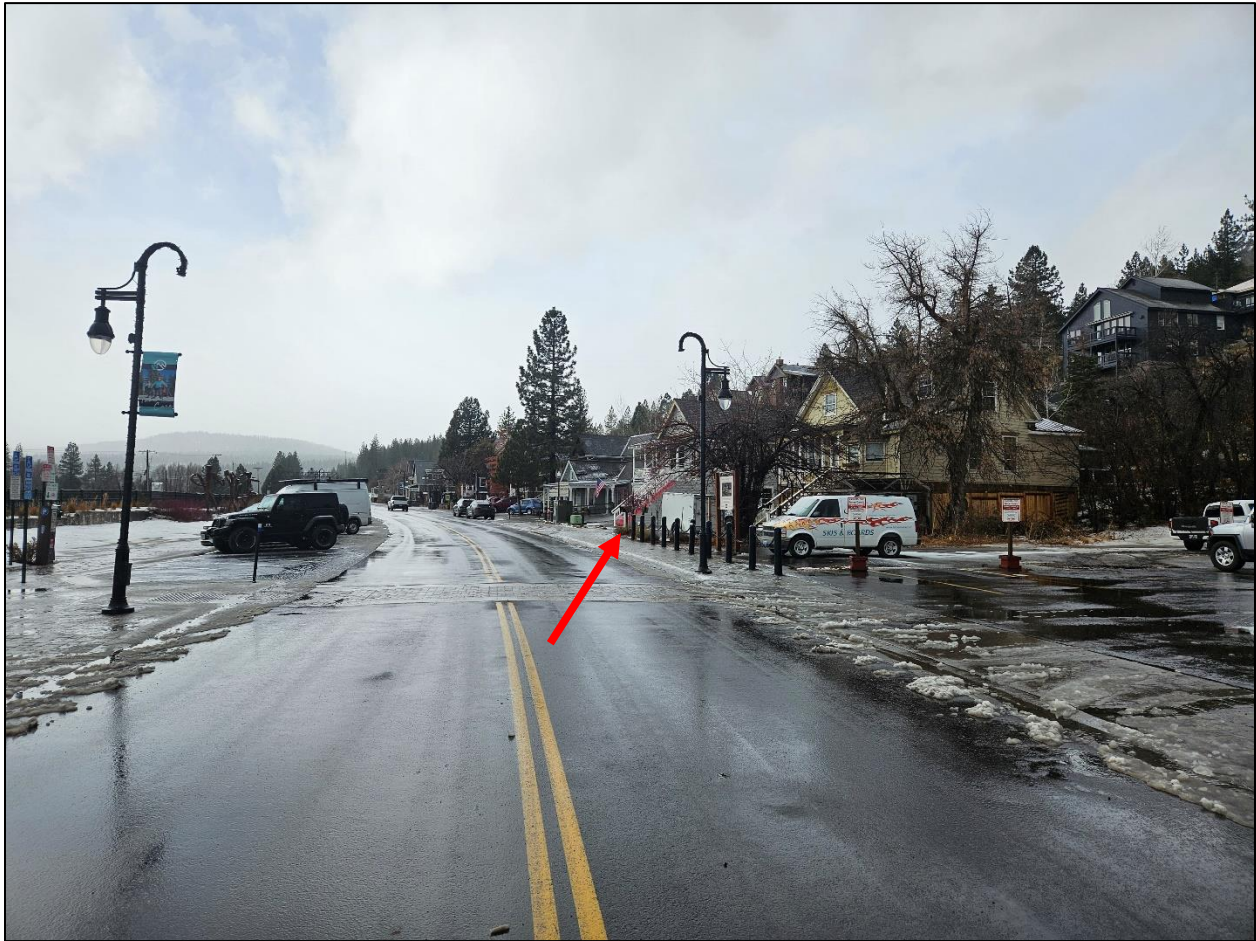
*Photograph 10: View west along Donner Pass Road near project completion (showing reduced setback compared to other properties). Subject Property is denoted by the red arrow. Photo taken by Broadbent on November 21, 2024.*

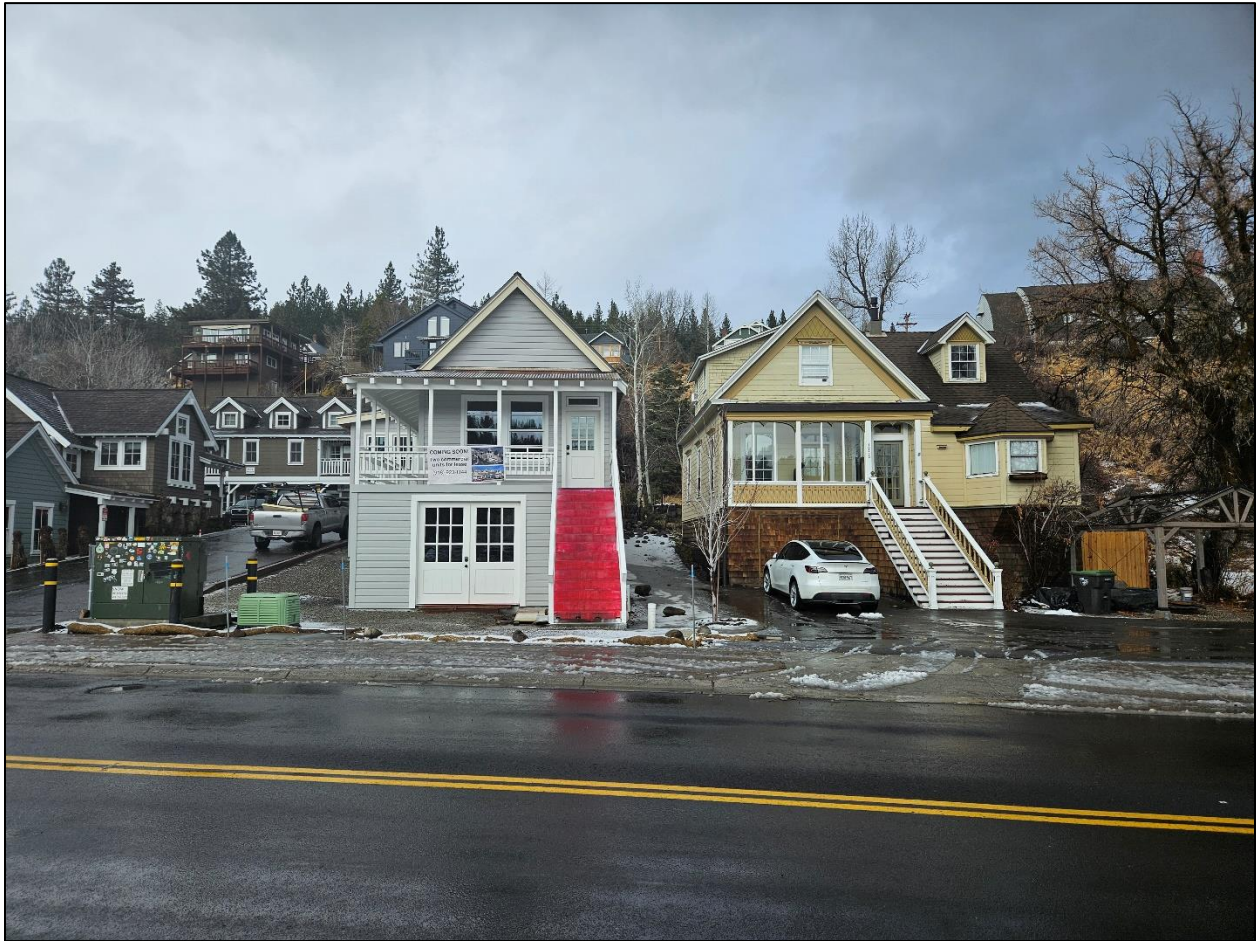
*Photograph 11: South (primary) elevation of Subject Property near project completion (showing reduced setback and raised porch compared to Campbell House). Photo taken by Broadbent on November 21, 2024.*

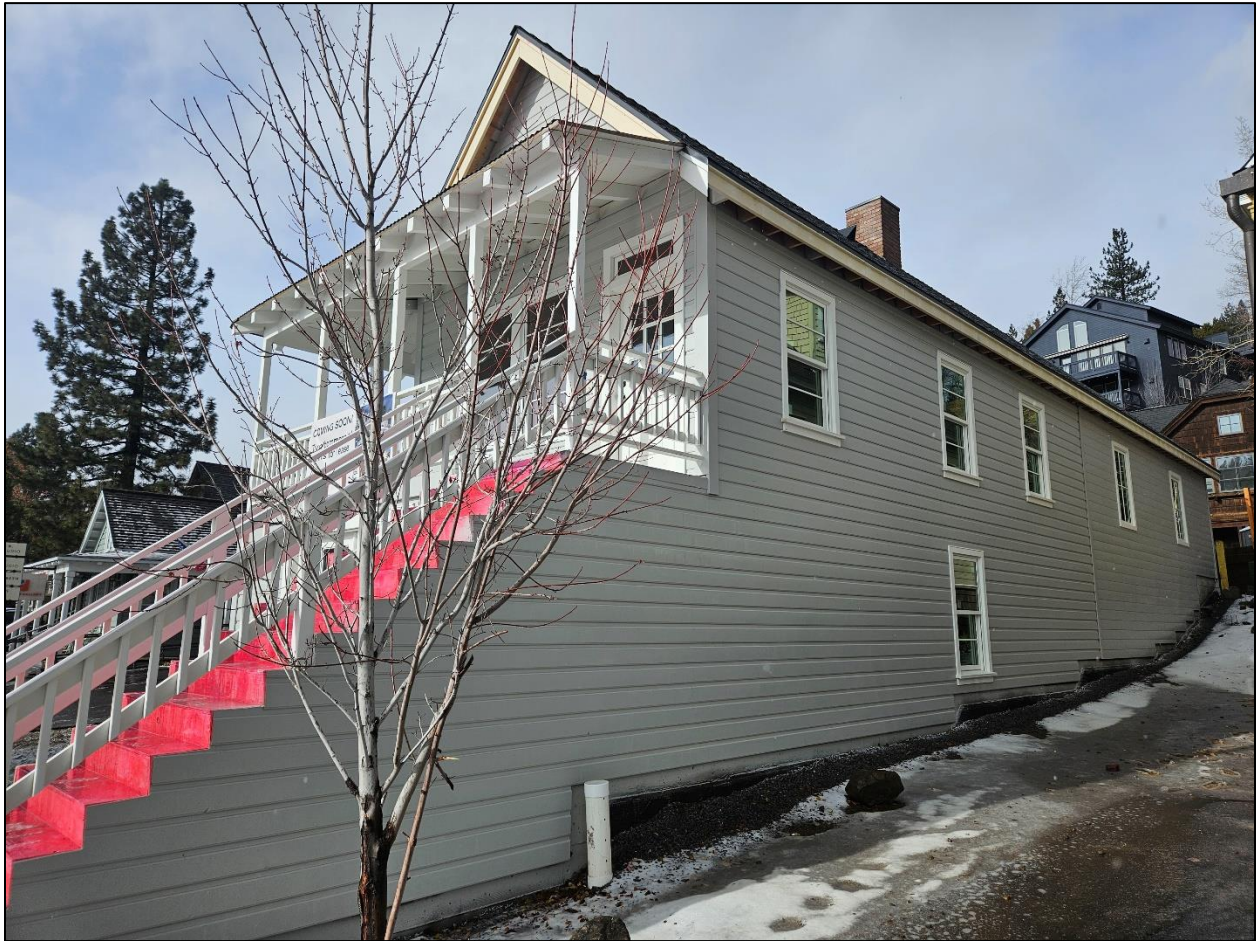
Design is the combination of elements that create the form, plan, space, structure, and style of a property. Historically, the Subject Property was a narrow rectangular building with a front gable and a porch that wrapped around the primary and west elevations. The project resulted in the construction of an approximately 715 square foot addition along the west and north portions of the building that nearly doubled the footprint of the building and changed its rectangular plan. The addition extended and raised the existing gable by 2' at the rear of the building and created a shed wing that extends from the west elevation, where the porch terminates. The project also raised the building approximately two feet (adding a first floor) and relocated it 11'-6" closer to the road. These alterations are visible from Donner Pass Road and the secondary access road that runs along the west side of the Subject Property. The current project also resulted in the reconfiguration of fenestration on all but the south elevation. Because of the massing, scale, and extent of the addition and relocation, and the window reconfiguration, the building no longer retains integrity of design.

*Photograph 12: East elevation of Subject Property near project completion (showing new windows and window arrangement, foundation, and addition marked by siding transition). Photo taken by Broadbent on November 21, 2024.*

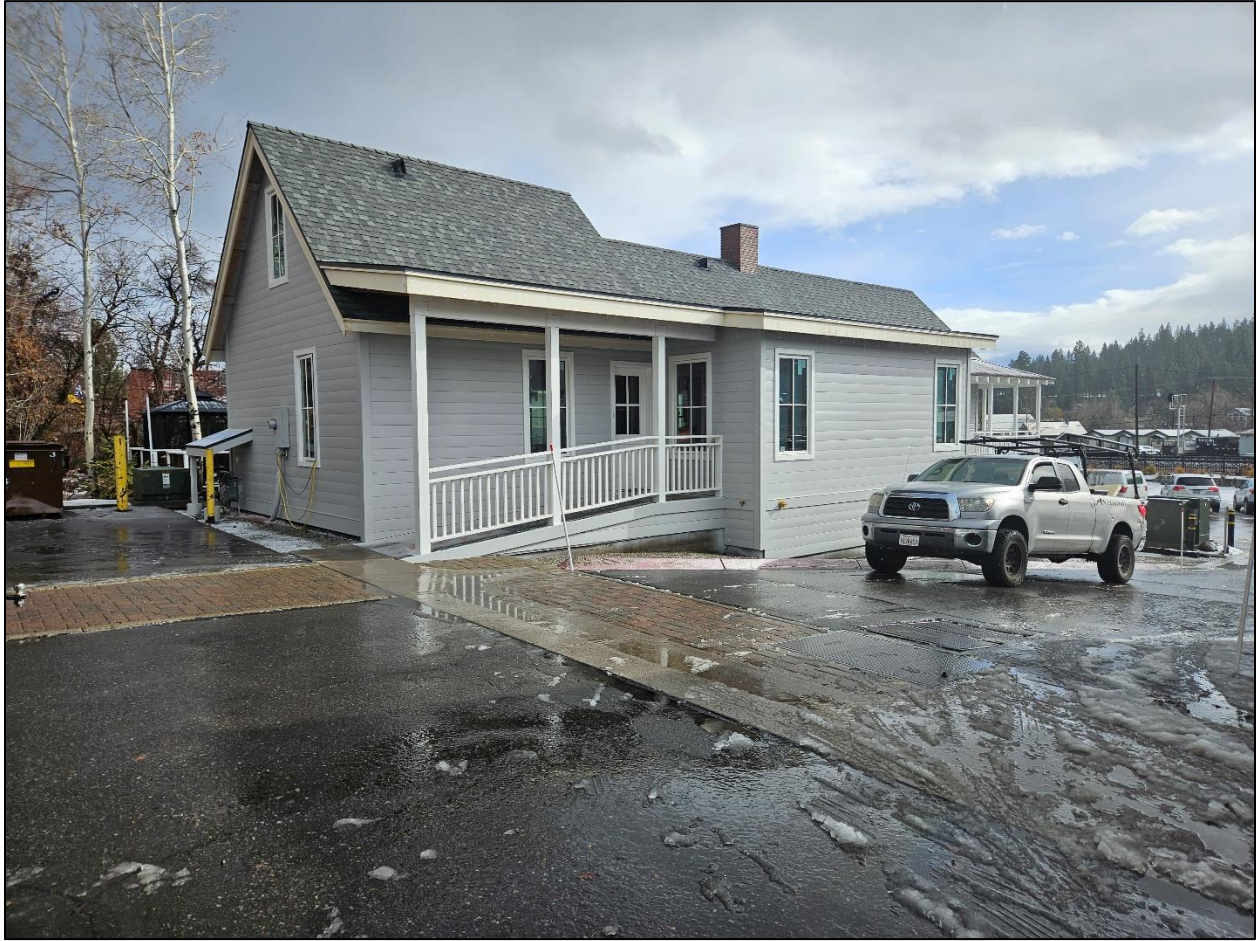
*Photograph 13: North and west elevations of Subject Property near project completion (showing addition). Photo taken by Broadbent on November 21, 2024.*
