State of California - The Resources Agency
DEPARTMENT OF PARKS AND RECREATION
PRIMARY RECORD

*Resource Name or #: THRI - 184 (1998: KEC-134-NN-8)

*P2. Location: Not for Publication Unrestricted *a. County Nevada
*b. USGS 7.5' Quad Truckee, CA Date 1992 T 17N; R 16E; NE 1/4 of NE 1/4 of Sec 15; Mt. Diablo B.M.
c. Address 10117 East River Street City Truckee Zip 96161
d. UTM: (Give more than one for large and/or linear feature) Zone 10; mE/ mN
e. Other Locational Data: (e.g., parcel #, legal description, directions to resource, elevation, additional UTM's, etc. as appropriate)
Parcel No. 19-151-13

BUILDING, STRUCTURE, AND OBJECT RECORD

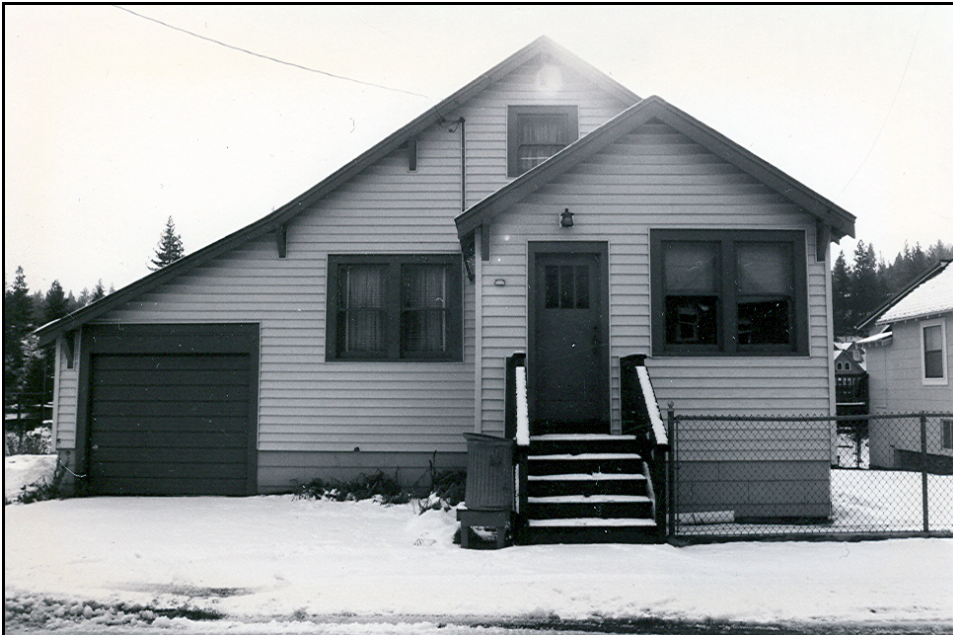
This is a single story, front-gable, early 20th century Vernacular cottage with minimal Craftsman and some Minimal Traditional influence. It has a non-historic, rubblestone appearing foundation which is probably only a veneer over concrete. Areas of asbestos skirting also are present, particularly along the north elevation. There is a part-daylight basement with access from the rear, where the lot slopes down. The building is wood-framed with modern aluminum siding to simulate clapboard. A small area of older Insul-Brick cladding remains visible near the south end of the east elevation. The roof is a moderate pitch front-gable with ribbed sheet metal roofing. It has open eaves with Craftsman-style angle braces/brackets in the gable ends. The eaves have exposed rafters and tails. An historic brick chimney is high on the north gable face near the ridge line and offset to the south end. The north (primary) elevation is dominated by an enclosed, front-gabled porch addition occupying the western half of the facade. A small, narrow flight of wooden steps and wooden stoop with simple wood posts and wood rails leads up to the door (not original). There is an addition to the core historic mass on the east elevation. This addition houses an attached garage (single bay, one car) and has an extended shed roof from the eastern eave. Based on the appearance and design, this addition likely dates to the c. 1930s. The rear (south) has an historic enclosed porch, as well as a modern, open, shed porch. The north door is a historic wooden form with three vertical lights in the upper one-third over a recessed panel. The windows are a mixture of late historic one-over-one, double-hung forms (paired and single) and modern casement units in historic openings. The basement appears to have original hopper or awning types with vertical divided-lights in wood frames.

*P5. Description of Photo: (View, date, etc.) North (primary) elevation; south-southeast view; 11/1998; Acc. #134-8-24.

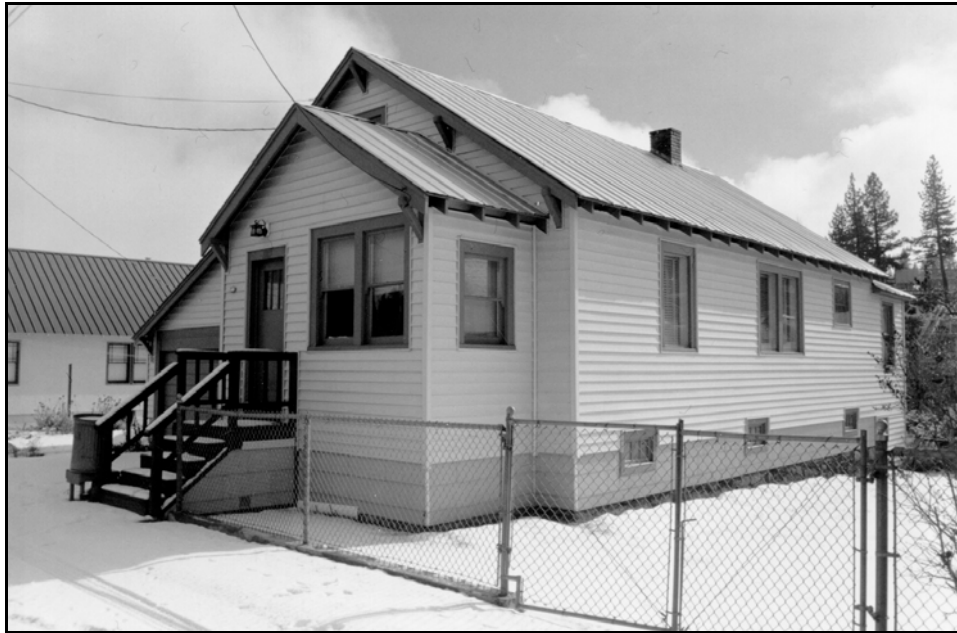
*P5a. Photo: (continued)

North (primary) and west elevations; south-southwest view; Acc. #134-9-2.

- Based on Sanborn map (1907*), original entry was a small rectangular porch or stoop centered on the north elevation. If restoration opportunities are directed towards original design, then entry should be renovated to represent the earlier plan and design. The existing entry represents historic period alterations (c. 1930s-40s).
- Replace modern windows with historically appropriate forms.
- Remove modern aluminum siding and restore original wood cladding beneath, if intact.
-
-
