State of California - The Resources Agency
DEPARTMENT OF PARKS AND RECREATION
PRIMARY RECORD

*Resource Name or #: THRI - 60 (1998: KEC-134-G1-2)

*P2. Location: ☐ Not for Publication ☒ Unrestricted *a. County Nevada
*b. USGS 7.5' Quad Truckee, CA Date 1992 T 17N; R 16E; NW 1/4 of NE 1/4 of Sec 15; Mt. Diablo B.M.
c. Address 10144 High Street City Truckee Zip 96161
d. UTM: (Give more than one for large and/or linear feature) Zone 10; mE/ mN
e. Other Locational Data: (e.g., parcel #, legal description, directions to resource, elevation, additional UTMs, etc. as appropriate)
Parcel No. 19-103-02

BUILDING, STRUCTURE, AND OBJECT RECORD

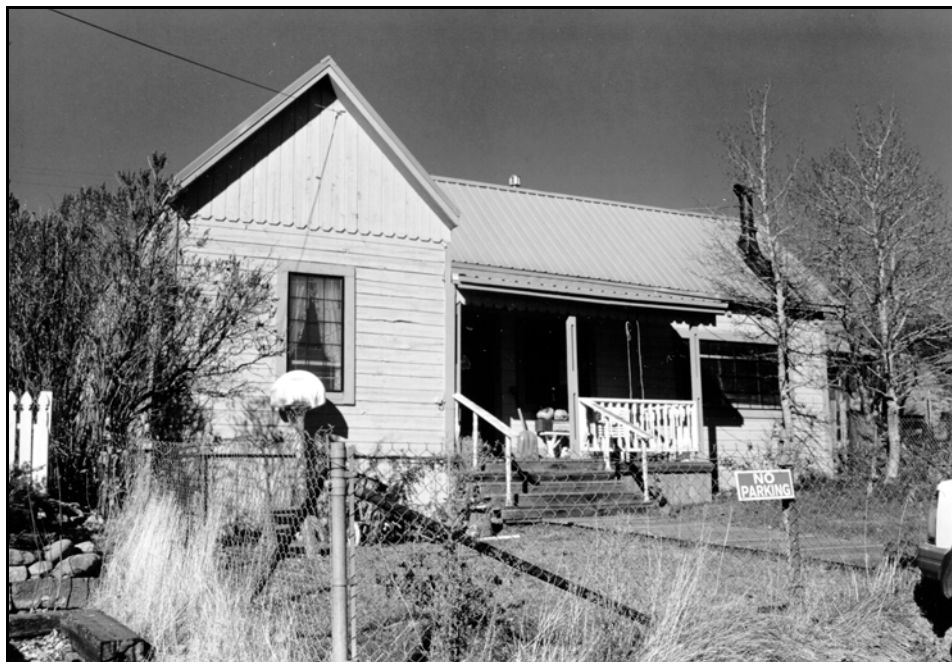
This is a small, one story, Folk Victorian cottage with gable cross-wing roof. It was constructed c. 1880 with a side facing "T" plan. The foundation is unknown due to wood plank skirting but may be stone. The building is wood-framed and clad with horizontal tongue-and-groove siding and corner boards. Cladding in the gable rake is vertical tongue-and-groove with chamfered ends. The roof is a steeply pitched cross-gable covered with contemporary ribbed metal sheets. The eaves are slight and enclosed. There is no chimney but a metal flue has an interior position on the south slope of the east mass. The south (primary) elevation has an entrance that is offset to the west end of the eastern cross-wing mass. It has a partial porch with dropped shed roof also covered with metal sheeting. The porch has simple 2x4 supports with an elaborate historic turned spindlework balustrade and stair balusters. The other elevations are obscured by vegetation. The main entrance is a modern, wood, 32-panel door with plain wood casing. The windows are modern replacements but in historic openings, also with plain wood casings. Windows include fixed pane and sliding metal sash (twelve-light, eight-light, 32-light). Decorative details include dentil blocks at the eave junction of the cross-wing, and the turned spindle work balustrade and stair rails. A new wooden boardwalk leads to the front entry. Overall, exterior alterations and replacements are minor and the building provides a decent, albeit modest, example of Truckee's vernacular residential architecture.

*P5. Description of Photo (View, date, etc.) South elevation; north view; 11/14/98; Acc. # 134-3-10.

- Replace multi-light windows with appropriate historic forms and materials (probably one-over-one double-hung wood sash)
- Replace 2x4 porch support posts with appropriate historic form - possibly simple square, or square chamfered
-
-
-

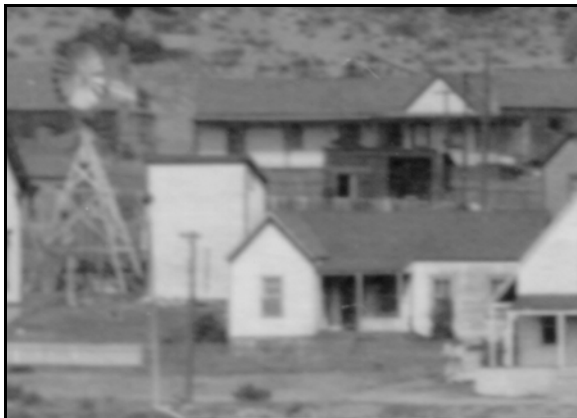
***P5. Photographs (continued):** Below are two historic photo images showing that the building has changed relatively little since the historic period.

South and east elevations; c. 1905. (Courtesy of TDHS)

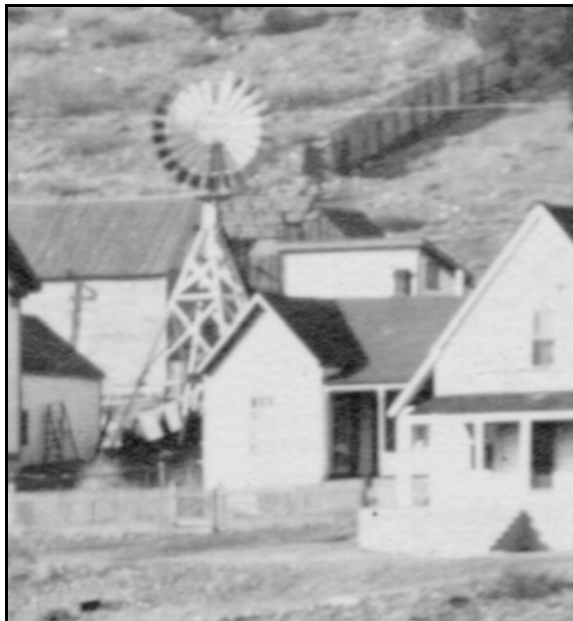
South and east elevations; c. 1913. (Courtesy of TDHS)
