ORDINANCE NO. 1453-21

AN ORDINANCE RELATING TO THE STORMWATER MASTER PLAN; AMENDING THE TUALATIN COMPREHENSIVE PLAN; AND AMENDING TUALATIN DEVELOPMENT CODE SECTIONS 74.630 and 74.640 (PTA 21-0001).

This 2019 Stormwater Master Plan (Plan or SMP) provides an overview of system improvements needed to address future growth, water quality, maintenance/system condition issues, and capacity issues.

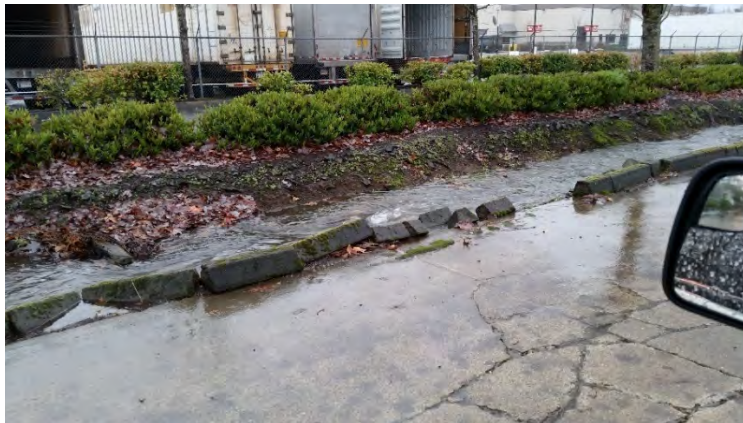
Image 1. Observed flooding of drainage ditch during December 2015 storm

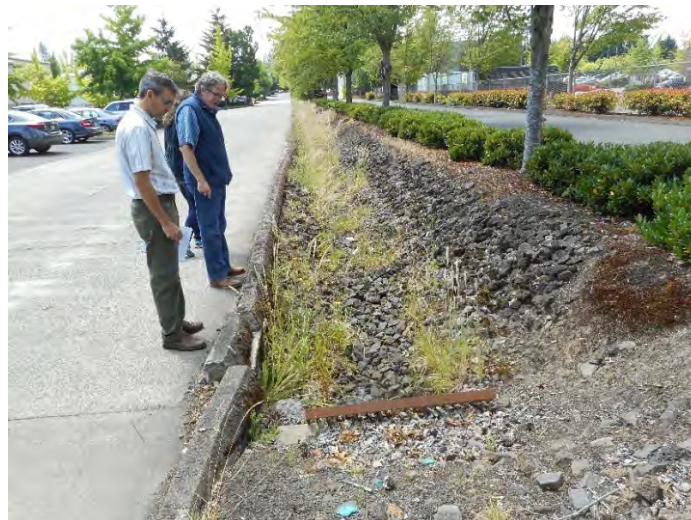
Image 2. Grated inlet and rock lined channel at downstream end of drainage ditch

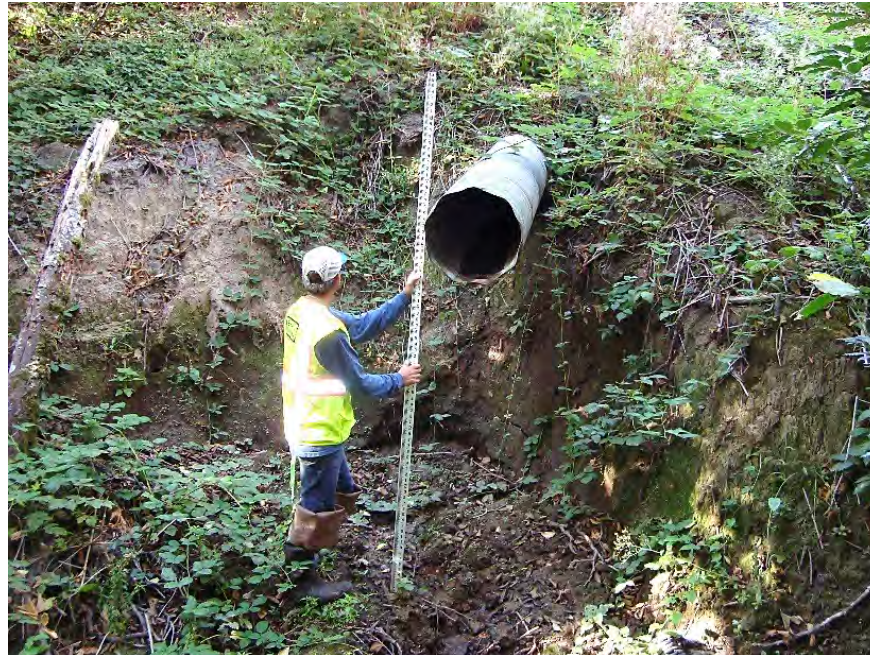
**Image 1. Perched outfall from Blake Street with severe bank failure**

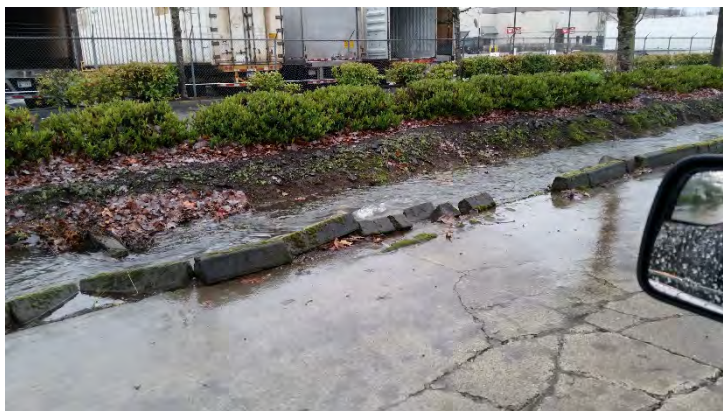
<p data-bbox="428 1083 1424 1213"><b>Location:</b> Manhasset Drive Open Channel <b>Photo number:</b> 1 <b>Description:</b> Flooding of open channel along Manhasset Drive during December 2015 storm event. Photo provided by City.</p>

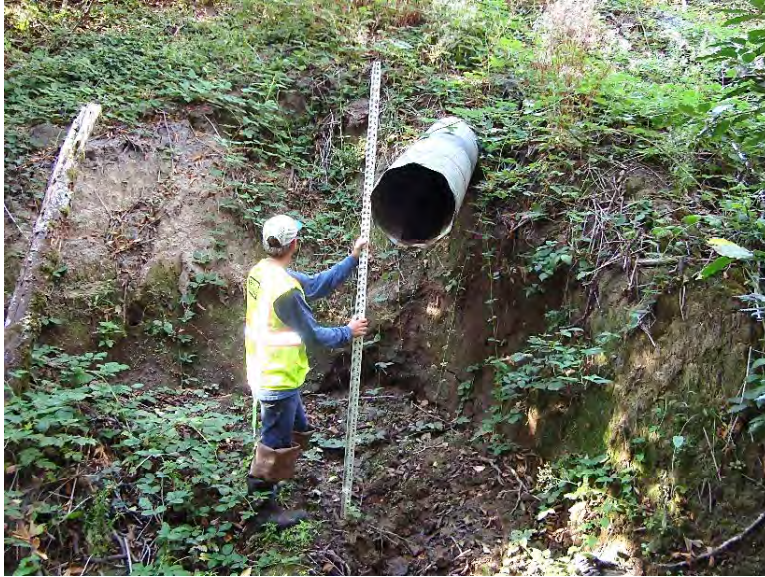
Saum Creek Reach #3 is divided by SW Blake Street. Downstream of SW Blake Street, a hillslope failure on the north side of the channel has caused the outfall that discharges stormwater piped from SW Makah Ct. to hang several feet above the stream bed (Photo 1). The hillslope failure caused several large trees to fall, resulting in a large number of branches, logs and debris in this reach. The entire north slope was saturated at the time of the site visit. Soil saturation could be a contributing factor to the slope instability in this location. The mechanisms of slope failure were not investigated in detail during the site investigation. Further investigation of the geologic condition along this slope is recommended in order to determine cause of failure and need for hillslope reinforcement.

*Photo 1. Hanging culvert on north side of Saum Creek Reach #3 in location of hillslope failure (September 2017)*

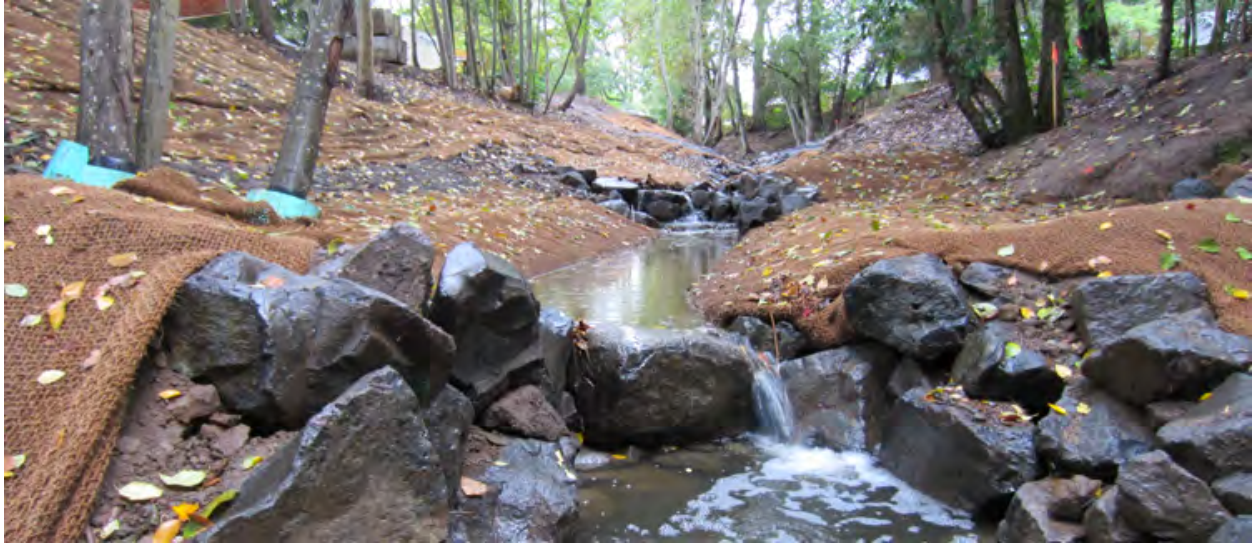
The channel upstream of SW Blake Street was restored in 2014 with a series of rock check dams and pools. This project was constructed in conjunction with a neighborhood water quality project. Prior to the restoration, the channel in this reach was significantly incised and banks were being eroded from high rates and volumes of stormwater runoff emanating from the surrounding residential development (Otak, 2013). A new stream channel gradient was established through the reach using rock weirs and splash pools to dissipate the energy (Photo 2) and the entire corridor was revegetated with native vegetation. A current view of the restoration area is shown in Photo 3. The channel structure (boulders and drop pools) is intact and erosion does not appear to be a current problem in this reach. However, the lower portion of the reach immediately upstream of SW Blake Street is very flat, and the ground is saturated (Photo 4). Saturated conditions, as well as the presence of invasive vegetation appear to be impacting native plants that have been planted in this corridor. There is a need for ongoing vegetation maintenance in the entire reach, but particularly in this area where an investment has already been made on the stream restoration project. Plant selection and/or locations may need some adjustment for the best chance of success.

*Photo 2. Otak photo of newly constructed Saum Creek channel in Chieftan/Dakota Greenway (c. 2013)*

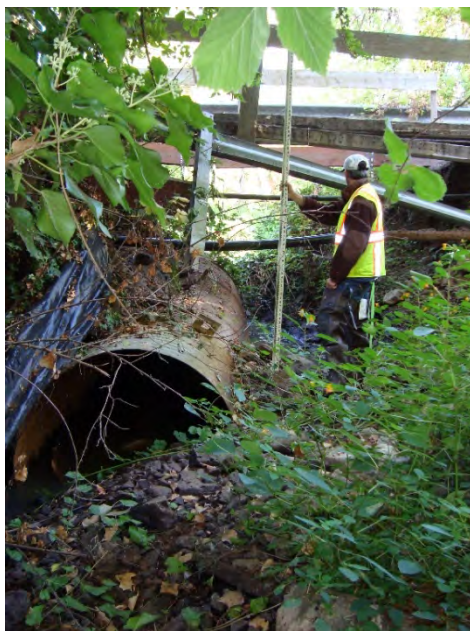
*Photo 8. Culvert placed in debris from washed out bridge to convey Hedges Creek.*

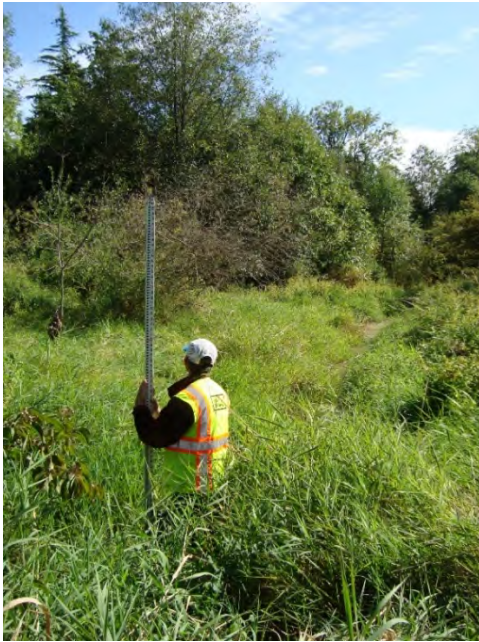
Approximately 1,200 feet upstream of the mouth, an 18-inch diameter stormwater outfall enters Hedges Creek from the south. Stormwater inputs at this location could account for some of the differences in stream characteristics upstream. Upstream of this location, in the Tualatin Community Park, the channel is mostly straight, with a wider floodplain, and a flatter gradient, and based on the channel conditions, erosive flows appear to be less frequent. No channel erosion was observed in this part of the reach. The channel is also largely overgrown with reed canary grass through this portion of the reach (Photo 9), and beaver dams were also observed. Vegetation management is needed to control reed canary grass in the Tualatin Community Park.

*Photo 9. Hedges Creek Reach #1. Reed canary grass-choked channel downstream of Tualatin Road.*

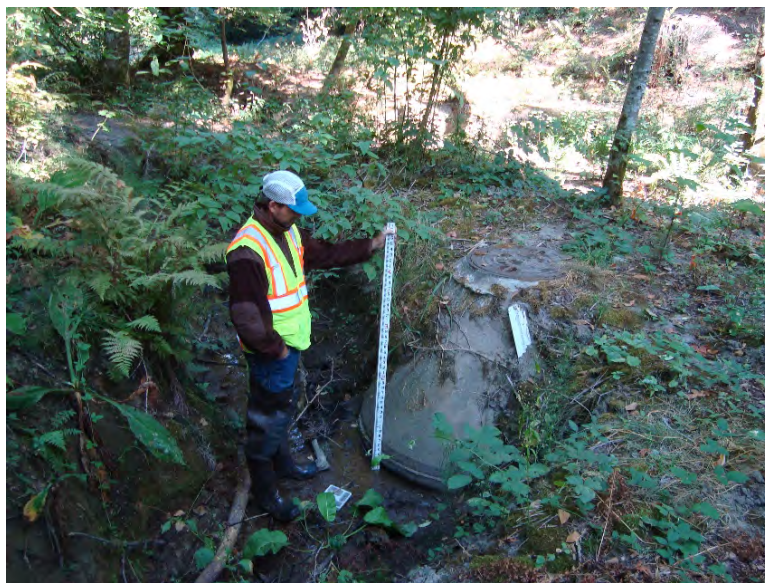
*Photo 12. Side channel incision and erosion around sanitary sewer manhole.*

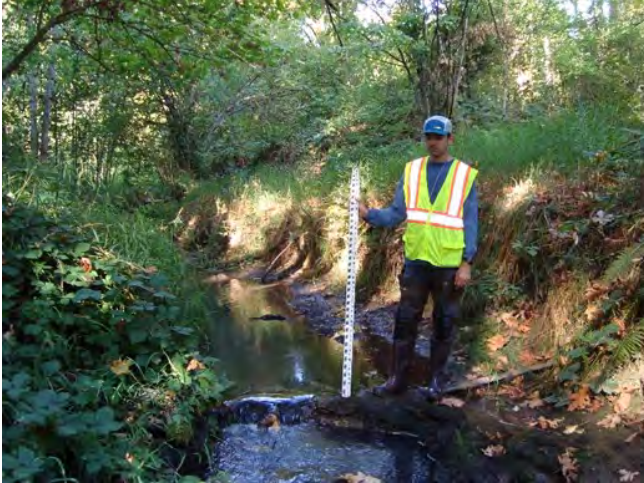
Hard clay forming pools within channel bed in Saum Creek Reach #2 (photo location shown below with camera icon)

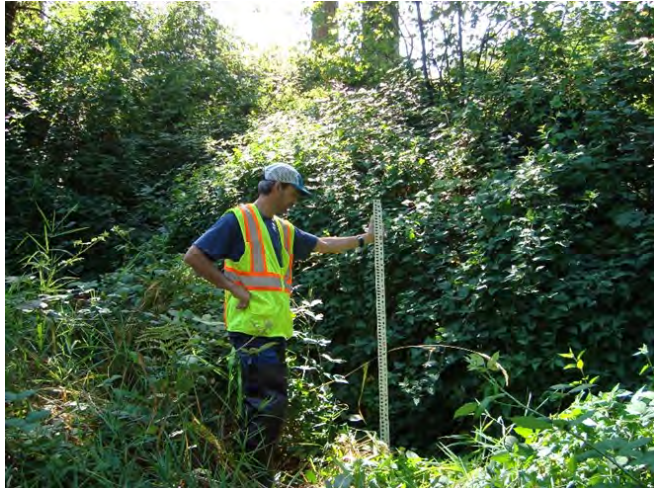
Typical photo of Hedges Creek Reach #2. Stream channel is overgrown with invasive vegetation. Channel is to the right and 4' below Ryan (standing on the bank). Photo location shown below with camera icon.

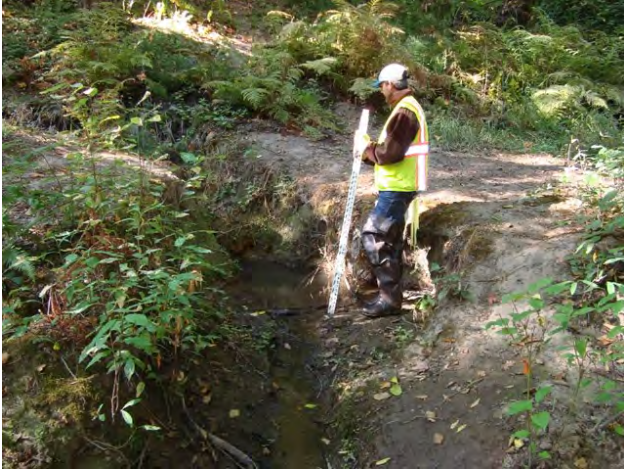
Incised side channel of Hedges Creek. Photo location shown below with camera icon.

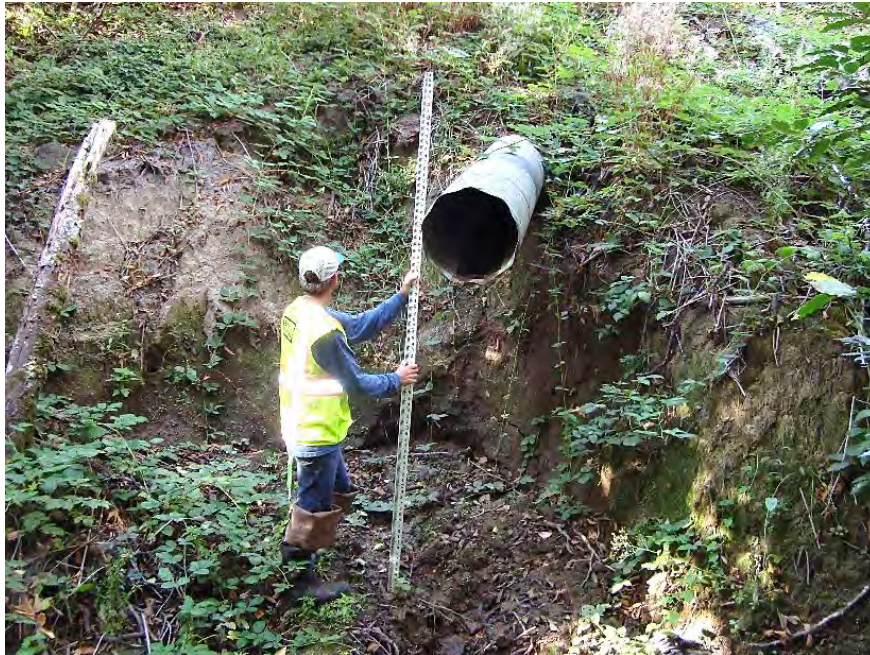
**Site location:** Downstream of SW Blake St.  
**Photo number:** S3-3  
**Description:** Perched culvert- hillslope failure on left bank

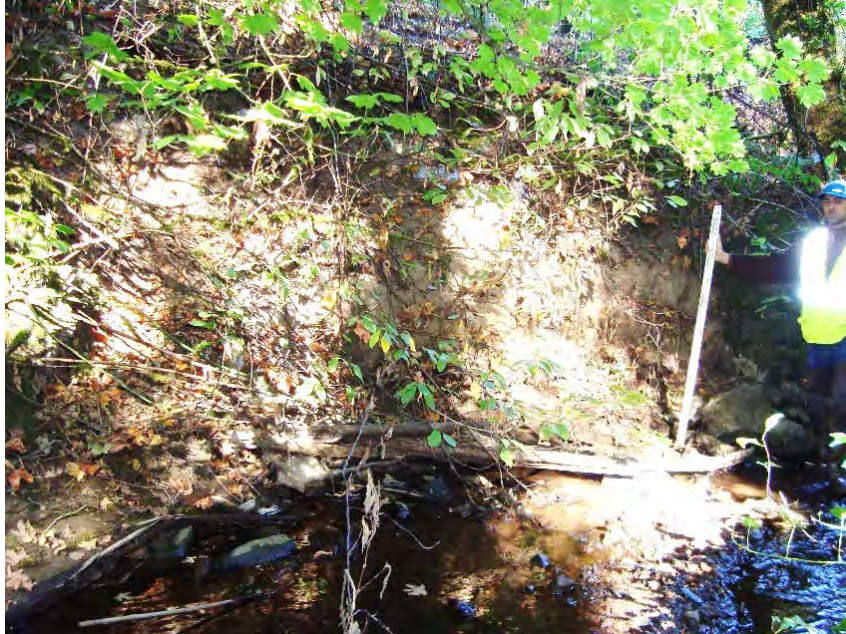
**Site location:** 175' upstream of SW 105<sup>th</sup> Ave.  
**Photo number:** H3-5  
**Description:** Left bank failure, missing wall segment adjacent to SW 105<sup>th</sup> Ave., outside bend

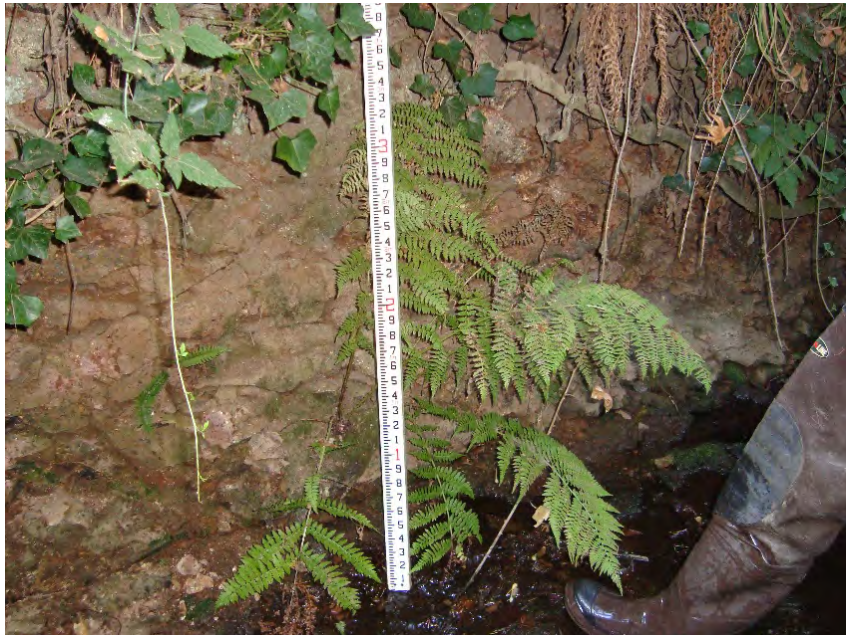
**Site location:** 500' upstream of SW 105<sup>th</sup> Ave.  
**Photo number:** H3-6  
**Description:** Bedrock outcrop in channel

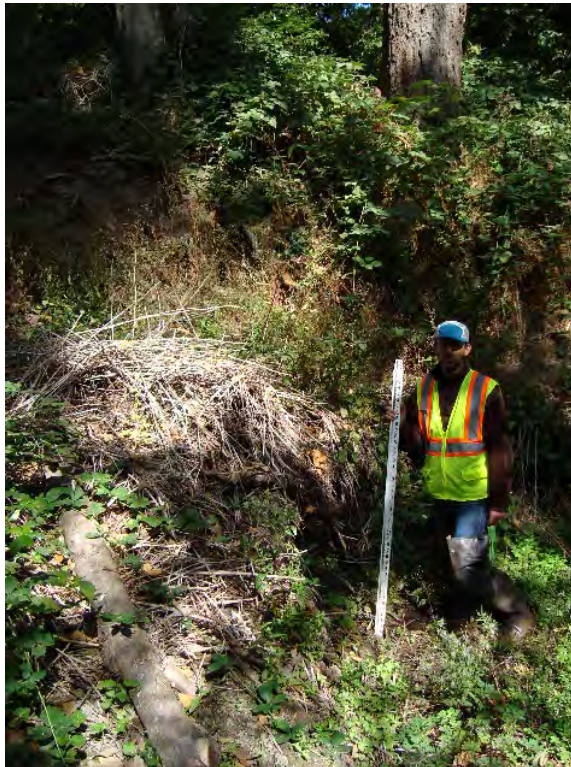
**Site location:** 1100' upstream of SW 105<sup>th</sup> Ave.  
**Photo number:** H3-16  
**Description:** Right bank slope failure, very wet

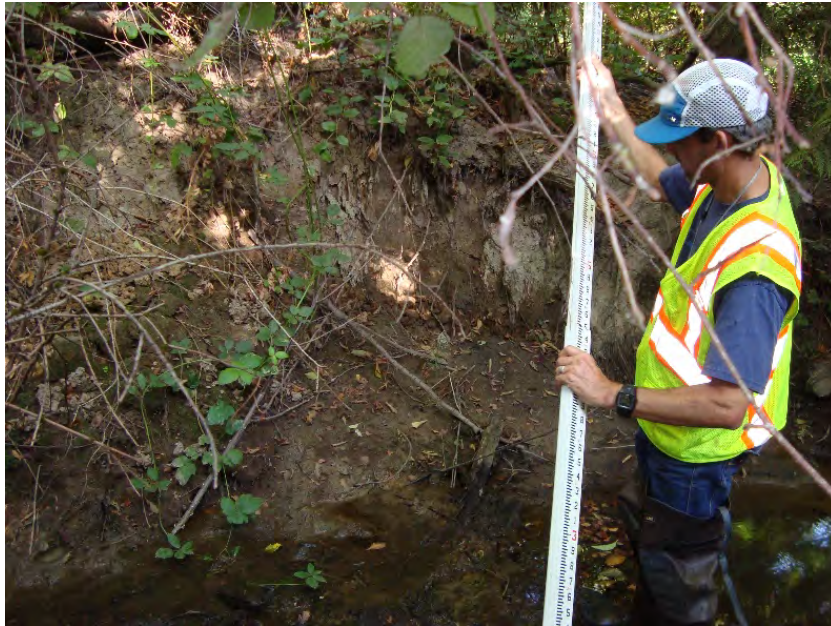
**Site location:** 500' upstream of confluence with S. tributary  
**Photo number:** H3-25  
**Description:** Left bank failure, incised channel, unstable

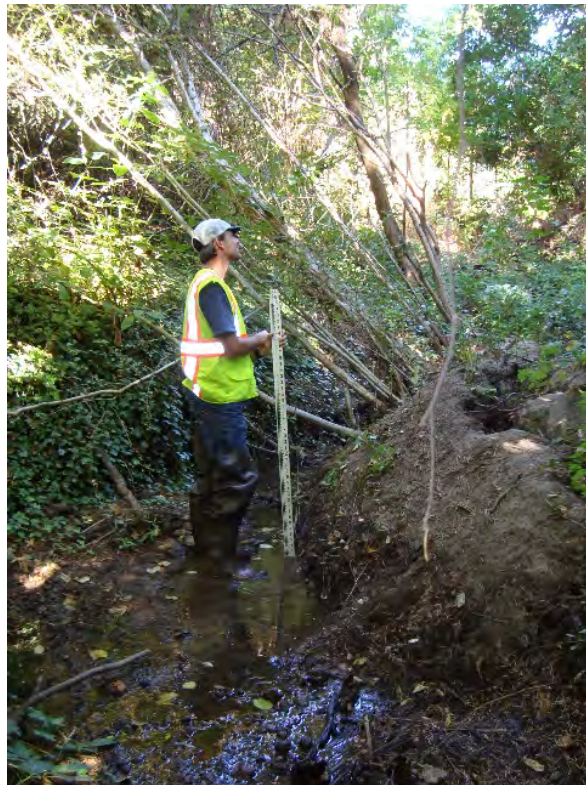
**Site location:** 600' upstream of confluence with S. tributary  
**Photo number:** H3-26  
**Description:** Left bank slumping
