Prepared for City of Tualatin Oregon

Stormwater Master Plan

April 2019 | DRAFT-FINAL

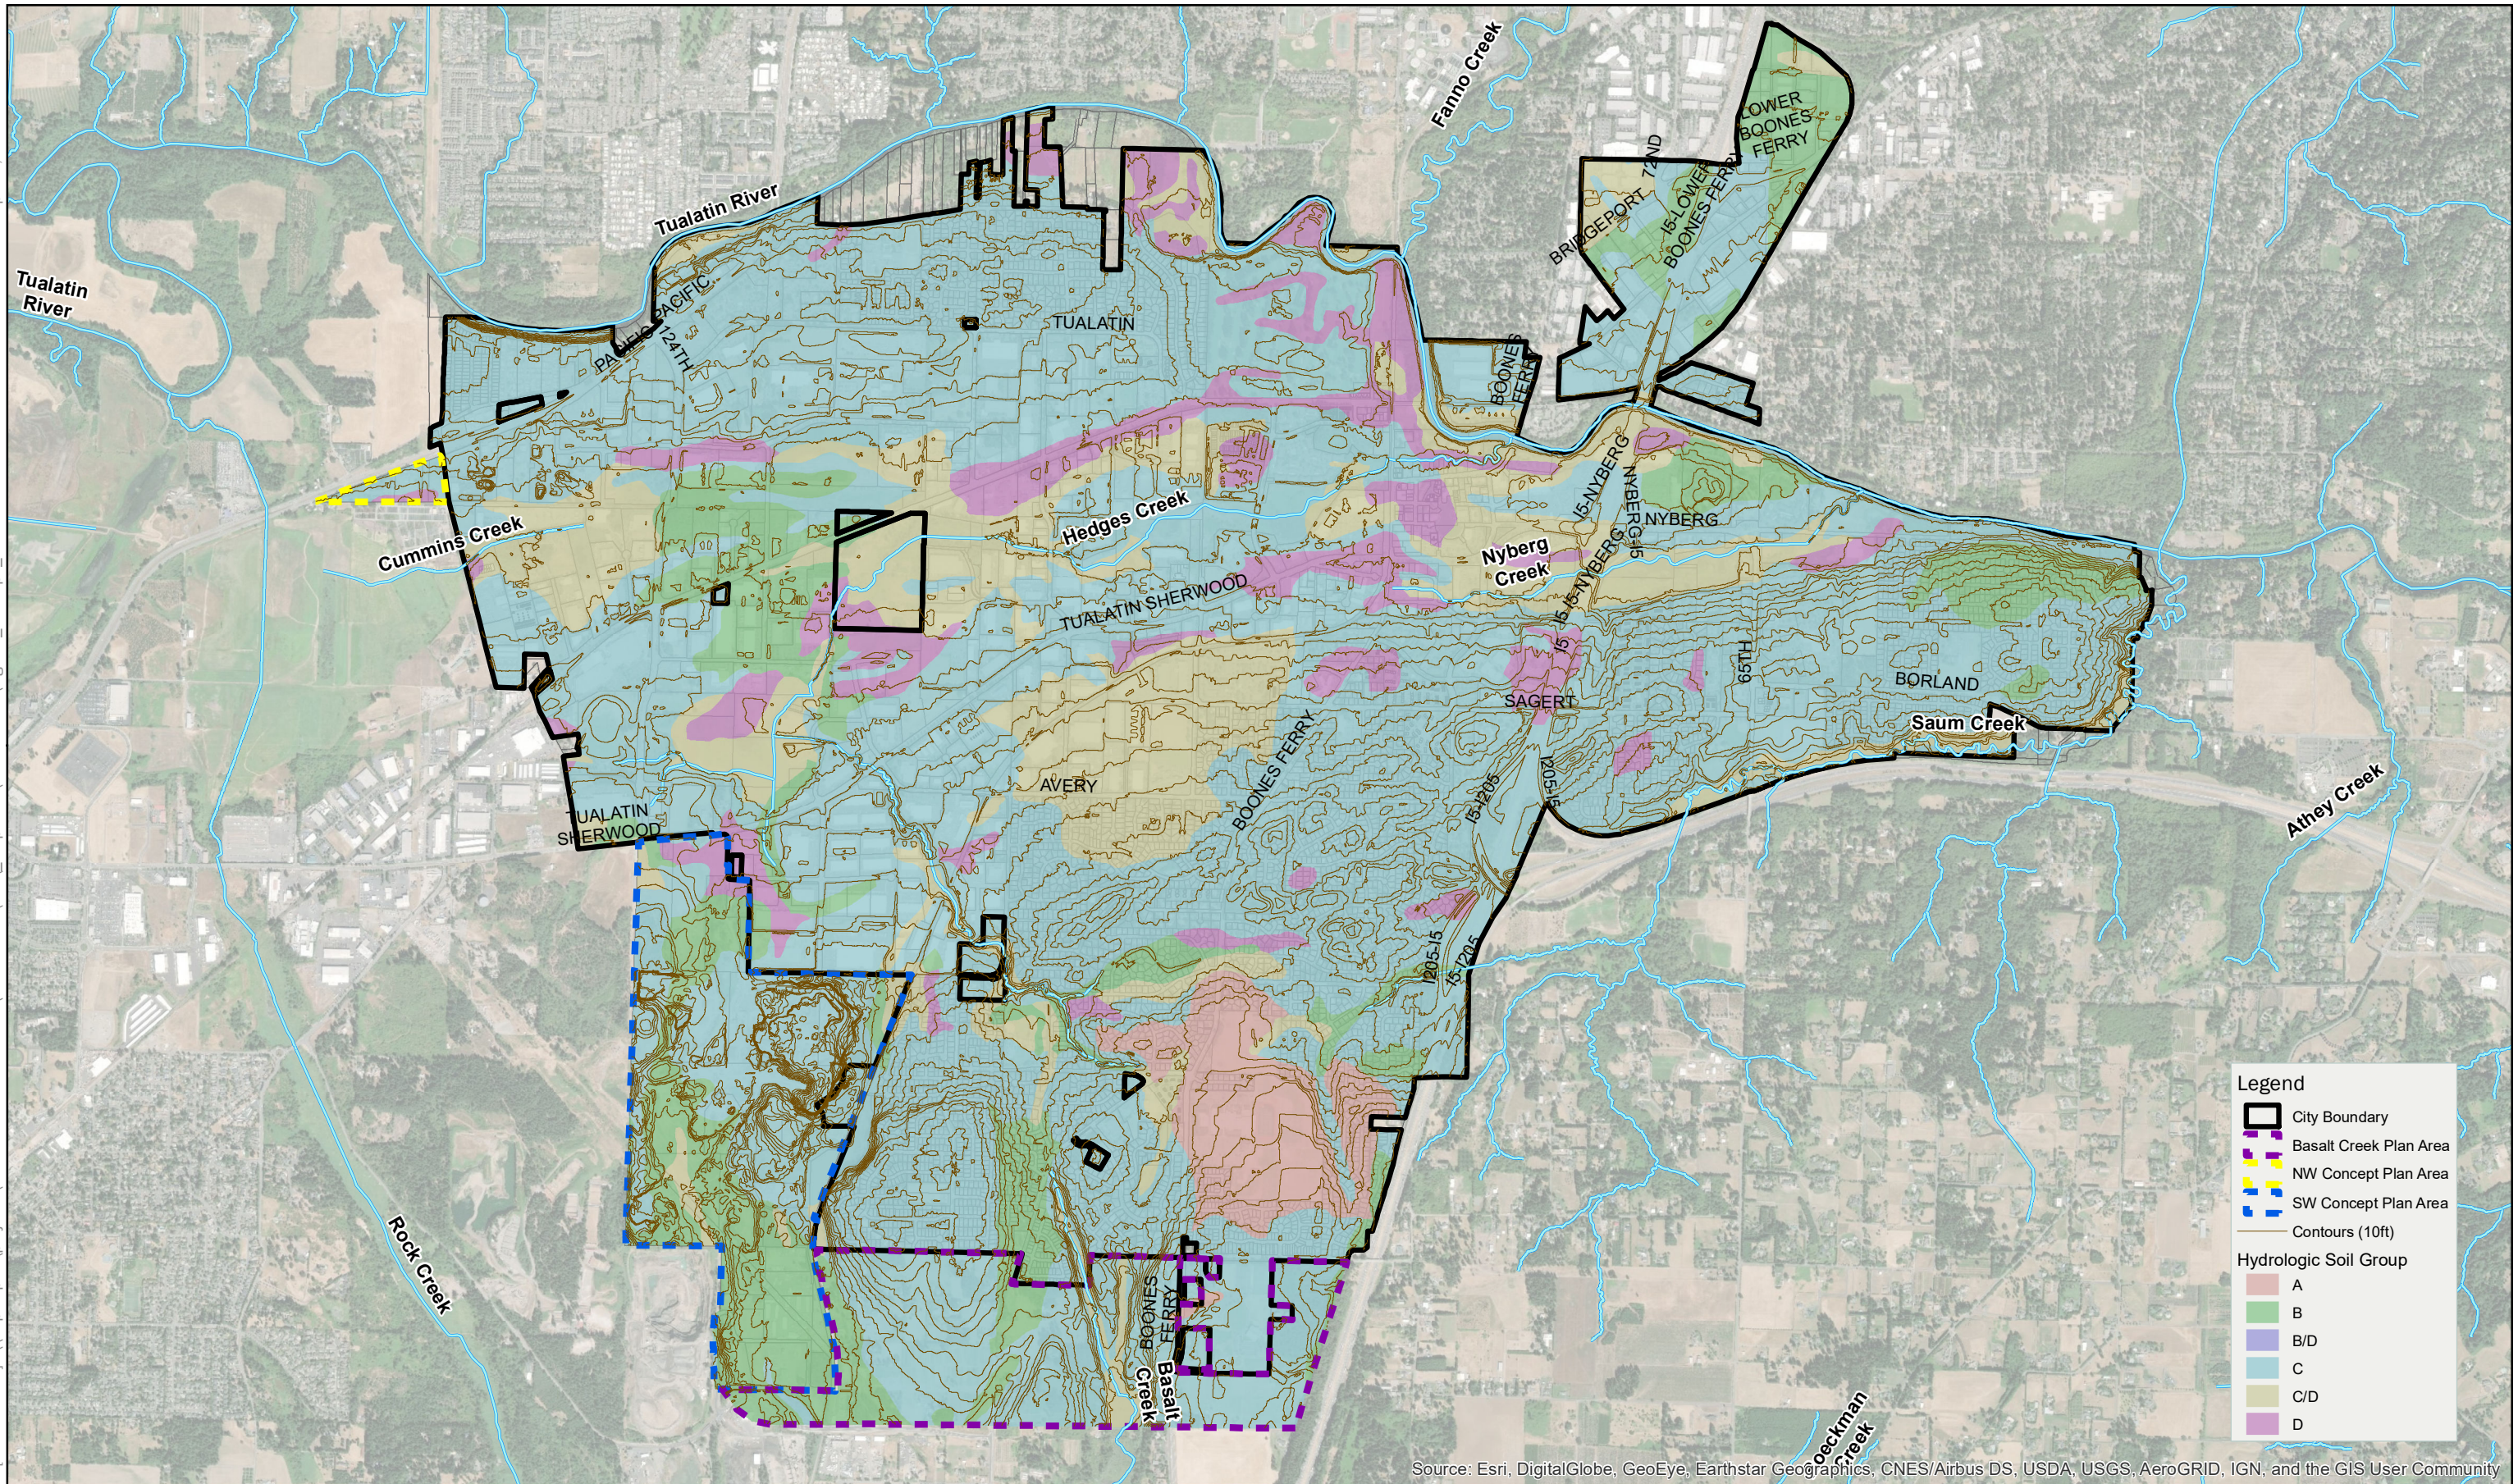
Figure 2-3
Topography and Soils

The National Resources Conservation Service (NRCS) Soil Survey online tool was used to gather soils information for Tualatin. Soils are an important watershed characteristic for evaluating potential runoff rates and volumes. Soils are generalized into four categories or hydrologic soil groups (HSG), which approximate soil runoff potential. These groups are A, B, C, and D, where A soils are characterized by high rates of infiltration and low runoff potential and D soils are characterized by low rates of infiltration and high potential for runoff. HSG conditions are reflected on Figure 2-3.

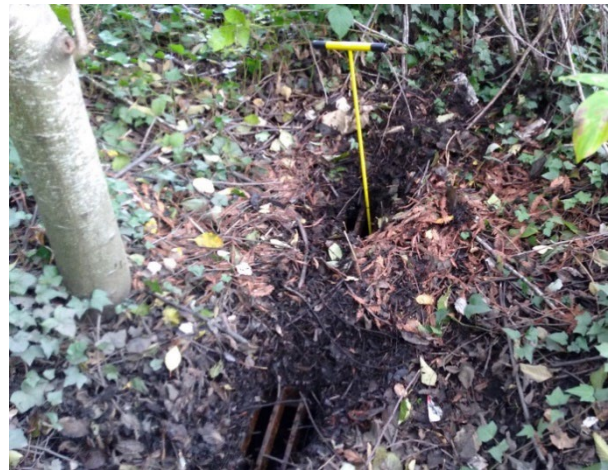
Figure 6-1. Example of buried outlet control structure at the Green Lot Swale

As part of this SMP effort, the City identified the need for a program (and annual funding mechanism) for continual public water quality facility maintenance. The program can be used to conduct both routine maintenance activities and support larger system restoration or redesign needs. Efforts should prioritize facilities identified through annual inspection efforts, including those priority locations listed above.
