Appendix A: CIP Fact Sheets

Project Identifier	CIP#1
Project Name	Manhasset Storm System Improvements
Detailed Location	Manhasset Drive
Model File	HE_MA_ALT05.xp
Contributing Drainage Area	41.4 acres
Estimated Existing / Future Impervious %	64.0%/73.4%
Project Objective(s)	Increases System Capacity (Flood Control)

Appendix B: Data Compilation and Preliminary Stormwater Project Development (TM1)

Appendix C: Hydrology and Hydraulic Modeling Methods and Results (TM2)

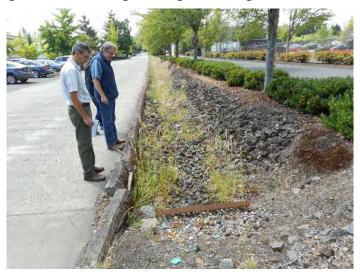
Image 1. Observed flooding of drainage ditch during December 2015 storm

City staff and residents have reported frequent flooding of the open conveyance channel between private properties from Tualatin-Sherwood Road to Manhasset Drive. Stormwater flows have exceeded the capacity of the channel, overtopping the banks of the channel and impacting adjacent parking lots and structures.

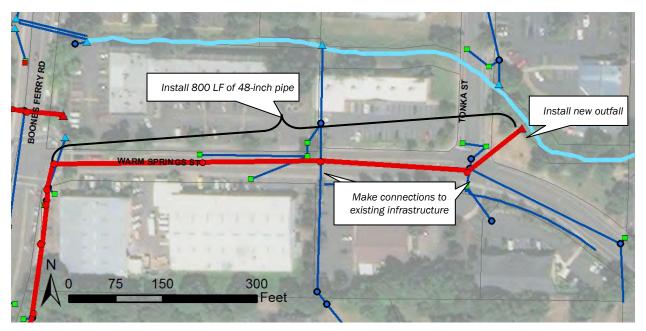
Figure 1. Construction details of Phase 1

Phase 1 must first be constructed to redirect approximately 51 acres of contributing drainage area from areas prone to flooding at Warm Springs Street and Tonka Street. This phase is also recommended prior to implementation of CIP #4 (Mohawk Apartments Stormwater Improvements). This phase includes the following:

- Disconnection of the existing stormwater system from the south at Mohawk Street.
- Replacement of existing infrastructure on Martinazzi with 1500 LF of 24-inch pipe from existing node 263397 (CIP system naming is 263397_NY-0290) to existing node 270963.
- Installation of 9 manholes and 8 catch basins along Martinazzi Avenue. 440 LF of 12-inch inlet leads are also reflected in the
 cost estimate for the connection of new and existing catch basins.
- · Construction of a new outfall to Nyberg Creek east of the bridge crossing with Martinazzi Avenue.

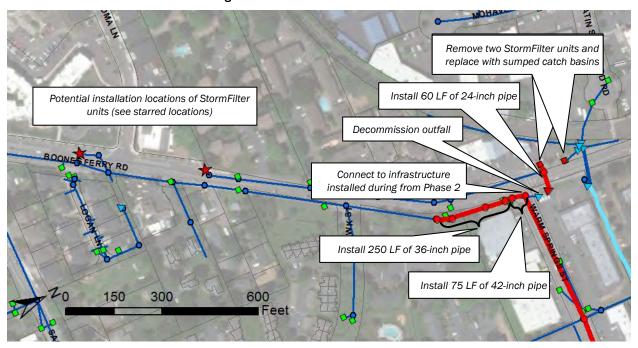
Figure 2. Construction details of Phase 2

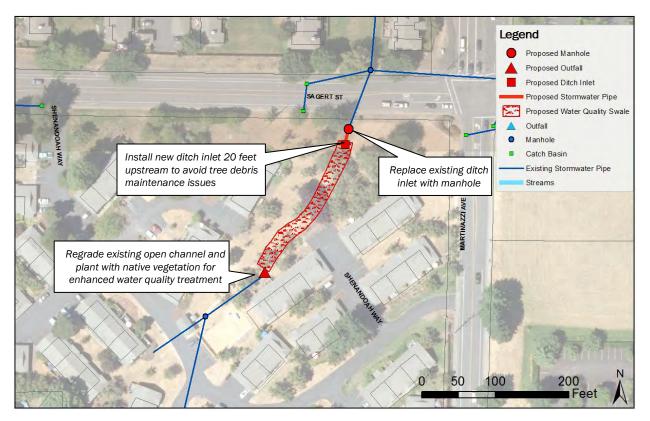
Figure 3. Construction details of Phase 3

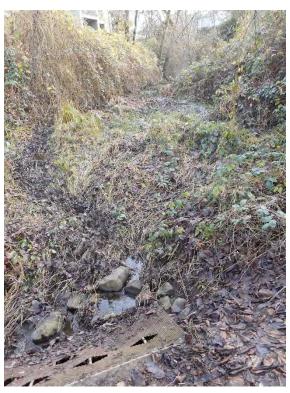
Image 1. Grated inlet and open channel near Mohawk Apartments

Downstream of the open channel, a new ditch inlet will be installed to replace the existing grated inlet. Limited earthwork and invasive vegetation removal will be conducted to regrade the channel and direct flow to the inlet. 170 LF of corrugated metal pipe will be removed and replaced with 170 LF of 36-inch-diameter HDPE pipe.

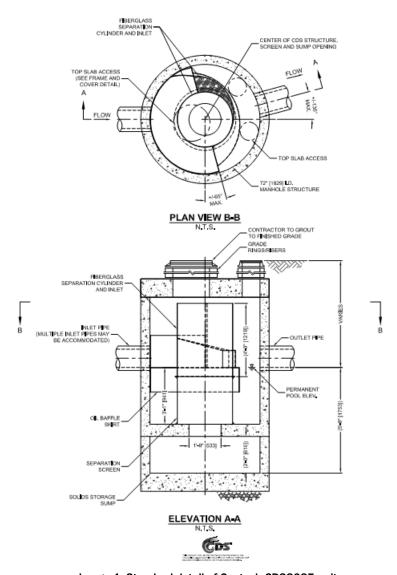
Image 1. Standard detail of Contech CDS3025 unit

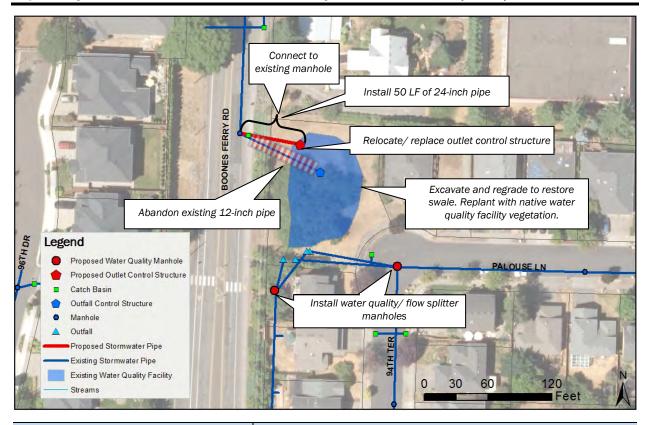
Figure 1. Construction details of new infrastructure

This project replaces infrastructure that is in poor condition and provides water quality treatment in the form of a bioswale.

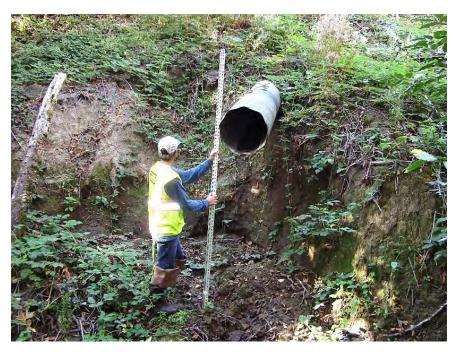
Image 1. Perched outfall from Blake Street with severe bank failure

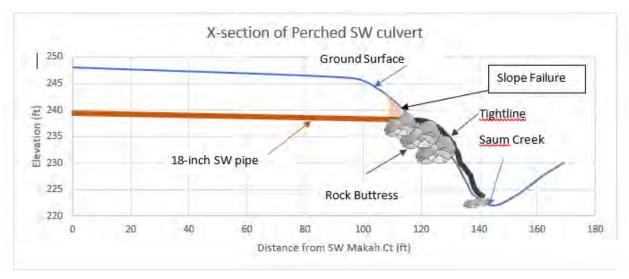
Figure 1. Hillslope Rehabilitation Option - Rock Buttress

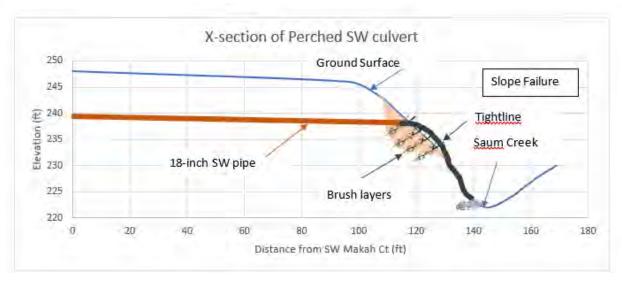
Figure 2. Hillslope Rehabilitation Option - Bioengineering with Brush Layering

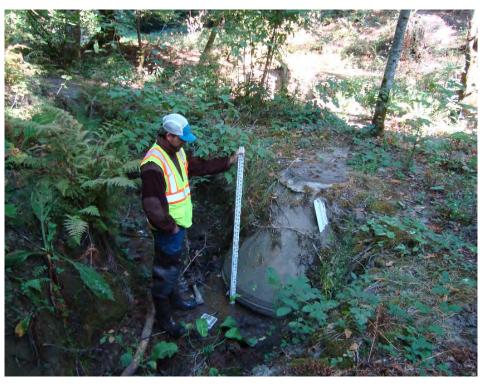
Image 1. Location 'M' exposed sanitary manhole and incised tributary

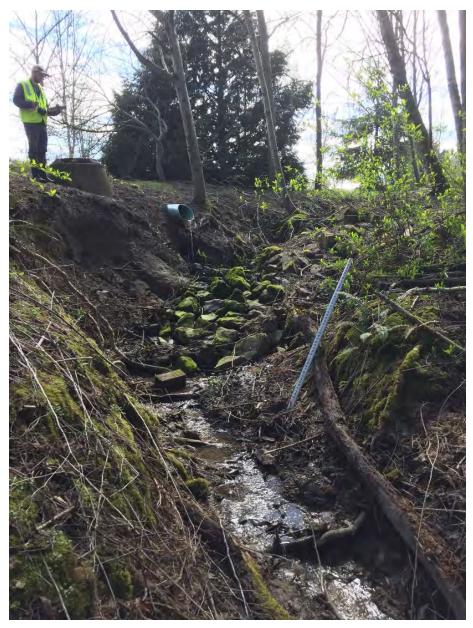
Image 2. Location 'N' outfall and channel erosion (photo provided by OTAK)

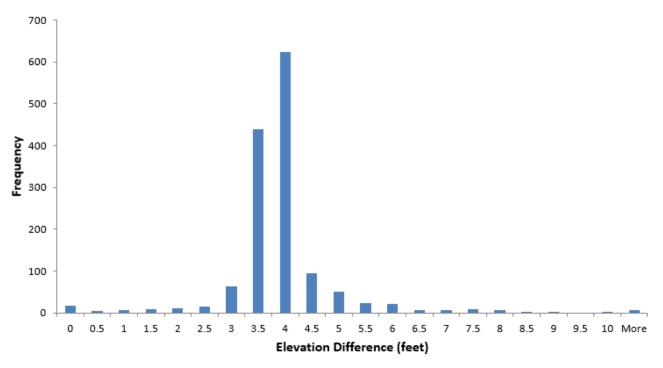
Figure 1-1: Original GIS Rim Elevation Comparison with LIDAR (July 2016)

In July 2016, a decision was made to convert the City's system information to the NAVD 88 datum. Thus, the City universally corrected their system elevation data by +3.52' to align more accurately with the NAVD 88 datum. The system information was updated and provided to BC in August 2016. A follow up review was conducted of the corrected rim elevation data (see Figure 1-2). Although some discrepancies existed, the corrected elevation data appeared more consistent with elevations interpreted from LIDAR. A decision was made to move forward with the corrected elevation data.

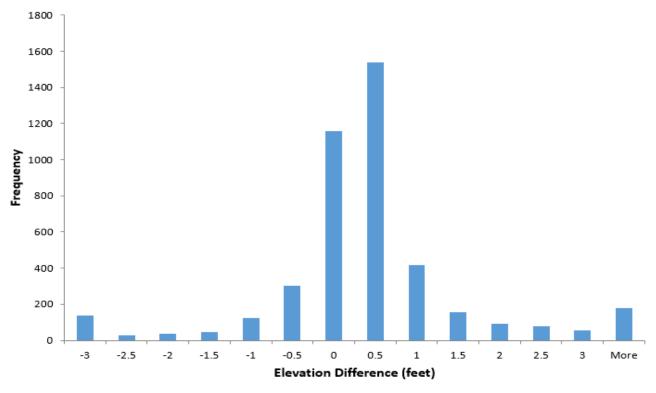
Figure 1-2: Updated GIS Rim Elevation Comparison with LIDAR (August 2016)
