TUALATIN RIVER ACCESS

SITE ASSESSMENT

WALKER | MACY April 2023

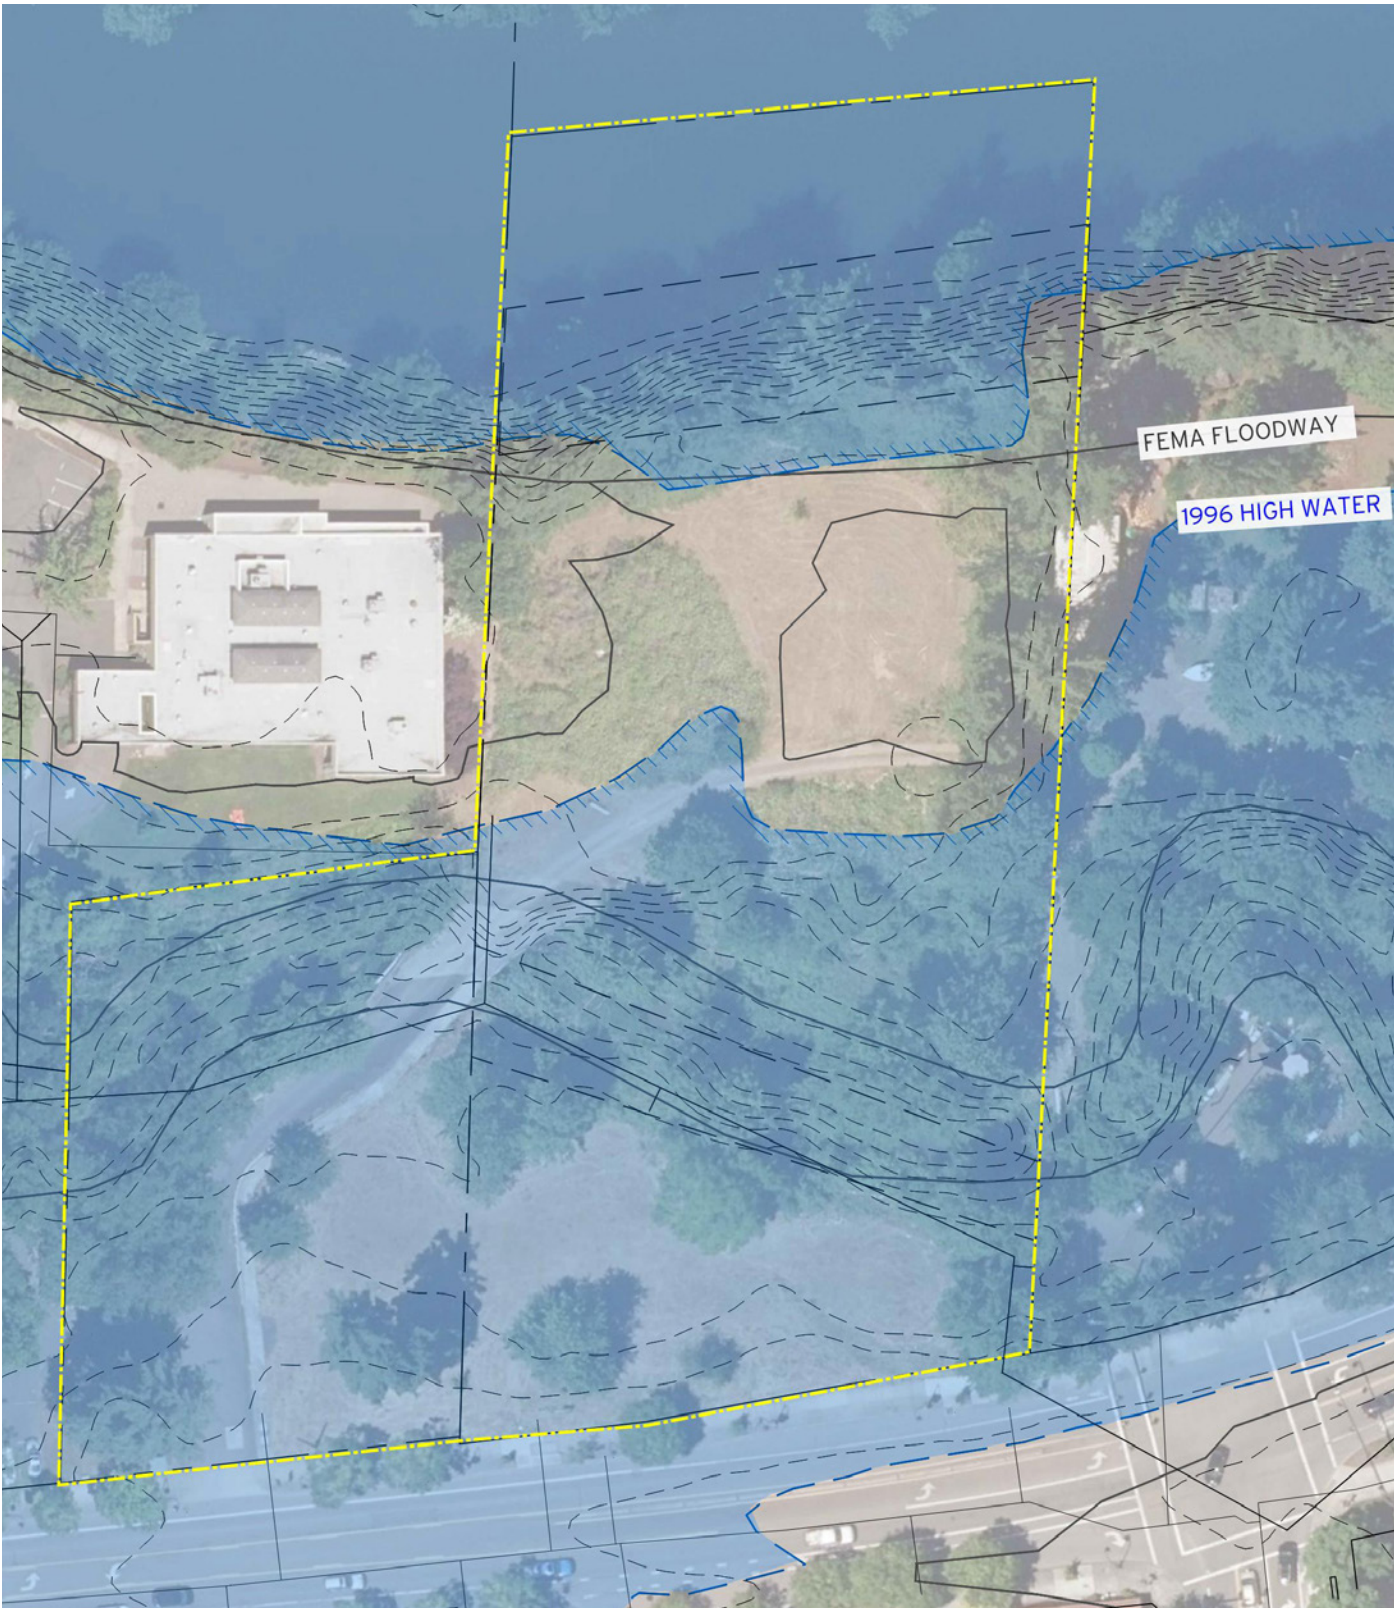
EXHIBIT 2B | RIVERBANK & FLOODPLAIN CONSIDERATIONS

The riverbank stability has two key factors: surface erosion, and internal geotechnical stability from slump failure. This parcel is located on the outside bend of river and is subject to erosive forces. The Tualatin River has been impacted by development over the years but retains its meandering character which does help reduce the stream energy. The site does show signs of some erosion along the shore, however given the size and age of the trees on the bank also indicate the erosion rate is low. The Tualatin river has a high sediment transport load which can quickly form shoaling and deposition on the riverbank when conditions permit. Careful consideration of riverbank improvements should limit measures that could increase erosion, improve bank stability and encourage sedimentation in the desired areas.

The riverbank is overstep, but also has survived a large flood, several high water events and has supported growth of very large trees in the last 30 years, indicating some inherent stability exists. The proposed improvements would dictate the scope and scale of future investigation necessary at this site.

This site is located adjacent to the Tualatin River which frequently experiences high water events. The central portion of the site is below the 100 yr flood elevation and could be flooded periodically, however the area by the main road and along the river are above the flood elevation. Sufficient areas exist at the location for siting of structures that would be prohibited within the flood zone. Mapping appears generally accurate and was established by the 1996 Metro flood photo. A previous development appears to have placed some fill in anticipation of future work. Depending on the proposed project this fill might require removal or additional investigation regarding past placement authorization from the city and FEMA may be required.

The floodway line is along the top of bank and development riverward of that line is generally prohibited, other than water dependent access structures. This development would require modeling and documentation to ensure it does not cause a rise in upstream flood elevations.
