**Re: CWS file 19-003074; 11045 SW Tualatin-Sherwood Road  
(Tax map 2S122DD Tax lot 00700, Tax map 2S127AA Tax lot 00500, Tax  
map 2S122D0 Tax lot 00600)**

Wetland Determination

11045, 10835, 10775 Tualatin-Sherwood Road, Tualatin, OR

**RE: Wetland Determination and Vegetated Corridor Assessment for 10835, 11045, 10775  
Tualatin-Sherwood Road, Tualatin, Oregon  
PHS #6836**

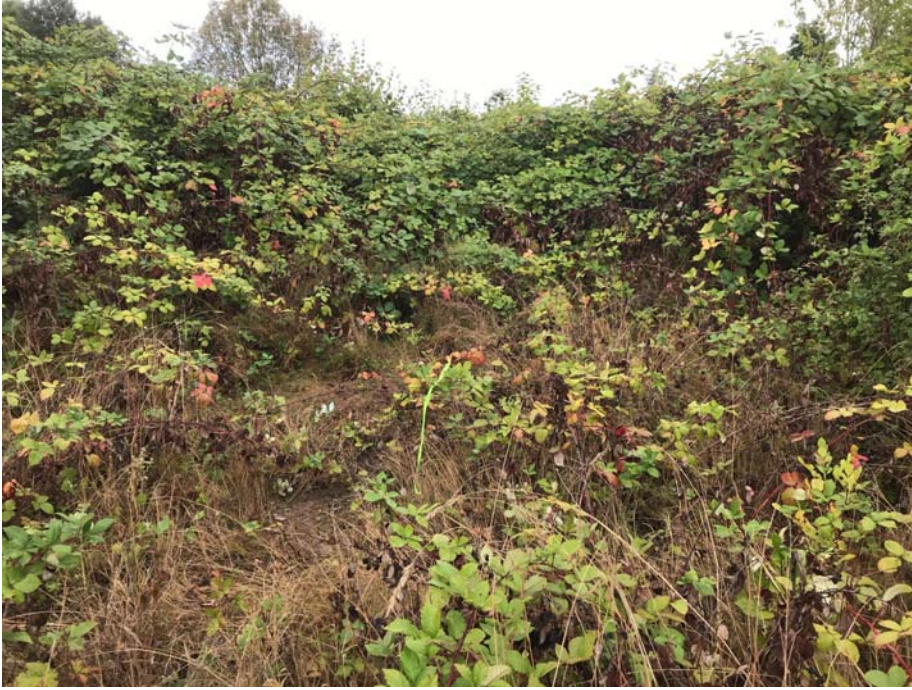
**Photo A:**

Looking southwest at Sample Point 1.

Sample Point 1 (Tax lot 600) was placed in the northern portion of the study area. Dominant vegetation in this area consists of Himalayan blackberry, colonial bentgrass (*Agrostis capillaris*, FAC), and velvet grass and meets the wetland vegetation criteria for wetlands. Hydric soils meet the requirements for depleted matrix; however, wetland hydrology indicators are not present.

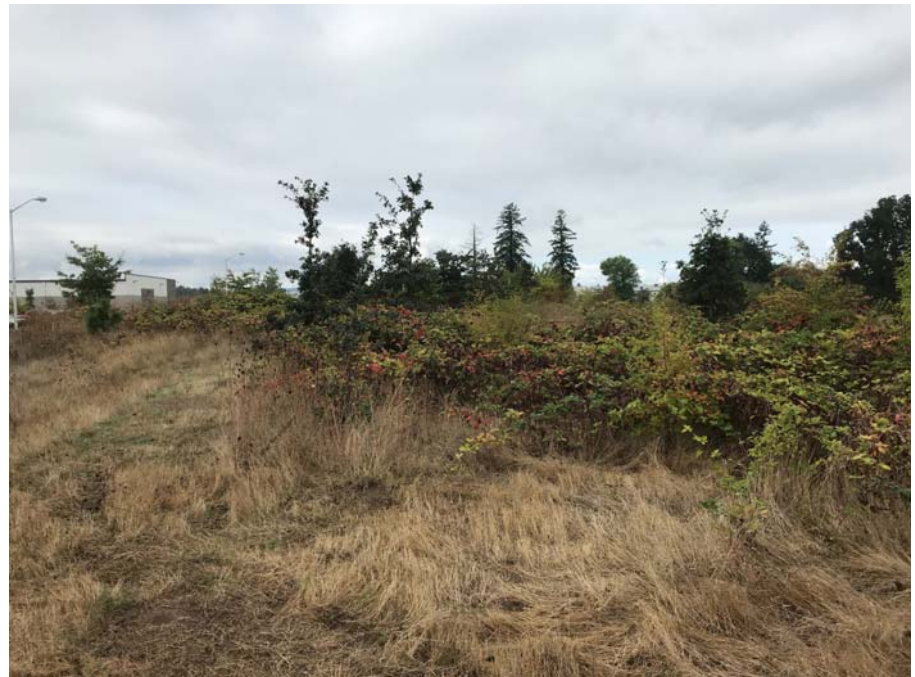
Looking west at a raised area with fill, north of SW Myslony Street in the northwest corner of the study area.

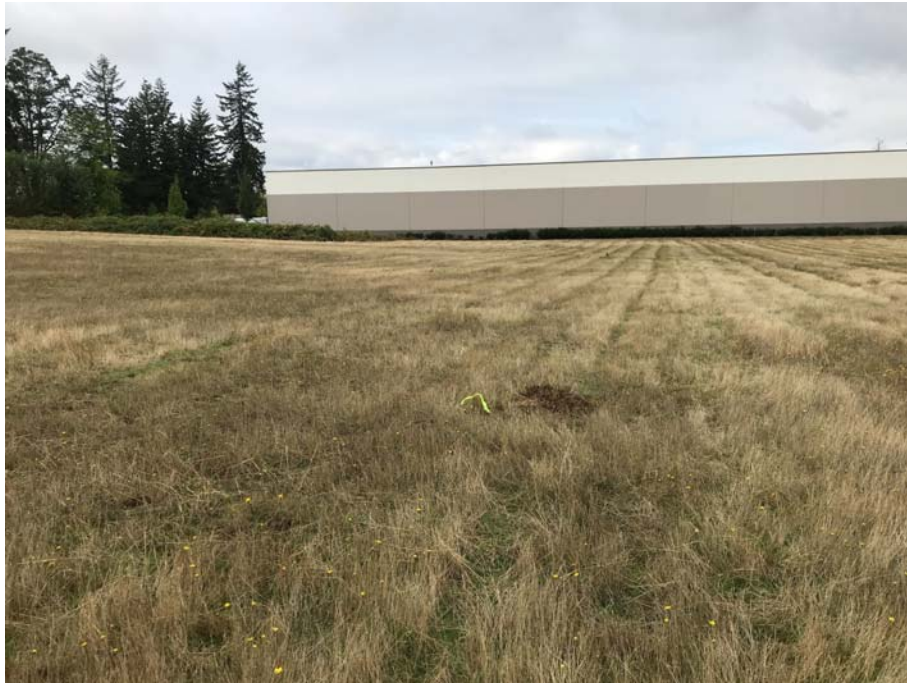
**Photo C:**

Looking southwest at Sample Point 2.

Sample Point 2 (Tax lot 600) was placed in the center of the field, which had recently been mowed. Vegetation consists of unidentified grasses and lesser hawkbit and does not meet the wetland vegetation criteria; hydric soils and wetland hydrology are also not present.

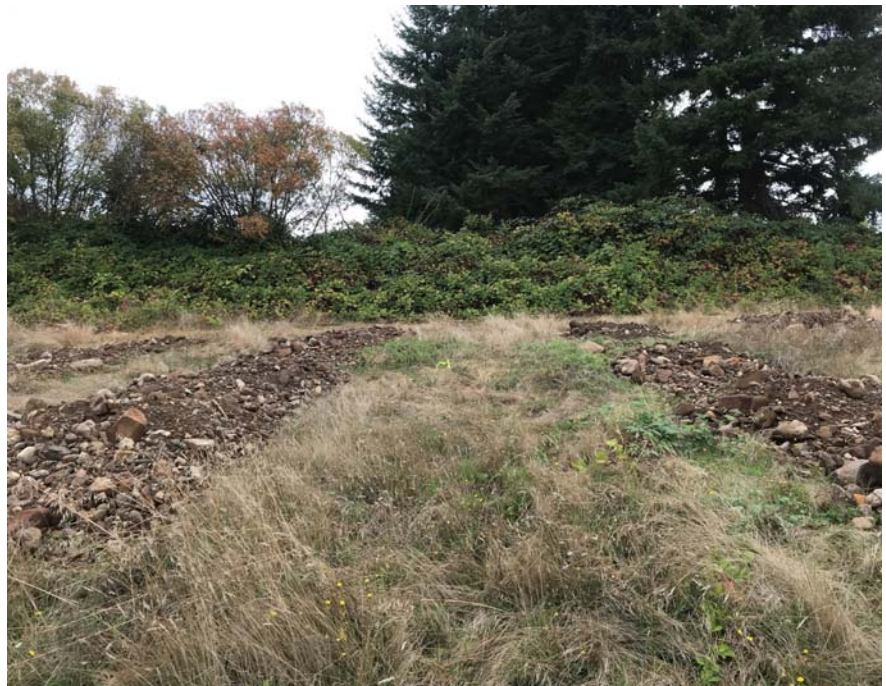
Looking east at Sample Point 3.

Sample point 3 (Tax lot 600) was placed in an area that had recently been disturbed, possibly for geotechnical excavations; however, there was adequate undisturbed ground available to assess vegetation, soils, and hydrology. Vegetation consists of unidentified grasses, black-bindweed (*Fallopia convolvulus*, FACU), and oat (assumed UPL) and does not meet wetland vegetation criteria; hydric soils and wetland hydrology are also not present.

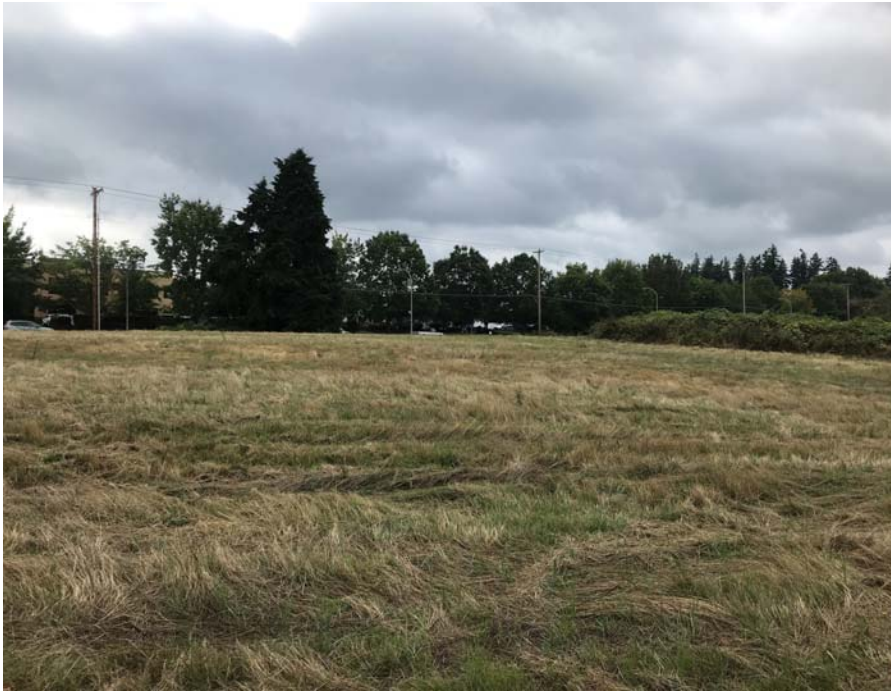
**Photo E:**

Looking south at southwest portion of study area (Tax lot 600).

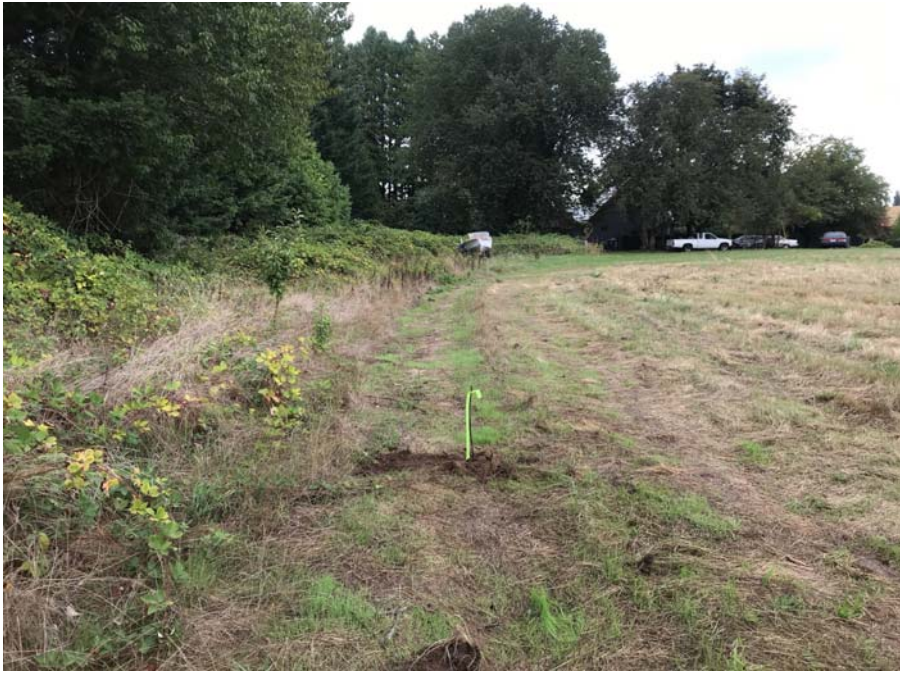
**Photo G:**

Looking east at Sample Point 5.

Sample Point 5 (Tax lot 700) was placed in the northeast portion of the study area. The dominant vegetation consists of Himalayan blackberry and ryegrass, which meets wetland vegetation criteria; however, hydric soils and wetland hydrology are not present.

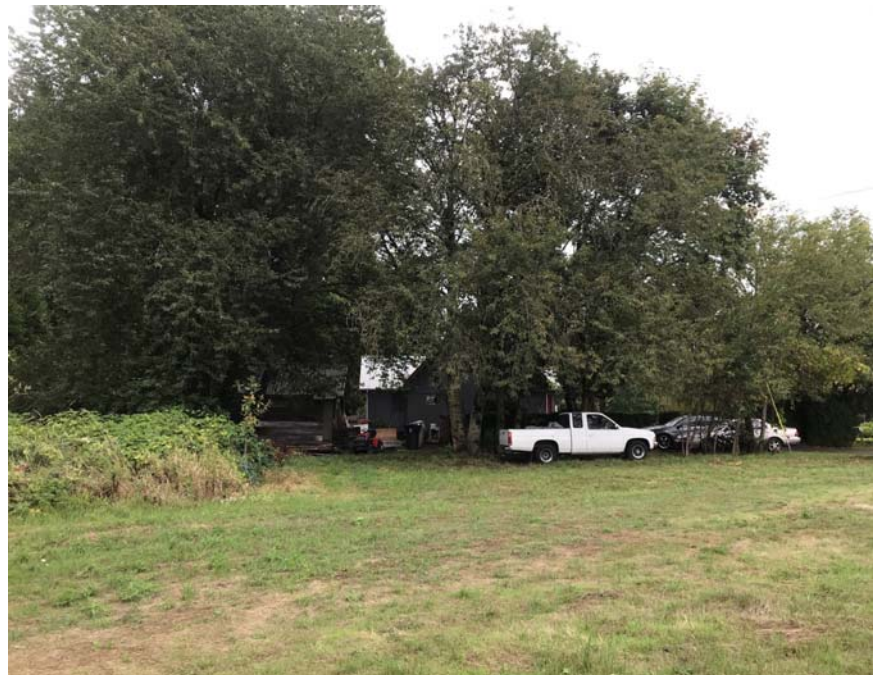
Looking east at residence in northeast portion of study area (Tax lot 700).
