# **Barnes Lake**

**2022 Aquatic Macrophyte Control Program**

**Prepared By  
Northwest Aquatic Eco-Systems  
855 Trosper Road SW #108-313  
Tumwater, WA 98512  
360-357-3285  
Pondweeds@comcast.net**

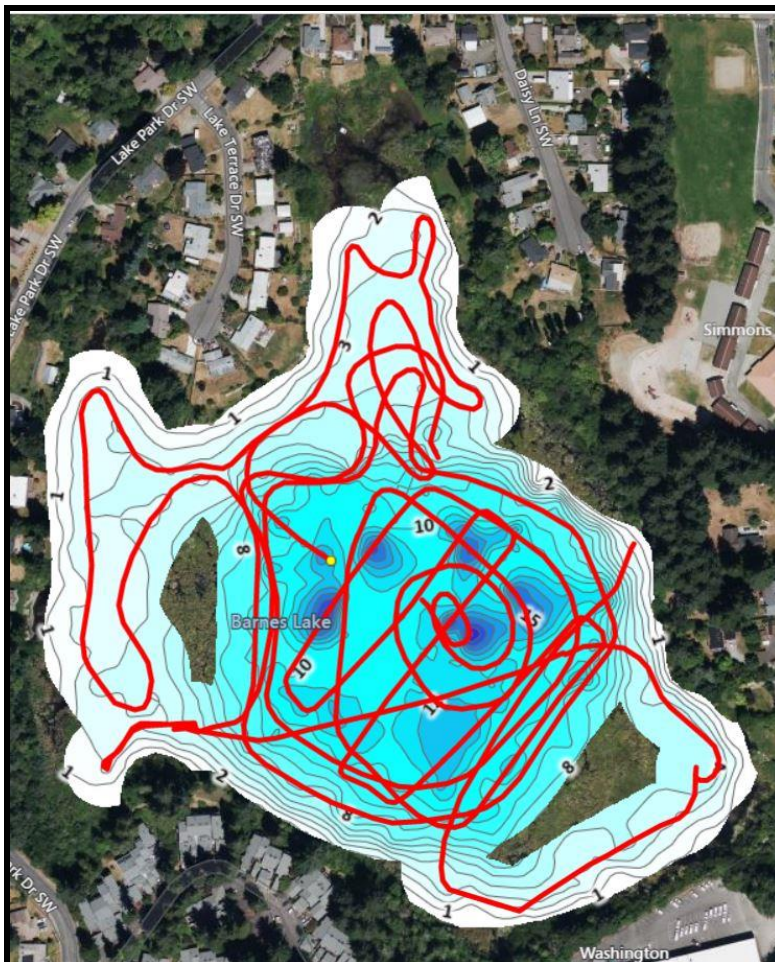
June 2022 Survey Tracks

Our protocol encompasses a surface vehicle transecting the lake along the entire littoral zone. Boat tracks are designed to be approximately 150 feet apart. Sonar beam data collection extends approximately 150 feet from all directions surrounding the boat. To ensure the efficacy of the survey, a bottom sampling rake is thrown from the boat at various locations lake-wide. The rake is then drawn across the lake bottom, brought to the surface and into the boat. Plants attached to the rake are identified and confirmed as being the same species as noted through the structure scan or visually noted through the water column. This sampling point is then incorporated into the data log file as a single point of reference, noting the species captured during the rake tow. These points are then added to the final project map.

BioBase survey technology provides accuracy in water depths of greater than 2.5 feet. Data collected below the three foot threshold may be skewed because of signal related issues from the reflected bottom transducer readings. These depth issues and data acquisition distributions are typical for the Branes Lake shallow canal and island sections of the lake. In general, survey efficacy was limited to the main lake basin.

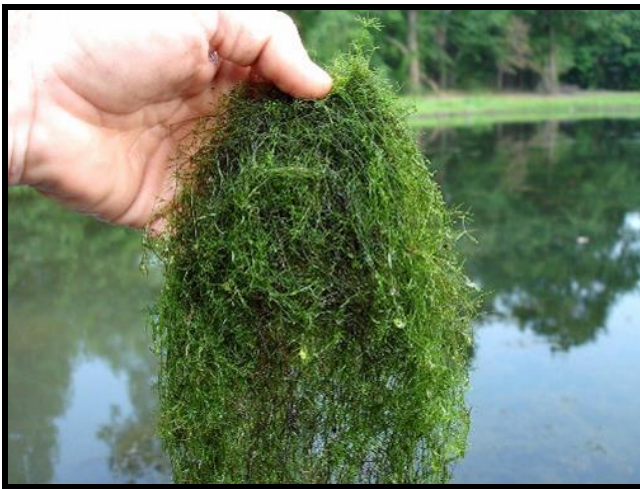
During the survey, 13 sampling data points were collected at the same locations as noted during 2021. Grab samples were collected and recorded. Previously stored data points were uploaded and observed on the onboard chart recording screen. The survey boat is directed to each data point for sampling. Our 2021 survey identified only one site (003) supporting bladderwort growth while the remaining sites exhibited no weed nitella growth. Four sites exhibited the presence of nitella.

2022 results identified ten sites containing bladderwort, four sites containing pondweeds and three sites containing coontail. Much of the lake bottom was supporting nitella growth similar to the 2021 survey. This species is typically associated with post fluridone treatments. Nitella looks similar to aquatic macrophytes but is an algae species. When trying to identify aquatic plants many residents misidentify this species as a plant simply because of its physical and growth characteristics. Nitella seldom creates water related recreational issues.
