BARNES LAKE ANNUAL REPORT 2024

AQUATECHNEX, LLC.
P.O. BOX 118
CENTRALIA, WA 98531

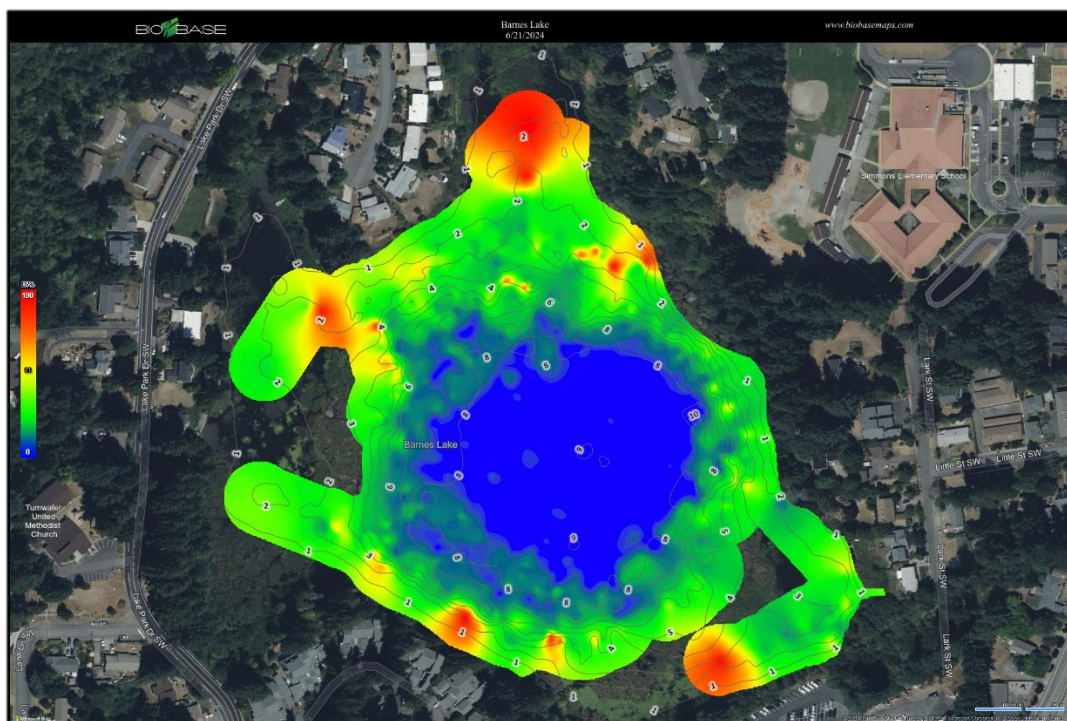
Barnes Lake Vegetation Heat Map 2024

The above map is the vegetation heat map that was taken during the hydro-acoustic survey. The colors indicate different levels of vegetation height that is taking up the water column. The hotter colors red, orange, and yellow indicate a high level of vegetation. The cooler colors green and blue indicate low levels of vegetation. The highest level of vegetation was in the northern part of Barnes Lake at the time of the survey. This area is also very shallow, which allows for vegetation to grow in. The middle of basin had little to no plant growth at time of survey. Purple bladderwort was observed floating around the middle of the basin during this survey.

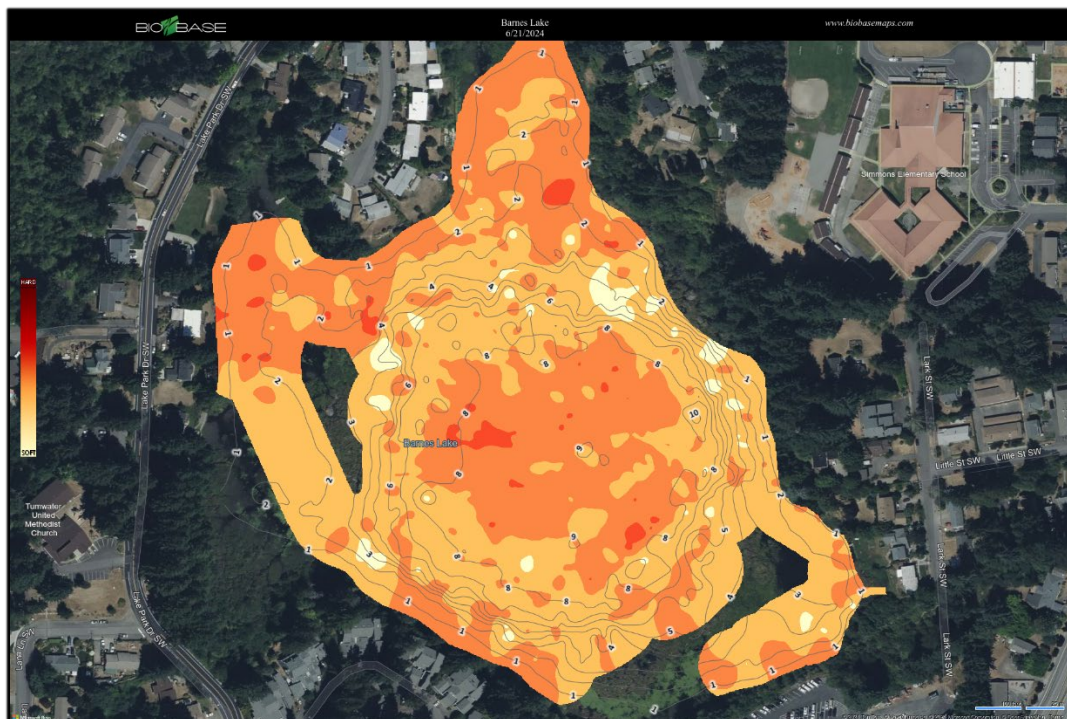
Barnes Lake Bottom Composition Map 2024

The above map is the bottom composition map generated from the hydro-acoustic mapping survey. The hotter colors, red and dark orange, on this map indicate hard substrates. The cooler colors, cream and light orange, indicate soft substrates. It was unexpected that most of the lake bottom was not soft, especially in the northern area. With the amount of sedimentation occurring in this area, we would expect to see softer sediment types here. Due to the high vegetation, there could have been an error in the readings that took place. Also, the depth of that area was very shallow which could have caused a misreading of the bottom sediments.

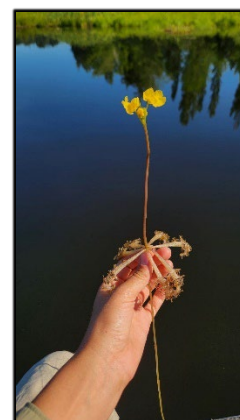
Figure 6: Common Bladderwort flower found at Barnes Lake.

As 2024 was our first year taking over the management of Barnes Lake, we learned a lot about Barnes Lake, and we have some recommendations to implement for 2025. In 2025, we recommend a full lake Sonar (fluoridone) application. This would systematically target the bladderwort that has become wider spread. This species of bladderwort produces a seed that drops during the season. Due to Bladderwort’s modes of reproduction and mobility, this aquatic plant will require multiple seasons to achieve control. Earlier season control prior to the Bladderwort’s seed production will be required.

If Sonar is not utilized, we recommend using Aquathol K vs. Diquat for the treatment of bladderwort. We recommend this chemistry because unlike diquat, it does not become inactivated once in contact with sediment and other particles that it could encounter prior to

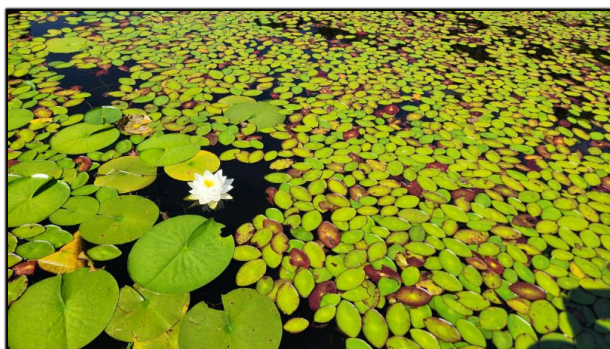
The following map shows the locations of the invasive species that were present at the time of the survey. These species are the white-water lily (figure 7) and bladderwort. Himalayan blackberry and water hemlock were not part of this survey; however, they were noted by the biologist on site as species of concern. A fall survey was conducted from shore due to the shallow depth of Barnes Lake. Due to this, points were not able to be taken to accurately represent the locations of the species of concern.

Figure 7: White water lily and watershield at Barnes Lake.

Additionally, we recommend utilizing Imazamox, also known as ClearCast, to treat the white-water lily (WWL) that is around the lake. Sonar may have some initial effects on the WWL that is present in Barnes Lake, however, it will rebound later in the season, once the concentration has decreased throughout the lake. Imazamox is an EPA register reduced risk herbicide, meaning that it is less harmful to the environment and humans than other older chemistries.

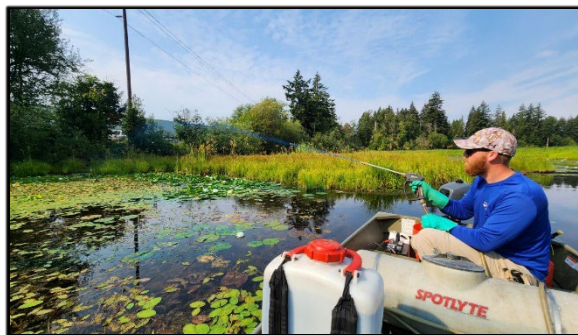
Aquatic Biologist Scott Conrade and Aquatic Technician Ellie Karpf were on site for the application. The treatment crew utilized a 10ft john boat, equipped with a 2.5 hp Yamaha motor. A Spotlyte treatment system was used to apply diquat to the bladderwort using a boom with drop hoses. The Spotlyte system was also utilized to apply Imazamox to treat the WWL, via a foliar application (figure 8). A surfactant was also added to the mix to help break through the cell walls of the lilies and help keep the product in place until it has entered the plant.

Figure 8: Aquatic Biologist, Scott Conrade treats WWL. (Not pictured) Aquatic Technician Ellie Karpf aids in the application.
