- Tree Protection Plan-

KINGSWOOD APARTMENTS

Kingswood Drive SW
Tumwater, Washington

Date: July 6, 2022

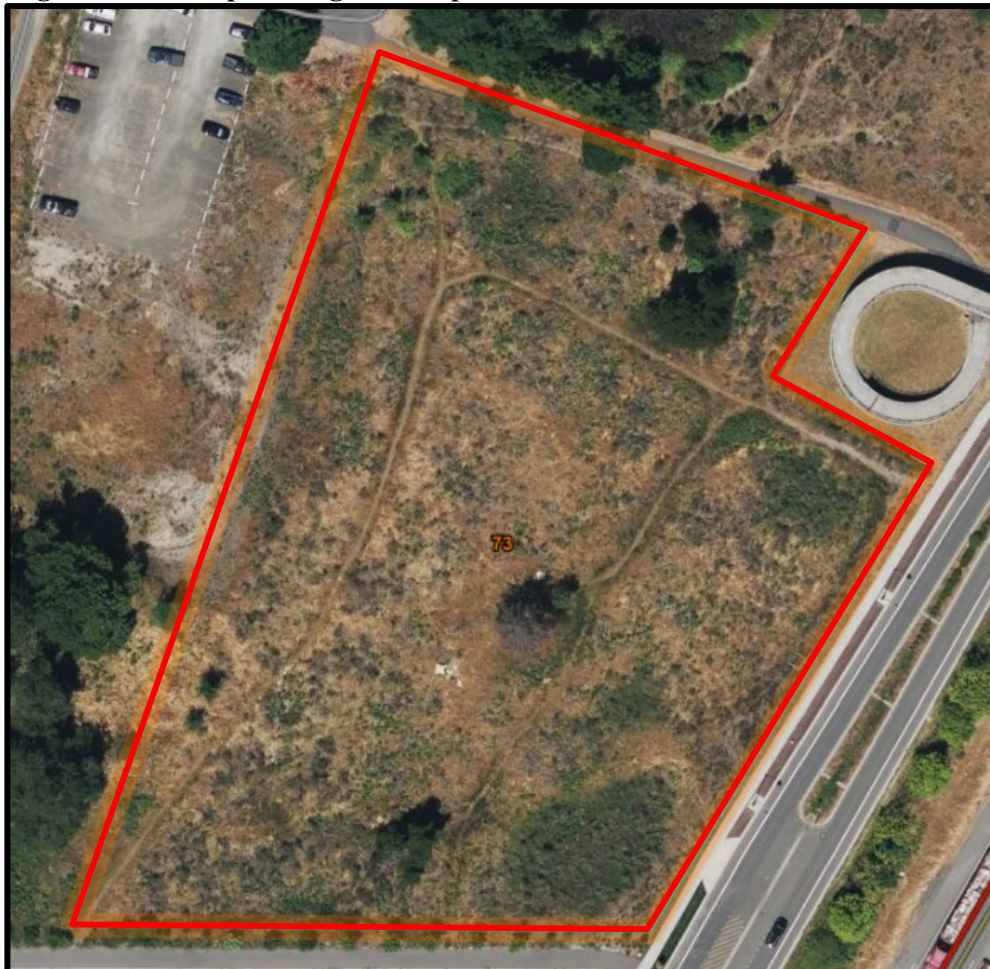
Figure 1: Soil map of Kingswood Apartments Site.

According to the Thurston County Soil Survey, the one soil type located on the site is the Nisqually loamy fine sand, a very deep, somewhat excessively drained soil found on terraces. It formed in sandy glacial outwash. Permeability is moderately rapid in the surface layer and very rapid in the substratum. Available water capacity is moderate and effective rooting is over 60 inches. Windthrow hazard is slight under normal conditions. Droughtiness during the summer months may cause seedling mortality.

73 - Nisqually loamy fine sand

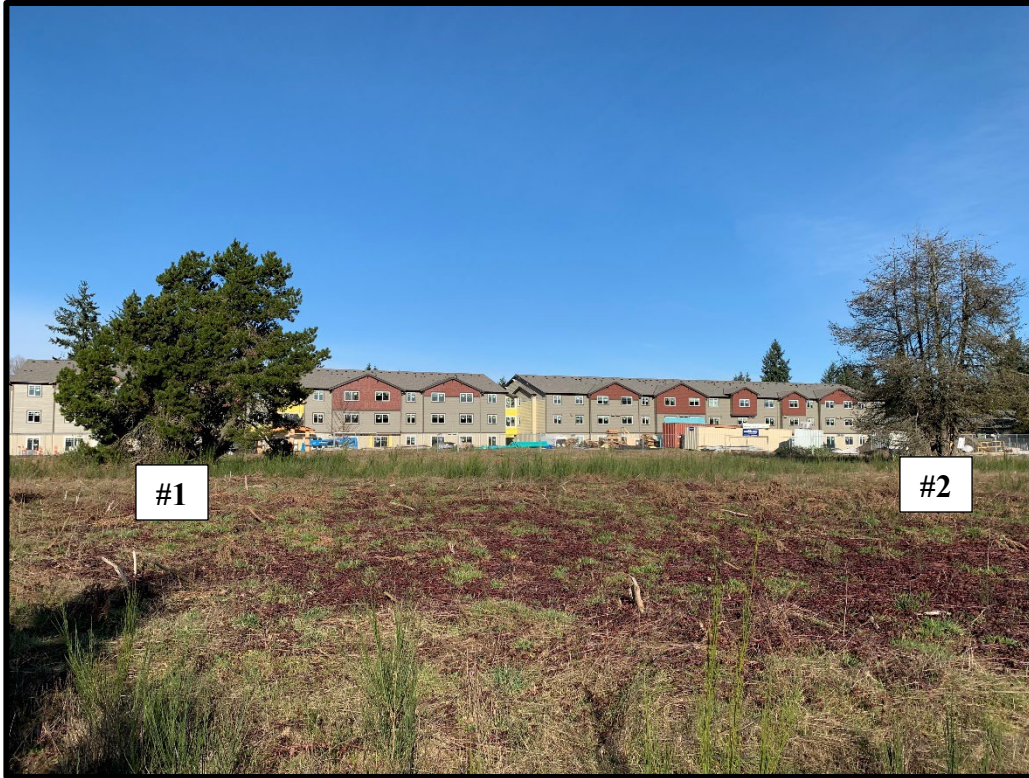
Type I: This type contains all trees in the project area. There are three black locust (*Robinia pseudoacacia*) and 10 shore pine (*Pinus contorta*) trees growing in the type. The trees range from 5 to 20 inches DBH. The condition of the trees ranges from ‘Dead’ to ‘Fair’. Black locust however, is considered to be an invasive species and not recommended for retention on new projects. The following Table 1 is a list of all trees on the site.

Photo 1. View of cover type I and trees 1 & 2 on Kingswood Apartments Site.

Due to poor tree quality, the invasive nature of black locust, and the tree locations being under the footprint of improvements, no trees are planned to be retained.

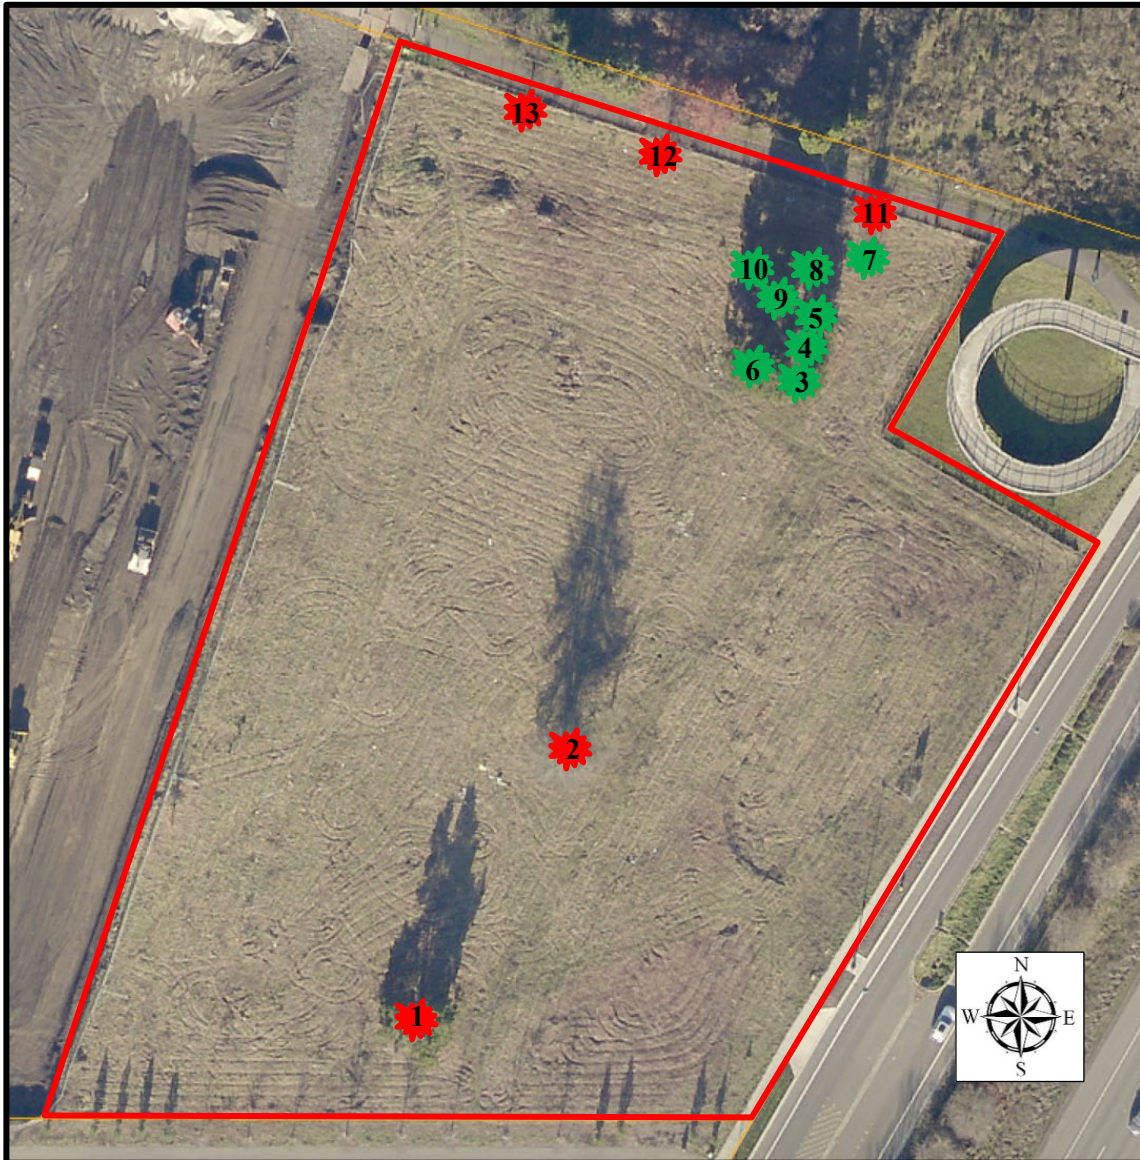
Kingswood Drive Apartments Site Tree Locations

★ Healthy Tree

★ Unhealthy Tree

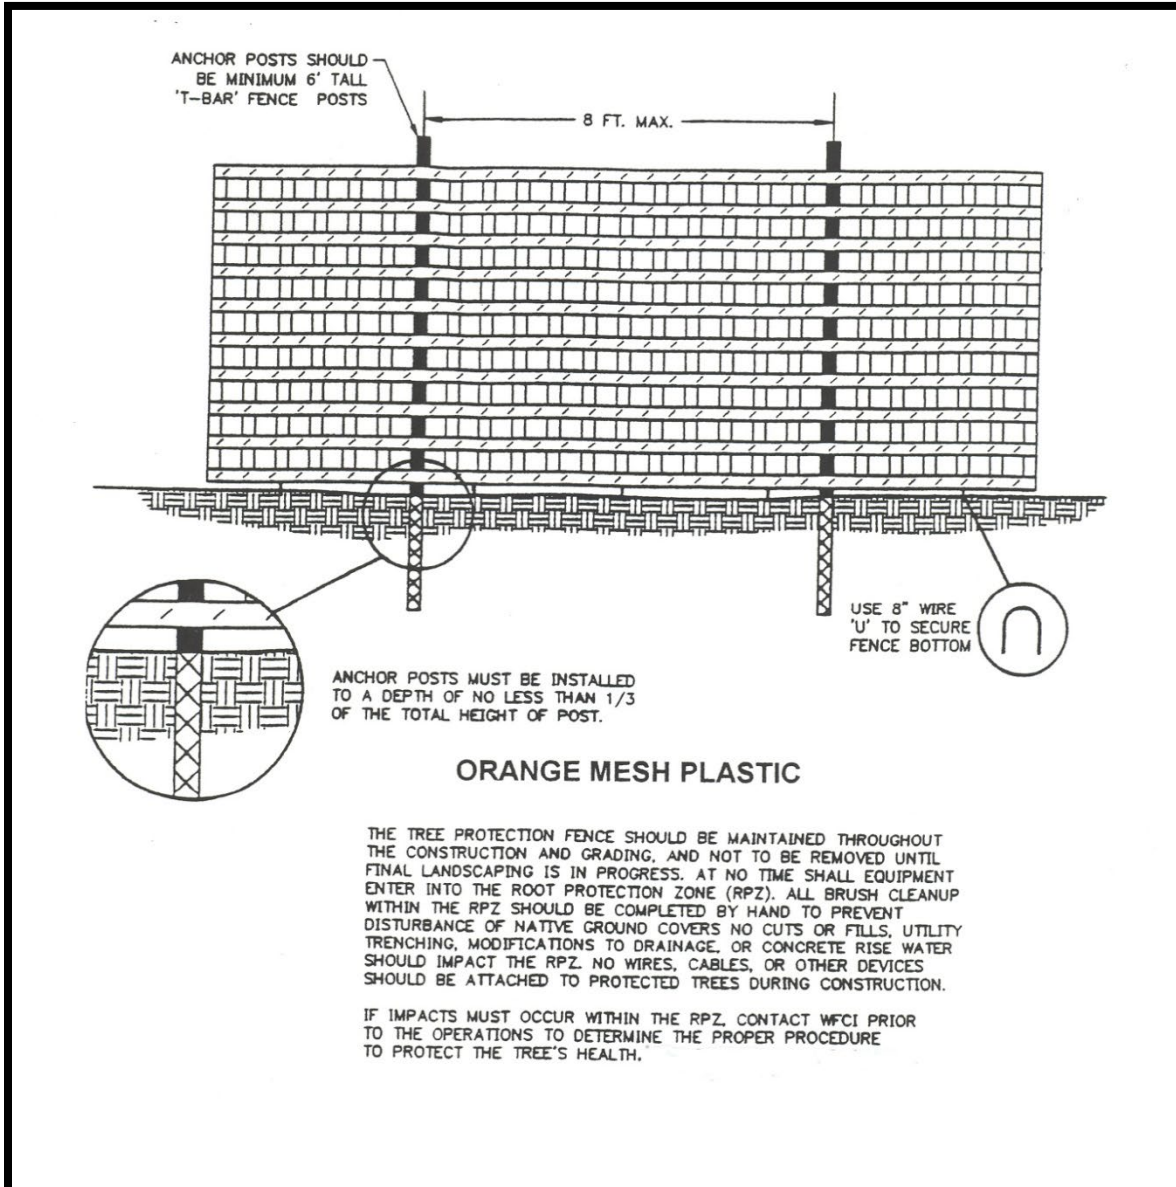
Tree Protection Fence Detail

If trees were saved, the tree protection fence should be orange mesh plastic, and be erected after logging and clearing, but prior to grading. No trenches, cuts, fills, drainage modification, irrigation lines, storing of materials, equipment operation, or other activity should occur within the critical root zone of protected trees. The tree protection and silt fences should be installed at least 5 feet beyond the driplines of trees to be saved.
