***Geotechnical & Stormwater Evaluation***

***Proposed Retail Development  
1401 & 1551 Kingswood Drive SW***

Report  
Geotechnical and Stormwater Evaluation  
Proposed Retail Development  
Kingswood Drive  
Tumwater, Washington  
File No. 519-001-01

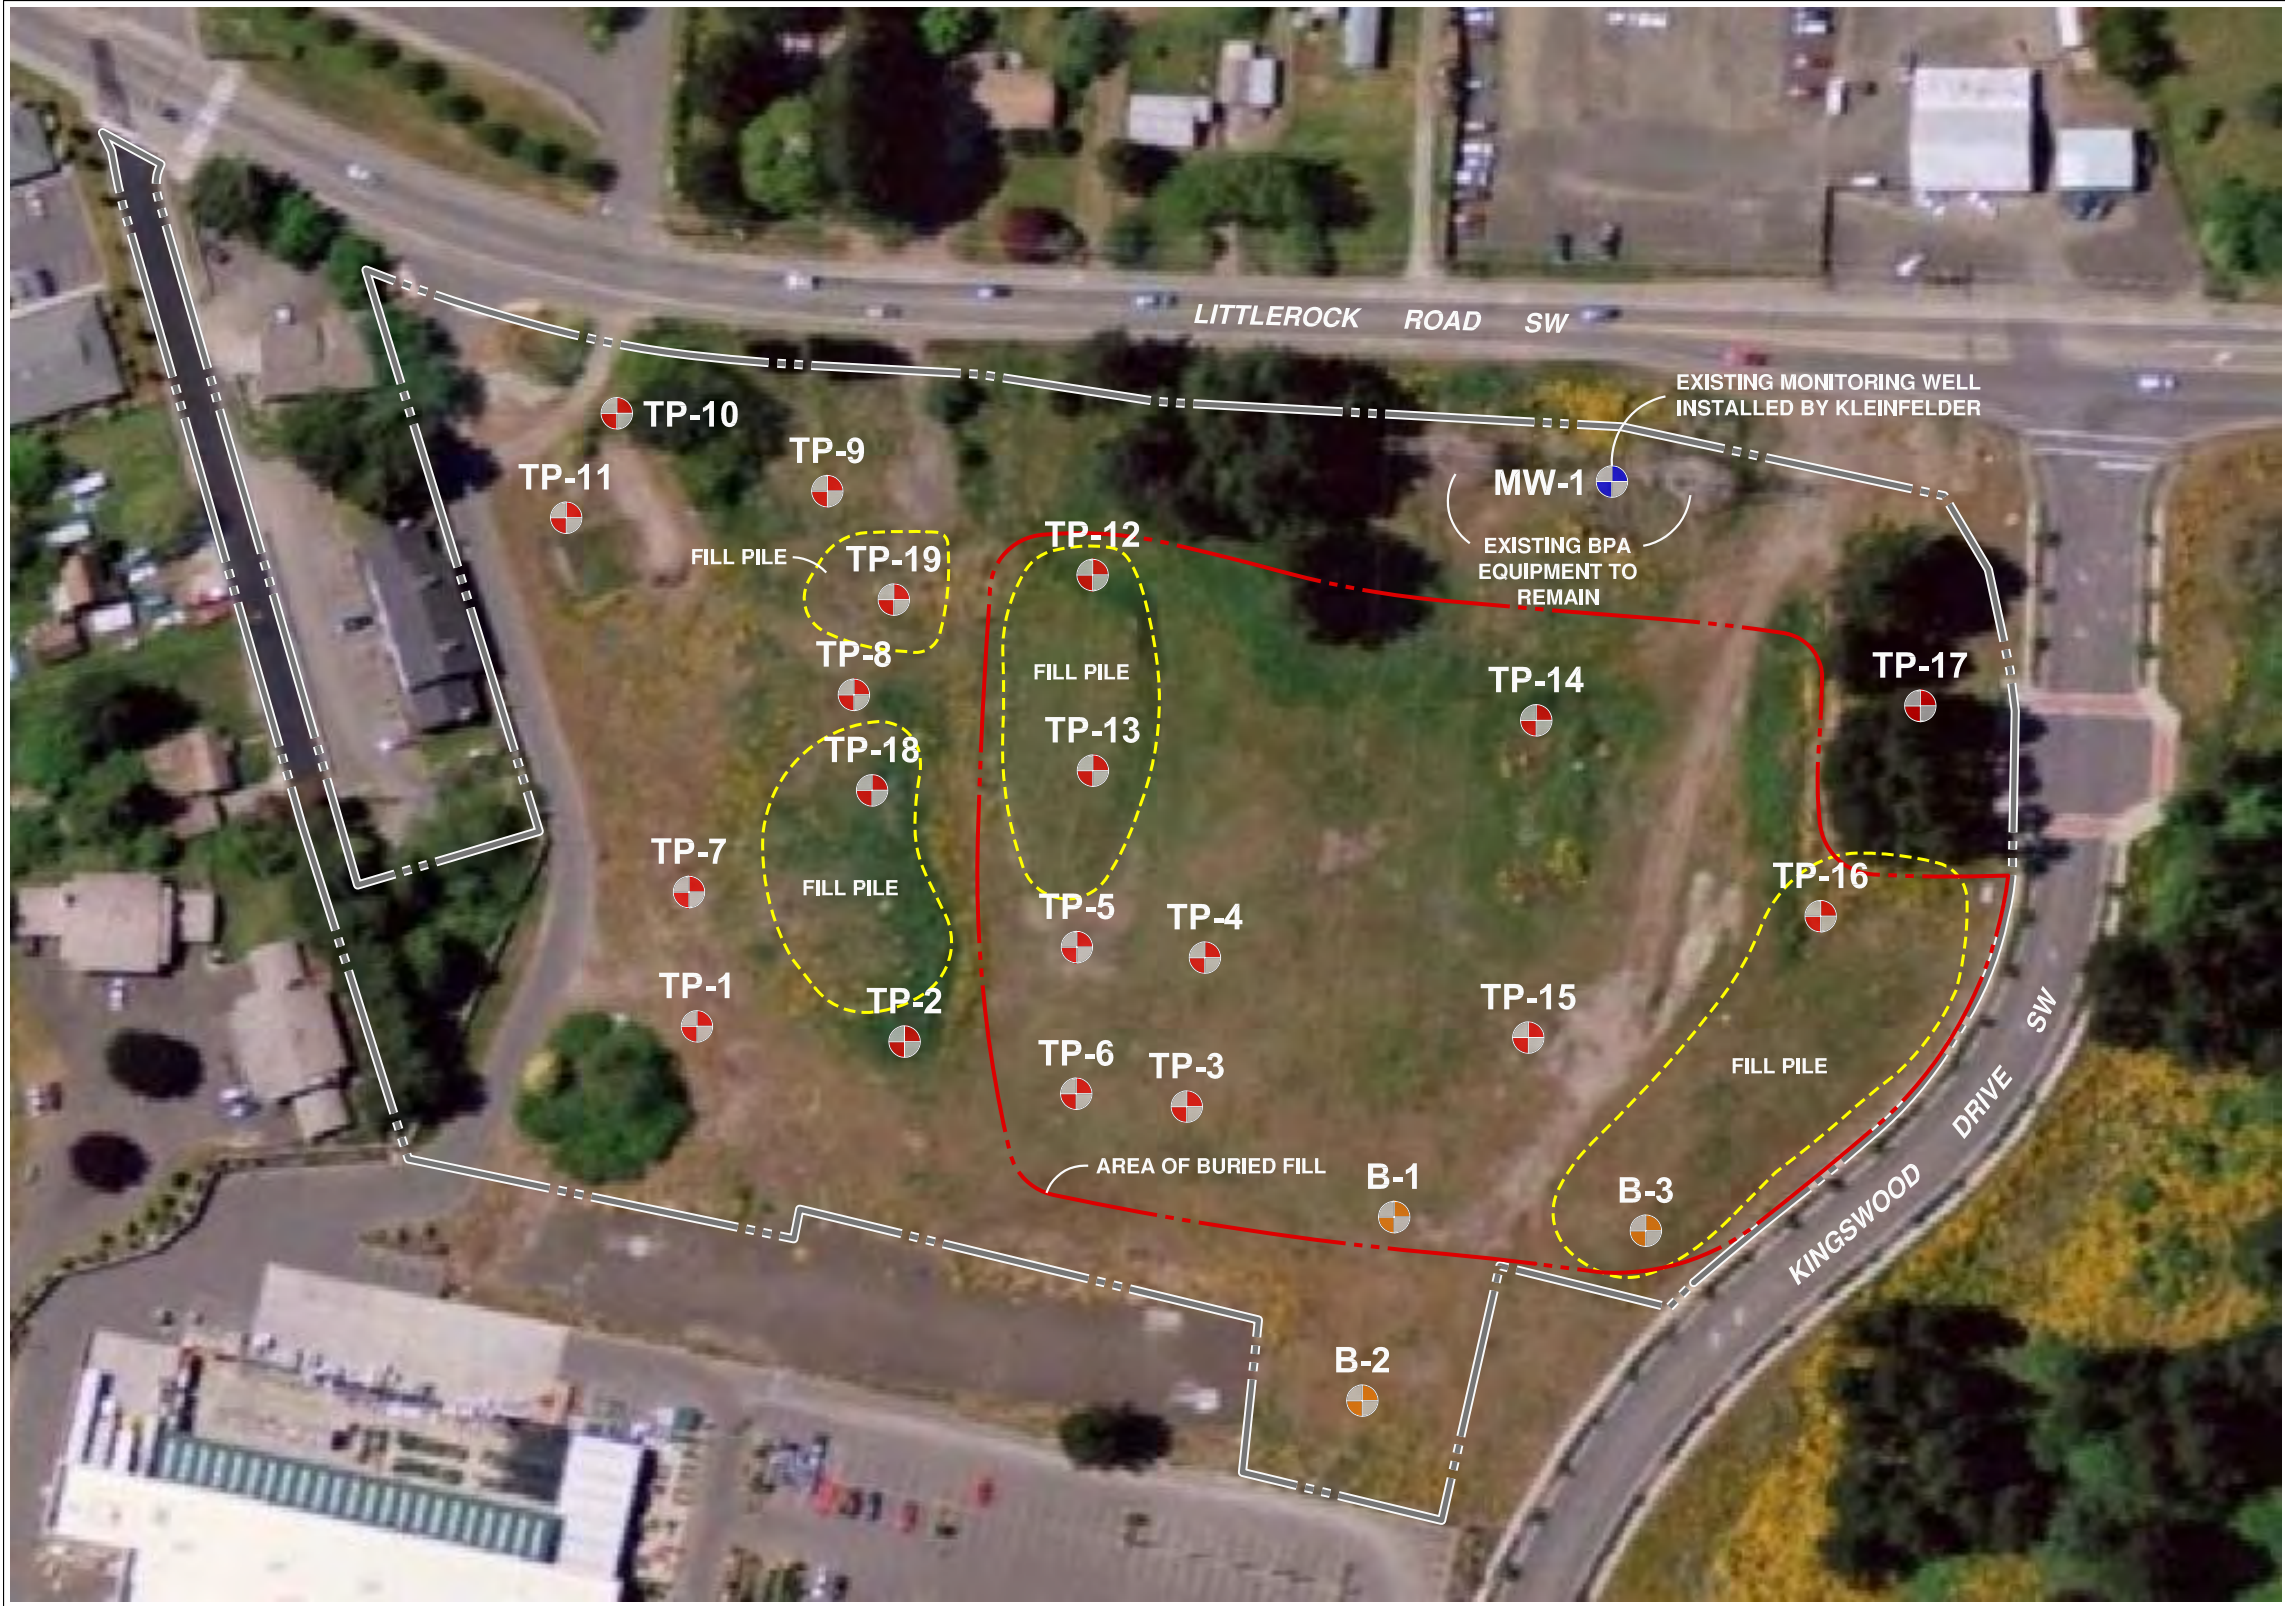
Subsurface conditions at the site were explored by advancing 3 borings and 19 test pits at the approximate locations shown in Figure 2 on March 28 and 29 2011. The test pits were excavated using a small, track-mounted backhoe. The test pits were completed to depths ranging between 5 and 11 feet below ground surface. Borings were conducted using a truck mounted probe rig to obtain subsurface samples continuously to the total depth of the borehole.

Unsuitable fill materials such as trash and wood debris should be excavated and removed from the site. Overlying material and some material within the fill such as brick and concrete debris may be reused as structural fill provided they meet the requirements of structural fill as detailed later in this report. The general area of unsuitable and uncontrolled fill found at the site is shown in Figure 2.

Significant quantities of uncontrolled and unsuitable fill were encountered in test pits and borings conducted in the north-central portion of the site extending to depths of 14 feet. The unsuitable fill materials consisted of brick, concrete, wood-waste, construction debris and trash. Uncontrolled fill, particularly fill containing significant quantities of wood and wood-waste such as logs and stumps, can be expected to settle over time as the wood decays. Long-term settlement can result in pavement distress or failure, utility disruption or deflection of floor slabs.
