## Tumwater Townhomes Arborist Report Tumwater, WA

**Prepared For:** Brandon Johnson, JSA Civil  
Owner's Representative

**Prepared By:** Colin Owen, SCJ Alliance  
ISA Certified Arborist PN-9606A  
ISA Tree Risk Assessment Qualified

**Date:** December 6, 2024

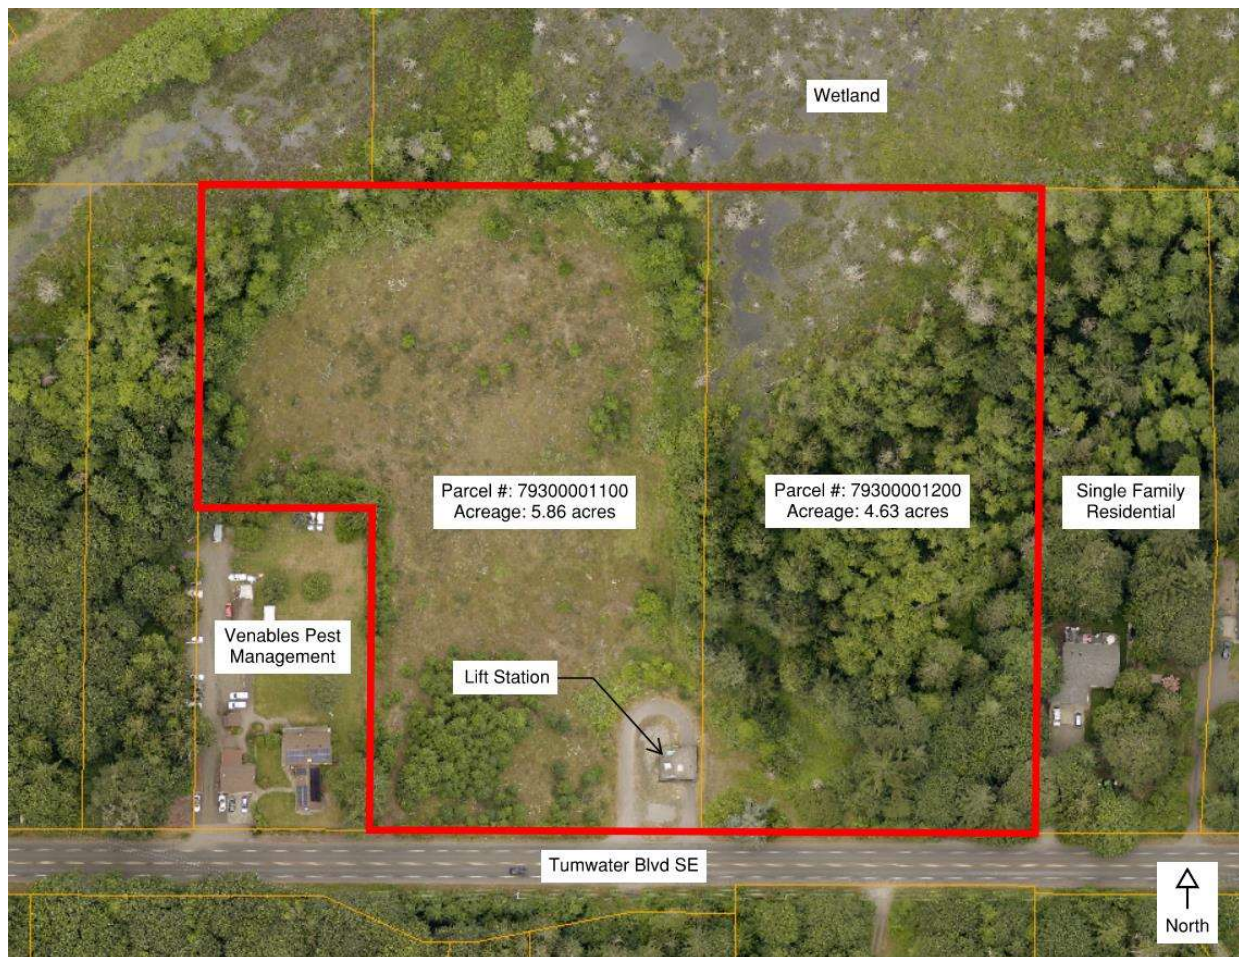
**Figure A: Aerial View of Project Site**

The entire project site is bordered to the north by a large wetland. To the west it is bordered by a commercial property occupied by a pest management company and, to the east, a single family residential property. To the south, the property fronts Tumwater Boulevard. (See [Figure A: Aerial View of Project Site](#) below)

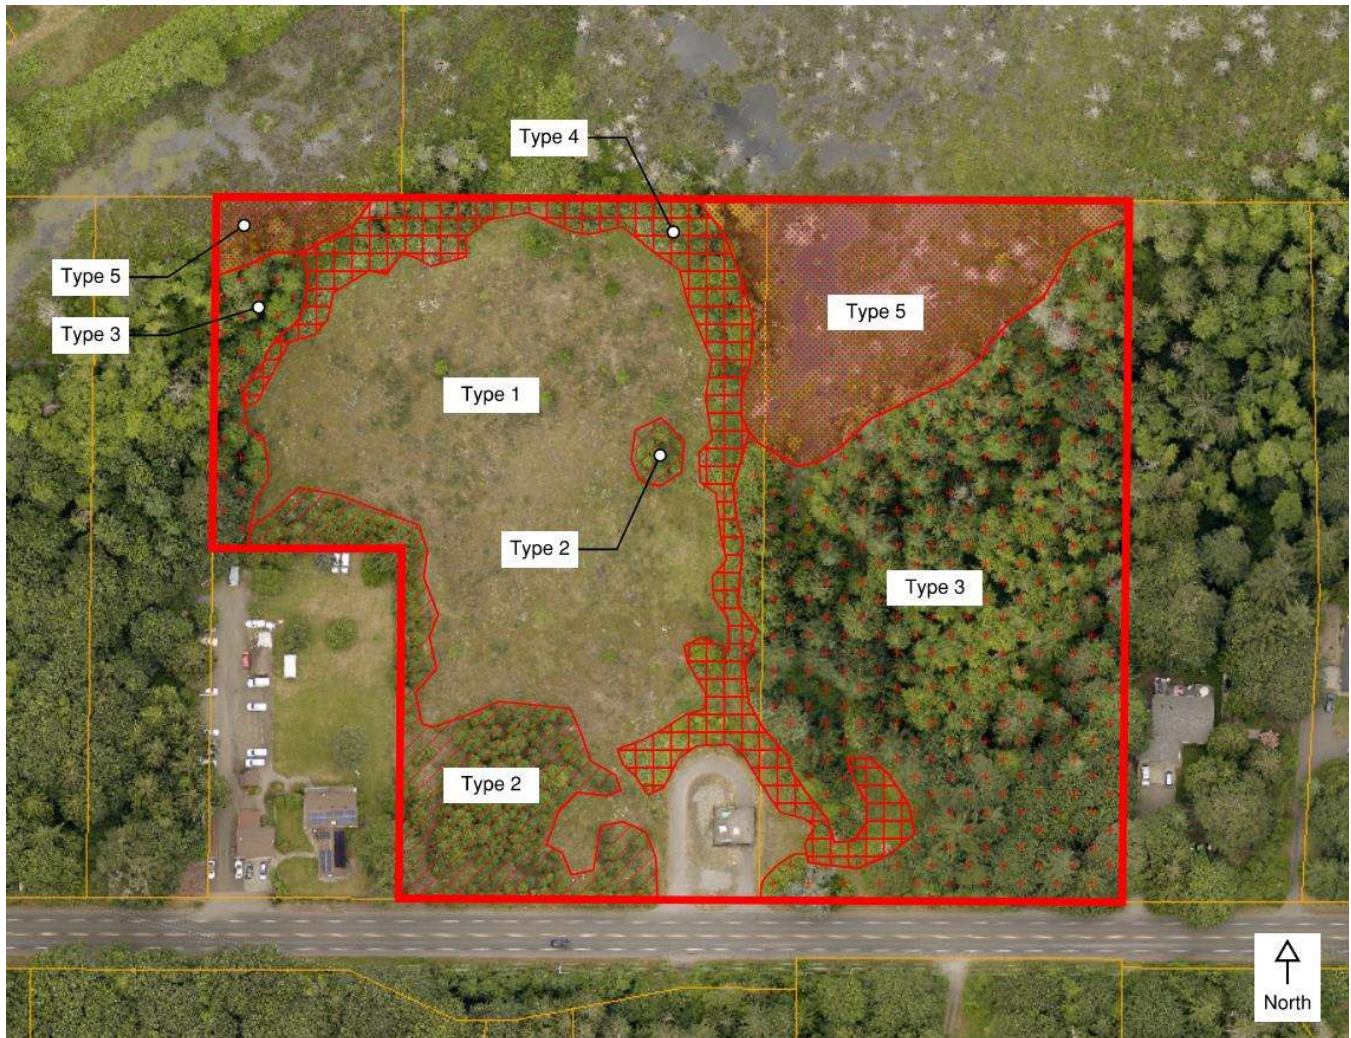
**Figure B: Locations of Vegetation Types**

There are five distinct types of vegetated landscapes on the site (see [Figure B](#) below):

**Type 1** is located primarily at the center of the developed west parcel and consists of a vacant grass field, interspersed with patches of Scotch broom and weedy perennials. Small clusters of 2-4" Douglas fir trees are located throughout this area. Trees in this area were inventoried individually.

**Type 2** is located primarily at the southwest corner of the developed parcel and consists of young (3" to 8") Douglas fir (*Pseudotsuga menziesii*) trees with negligible understory or vegetative groundcover present. Trees in this area were inventoried individually.

**Type 3** is located on approximately 75% of the undeveloped east parcel and along the western edge of the developed west parcel. It consists of the native tree, understory and groundcover species typical of this part of Western Washington. Dominant tree species include Douglas fir, Western hemlock, Western redcedar, and big leaf maple. The understory is heavily shaded, with fern species such as Western sword fern (*Polystichum munitum*) and deer fern (*Struthiopteris spicant*) dominating. Trees in and adjacent to the west parcel were inventoried individually, while trees in the east parcel were inventoried via plot sampling.

**Type 4** is located on around the perimeter of the developed west parcel and consists primarily of invasive Himalayan blackberry.

**Type 5** is a wetland. Assessment of wetlands and the inventory of plants therein is not included in the scope of this report.
