STAFF REPORT

Meeting Date:	June 15, 2023
Agenda Title:	COA 23-43 – 2 Court House Square
Requested Action:	Review proposal for the request to remove four specimen trees from the perimeter of the John Barton Payne Building and the adjacent FNB Wealth Building.
Department / Agency Lead:	Community Development
Staff Lead:	Casey Squyres

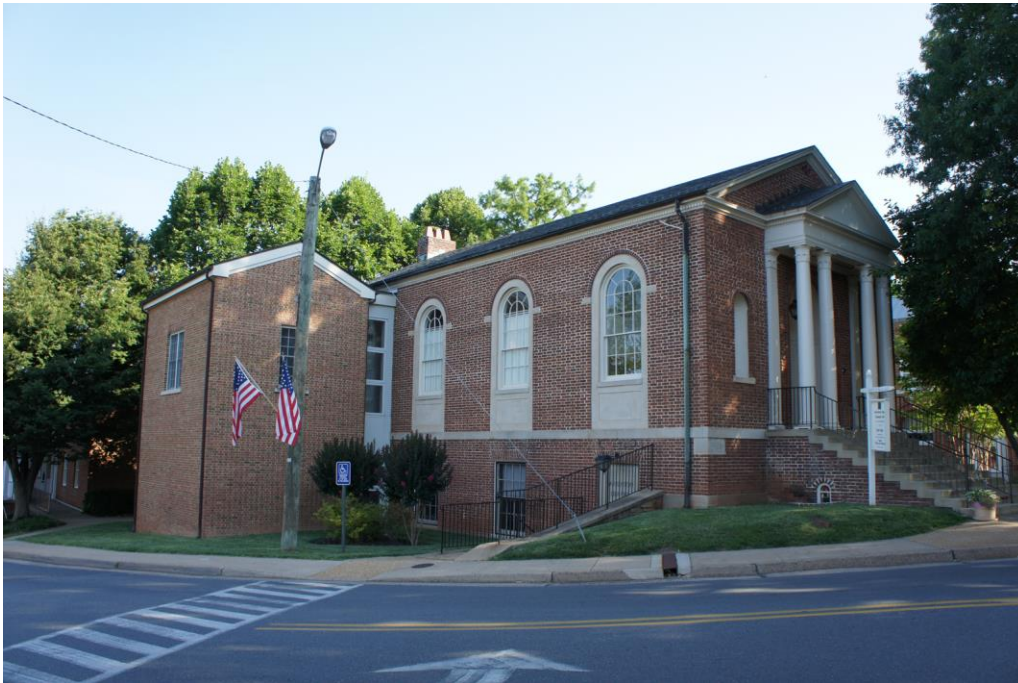
*Image from 2019 architectural survey

** The three Linden trees and the Bald Cypress tree in question are visible behind the building.
