Community Development  
Department

# **STAFF REPORT**

<b>Meeting Date:</b>	July 24, 2025
<b>Agenda Title:</b>	COA 25-53   3 Hotel Street
<b>Requested Action:</b>	Review proposal for the request to conduct in-kind exterior rehabilitation.
<b>Department / Agency Lead:</b>	Community Development
<b>Staff Lead:</b>	Casey Squyres, Historic Preservation Planner

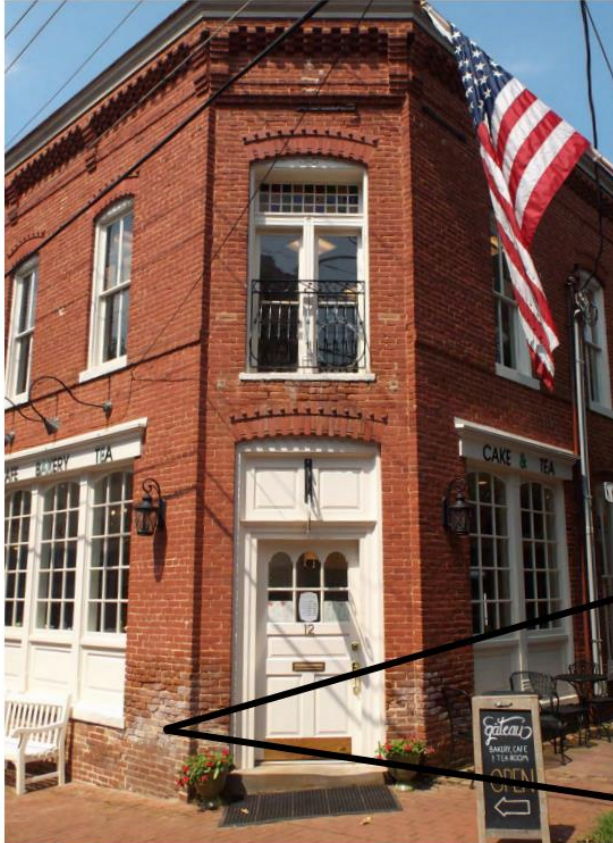
Figure 3-23 Salt efflorescence is a sign of nemetual moisture on masonry surfaces

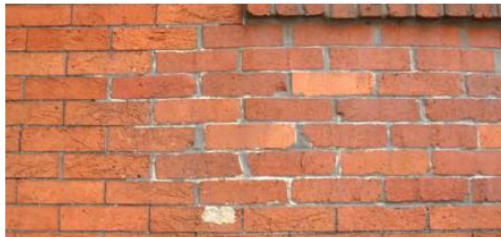
Figure 3-24: This brick wall was improperly repaired; the replaced mortar does not match the existing mortar profile, color, composition, or texture. Further, an improper re-pointing technique damaged the brick.

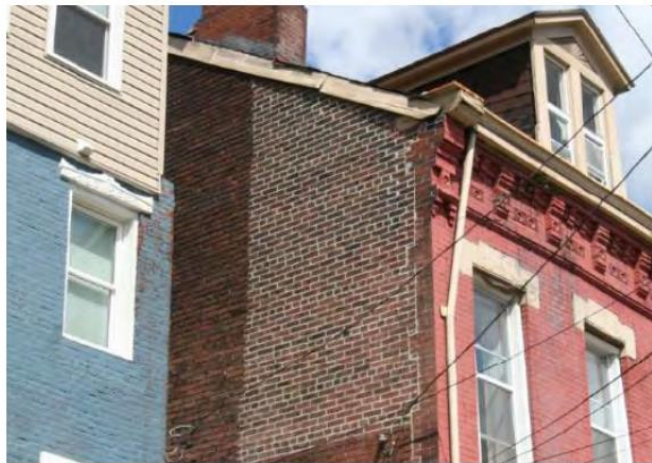
Figure 3-25: Do not re-point masonry joints with a mortar that does not duplicate the old in strength, composition, color, and texture, as pictured above. Whether original to the house or added at a later date—the appropriate design minimally affects the integrity of the house.

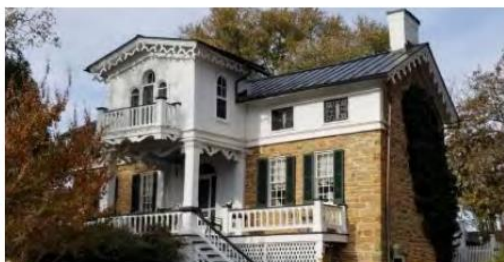
Figure 3-26: Identify, preserve, and retain all original wood features. Wood details are critical to the integrity of the built environment.

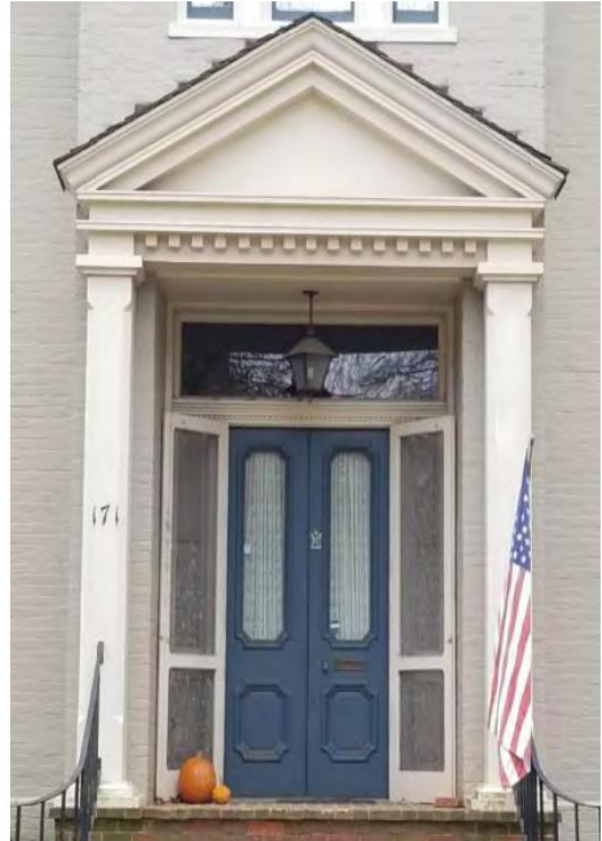
Figure 3-30: Preserve and retain original and historic-age doors such as these double-leaf, panel and glass doors. Note the corresponding screen doors, made to fit.

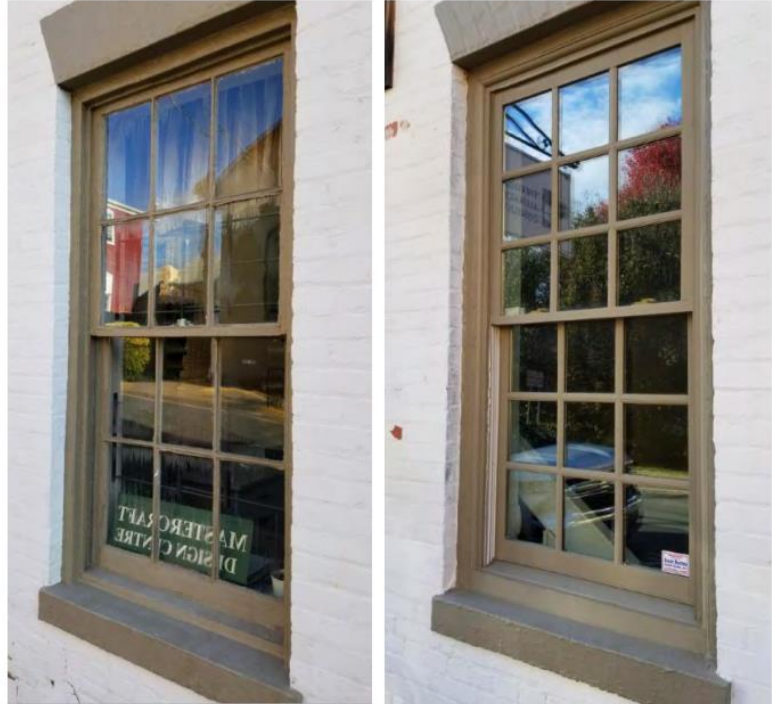
Figure 3-31: The window on right is a wood replacement with moderately accurate detailing. It mimics an original window, as seen on the left. The replacement has slightly thicker muntin profile than the original and also has an incorrect division of lights (nine-over-nine-light as opposed to the original six-over-six-light sashes). Despite these inconsistencies, it is a good fit for the historic district.

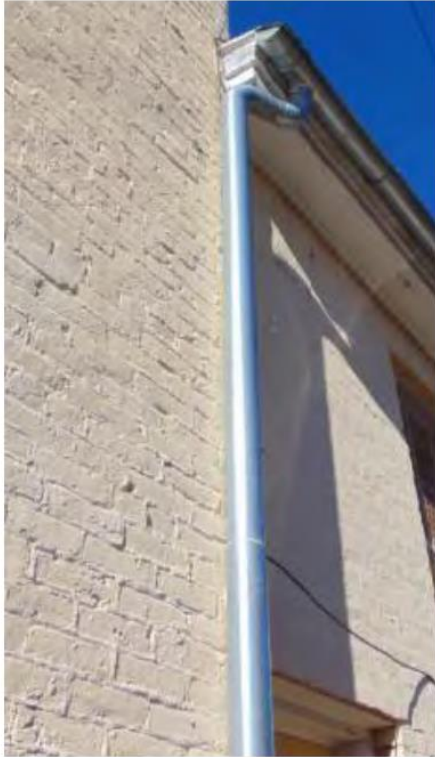
Figure 3-43: This galvanized steel downspout is not historically appropriate. To comply with the guidelines, the downspout should be painted to blend in with building.

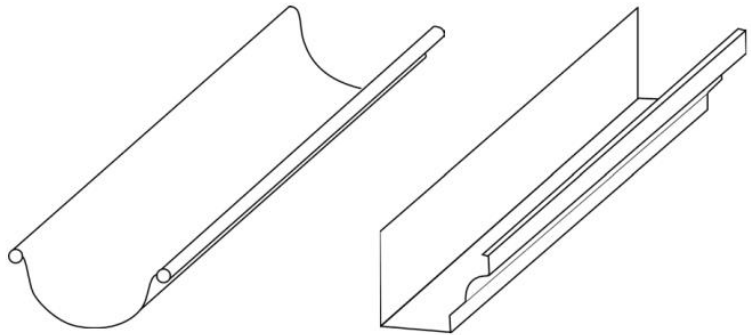
Figure 3-44: Half-round gutters (left) are the typical gutter style seen throughout the historic district. Half-round gutters best represent the rain system style of colonial houses. K-style gutters (right) were introduced in the late 1940s.

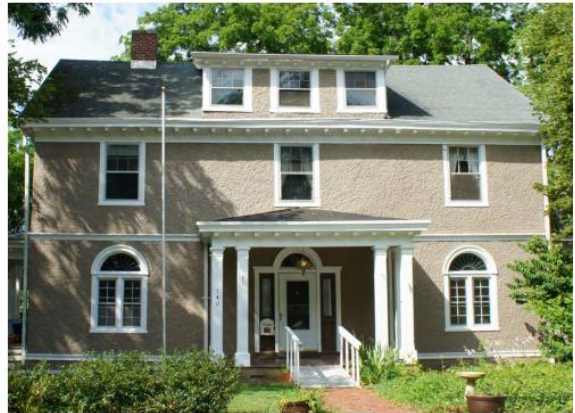
Figure 3-45: The cornice of 140 Winchester is a prominent architectural feature typical in Colonial Revival structures.

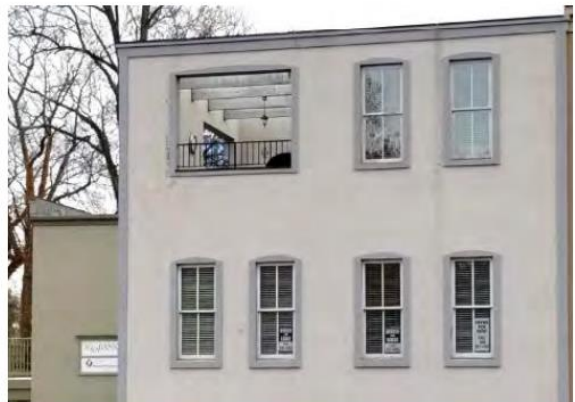
Figure 3-46: This interesting rooftop deck appears to be integral with the building. It is located at the rear of the property, is minimally ornamented, and maintains the rhythm and patterning of the fenestration pattern.
