WARRENTON UNITED METHODIST CHURCH

WATERS OF THE U.S. (WOTUS) AND WETLAND DELINEATION REPORT

APRIL 29, 2024

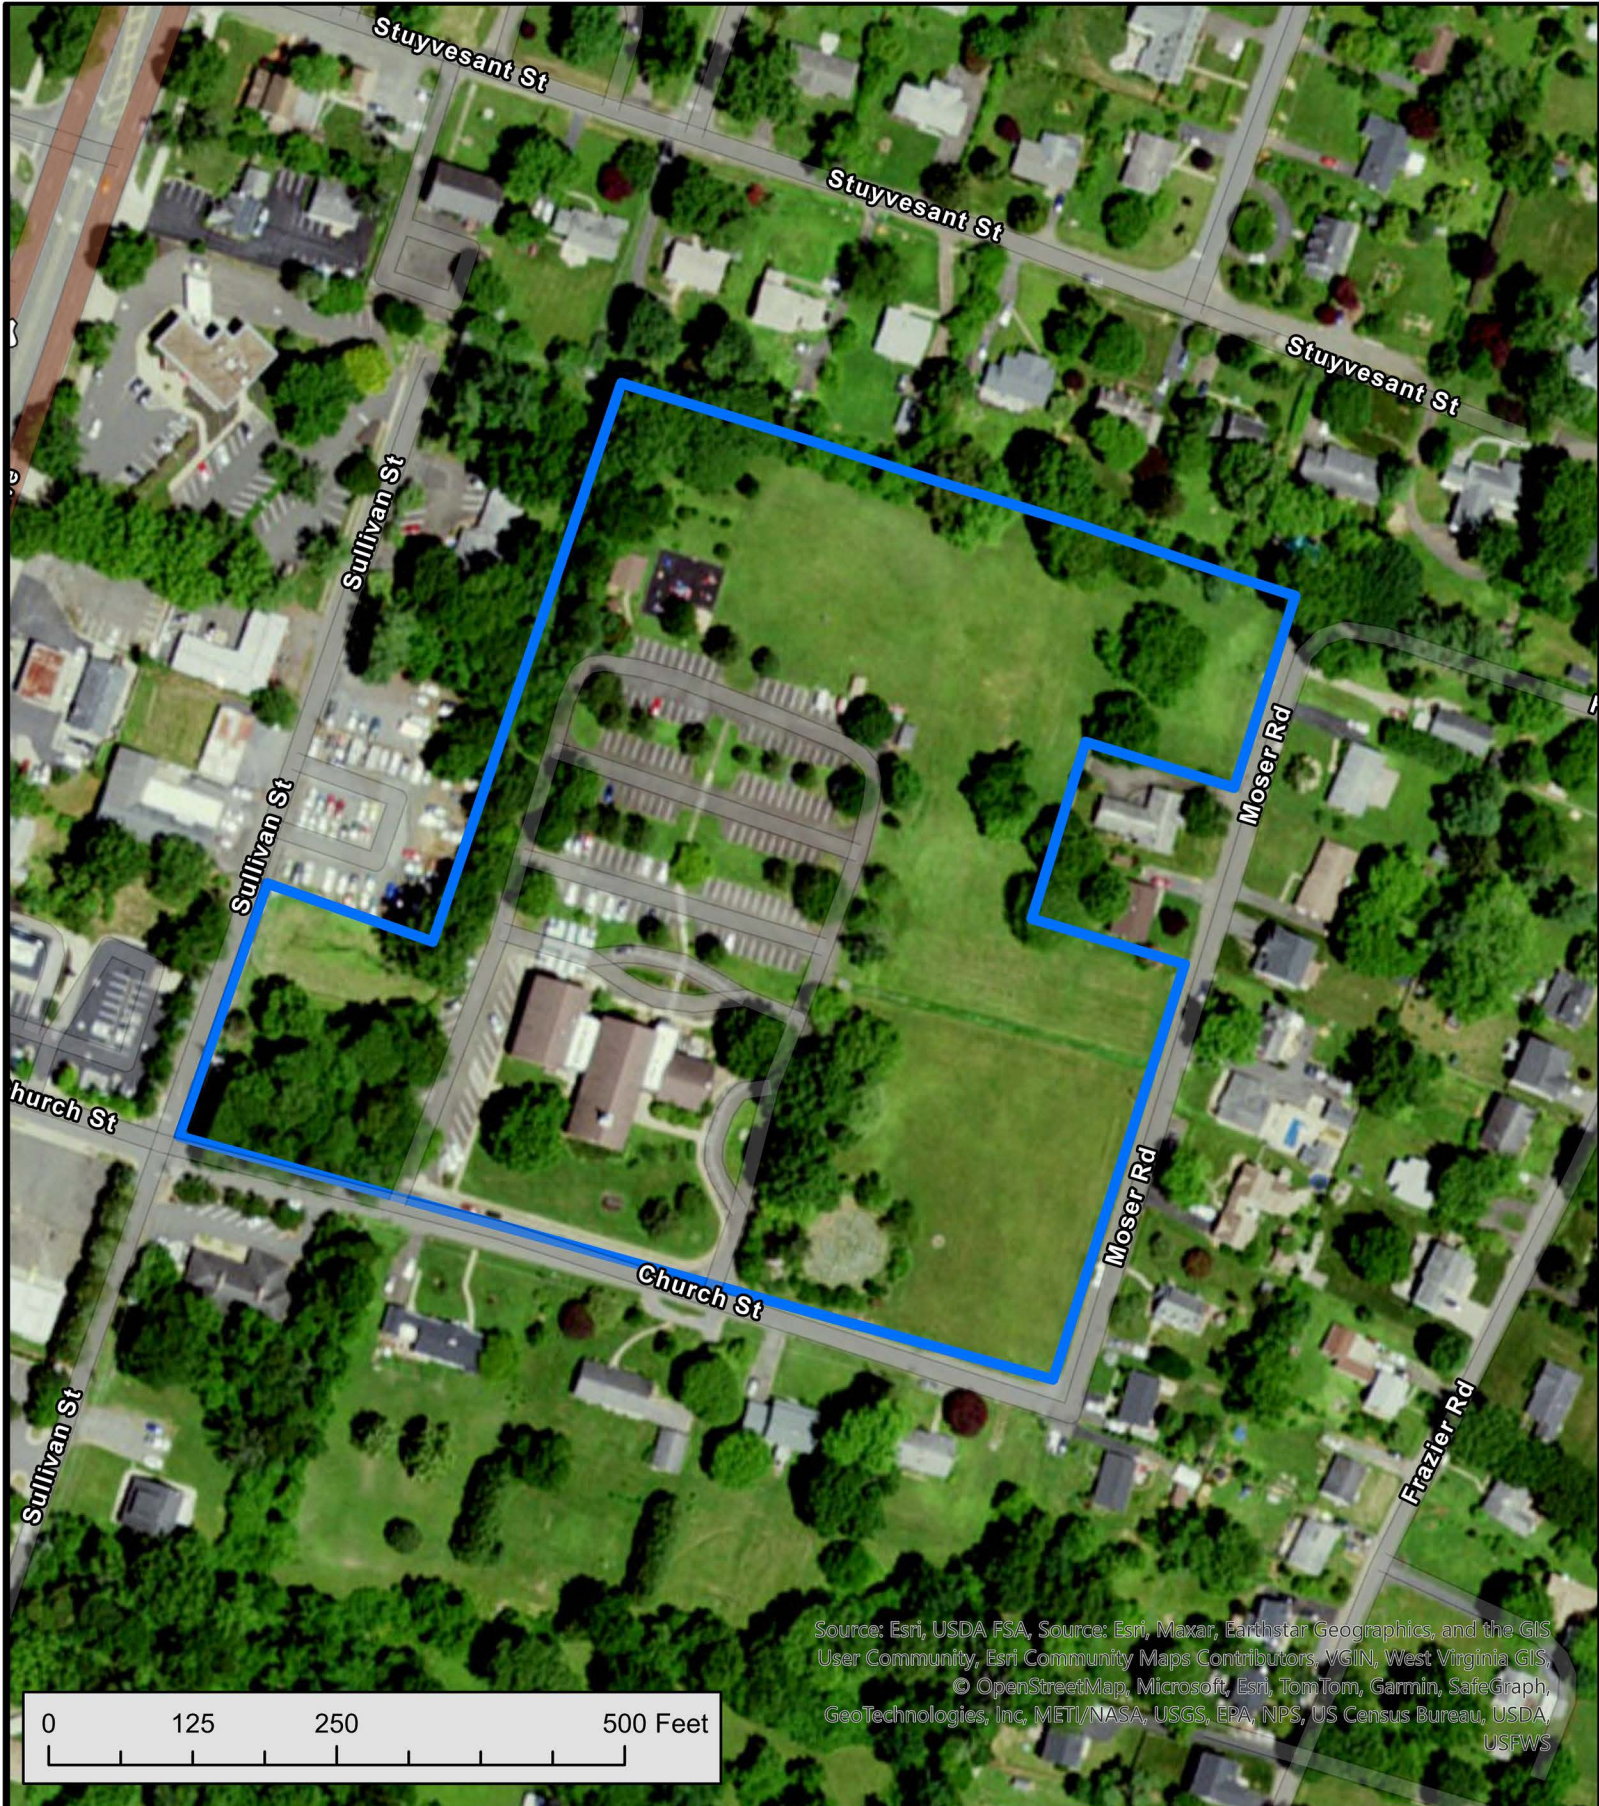
<p>Warrenton UMC Exhibit #2: USGS Topographic Map Warrenton, Virginia</p>	<p>Legend</p> <p> Study Area</p>
--	--	--	---

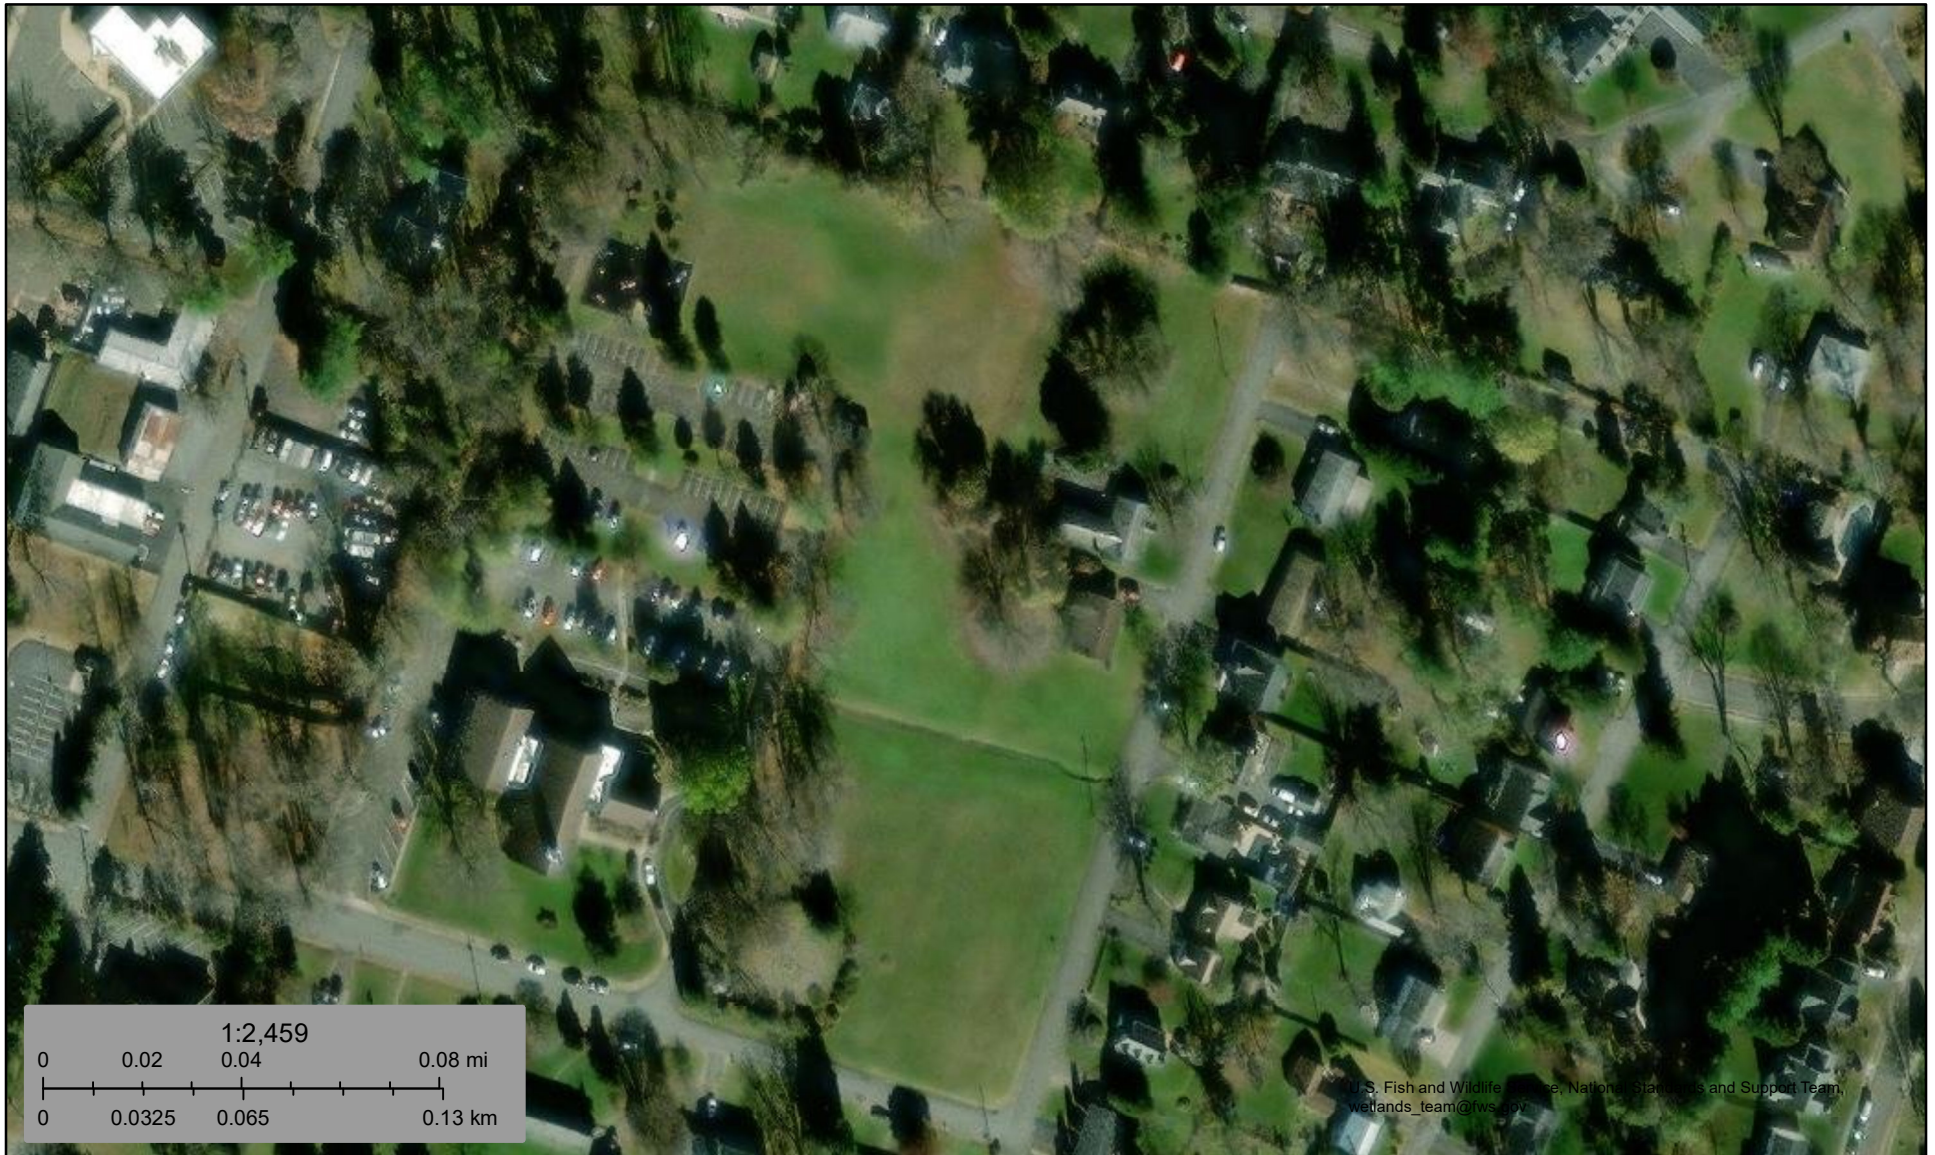
National Wetlands Inventory

Warrenton UMC

Prior to conducting field work, IA conducted database reviews to determine the existing documented resources within the study area. The U.S. Fish and Wildlife Service (USFWS) National Wetland Inventory (NWI) database ([Exhibit 4](#)) was reviewed to determine if any wetland or stream features have been documented within the study area. As noted in this exhibit, no wetland or stream features have been documented on or within 100-feet of the study area.

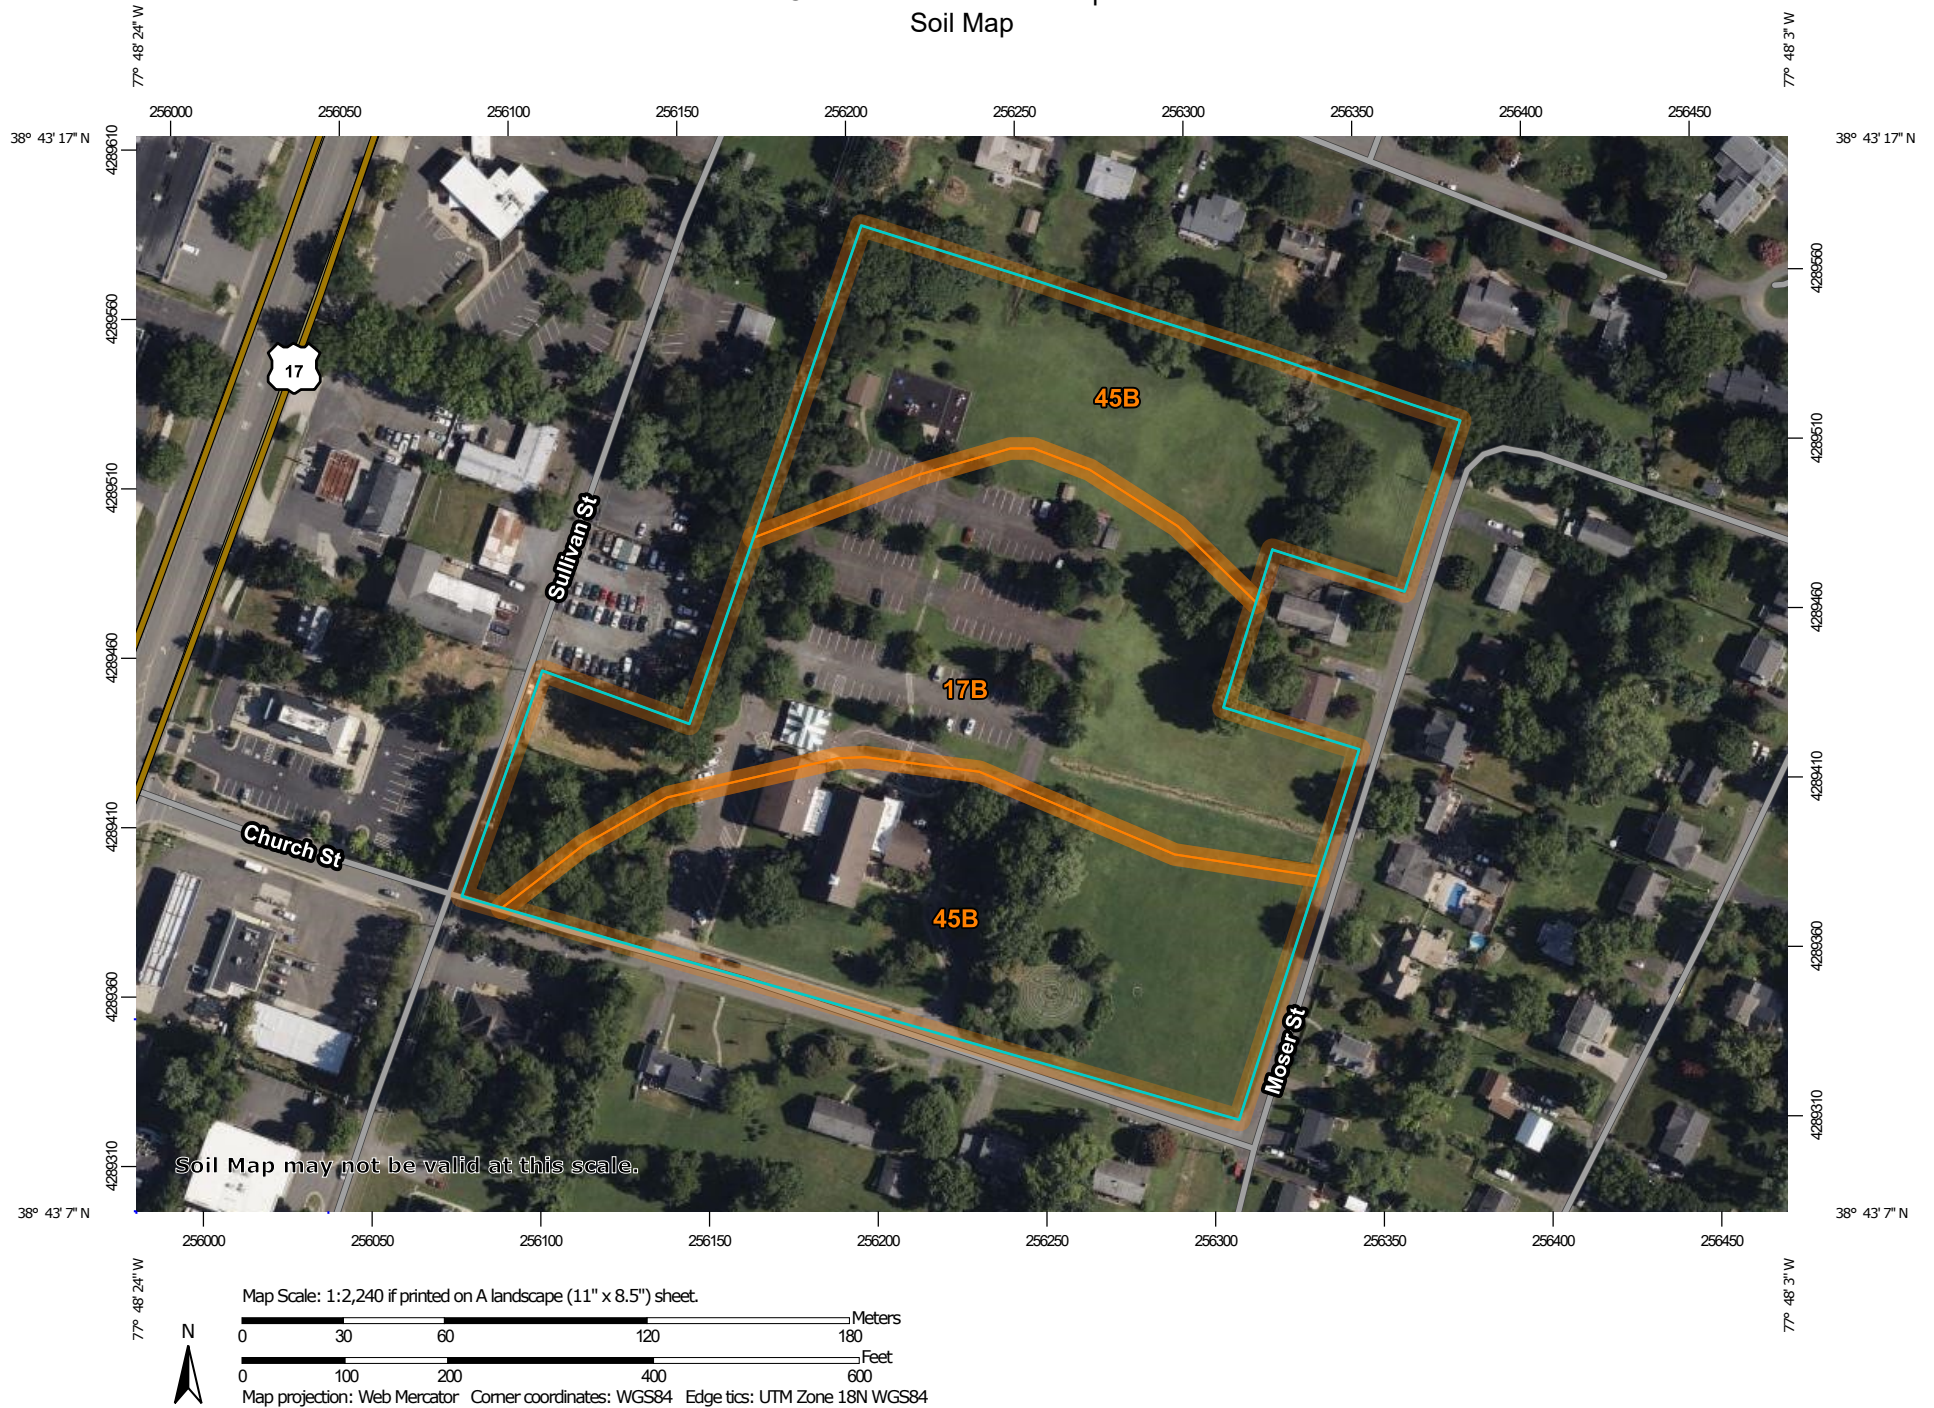
Custom Soil Resource Report Soil Map

U.S. Department of Agriculture (USDA) Natural Resources Conservation Service (NRCS) ([Exhibit 5](#)) data was reviewed to determine the soil characteristics within the study area. The central portion of the Area of Interest (AOI) developed on the NRCS database is mapped as Middleburg loam (17B), a mapped hydric soil. The remaining soils mapped within the NRCS AOI are mapped as nonhydric.

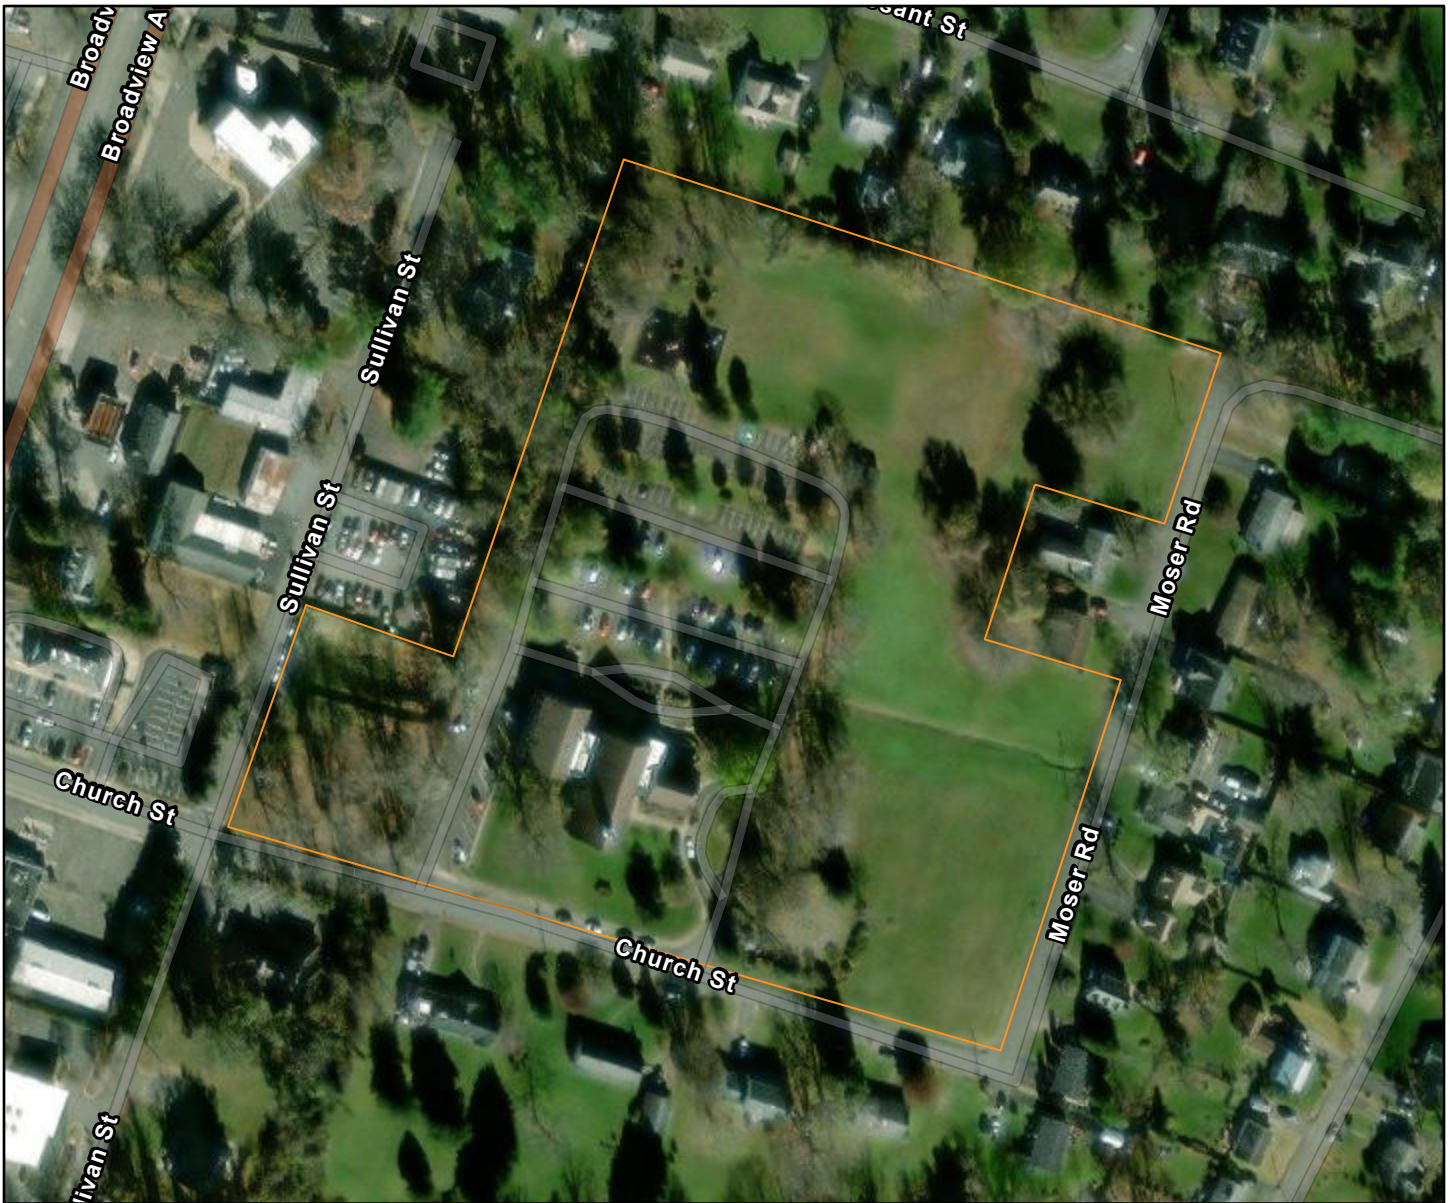
WetCat Report

April 19, 2024 - Created from the Wetland Condition Assessment Tool Viewer (WetCAT)

- Study Area
- Virginia-APNEP Boundary Combined
- Hydrologic Units (12-digit)

In preparation for field work, the Virginia Department of Environmental Quality (DEQ) Wetland Condition Assessment Tool (WetCAT) database ([Exhibit 7](#)) was reviewed for documented features and watershed data surrounding the study area. No stream or wetland features have been mapped within the study area by DEQ.

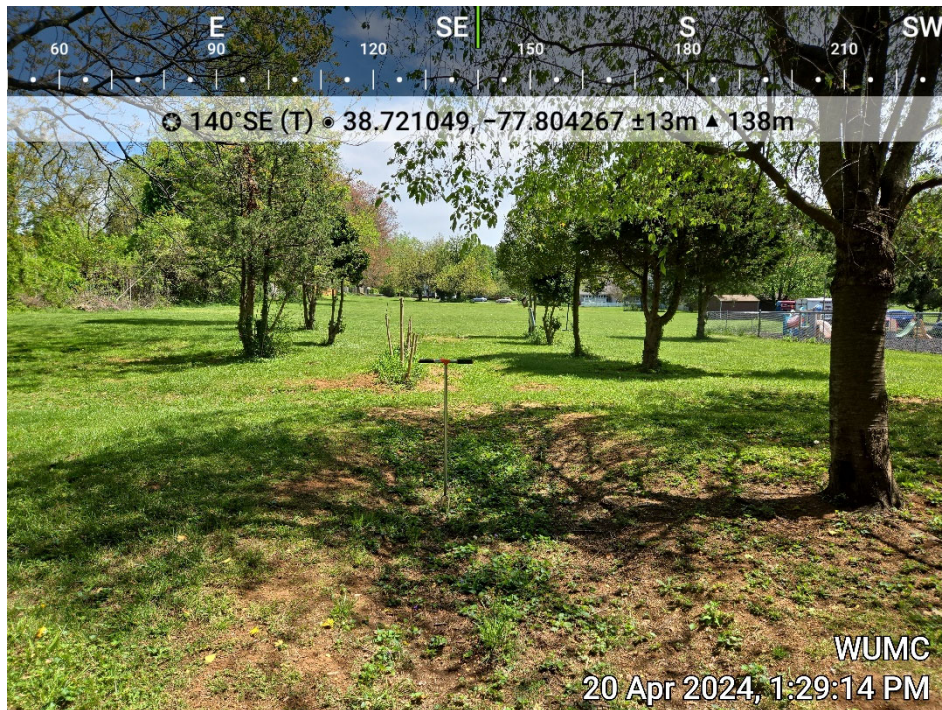
1. Looking southeast at the upland swale located in the northwestern corner of the study area. No state waters or Waters of the U.S. (WOTUS) are located in this portion of the study area.

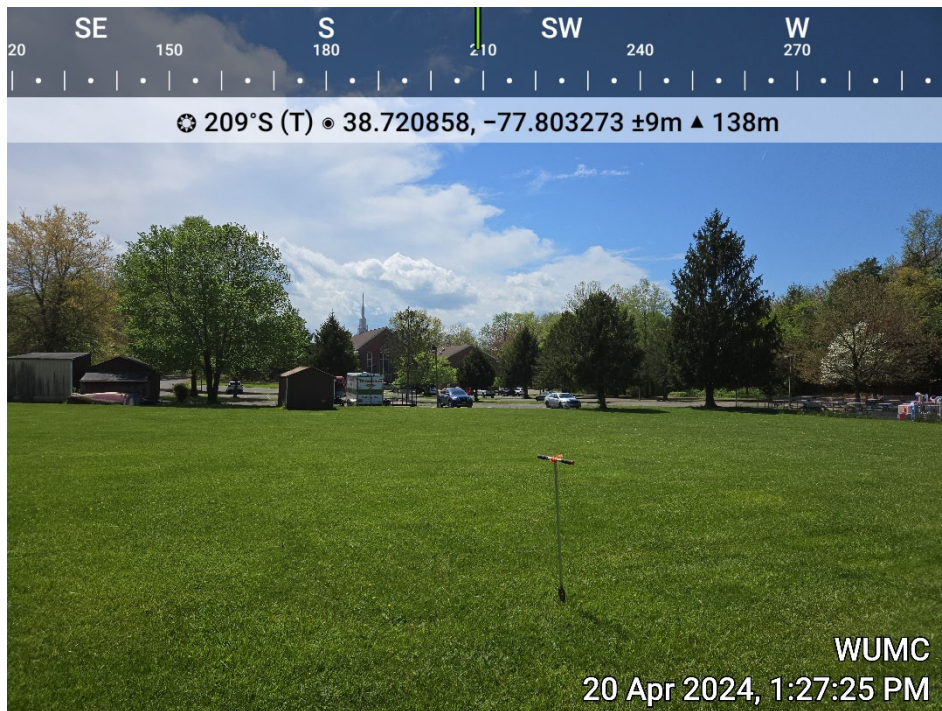
2. Looking south at the maintained lawn located in the northern portion of the study area. No state waters or WOTUS are located in this portion of the study area.

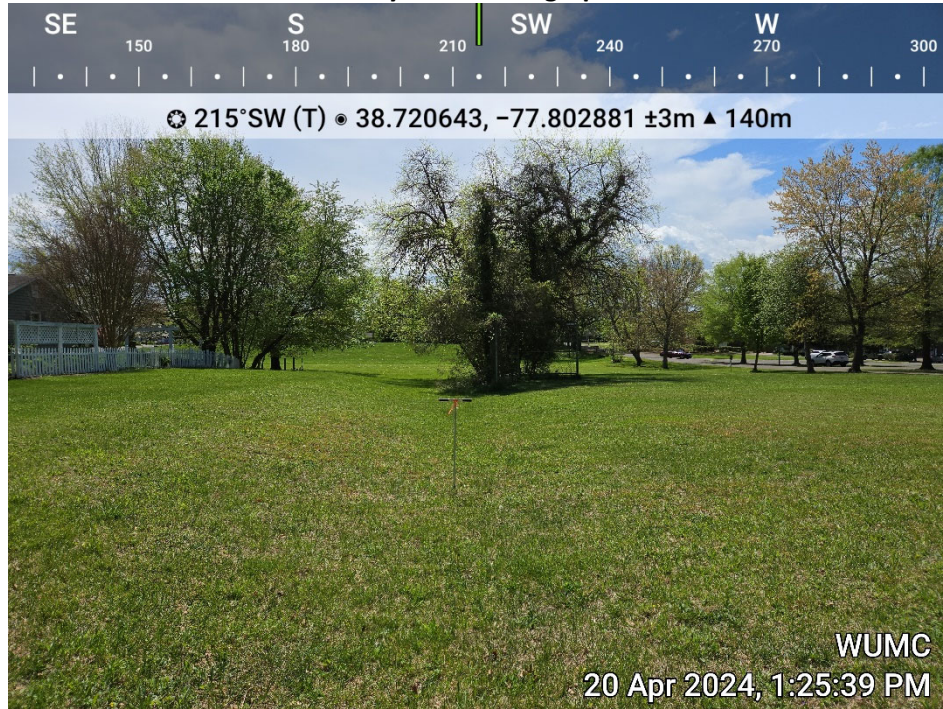
3. Looking south at the swale located in the northeastern corner of the study area. No state waters or WOTUS are located in this portion of the study area.

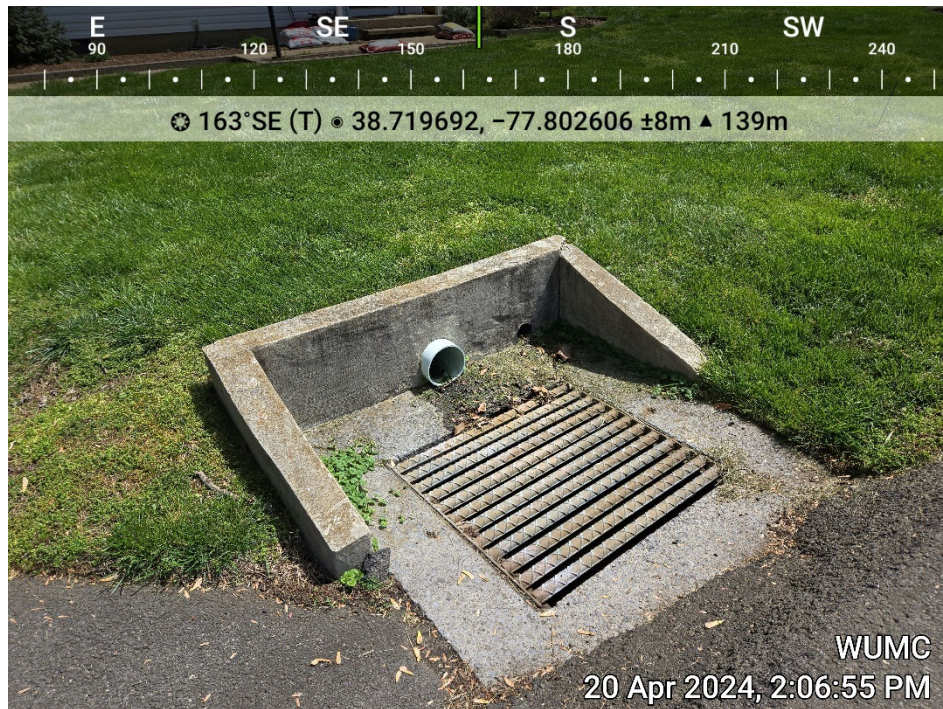
4. Looking at the yard inlet located to the east, upslope, of the stormwater swale located in the eastern portion of the study area. This inlet conveys stormwater flow along Moser Road and connected to underground stormwater pipes and outfalls west of Moser Road.

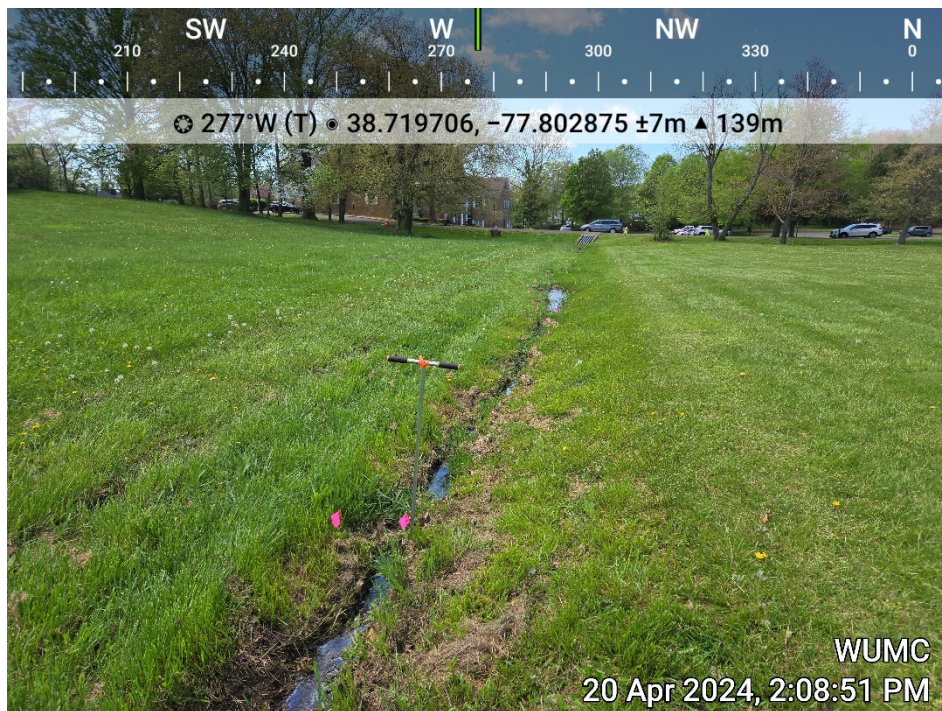
- Feature S-1: This feature is located in the eastern portion of the study area and is located within a manmade stormwater swale constructed during the development of the property (Exhibit #9, Photos 5-8). This feature exhibits a discontinuous ordinary

high-water mark (OHWM) and was identified as a stream channel utilizing the DEQ Stream Identification Field Data Form. An assessment utilizing the Fairfax County DPWES and NCDWQ protocols identified the stream as intermittent, with scores of 9 and 16.5, respectively.

6. Looking west (downslope) at the stormwater swale (Feature S-1) located along the eastern portion of the study area. This portion of the stormwater swale exhibits a discontinuous OHWM; however, it has been classified as an intermittent stream channel.

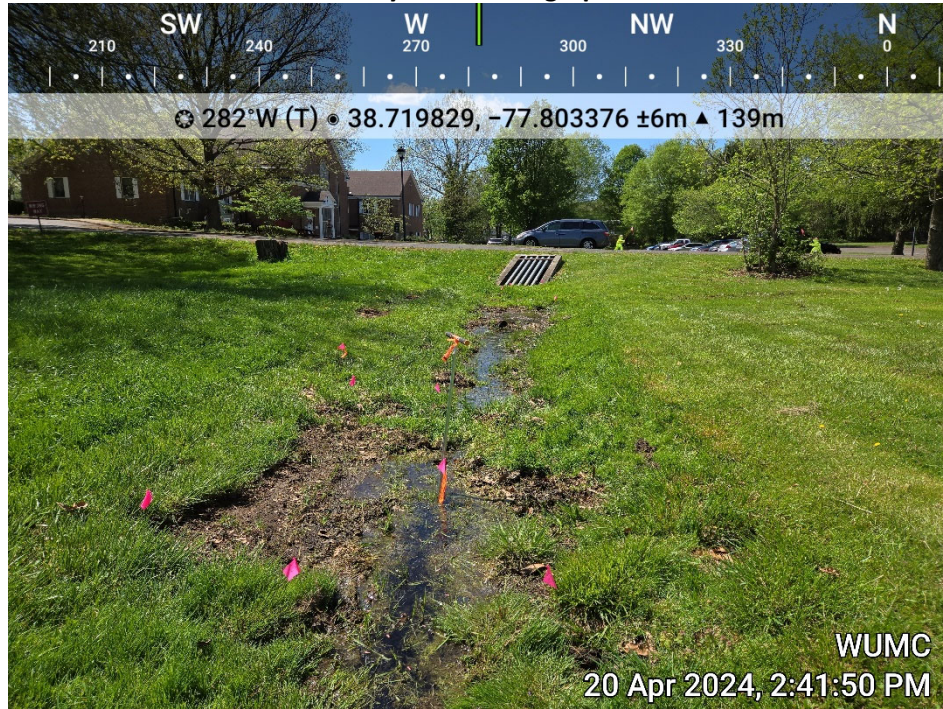
A wetland delineation data point (Exhibit #10, Data Point #1) was conducted to document the conditions at the downslope end of this feature where an OHWM is absent. As noted within this data point, hydric soil and wetland hydrology parameters were satisfied at this location. However, the feature lacks hydrophytic vegetation. Therefore, this feature was classified as an intermittent (R4) stream channel.

7. Looking west (downslope) at Data Point #1 located within the stormwater swale (Feature S-1) located in the eastern portion of the study area. Wetland hydrology and hydric soil indicators are satisfied; however, hydrophytic vegetation is not present within this swale. A continuous OHWM is lacking in this portion of this feature. However, this feature has been classified as an intermittent stream channel due to the upslope characteristics.

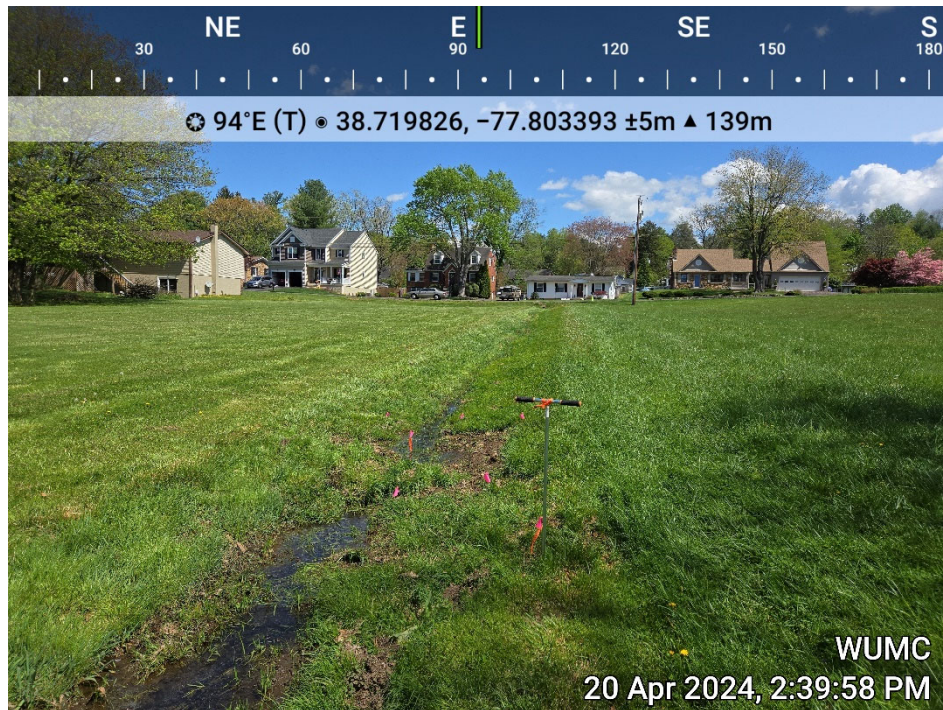
8. Looking east (upslope) at Data Point #2 located adjacent to the stormwater swale located in the eastern portion of the study area. The hydric soil indicator is satisfied at this location; however, wetland hydrology and hydrophytic vegetation is not present within this swale.

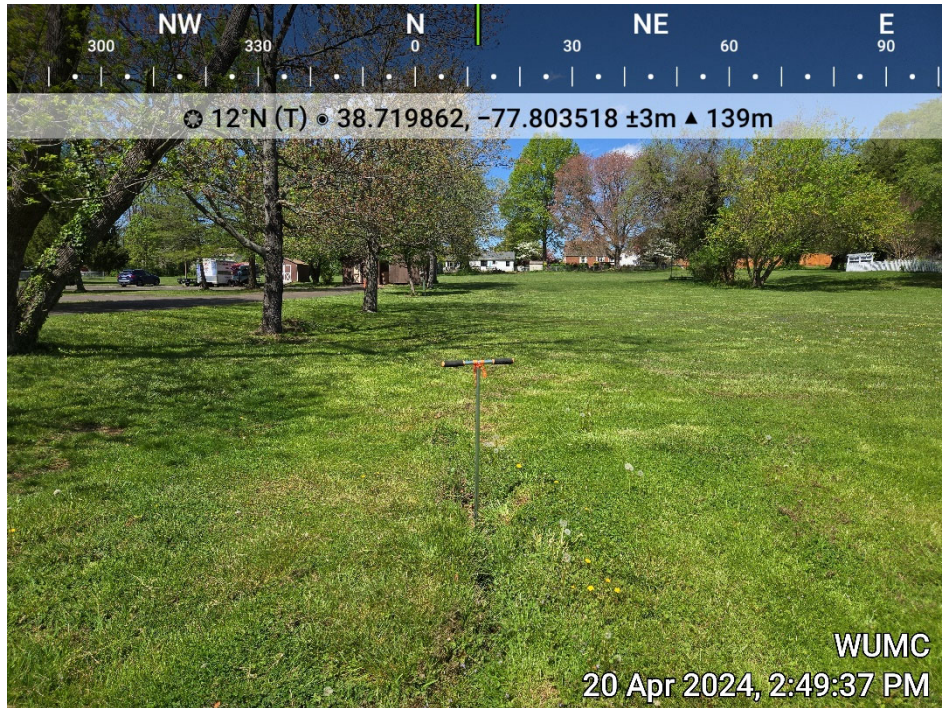
9. Looking north at the upland swale located in the central portion of the study area. Hydric soils and an ordinary high water mark (OHWM) are absent. No state waters or other WOTUS are located in this portion of the study area.

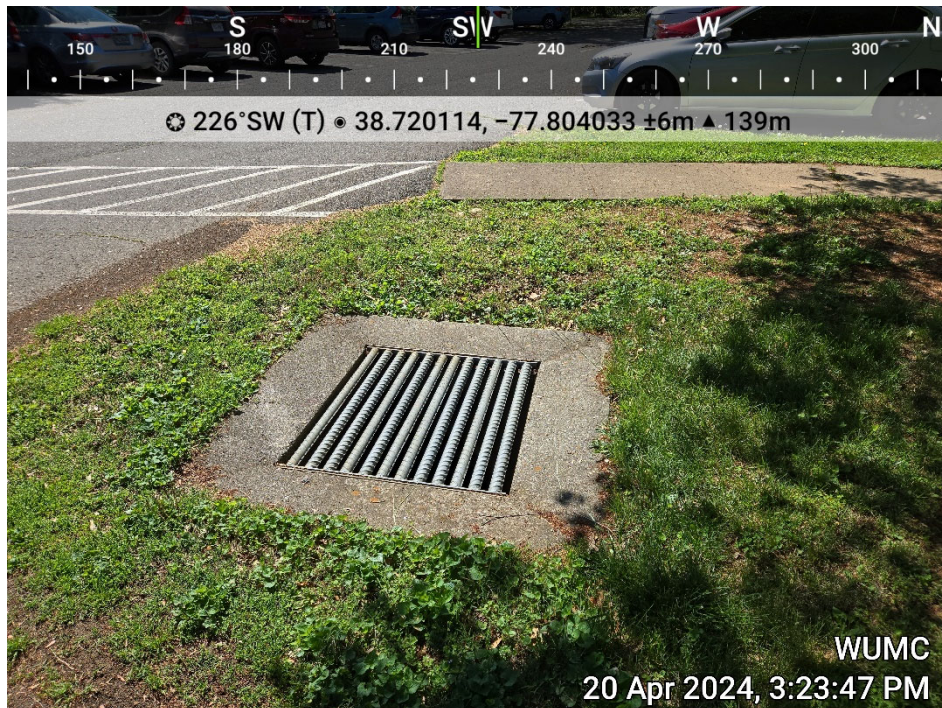
10. Looking at a yard inlet located within the parking lot in the central portion of the study area.

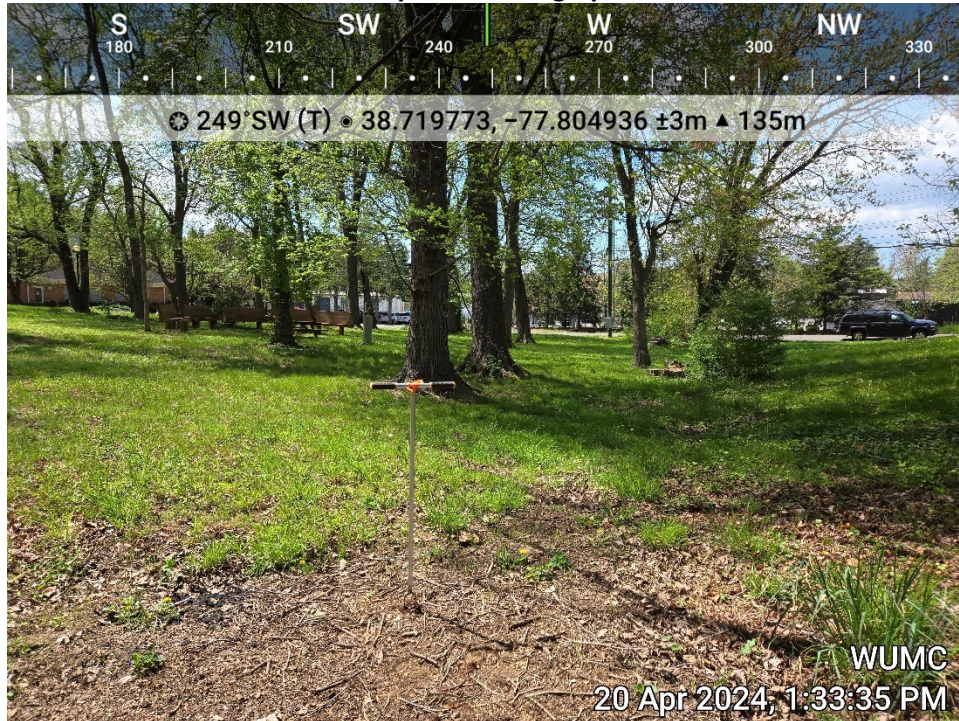
11. Looking southwest at the swale located in the southwestern portion of the study area. No state waters or WOTUS are located in this portion of the study area.

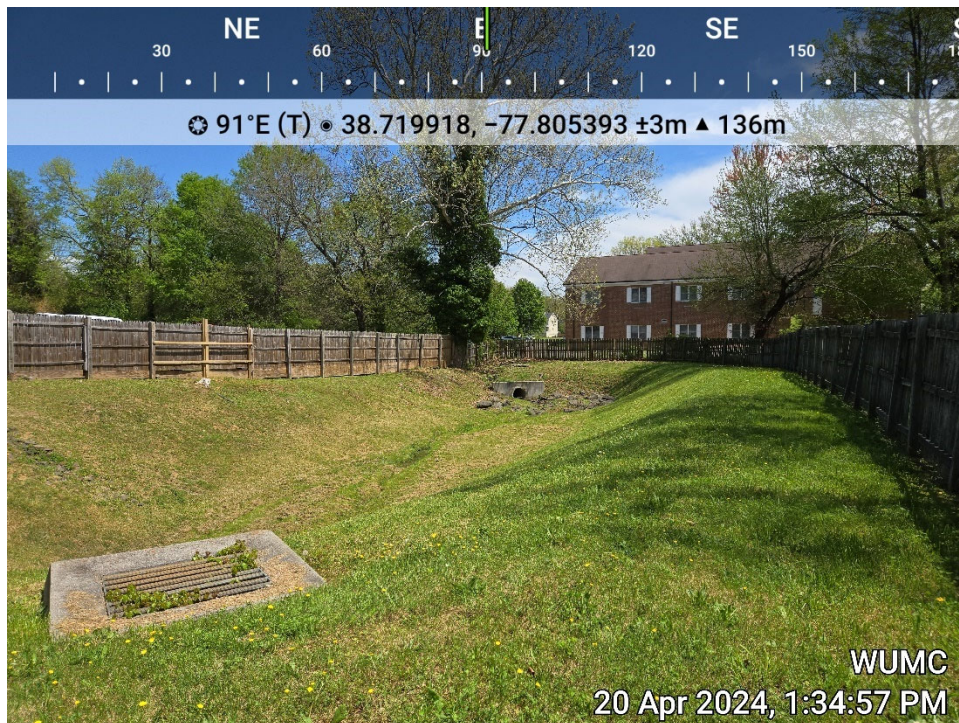
- Feature S-2: This feature, located within a stormwater retention basin, was determined to be an R4 stream channel. Due to obstruction by a security fence, the approximate limit of the stream channel within the retention basin is depicted on the Wetland and WOTUS Delineation Map (Exhibit #12).

12. Looking east at the stormwater swale (Feature S-2) located within a constructed stormwater retention feature located at the western portion of the study area. A continuous ordinary high water mark and hydrophytic vegetation are not present within this feature. No wetlands or WOTUS are located within this portion of the study area.

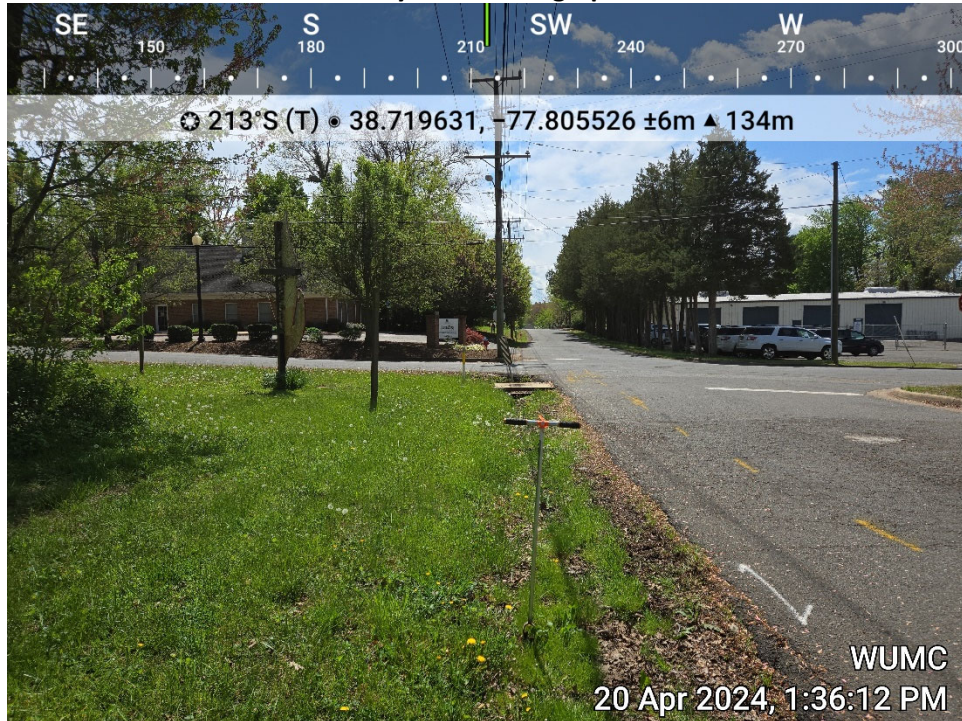
Several upland swales are located within and immediately adjacent to the study area. These topographic features lack hydric soils and a continuous OHWM. These features are noted on the Wetland and WOTUS Delineation Map and shown in the Study Area Photographs (Exhibit 9).

13. Looking south at the upland swale located along Sullivan Street. No OHWM or wetland indicators are present within this swale. No state waters or other WOTUS are located in this portion of the study area.

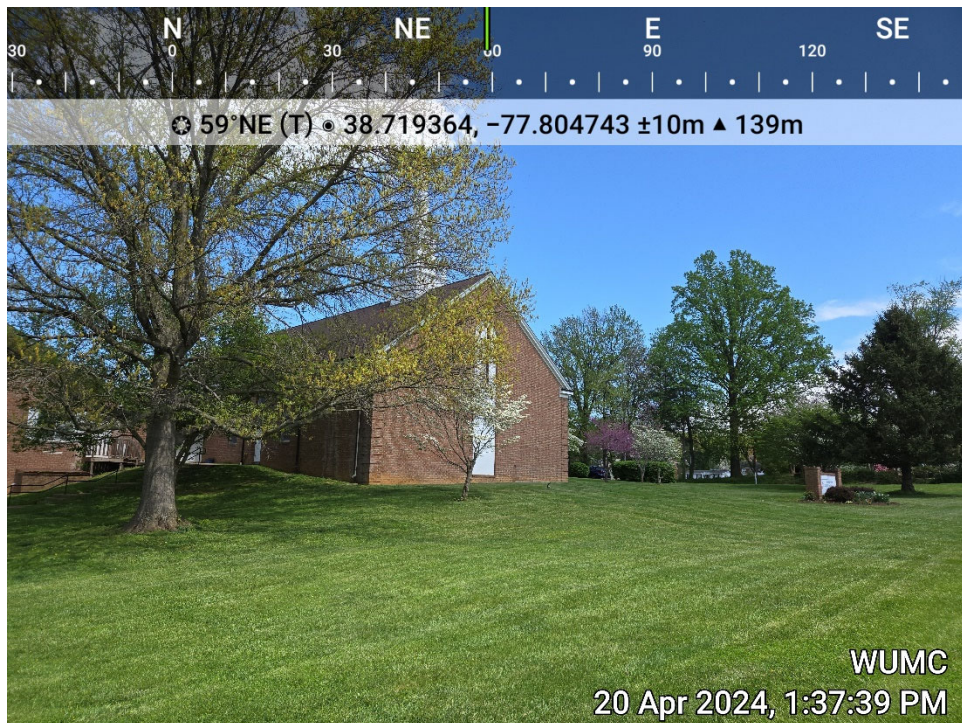
14. Looking northeast at the Church located within the southern portion of the study area. No state waters or other WOTUS are located in this portion of the study area.
