TOWN OF WARRENTON

MEMORANDUM

FROM: Public Safety and Transportation Committee
THROUGH: Brandie Schaeffer, Town Manager
FROM: Denise Harris, Planning Manager
DATE: August 8, 2019
SUBJECT: Waterloo/Chestnut Intersection Improvements

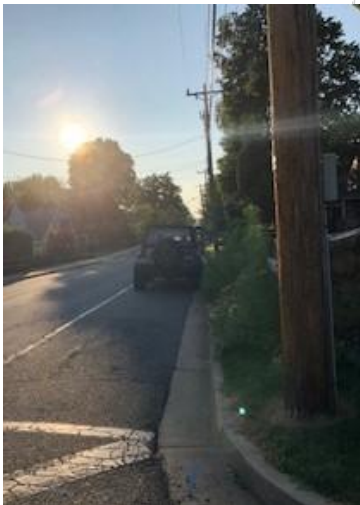
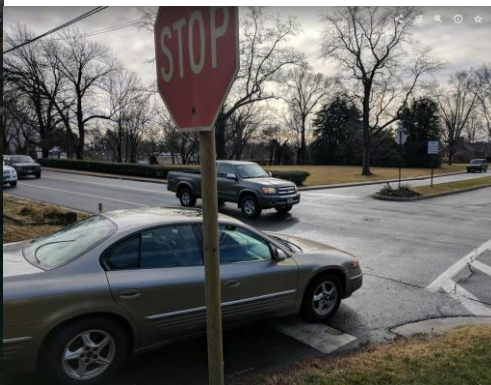
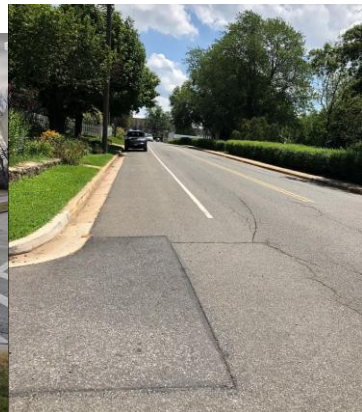
Concept 1 provides for a bulb out and increased site distance on N. Chestnut by pulling forward the stop bar while moving the on street parking back. It also introduces ADA ramps. It does not include any traffic calming on the travel lanes of Waterloo nor resolution to site distance issues on the west side of Waterloo. This option does not require right-of-way or utility easement modifications.

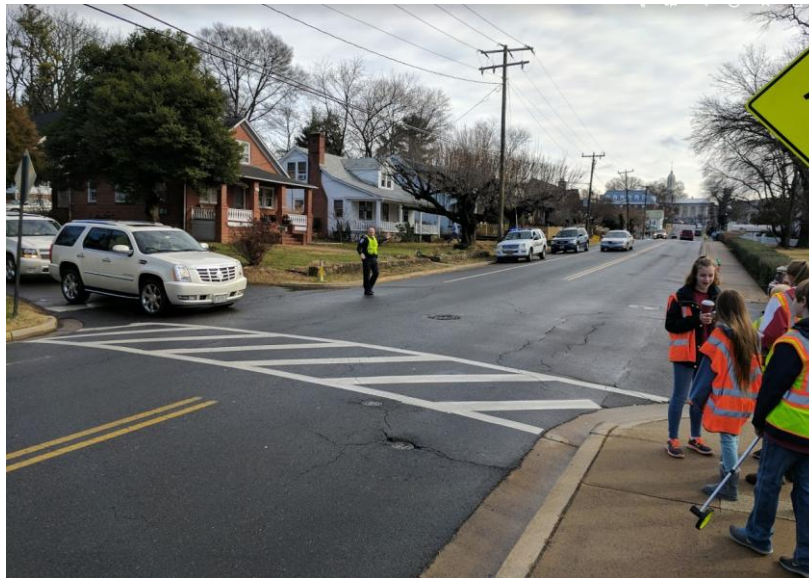
Concept 2 incorporates medians to provide pedestrian crossing refuge, as well as increases the sight lines for vehicles on N. Chestnut Street. However, this concept does not incorporate traffic calming techniques for vehicles on Waterloo heading east. Unlike Concepts 1 and 3 it can not be “built upon” with additional sidewalk improvements on Chestnut due to the lack of a bump out with ADA ramp compliance. Indeed, this Concept terminates the crosswalk as it does today into an unprotected area seen in the picture below.

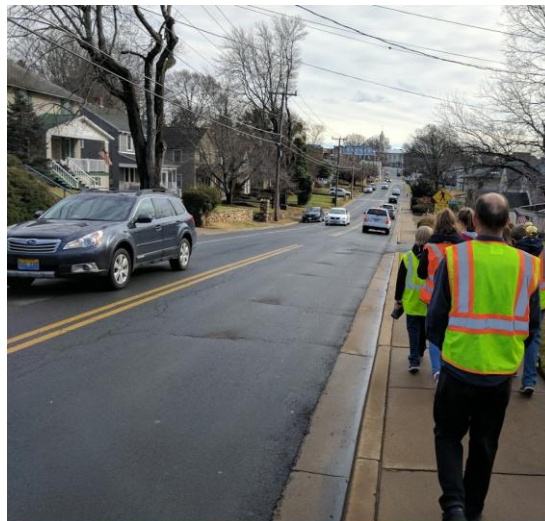
Concept 3 is the same intersection improvement as Concept 1; however, it takes a more comprehensive traffic calming approach on Waterloo. By introducing chicanes and alternating the on street parking, as recommended in the Walkability Audit, vehicles traveling on Waterloo are more likely to stay within the 25 mph speed limit. Speed is a factor on this stretch of road due to the long site lines. It is further exasperated by sunrises and sunsets that tend to blind drivers on Waterloo. This Concept also repeats the bump out improvements by introducing the treatment at Warrenton Blvd. Additional benefits for consideration are the introduction of greenscaping.

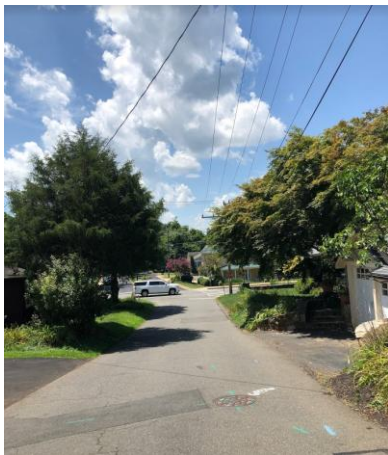
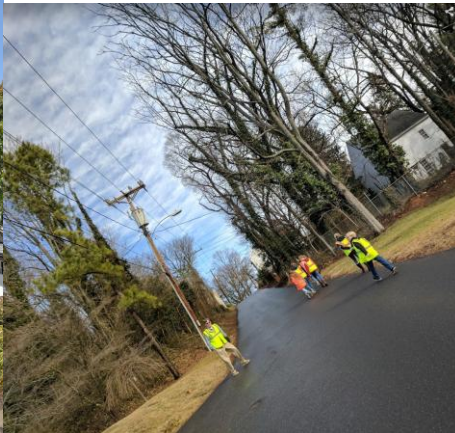
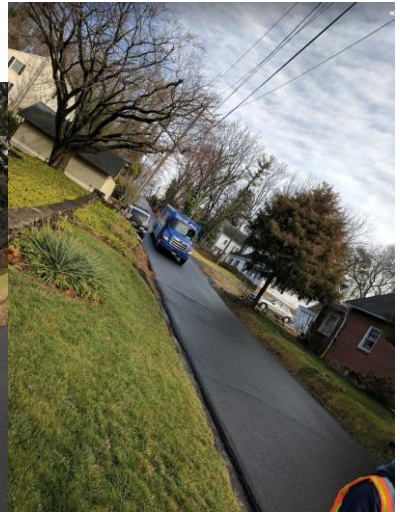
Concept 1 and 3 Addition

The benefit of the approach of Concepts 1 and 3 are they allow for a future sidewalk to be installed on N. Chestnut Street without additional right-of-way or utility relocations. If the Waterloo crosswalk was moved to the east side of the intersection, there would be the need to engage in these additional costs.

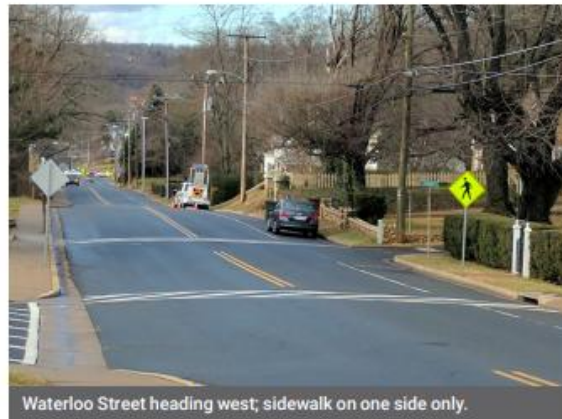
Waterloo Street heading west; sidewalk on one side only.

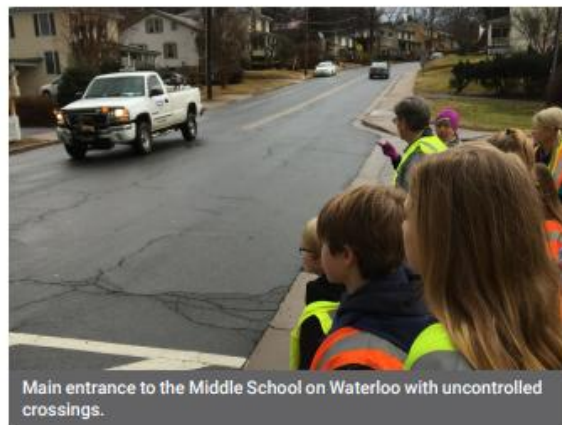
Main entrance to the Middle School on Waterloo with uncontrolled crossings.

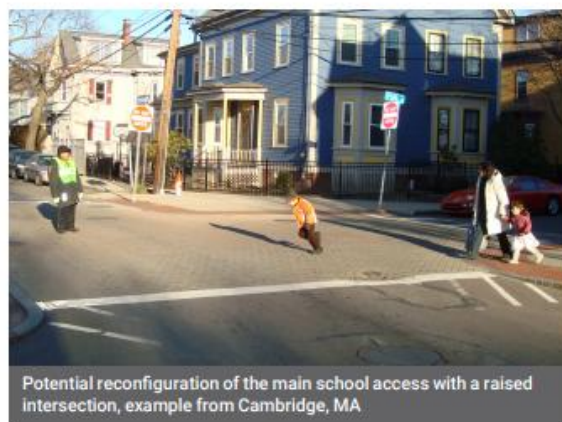
Potential reconfiguration of the main school access with a raised intersection, example from Cambridge, MA

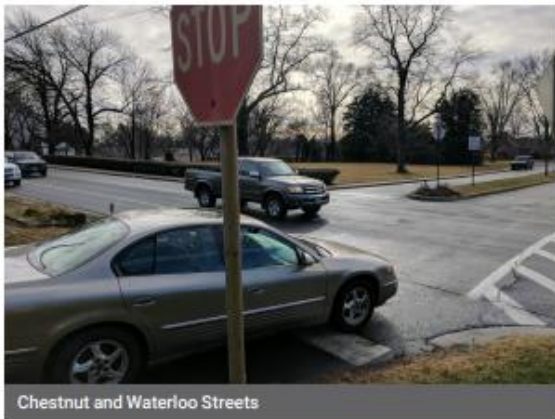
Chestnut and Waterloo Streets

The intersection of Chestnut Street with Waterloo provided a good example of common issues along the corridor. The slightly offset layout of the intersection – South Chestnut has a median divider that means traffic coming from South Chestnut Street onto Waterloo is not lined up opposite North Chestnut – creates enough ambiguity among both motorists and pedestrians (especially school students) that motor vehicle traffic tends to dominate proceedings even though there is a marked crosswalk on Waterloo. Drivers are watching for other cars as they turn out of S Chestnut, and may not see or have enough time to react to pedestrians crossing Waterloo in the crosswalk.

several stories of cars being hit in that intersection and even shared pictures of recent crashes. This intersection is a key link between the neighborhoods on Winchester Street and Waterloo Street, and serves as a popular walking route for students and residents accessing the schools and businesses on Waterloo Street. This walking pattern will increase if the County chooses to relocate the Warrenton Branch Library to this intersection.

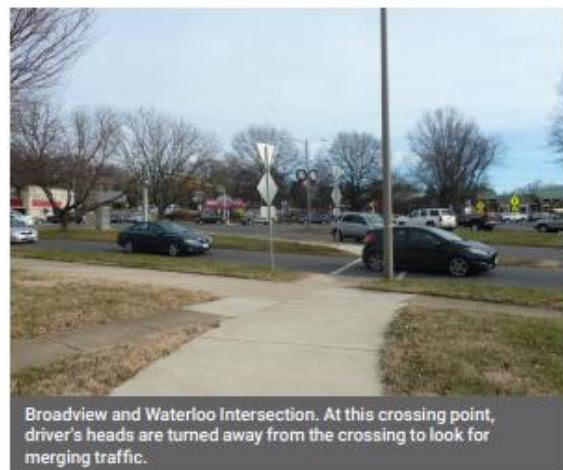
Broadview and Waterloo Intersection. At this crossing point, driver's heads are turned away from the crossing to look for merging traffic.

During the walk audit, the study team spent time observing the free-flow right turn lane on the northwest corner of the Broadview/Waterloo intersection. As it is currently designed, there are two locations for pedestrians to cross the right turn lane, one at each end of the slip lane.

While this configuration provides pedestrians with direct routes to the sidewalks in both directions, audit participants were struck by the fact that almost every driver turned their head to check for merging traffic as they reached the second crossing point (closest to Frost Road). Thus, at the critical moment when they should be checking to see if there are pedestrians approaching the crosswalk, their heads are turned in the opposite direction.

When there is oncoming traffic, drivers keep their heads turned over their left shoulders until they see a gap, and often proceed through the intersection without looking directly ahead or back to the right. If drivers do not see any oncoming traffic, they will accelerate through the crosswalk. A better design would have a single marked crosswalk located closer to the midpoint of the turn lane, well before the point where most drivers turn their heads to look back over their shoulders while maintaining the principle that pedestrians will cross at the shortest point. This would have not have been obvious without observing driver behavior as part of the walking audit.

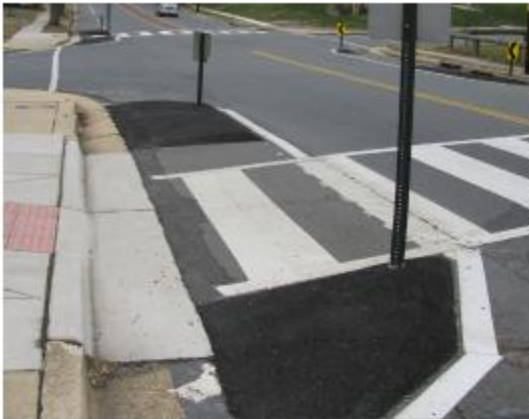
Temporary bulb-outs at an intersection in Alexandria, VA

1. Install bulb-outs (C.6.) on Waterloo Road at N. Chestnut Street to daylight the intersection for pedestrians and provide pedestrians a visible place to wait to cross the Waterloo Road. Consider adding bulb-outs to S. Chestnut Street at Waterloo Road to reduce crossing distance for pedestrians.
2. Switch parking lane from the north to south side of Waterloo Road from N. Chestnut to Garrett Street (except for the section in front of the middle school). This would provide a buffer to the sidewalk and create a modest chicane along the length of Waterloo Road to help reduce vehicle speeds.

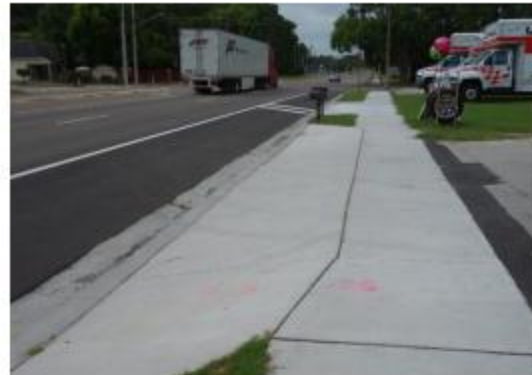
This section of new sidewalk on a major road in Jacksonville, FL maintains a level surface for the sidewalk and a more steeply sloping driveway apron for motor vehicle access.

3. Replace parking lane with new sidewalk (A.5.) between the existing marked crosswalks at the school entrance and Frazier Road; install Rectangular Rapid Flashing Beacon (RRFB) or Hawk Signal at one of the two crossings.

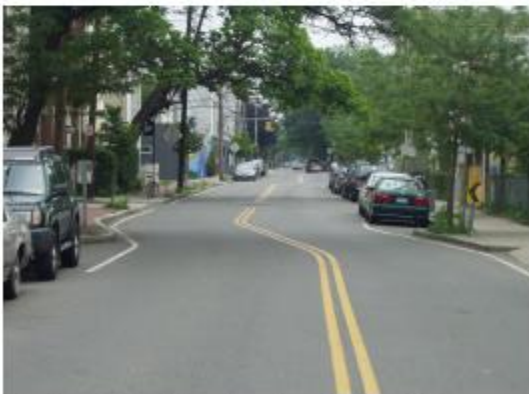
Creating a traffic calming chicane by switching parking to alternate sides.

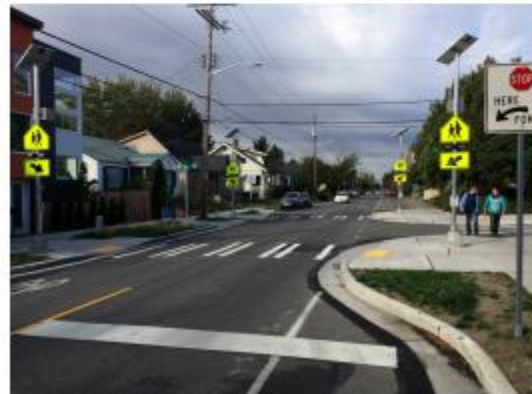
This Rectangular Rapid Flashing Beacon installation is at a school crossing on a busy neighborhood street in Seattle.
