WETLAND DELINEATION REPORT

600 & 700 Hoffmann Drive

Watertown, WI 53094

PROJECT #: 23-198

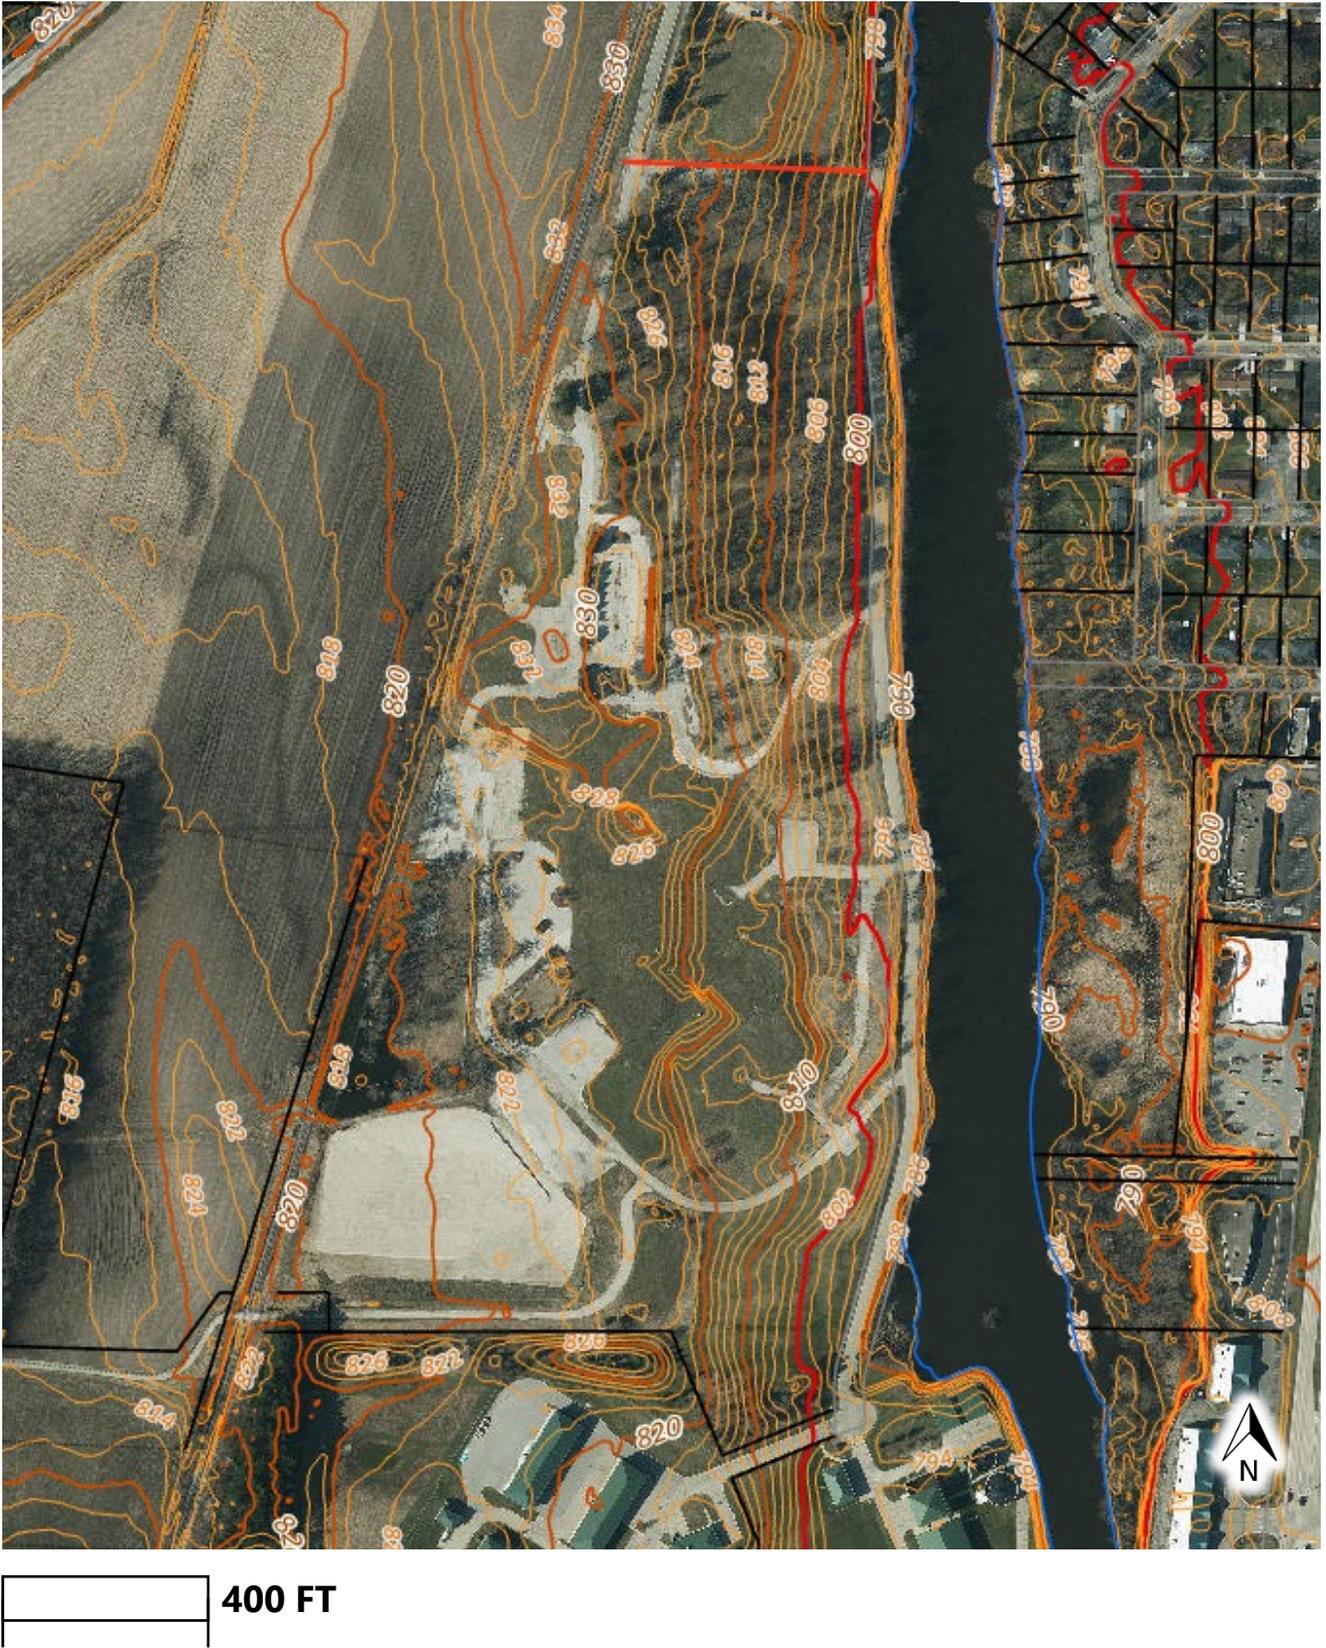
FIGURE 2. TOPOGRAPHIC MAP

The topographic map (**FIGURE 2**) shows that the property slopes towards the Rock River to the east. Elevations are at 830 feet above Mean Sea Level at its highest at the west end and 794 feet at its lowest on the east side. The slope is approximately 5% across the width of the property.

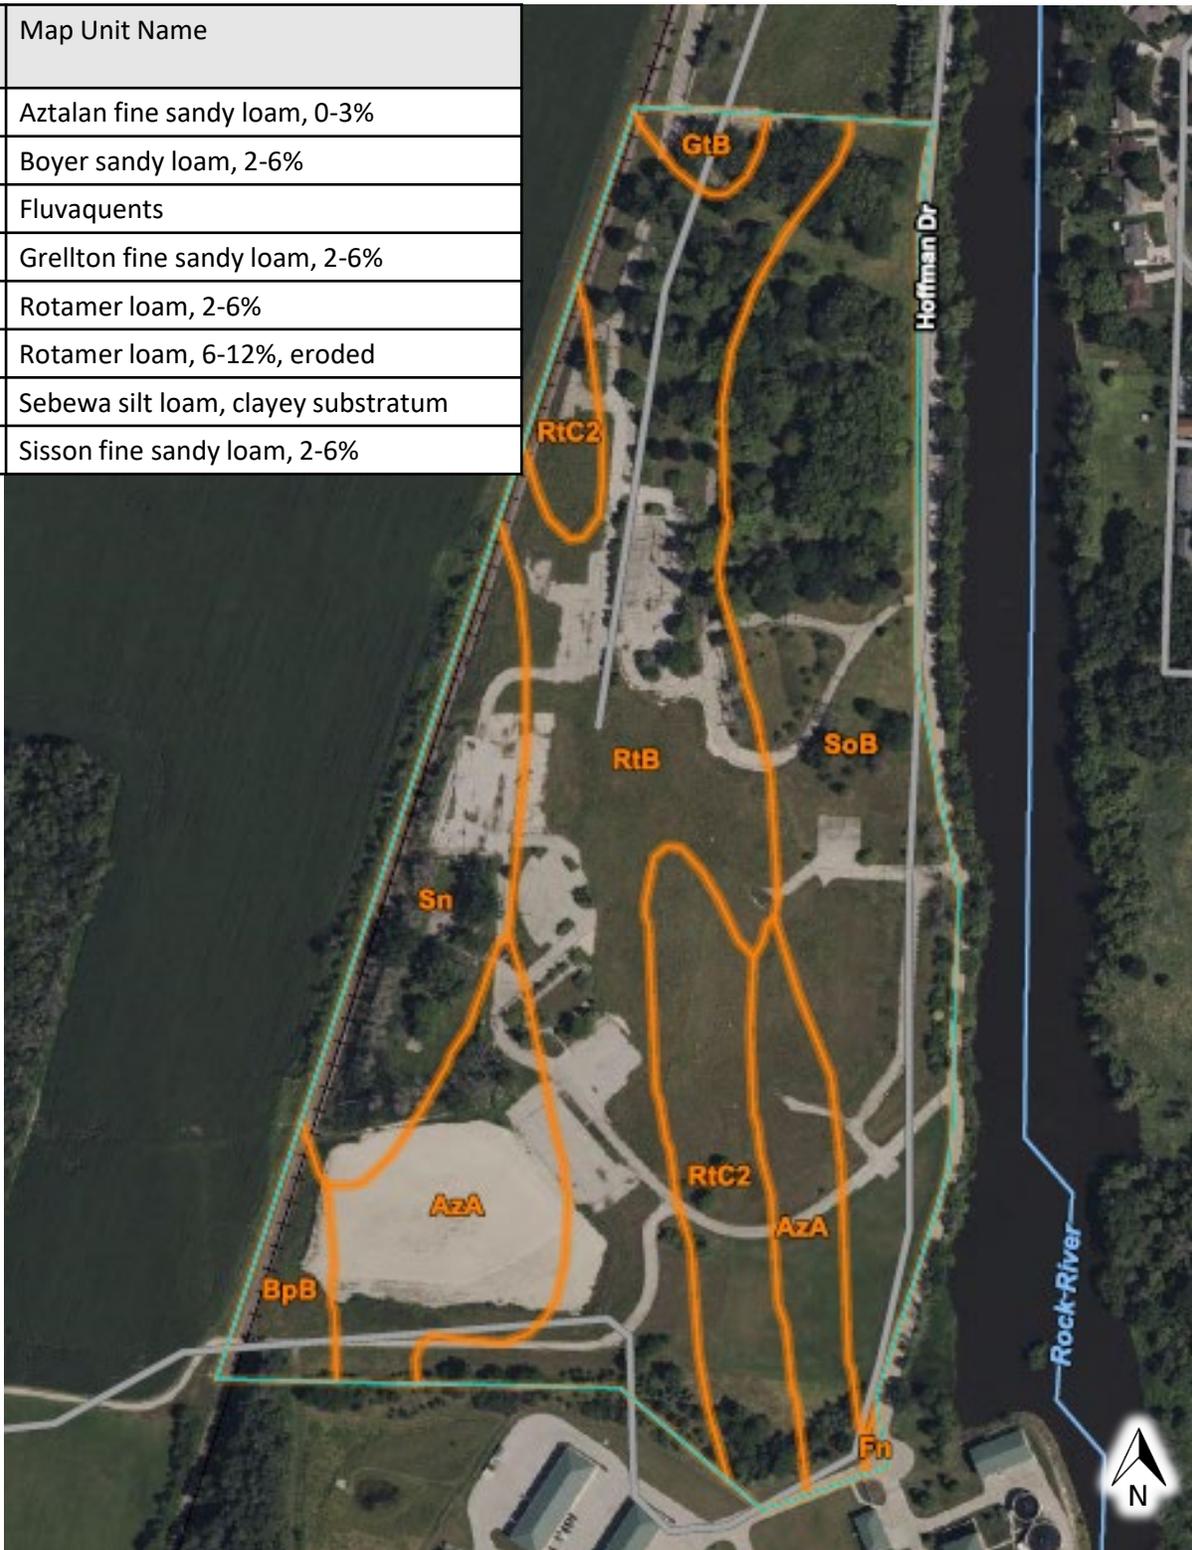
FIGURE 3. SOIL SURVEY MAP

The soil survey map shows an area of Sebewa silt loam, a hydric soil type, along the west boundary at the top of the hill. A very tiny area of Fluvaquents, another hydric soil type, is

located in the southeast corner near Hoffmann Drive (**FIGURE 3 & FIGURE 4**). The Aztalan fine sandy loam may include a small amount of hydric soil types in depressions. There are two areas of Aztalan fine sandy loam near the south side of the parcel. All of the soil types occurring on the property are listed in **Table 2**.

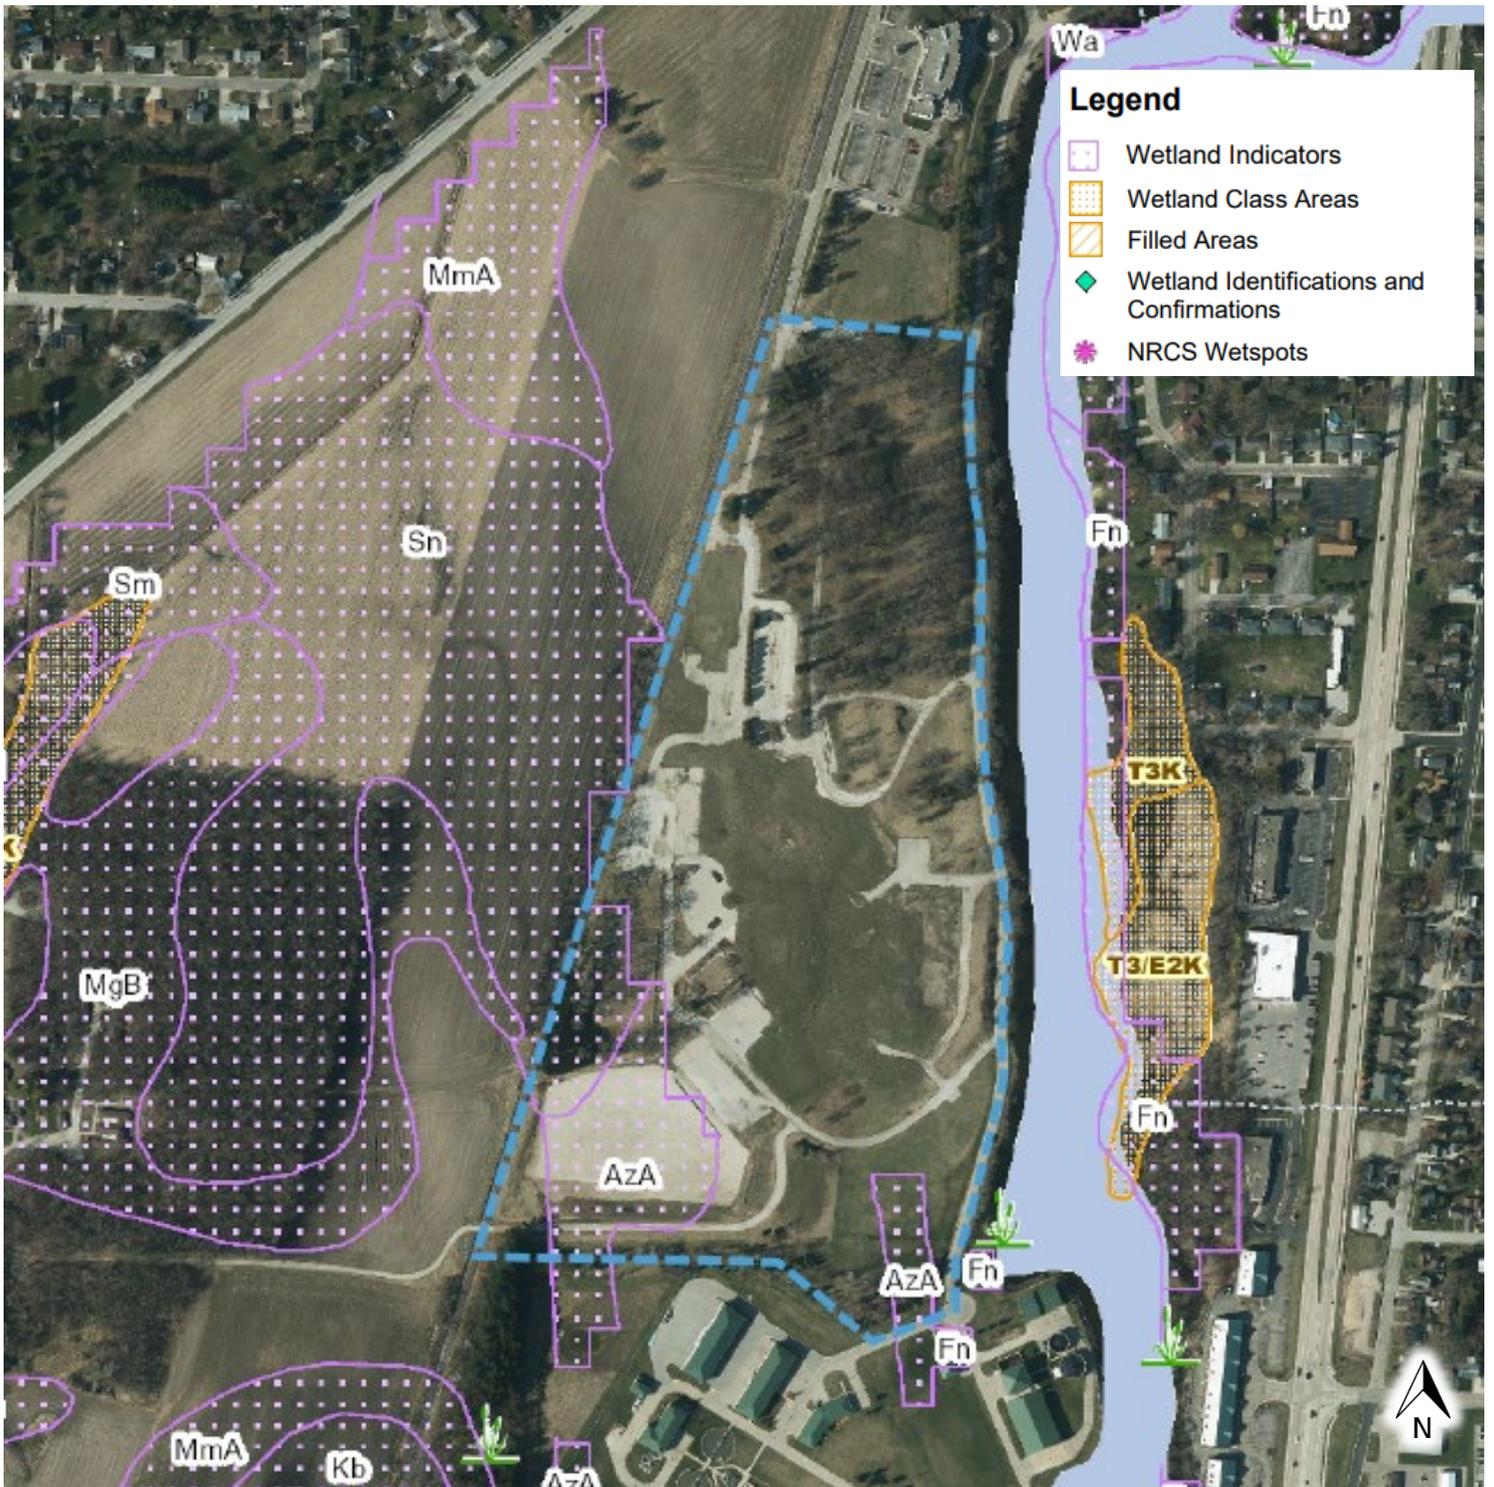
FIGURE 5. WWI MAP

The Wisconsin Wetland Inventory does not identify any wetlands within the project area (**FIGURE 5**). However, purple wetland indicator soils are shown in the areas of Sebewa and Aztalan soils; therefore, a wetland delineation was necessary.

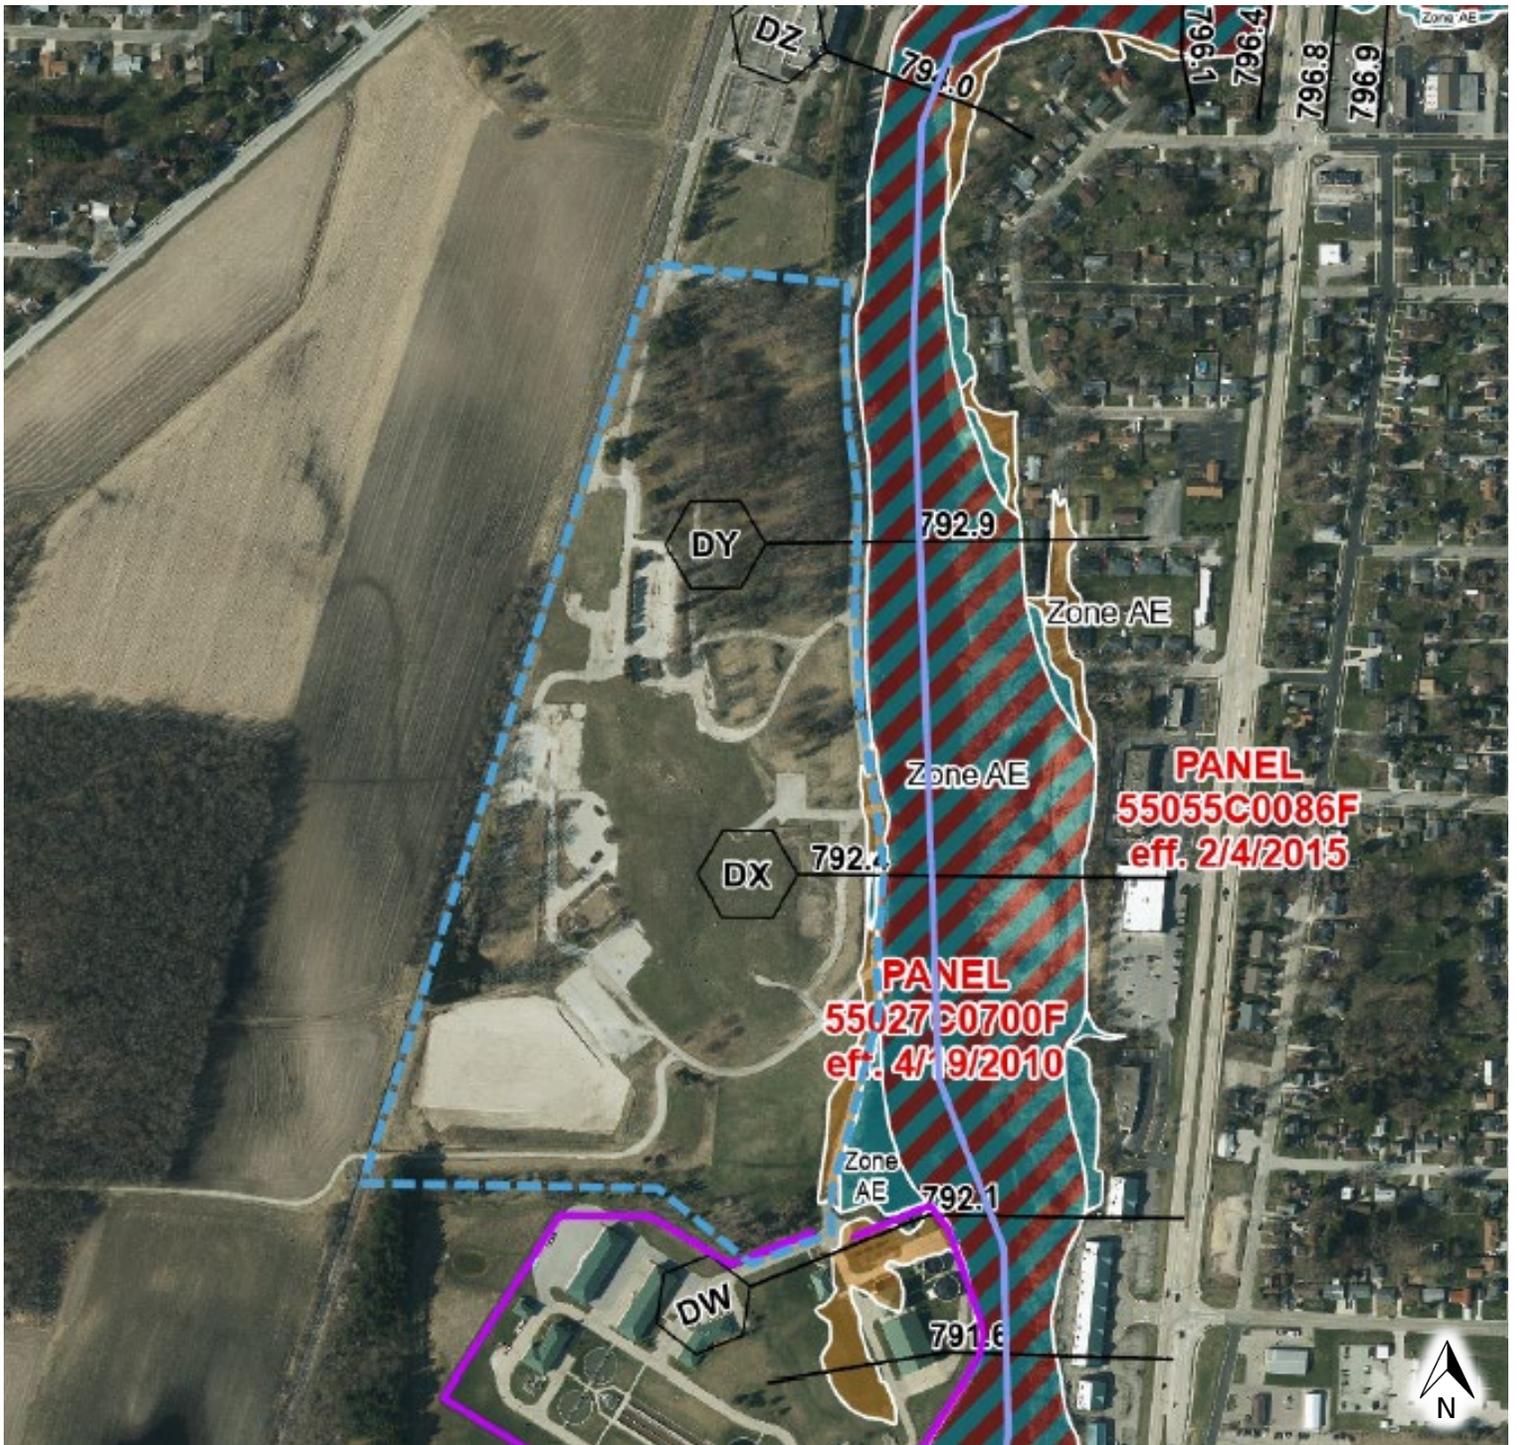
FIGURE 6. FLOODPLAIN MAP

The floodplain FEMA map (**FIGURE 6**) shows that a small amount of the 500-year floodplain crosses Hoffmann Drive and onto the eastern edge of the property. Most of the property is outside of the floodplain boundary.

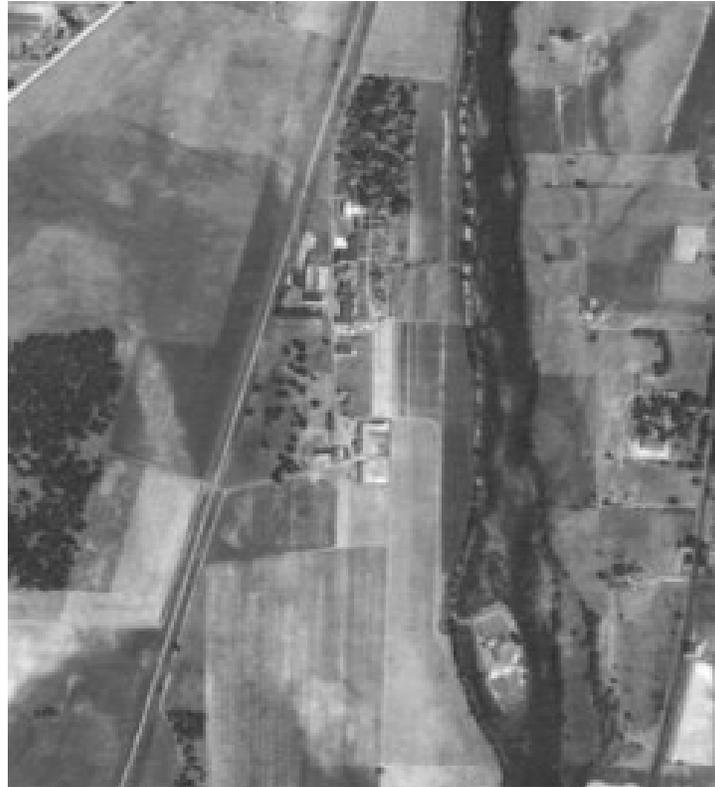
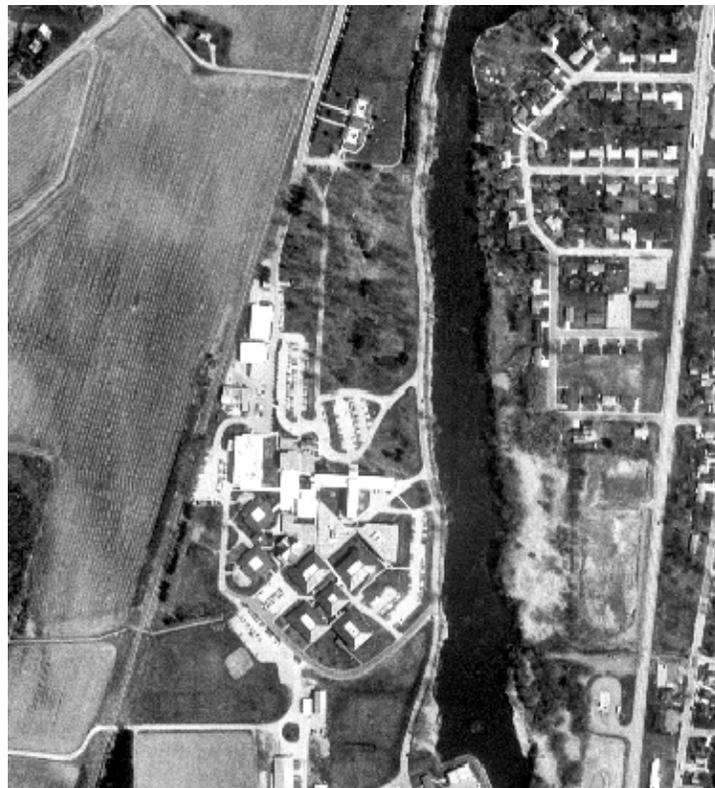
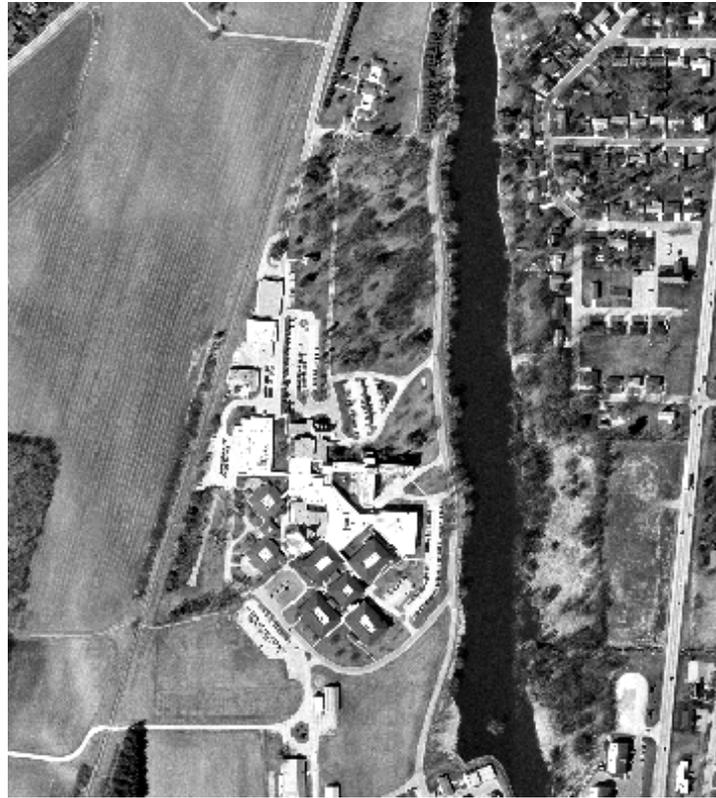
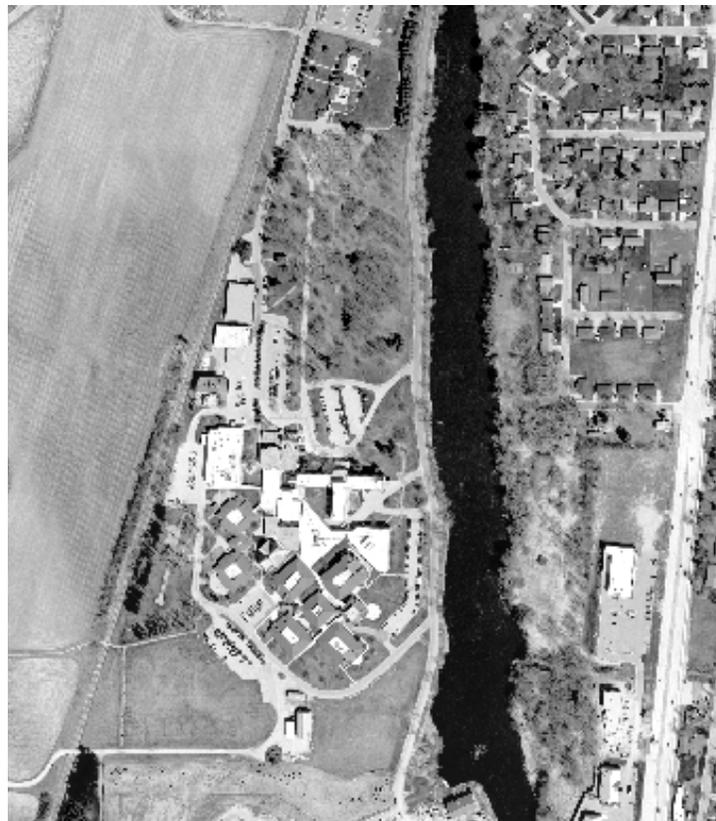
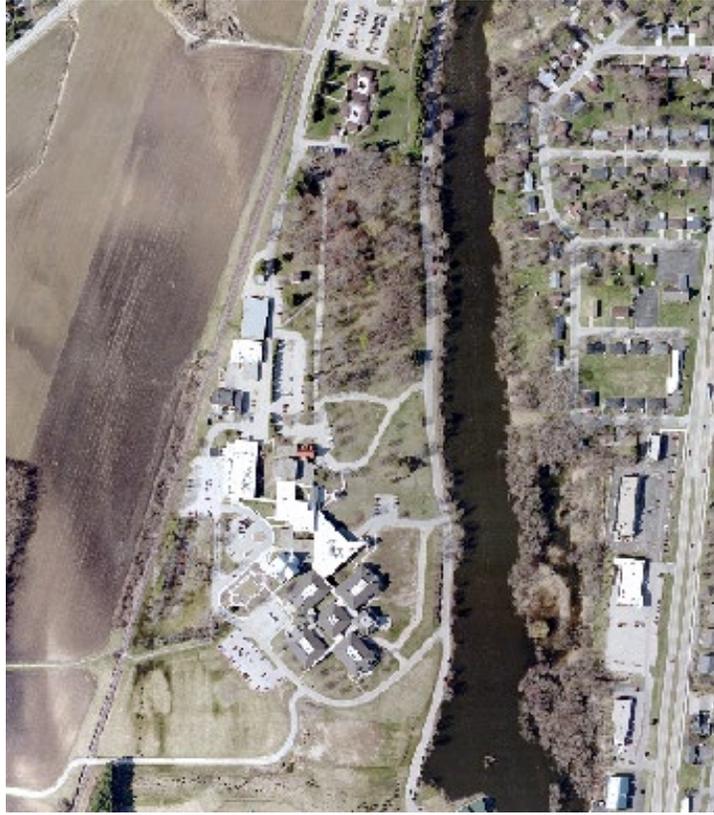
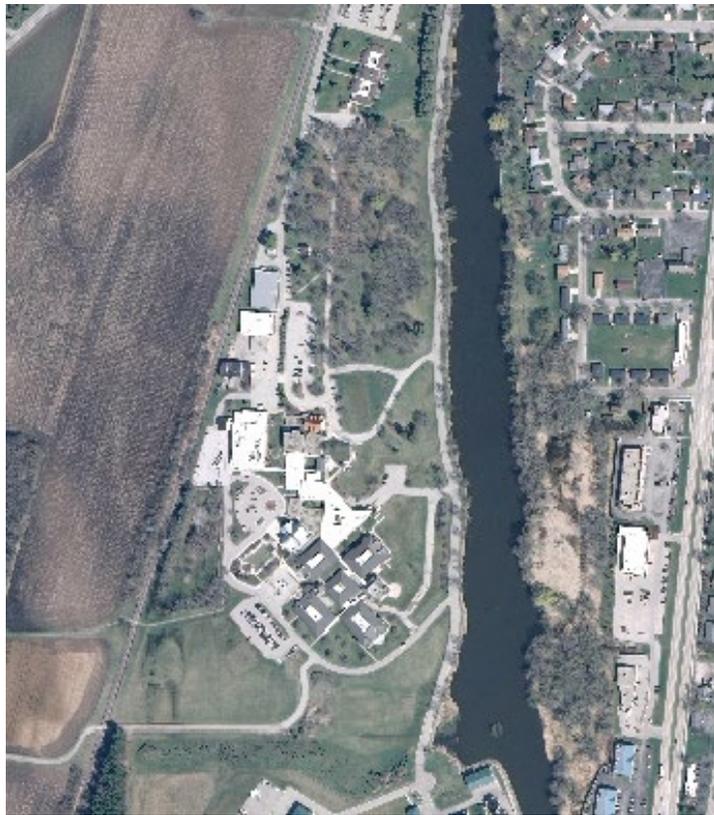
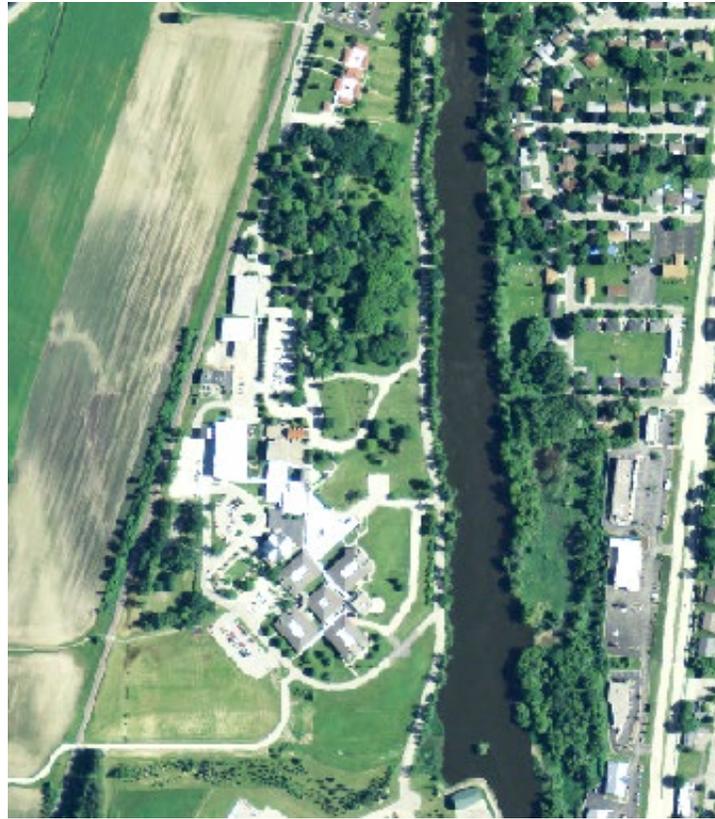
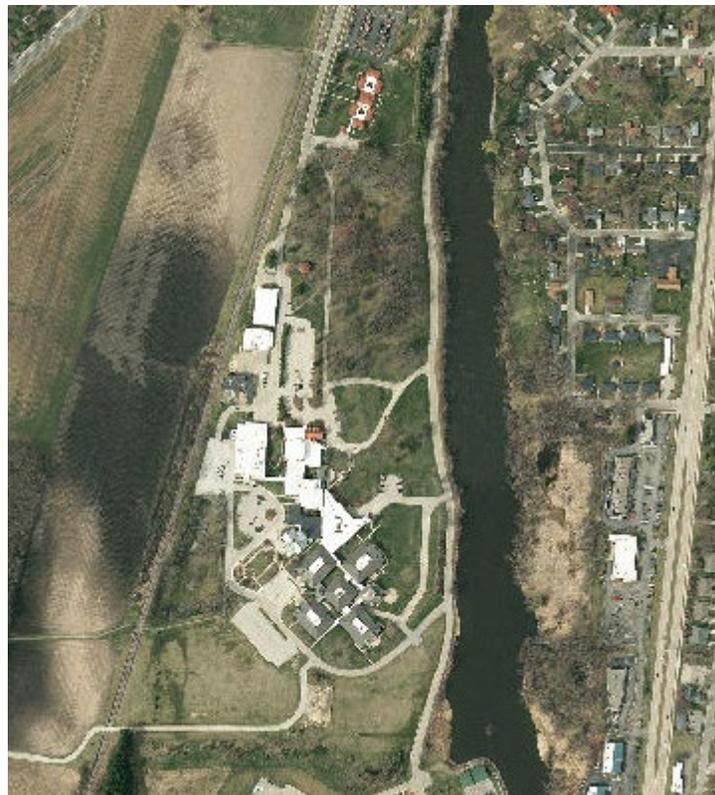
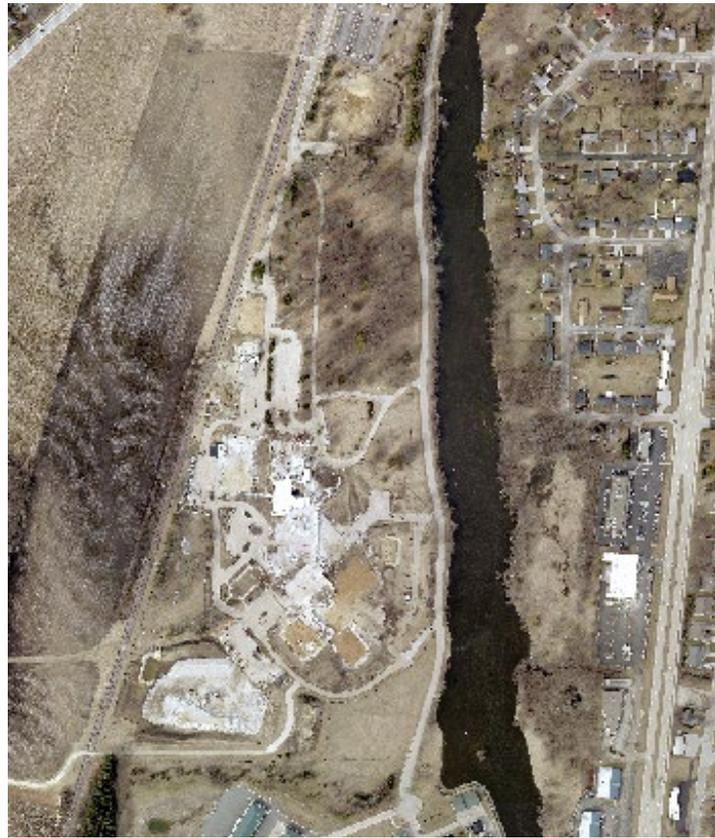
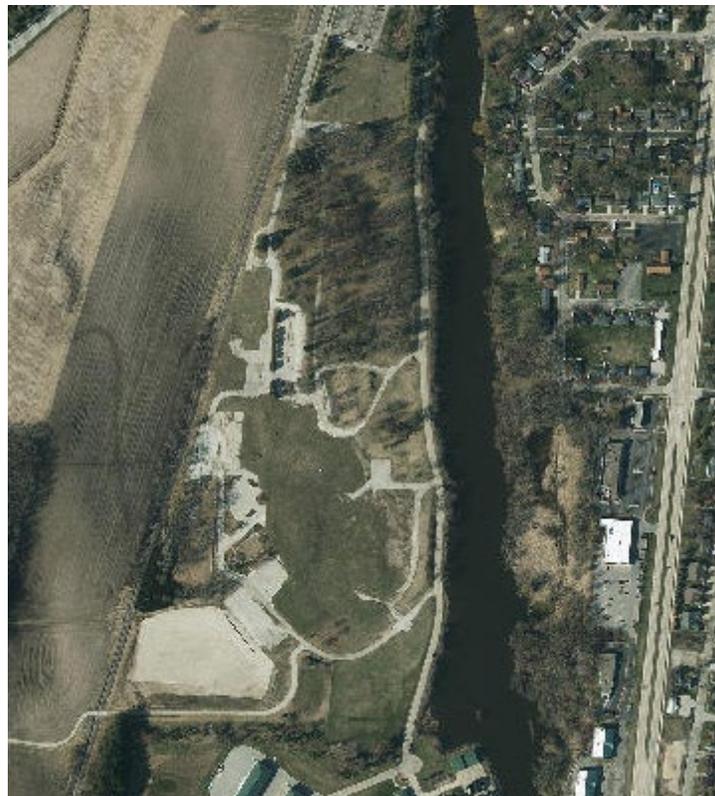
FIGURE 7. HISTORIC AERIAL PHOTOS

Historic aerial photographs revealed that the subject property was either pasture and/or nursery land as of 1937 (**FIGURE 7**). By 1996, a campus with a collection of buildings and landscaping had been built on the property. The campus began to be demolished sometime around 2018. A fill area had been placed in the southwest corner of the property at that time as well. By 2020, most of the buildings had been removed, but the old roads and parking lots remained in place.

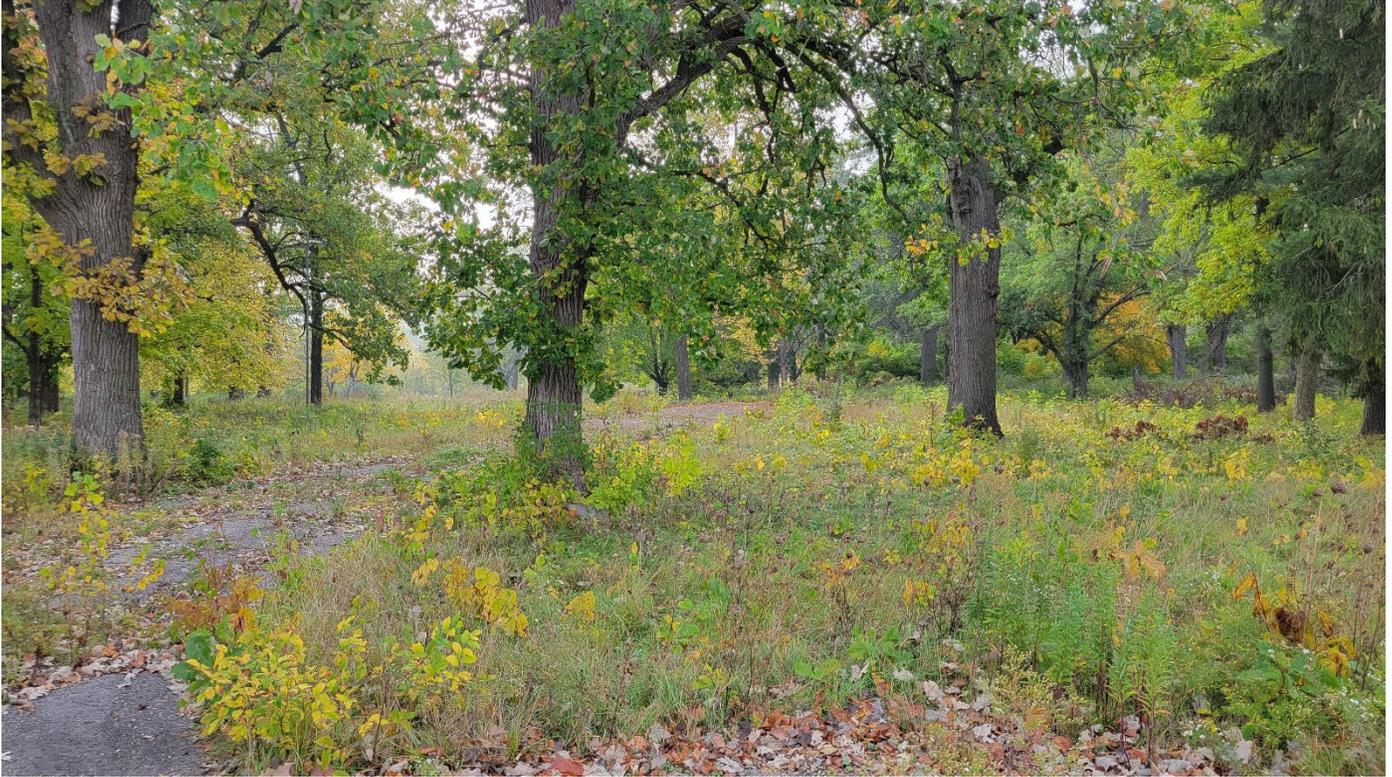
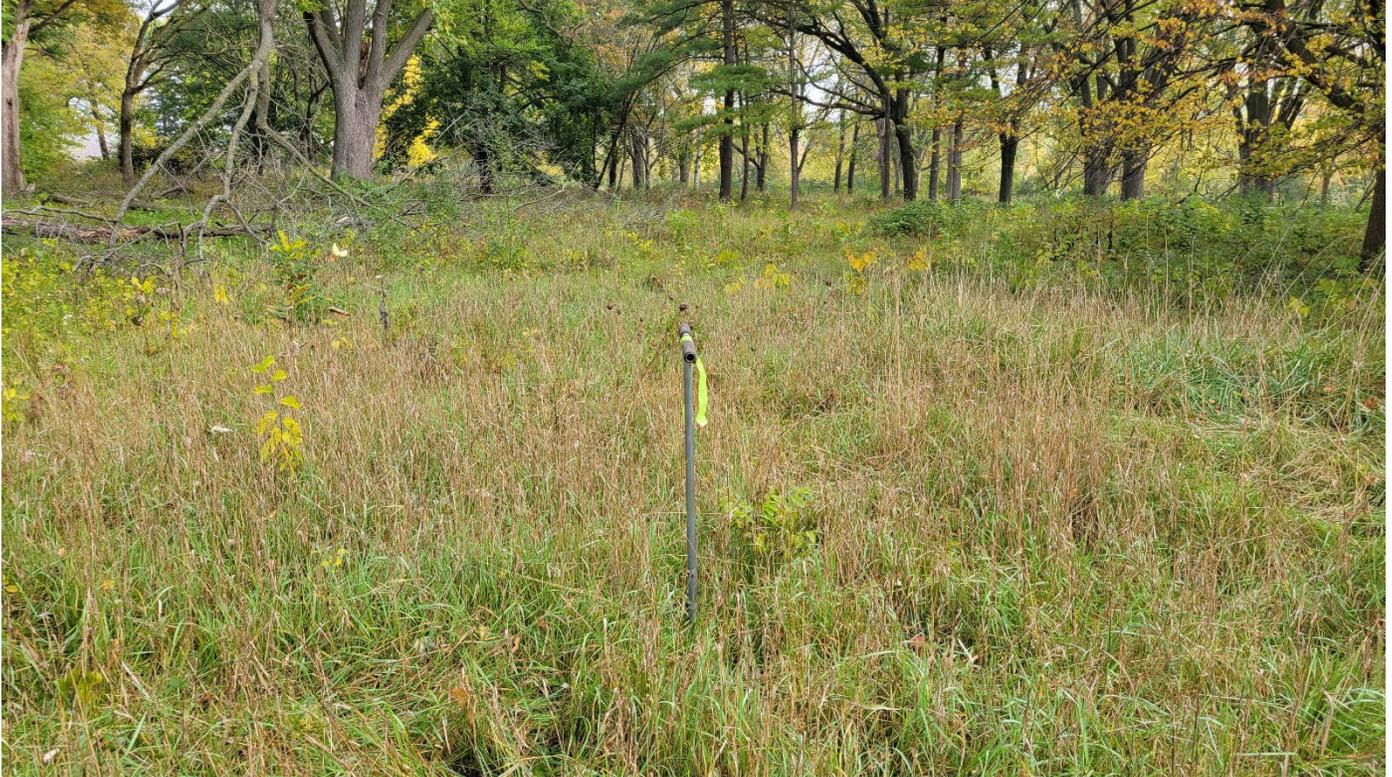
FIGURE 8. SITE PHOTOS

Data point #1 was taken on a slight terrace in open woods where the lawn was allowed to go fallow. The dominant species were American basswood, silver maple, and quackgrass. The signs

of wetland hydrology included one secondary indicator for Geomorphic Position. However, the soils were non-hydric and the vegetation was upland in nature.

Open woods with lawn left fallow on former campus.

View of DP 1.

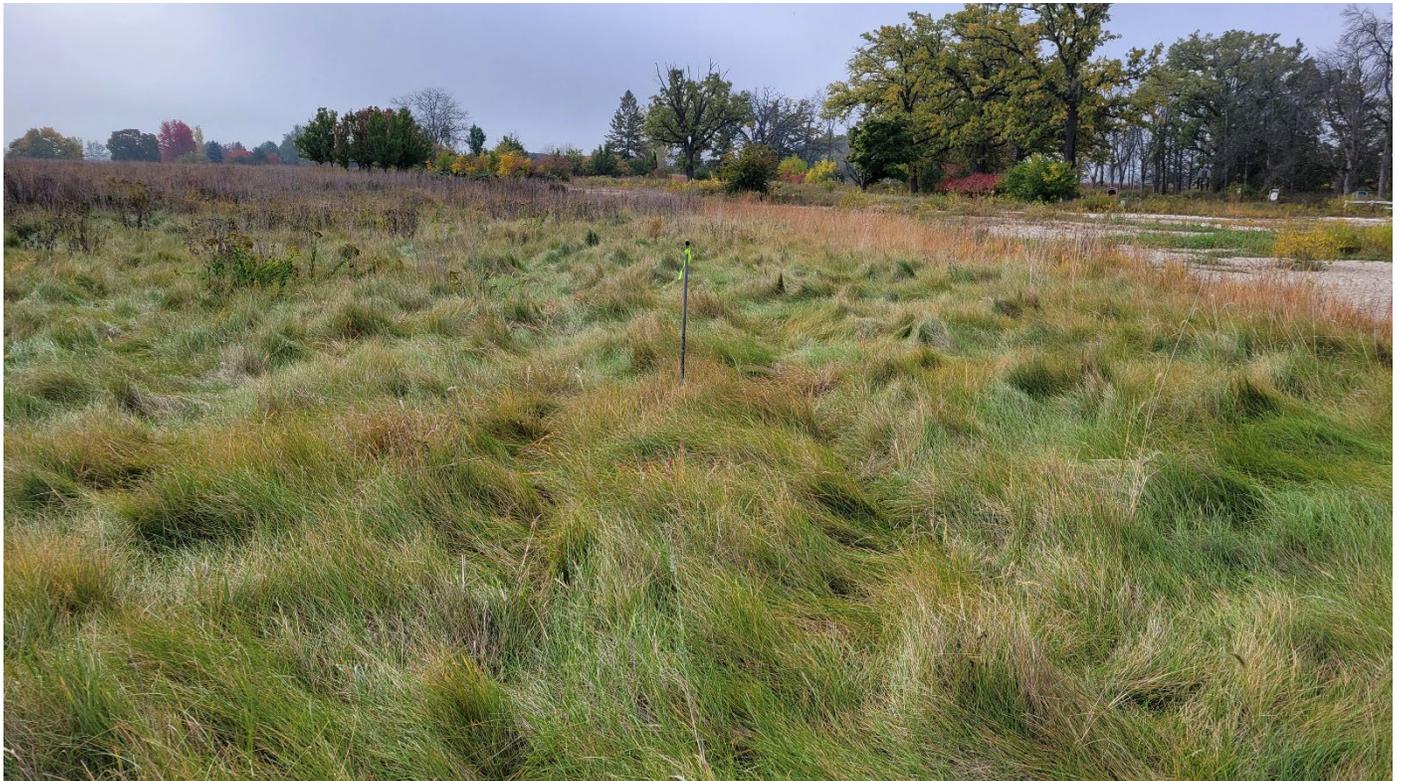
DP 2.

Data point #2 was taken in a depression next to an old parking lot. The dominant species was Kentucky bluegrass. The soils were a non-hydric layer of silty clay loam over gravel fill at 9 inches below the surface. Hydrology indicators were lacking aside from the one secondary indicator for Geomorphic Position.

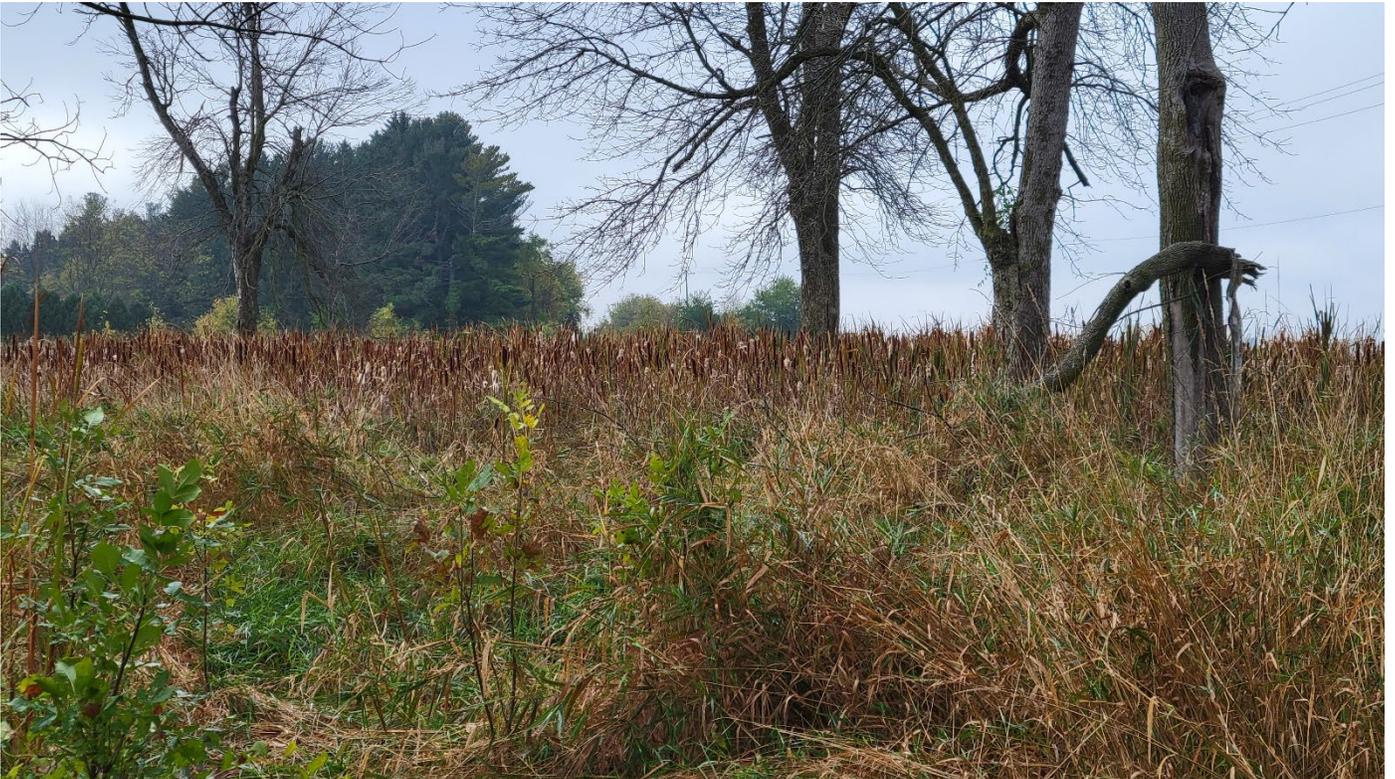
Wetland A.

This wetland is an emergent wetland in a depression that occurs in the area mapped as the hydric Sebewa silt loam. The fill pad that was constructed in the southwest corner of the

property may have trapped water in this area, making it wetter than it may have been previously. It was dominated by broad-leaf cattail and had an overstory of dead ash trees (#3). Soils met the hydric criteria for A12. Thick Dark Surface, F1. Loamy Mucky Mineral, and F6. Redox Dark Surface. Hydrology indicators included Geomorphic Position and FAC-Neutral Test. The adjacent upland point (#4) was approximately 1.5 feet in elevation higher than the wetland point and occurred in open woods. The dominant species were bur oak, white ash, green ash, burning bush, Kentucky bluegrass, and Canada thistle. Soil hydric indicators and wetland hydrology were lacking.

The south end of Wetland A was also sampled in an area that was scrub-shrub wetland. The dominant species (#8) were sandbar willow, Eastern cottonwood, reed canary grass, and Kentucky bluegrass. The soils met the hydric criteria for F6. Redox Dark Surface. Hydrology indicators included Drainage Patterns, Geomorphic Position, and FAC-Neutral Test. The upland point (#7) was taken on a convex hillslope about 12-18" above the wetland. The dominant species were mulberry and Kentucky bluegrass. Soils were non-hydric and hydrology was absent.

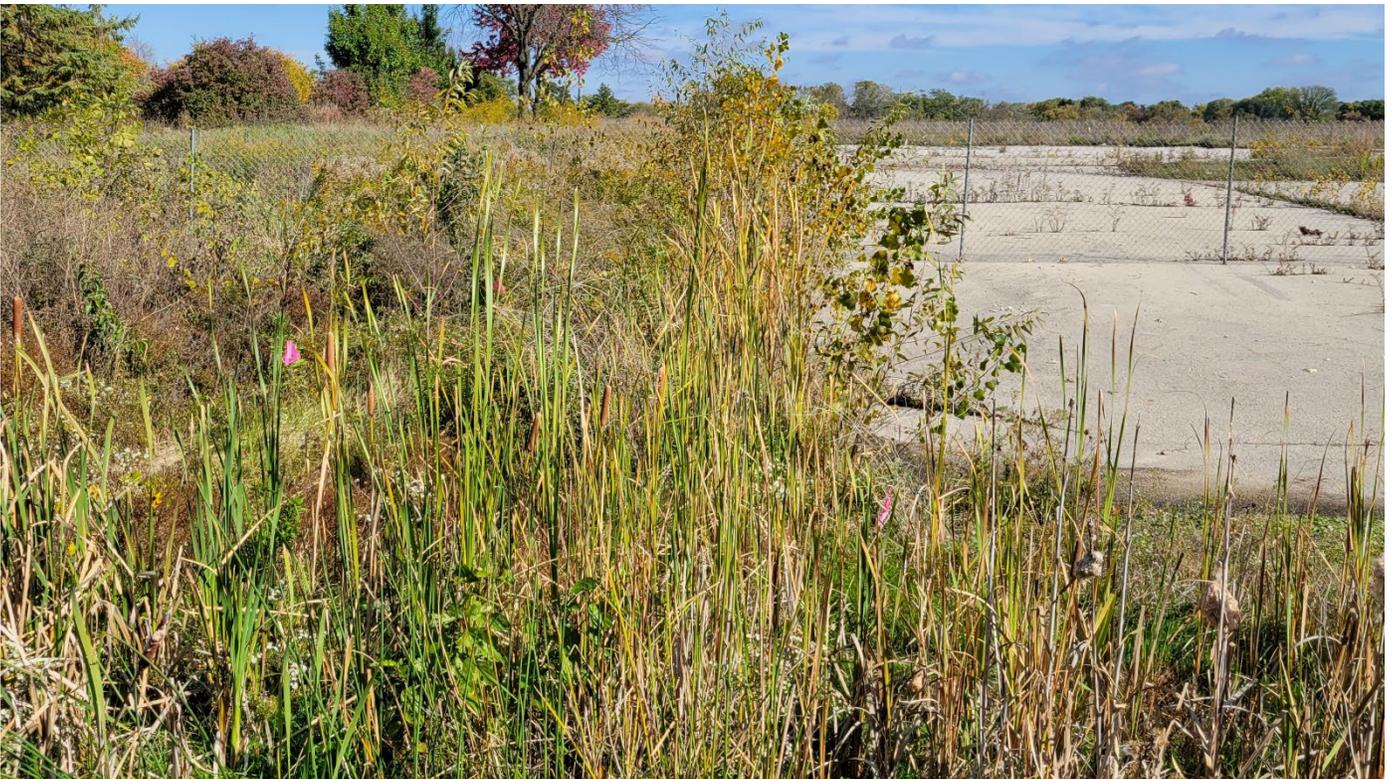
Wetland B.

This wetland is an emergent wetland pocket that receives runoff from an impervious area. The dominant vegetation (#10) included Eastern cottonwood, black willow, and broad-leaf cattail. There was a restrictive layer of gravel at four inches below the surface, but the soils met the criteria for F6. Redox Dark Surface. Hydrology indicators included Saturation, Geomorphic Position, and FAC-Neutral Test. The upland data point (#9) was taken on a gravel berm that was adjacent to the wetland and was also trapping water in the wetland. The dominant species on this berm were smooth sumac, wild lettuce, Canada thistle, and quackgrass. Hydric soils and wetland hydrology indicators were absent.

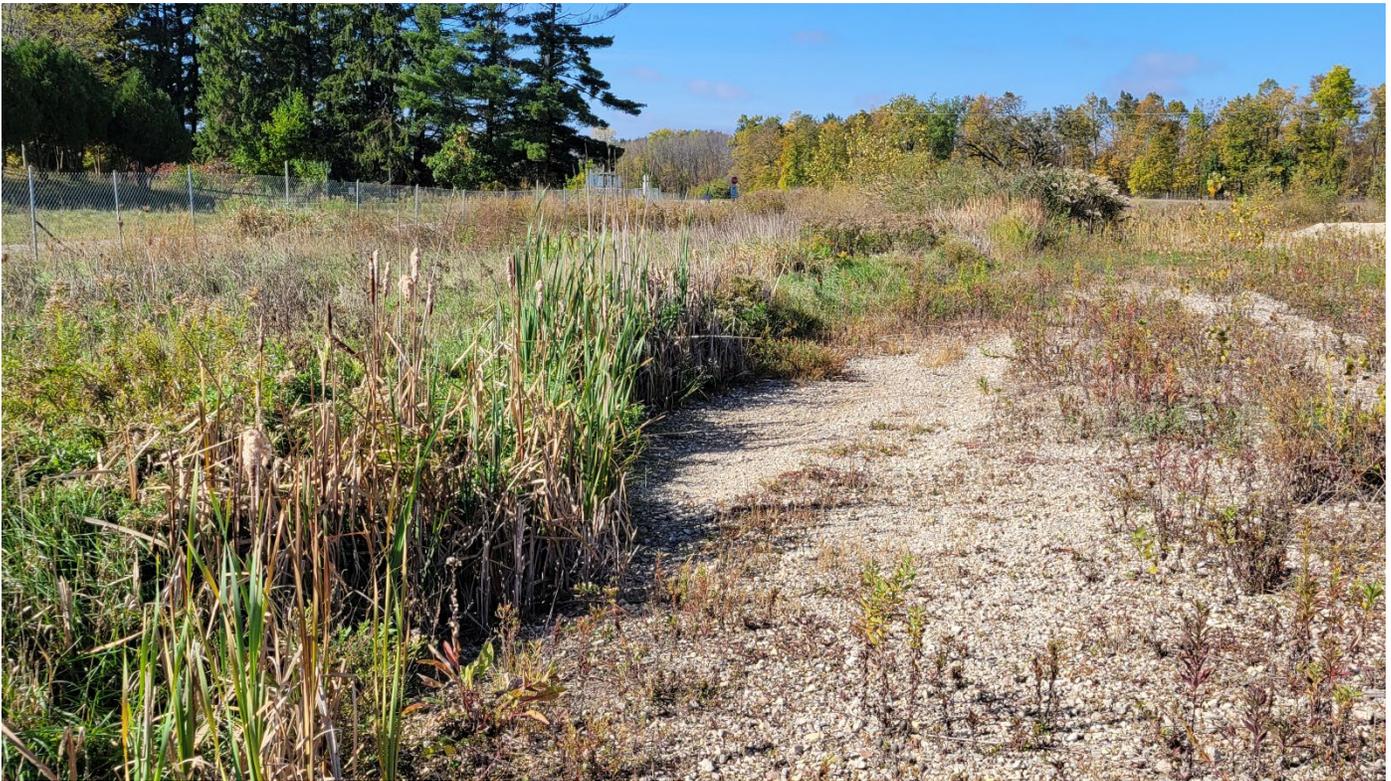
Wetland C.

This wetland is an emergent wetland in a swale that occurred along the south edge of the fill pad in the southwest corner of the parcel. The dominant vegetation (#5) included broad-leaf cattail. Hydric soil indicators for A11. Depleted Below Dark Surface, F3. Depleted Matrix, and F6. Redox Dark Surface were met. Hydrology indicators included Geomorphic Position and FAC-Neutral Test. The upland data point (#6) was taken on a hillslope that separated Wetland B from Wetland A. The dominant species were tall fescue and Kentucky bluegrass. The soils met the criteria for F6. Redox Dark Surface but hydrology indicators were lacking and the vegetation was upland in nature.
